EMERGENCY REHABILITATION OF BROWNSBARN BRIDGE

V.PAKRASHI¹, J.KELLY¹, J.HARKIN² & S.NANUKUTTAN²

¹Roughan & O'Donovan Consulting Engineers, Dublin, Ireland

Abstract

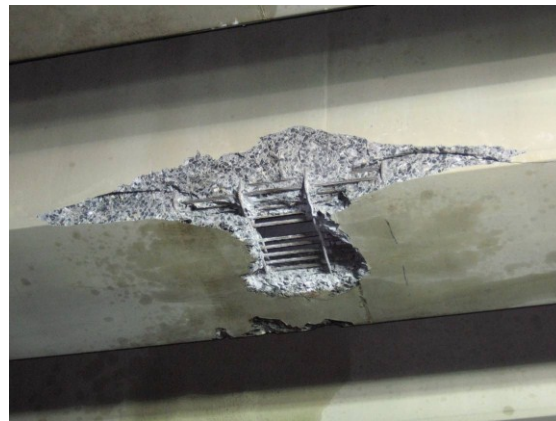
The impact damage affected two of the prestressed U8 beams the bridge consists of. The edge of the outer beam was damaged in a relatively benign fashion than a more extensively damaged inner beam. The main requirements of the rehabilitation involved

detailed repair of both beams including the introduction of some of the lost prestress into the damaged location of the inner beam. Although one of the prestressing strands was severed on the outer beam, it was computed that apart from this isolated severing of a strand, the prestressing tendons are essentially unaffected in both of the damaged beams. Under these circumstances, it was not envisaged that the damaged prestressing strand will be replaced.

The damage extent was assessed and estimated by a number of techniques including an initial visual, photographic and hammer tapping condition survey. The extent was further investigated by incorporating an impact echo test (Tinkey et.al, 2005). In addition, a 3-D visualization was made available through laser scanning. Figure 2 and Figure 3 show the impact damage photograph and the 3-D visualization respectively. Significant damage was established to be extending at least 1.5m on either side of the visually apparent damage.

Figure 2 – Photograph of Impact Damage

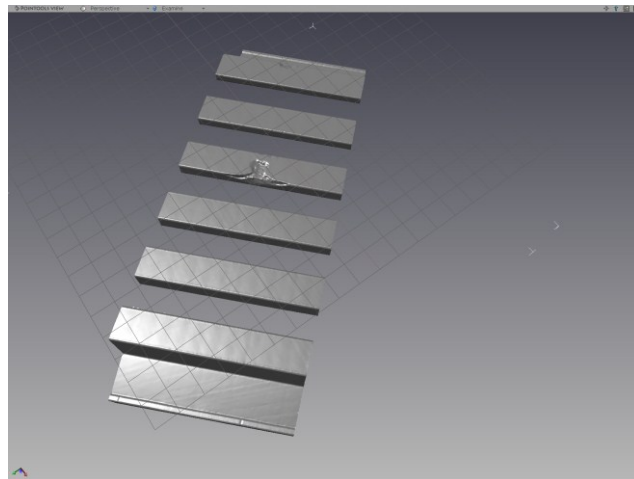
Figure 3 – 3-D Laser Scanning Visualisation made Available by Coastway Ltd.

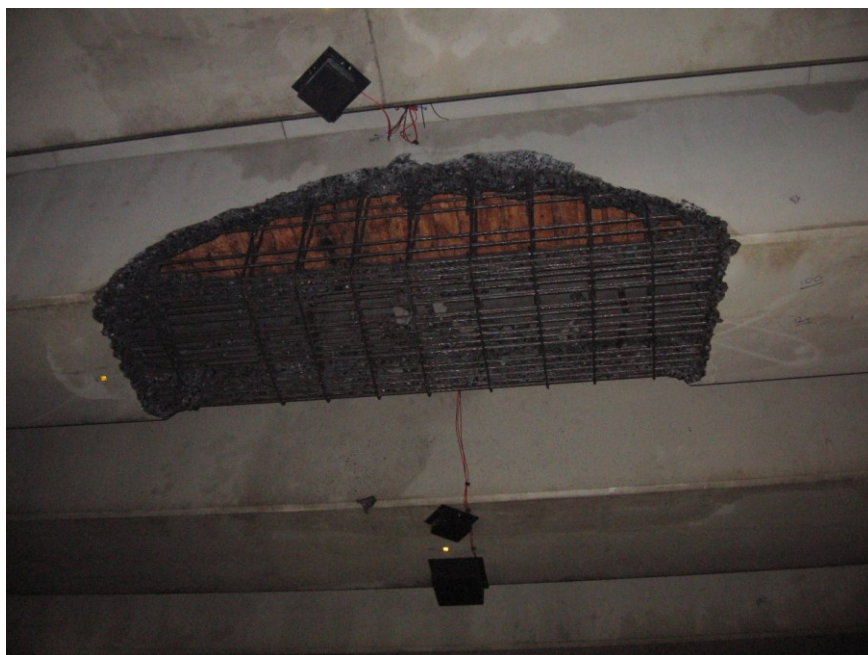
Figure 5 – Removal of Concrete through Hydrodemolition

was carried out. The organisation of hydrodemolition, including the erection of safety fencing and scaffolding was carried out during this time by Structural Concrete Bonding. Figure 5 shows a photograph of the removal of concrete through hydrodemolition. Although this method is a high risk activity and should only be carried out by experts, the process was chosen to be the best for the current project due to its precision and low impact on the existing strands.

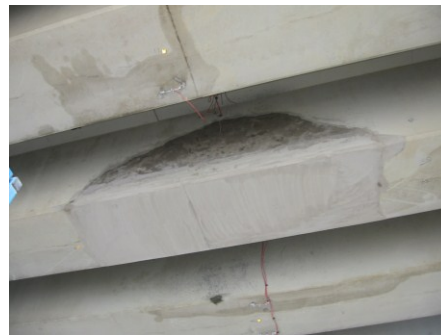
Figure 6 – Repaired Section of Damaged Beam

Hydrodemolition was followed by the installation of embedded strain gauges within the existing tendons and the application of high strength repair material. The material was expected to gain adequate strength within 12 hours and can take significant tension as well.

The preload was removed from the top of the bridge after the repair material gained adequate strength and some amount of prestress was reinstated following the removal of prestrain. The repaired section is shown in Figure 6 while the removal of preload is shown in Figure 7. A sample photograph of the traffic management provided by Complete Highway Maintenance throughout the rehabilitation is provided as Figure 8.

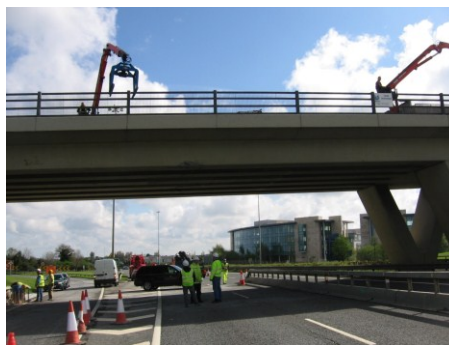
Figure 7 – Removal of Preload

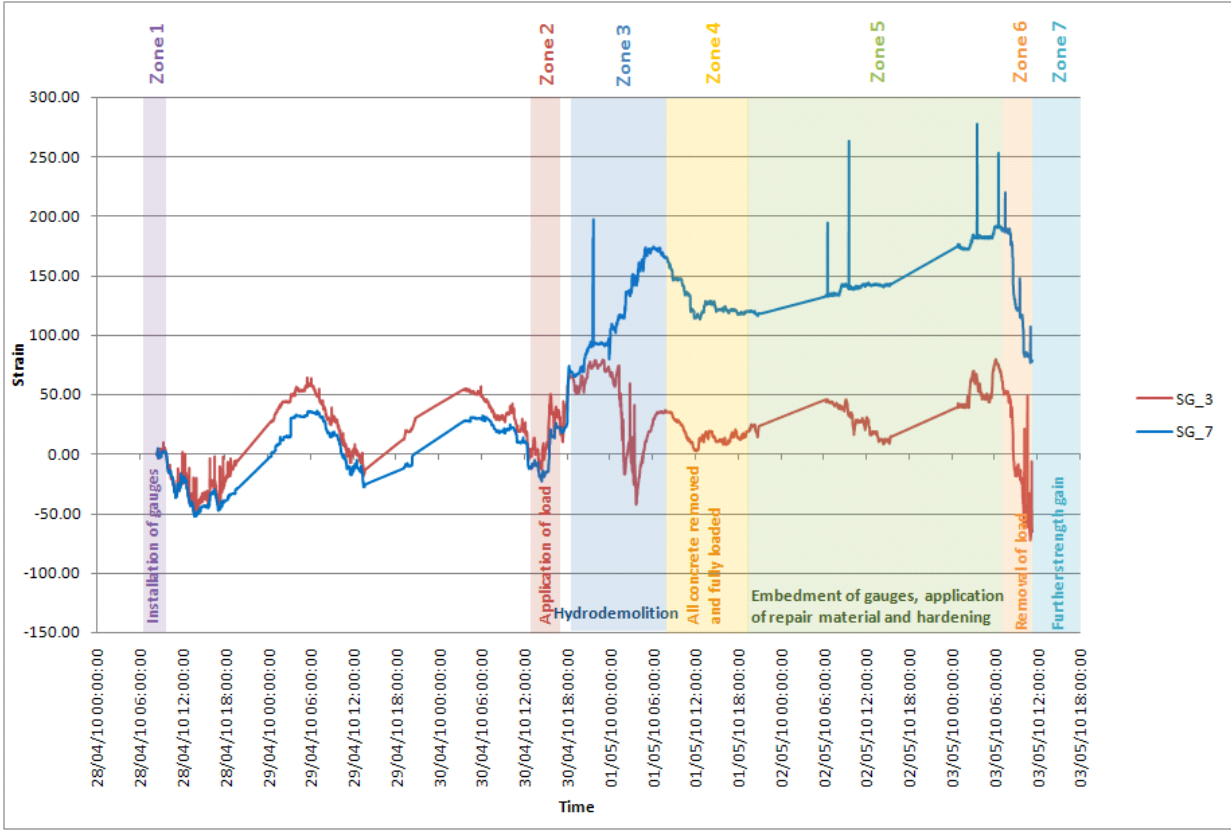
Figure 9 provides the example of two strain gauges from adjacent beams (damaged and undamaged) results during the entire rehabilitation process and zones them into the main activities along the timeline. The strains are in multiples of 10^{-6} . This graph creates the departure point of detailed structural health monitoring analyses including the effects of thermal oscillations, shrinkage characteristics, redistributions of strains, release of entrapped strains, participation and energy flow of adjacent beams and the real mechanics of structures similar to Brownsbarn Bridge. Such analyses are beyond the scope of the current paper.

Figure 9 – Activity Footprints in Strain Gauge Monitoring Data and Event Hotspots
