## Full-Scale Tests of a Wood-Frame Structure under Extreme Wind Loads

# Full-Scale Tests of a Wood-Frame Structure under Extreme Wind Loads

Derek A Stedman

Department of Civil and Environmental Engineering  
Faculty of Engineering

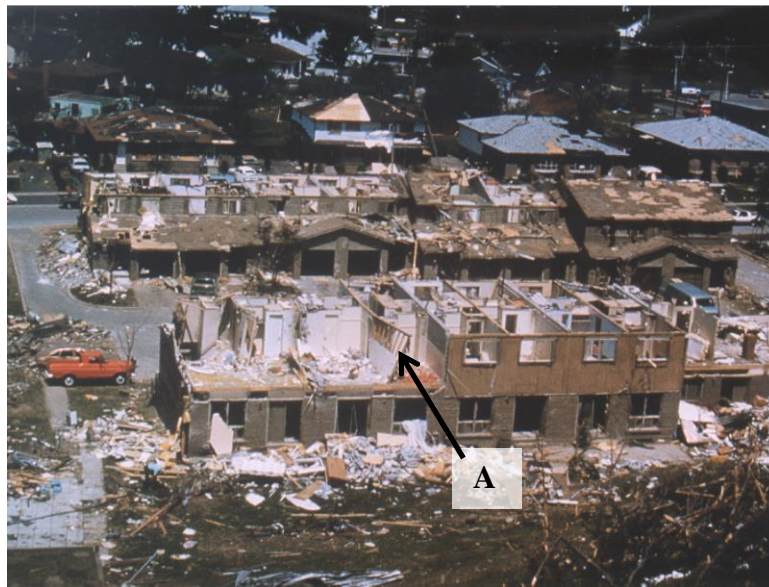
A tornado struck the town of Barrie on May 31 1985, which was rated F4 (this was before the implementation of the EF scale). Figure 1.3 shows some of the damage. There is a vast range of damage, from massive destruction the front to minor roof damage near the back. The progression of damage shows the expected progression of damage as the wind speed increases. On the right side, where roofs are in place, shingles have been damaged. The building roof in right-hand foreground has failed but the exterior walls have remained intact; research has been done in this field (Morrison et al., 2012; Reardon, 1986; Xu et al. 1996; Kopp et al., 2011 and Henderson et al. 2009). Moving from the right to left of the building in the foreground, the building goes from the roof removed and no exterior wall damage to roof and exterior walls removed, an example of such

damage can be seen at A. The level of damage at A is significantly higher and more likely to cause injuries or deaths. Limited research has been done on the wind speeds required to cause the walls to fail after the roof has failed (as seen in Figure 1.3), hence the need to examine this type of house failure.

Figure 1.3 - Tornado damage in Barrie, Ontario 1985 (from Davenport and Kopp, 2002).

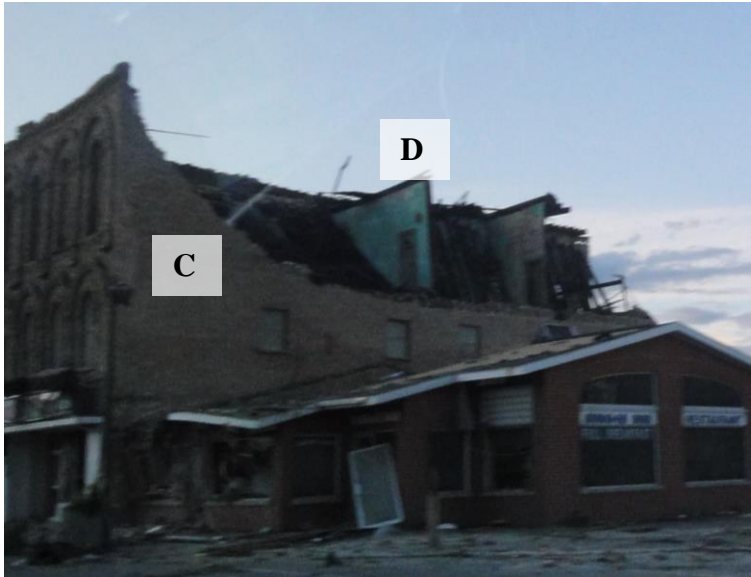
Figure 1.4 -A damaged structure in Goderich, Ontario. Picture courtesy of Sarah Stenabaugh

Figure 1.4 shows a multi-storey brick structure following the tornado; the top storey exhibits significant damage while the lower floors have remained intact. In particular, the roof and exterior walls have failed. The damage patterns at C and D are very similar to those seen after the Barrie Ontario tornado; the exterior wall has failed and the interior wall has not.

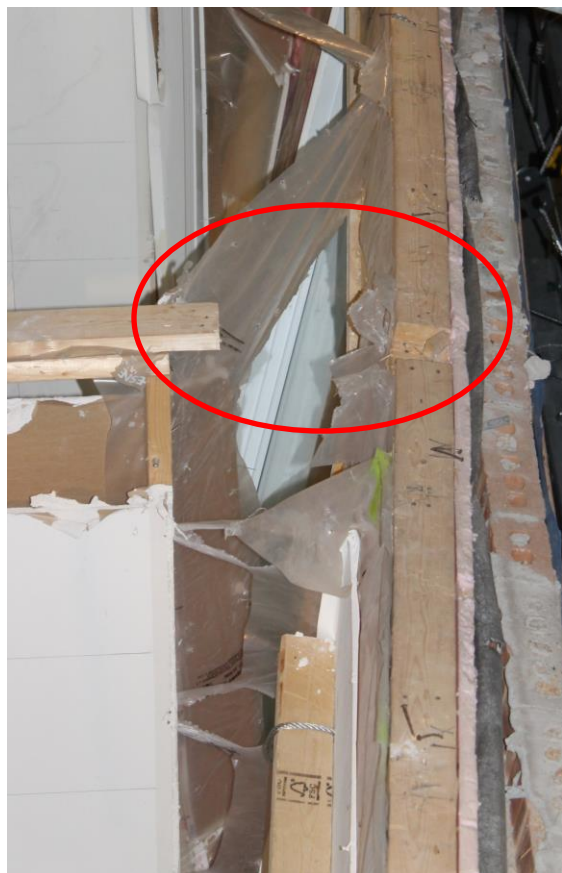
The A10-J10 wall failure happened after loading had caused substantial visible bending and displacement in all four walls, but most noticeably the A10 – J10 (South) and J1 – J10 (East) walls. The top plate on the South wall (A10-J10) appeared to be acting as one long beam with the two connecting interior walls substantially limiting the overall displacements. Ultimately, it was the failure of the connections between the interior walls and the exterior wall which failed, as shown in red in Figure 4.1. The implications of the roles of the interior-exterior wall connections with respect to overall house strength are discussed in Section 5.1.

Figure 4.1 – The segment of wall C10 - E10 after

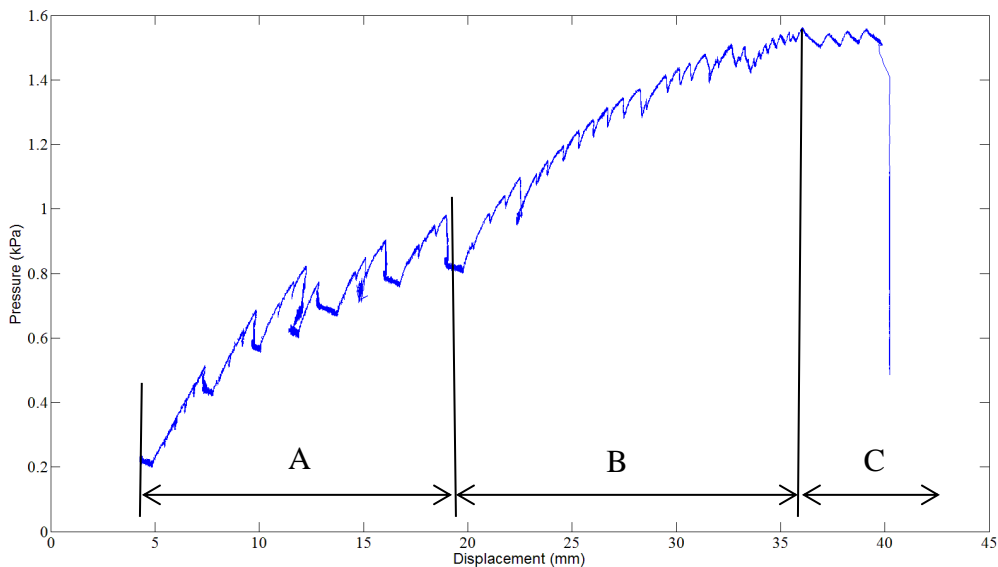
The load-displacement curve for the South wall spanning F10 – J10, shown in Figure 4.2, depicts the process leading up to failure. The load is plotted as net pressure across each wall. Pressure was calculated based on the assumption of uniform loading using the locations where the load pads were applied by dividing the load applied to each load pad by the relevant tributary area. In this Figure, the displacement is at the top plate level from displacement transducer NE1 (Figure 3.20a), part way along the way at location I1.

**Figure 4.2 – The load deflection curve for wall F10 – J10, from a displacement transducer at I1**

In the region C, the wall cannot resist any higher load, corresponding to the onset of failure. The maximum resistance of a wood structure may be time dependant, decreasing as the load is applied more slowly. Morrison and Kopp (2011) found this to be an insignificant issue for failures of connections, hence, detailed examination of time effects are not considered in this thesis. The key failure was at the interior-exterior wall connections as shown in Figure 4.3. This failure occurred at a load of about 1.5 kPa. Comparing the damage shown in Figures 1.3 and 1.4 (from tornado damage surveys) to that in these Figures, there is some similarity indicating that this may be a common type of failure of wall systems following global roof failure.

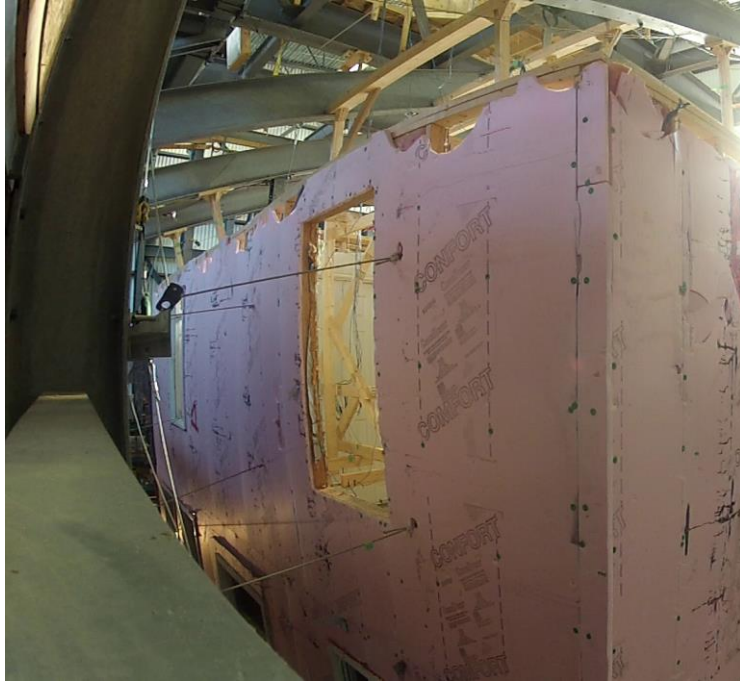
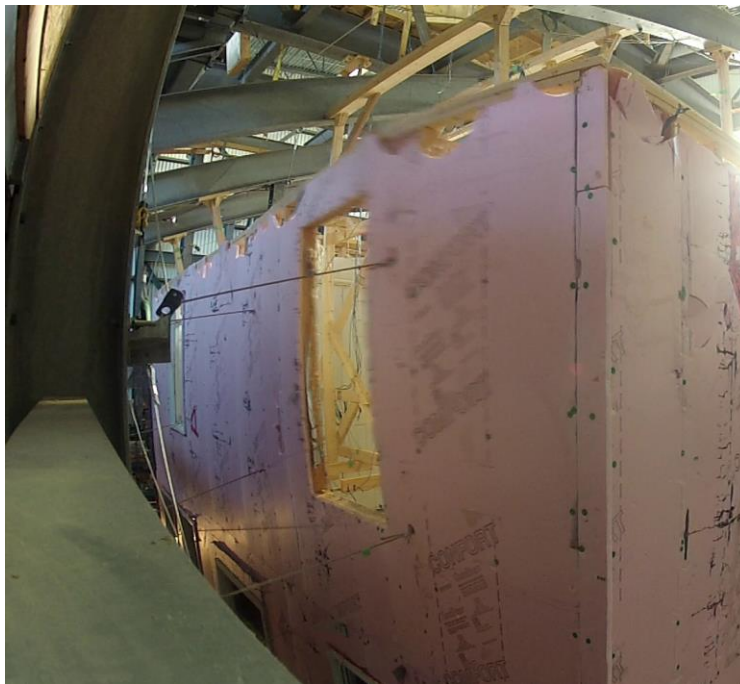
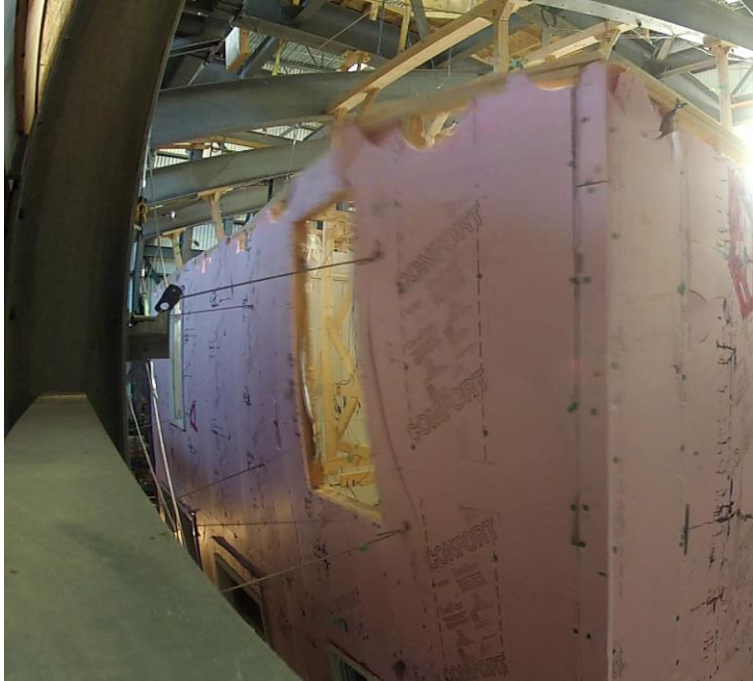
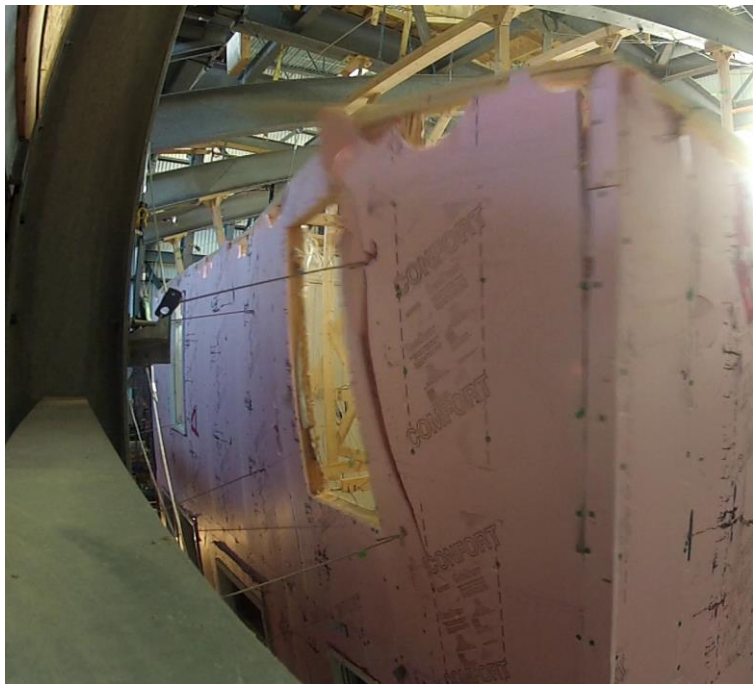
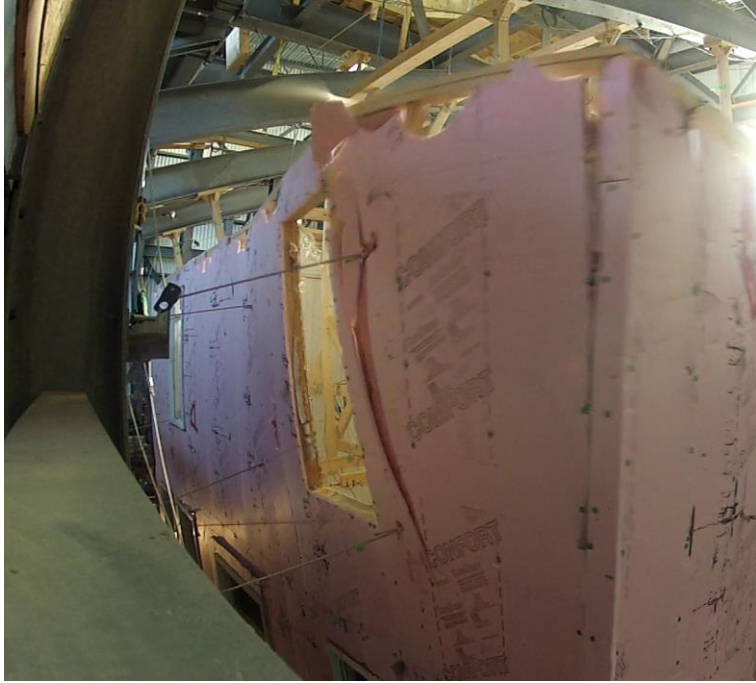
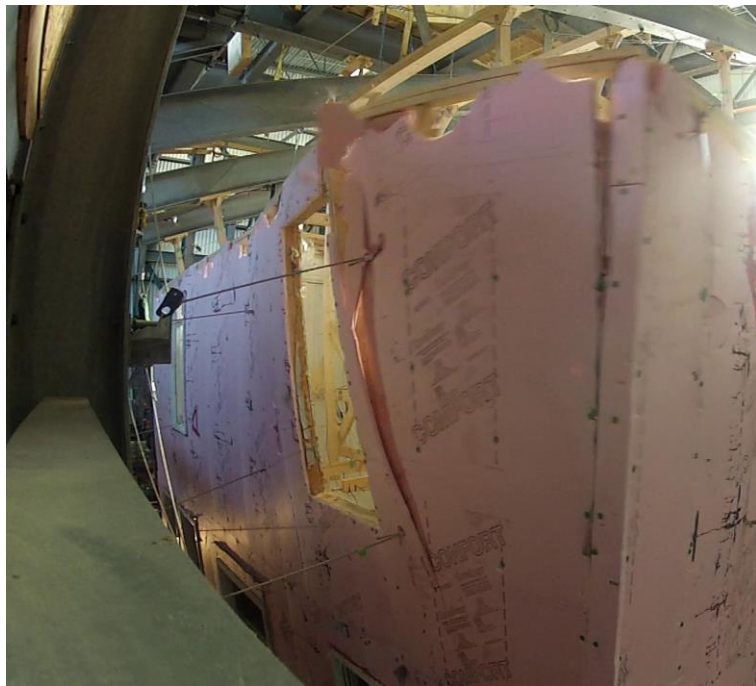
Following the tests on the full house clad in brick veneer, the bricks were removed from the house and local testing was conducted on un-damaged portions of the walls. The first catastrophic failure for house without brick veneer is discussed here. This failure was preceded by large displacements and initiated with a split occurring in the top plate. Figures 4.4a – 4.4f show the progression of the failure as recorded by a video camera at 30 frames per second, with the image sequence spanning a duration of less than 0.2 seconds. Due to the large magnitude of the displacements which occurred with the failure, the LVDTs did not capture the dynamic movement of the wall immediately after the top plate failed. In Figure 4.4a the wall is still intact, progressing from 4.4b to 4.4d, the top plate can be seen to be splitting and a large vertical crack is forming in the Styrofoam beneath the top plate split. In Figures 4.4c and d, the initiation of a vertical crack along the edge of the corner can be seen. Finally, Figures 4.4e and f show the propagation of the cracks and continuation of the failure to the final displacement of the wall.

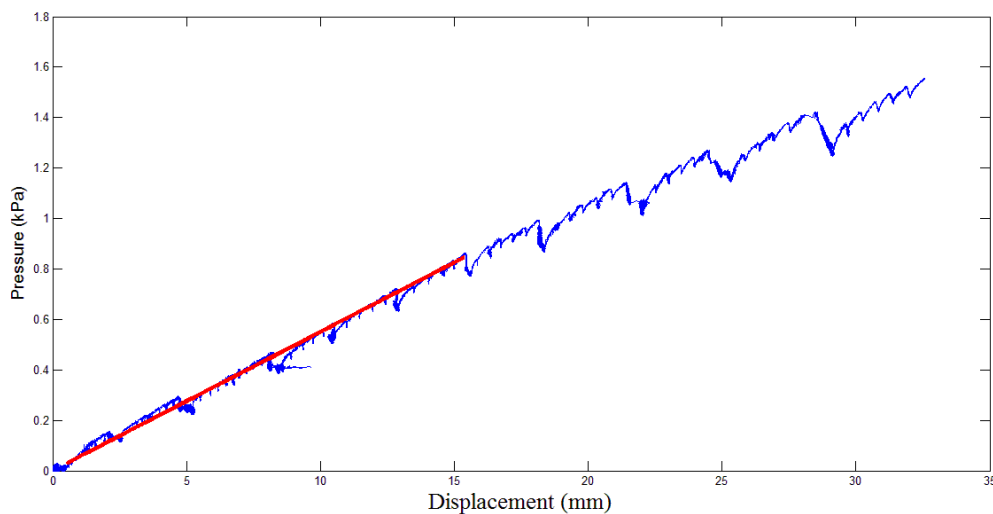
The load-displacement curve for this wall is relatively linear up to an applied pressure of about 0.8kPa. This is shown in Figure 4.5, which shows the pressure-displacement curve for an LVDT located at the top of the wall, about 160mm from the corner located at A1 towards B1. It is noted that this failure load is the same as was observed for the first failure of the full house with the brick attached (along wall A10 – J10, as discussed in the previous section). However, when wall A1-D1 failed, there was negligible damage at the current location, indicating that the brick veneer has a substantial effect and that the first failure would have occurred at a much

**Figure 4.5 - Load Displacement curve for the wall A1-D1.**

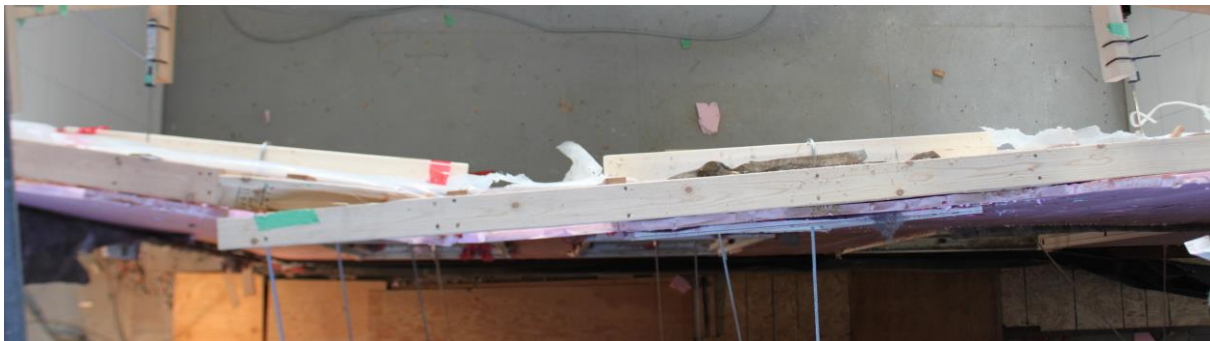
**Figure 4.6 - Plan view of wall E1-J1 after catastrophic failure.**

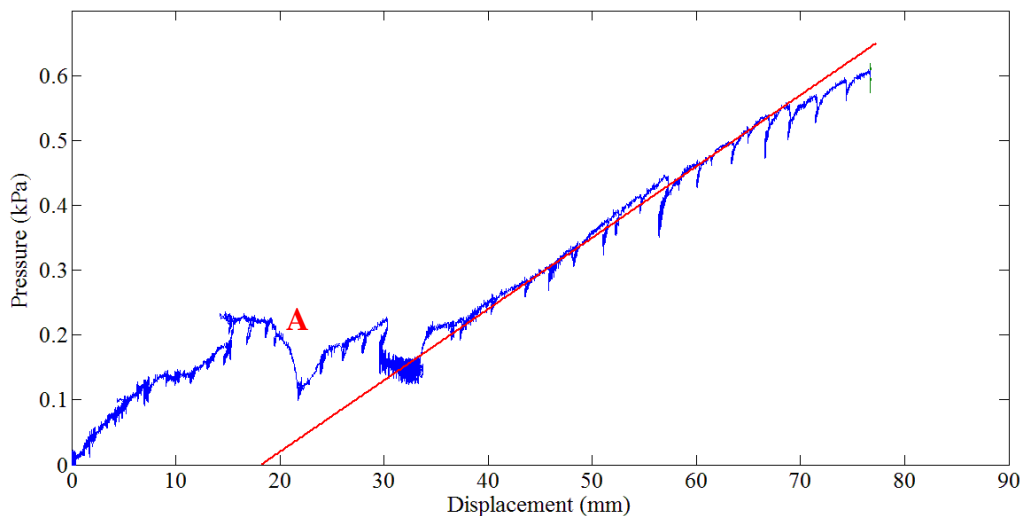
The load-displacement curve is shown in Figure 4.7, where a linear section can be seen, as shown by the red line. The Figure provides the results for the wall segment E1 – J1, with the displacement measured at the top plate at location F1. For lower loads, there is the typical increase in load and displacement, followed by a region where the load remains relatively constant while displacement increases. This is due to the loading and failure of the A1-D1 wall described in Section 4.2. When that section of the wall was on the verge of failure, load increases

From the data, this failure occurred at a pressure of 0.6 kPa, significantly less than the failure load of other walls. However, it sustained the highest loads in the earlier experiments. As with the first full house experiment with brick veneer in place, the wall failures appear to be similar to damage survey observations (e.g., Figures 1.3 and 1.4) which show similar final states. As previously discussed, the net loading effects allow loads applied at one location to be

**Figure 4.7 - A load displacement curve for wall E1-J1.**

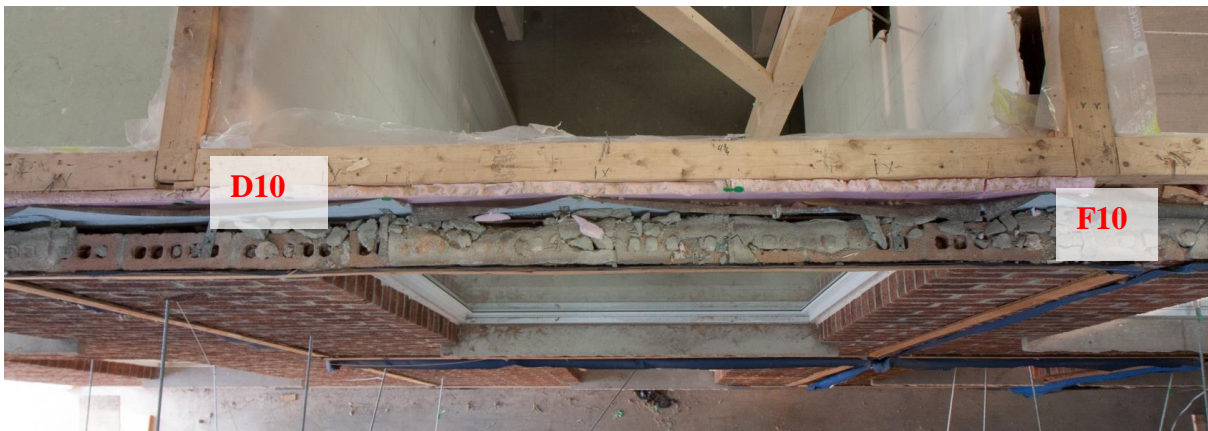
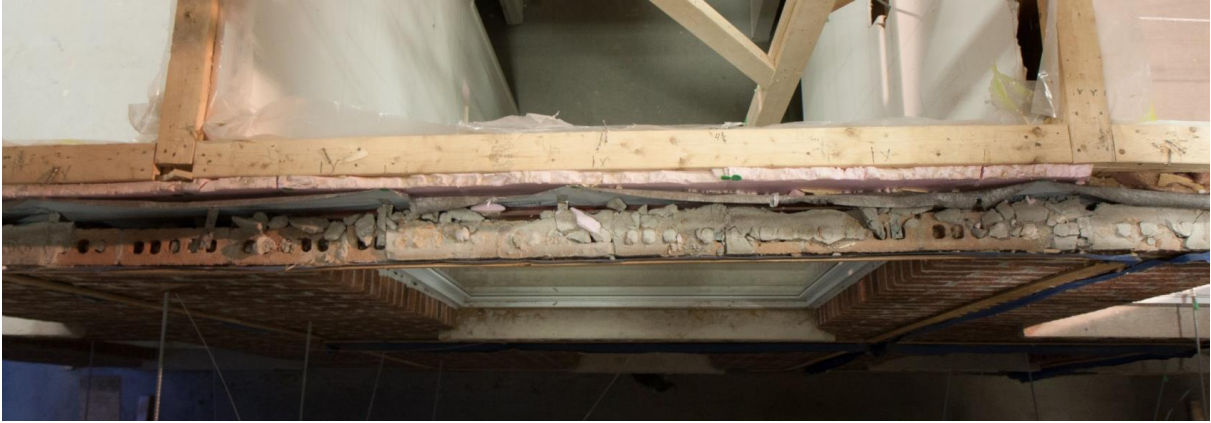
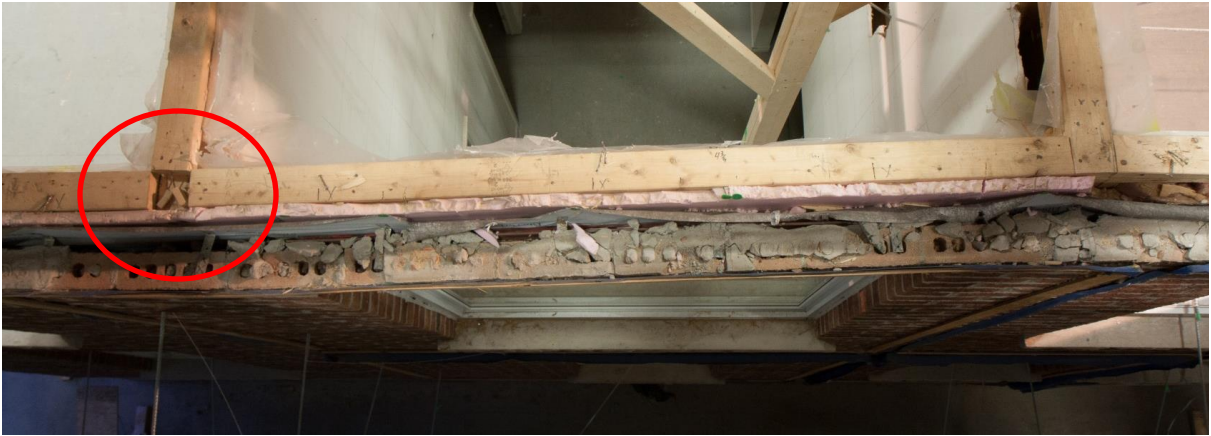
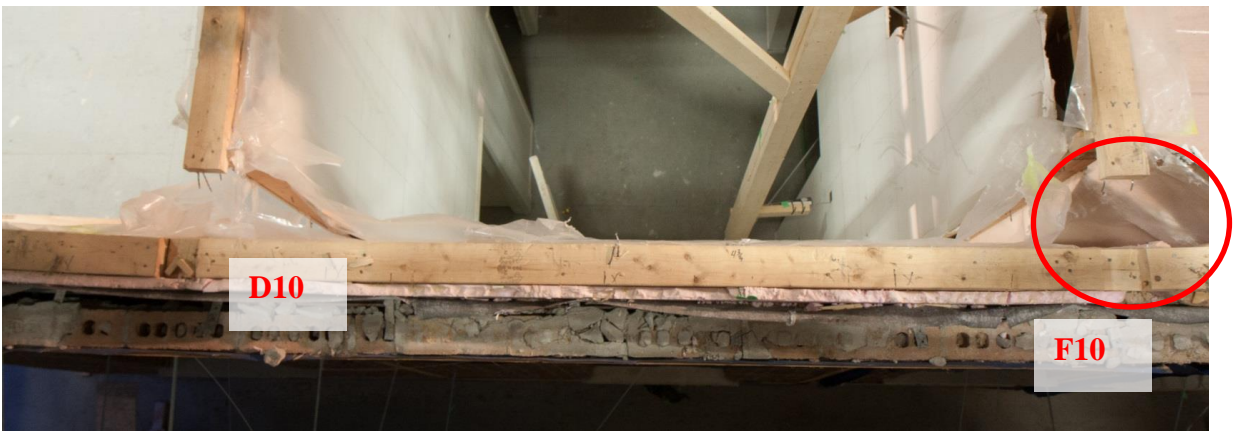
If observed in real time, the failure of the two joints located at D10 and F10 appears to be simultaneous. However, a frame-by-frame analysis shows a different story. Failure first occurred at the joint at D10, followed by the joint at F10. Figures 5.1 to 5.4 show the progression of the failure: Figure 5.1 shows the wall in its unloaded state, Figure 5.2 shows the loaded wall immediately prior to failure, Figure 5.3 shows the wall after failure of the joint at D10 and Figure 5.4 shows the wall after failure of the joint at F10. Joint failures in each figure are identified by circles.

When the connection at D10 fails, the interior wall is no longer providing a restraint at the exterior top plate. Because Wall D10 is perpendicular to the loaded wall it transferred the out-of-plane (shear) forces in the exterior wall into racking forces in the interior wall, which is strong in this aspect. A result of the joint failing is loss of this load path. Following the failure at D10, the loads being applied to the exterior wall between A10 and F10 must be restrained at joint F10 and the corners. This immediately increases the net loads at joint F10, causing this joint to fail and catastrophic failure of the entire wall. A schematic of the change in load path is shown in Figure 5.5, which shows the approximate load path before the failure at D10 (top) and then after the failure at D10 (bottom). The Figure shows a basic approximation of how the reaction forces at the interior-exterior wall connections change when the connection at D10 fails. Thus, the connection strengths at the interior-exterior wall interfaces are extremely important for the strength of the entire exterior wall.

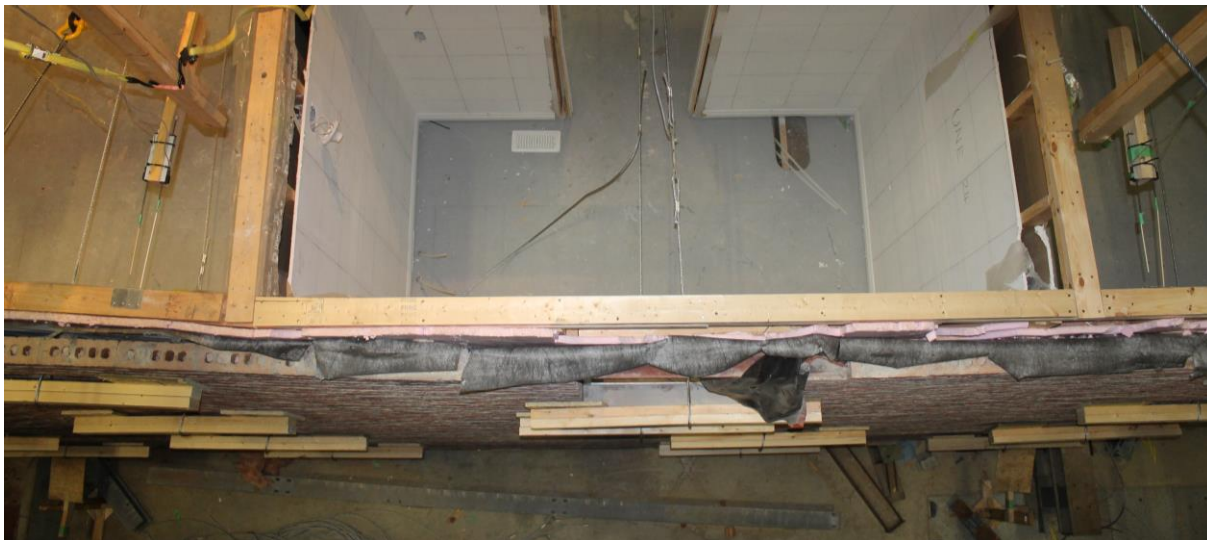
In the bathroom, there were no LVDTs, so no quantitative measurement could be made. Despite a vertical line of loads being applied in the middle of that room, where the maximum possible top plate bending effects would be seen, there was no bending noticed of this top plate (from observations and a qualitative analysis of photographs, such as Figure 5.7). The same loads were applied to this room as the master bedroom, which saw significant bending. This may be because the unsupported length of the bathroom wall is only 2/3 of the unsupported length of the master bedroom wall. For simplicity, if the walls are assumed to be simply supported beams subjected to a uniformly distributed load, the maximum deflection is governed by the span,  $l$ , to the power of four, as given by equation 5.1.

**Figure 5.7 - Wall J7-J3 (left to right) under load.**

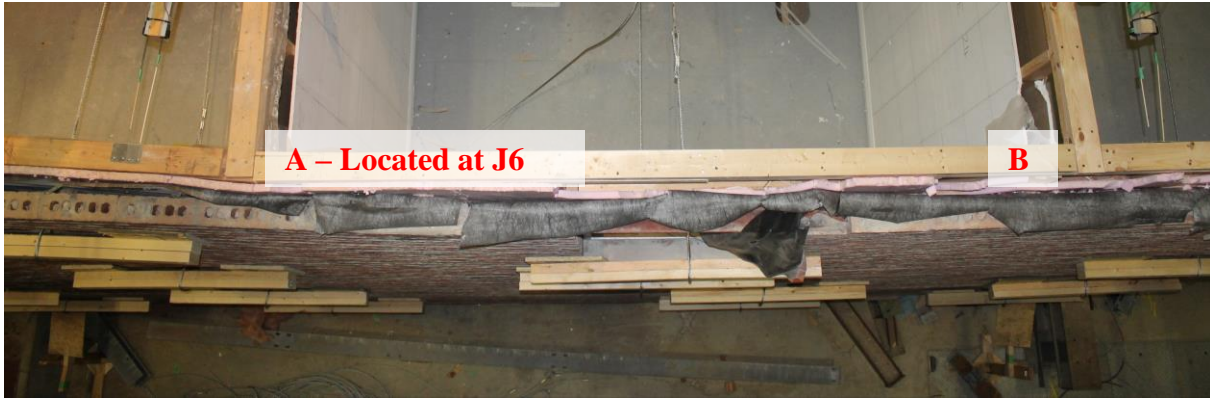
Cracking of the top plate occurred in several locations; Figure 6.1 shows a span of the East wall, the segment from J7 to J3. With closer examination (Figure 6.2), it can be seen that the top plate has cracked along the line of the nails (point A in Figure 6.1). This is a failure of the member due to overall deflection of the wall and the nails being placed too close to the edge of the top plate member. In addition, the bottom member of the top plate failed further along (B, or Figure 6.3) and moved out of alignment with the top member, as shown in Figure 6.3.

**Figure 6.1 - Looking along the East wall from J7 – J3.**

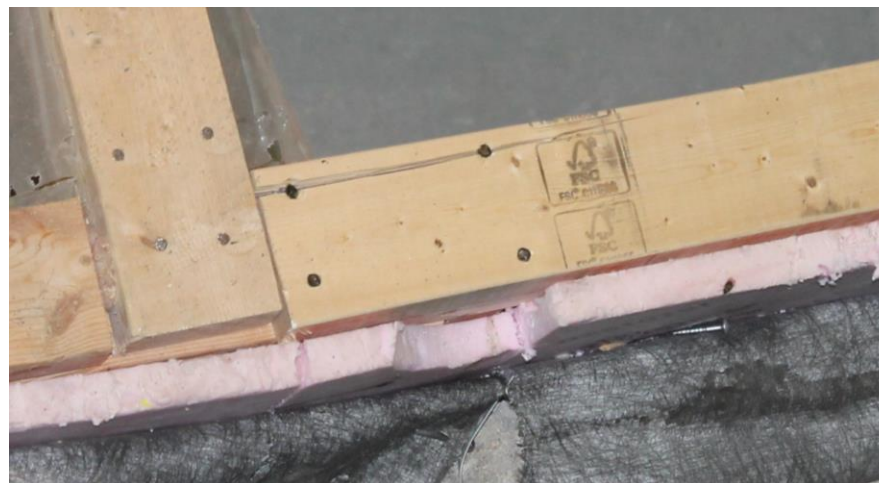
**Figure 6.2 - Close up of top plate crack (A in figure 6.1) J6.**

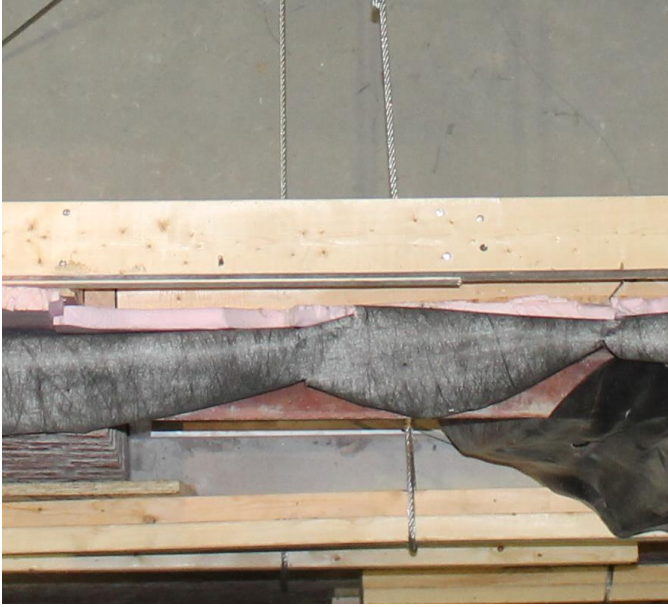
**Figure 6.3 - Close up view of top plate slip (B in figure 6.2) J4-J5.**

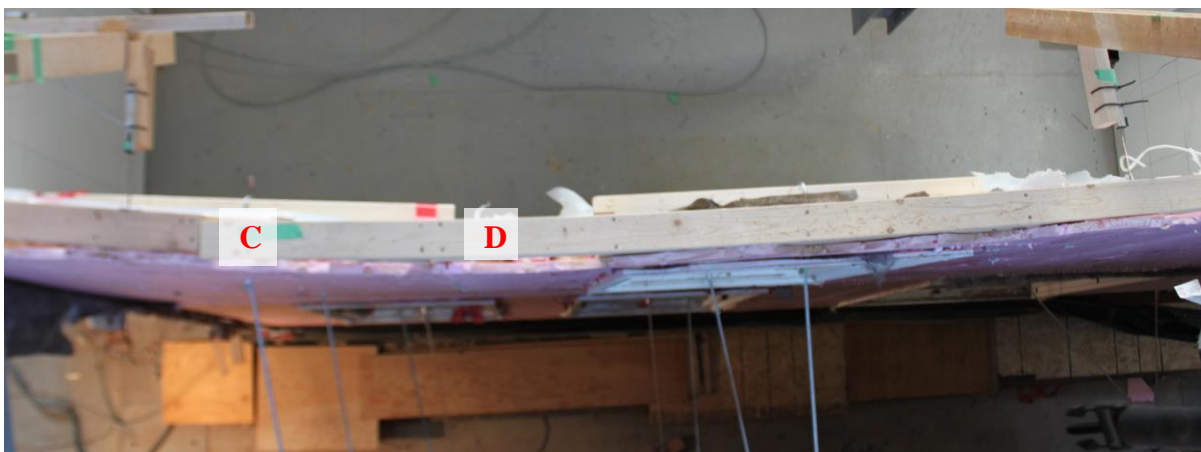
Cracking and failure of the top plate also occurred in the North wall spanning from E1 to J1 in the tests without brick veneer. This was the second catastrophic failure which occurred during the tests without brick veneer, occurring after the failure of the adjacent wall segment (A1 – D1), as discussed in Section 4.3. Failure of the top plate occurred at an area with

the nails. The wood in the connection failed, causing the top plate to become two members pinned at D (instead of one long member subject to bending). As with the previous failure, more nails placed closer to the center of the member would have created a stronger connection and given a higher failure load.

**Figure 6.4 - The North East wall prior to failure E1 – J1.**

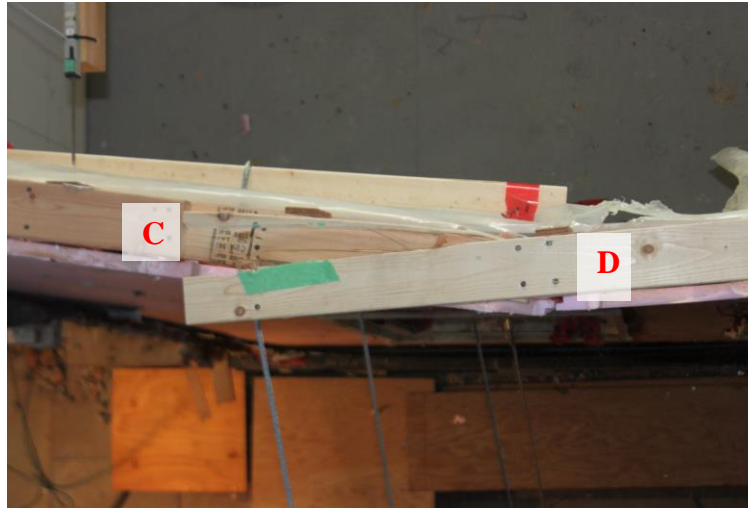
.A conclusion which can be gained from this is that the overlap of the top plate and the strength of the shear connection between the two top plate members effects the strength of the wall. If there had been more nails spaced with a longer overlap, it is likely the wall would have withstood a higher load before failing.

Figure 6.5 - The failure location on the North East wall H1-I1.

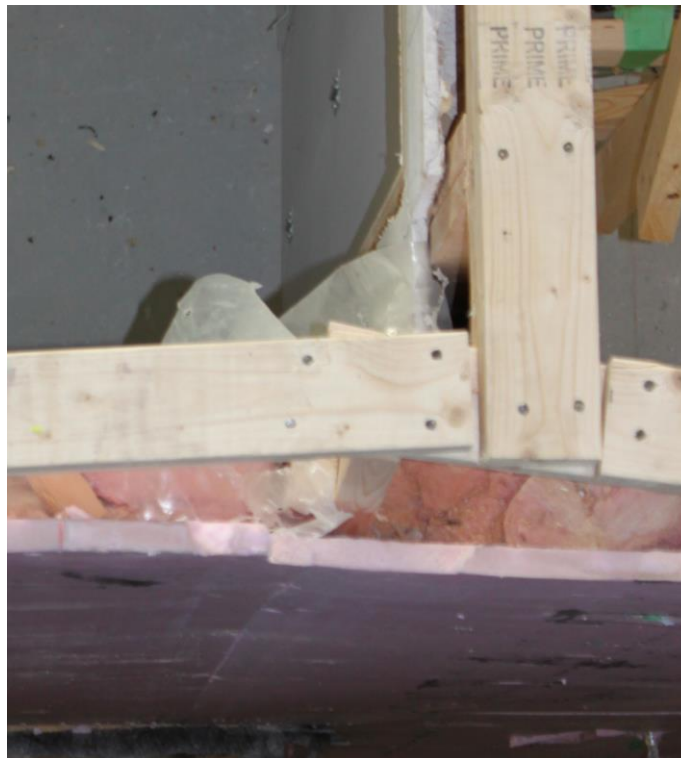
**Figure 6.6 – Minimal top plate overlap located at D1.**

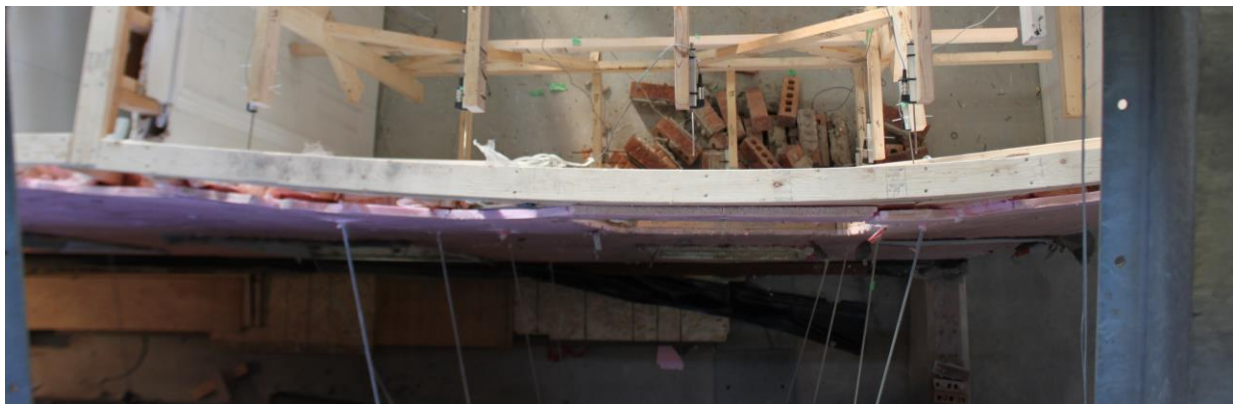
**Figure 6.8 - The top plate of exterior wall A1-D1, immediately before failure.**

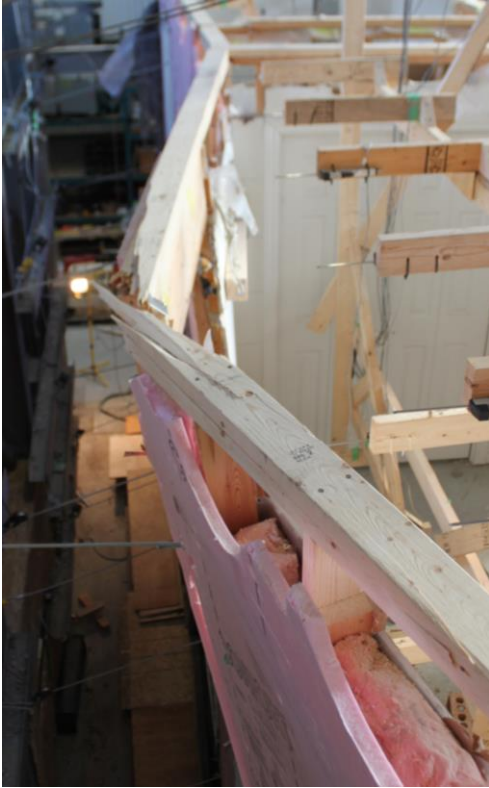
**Figure 6.9 - Wall section B1 immediately after failure.**

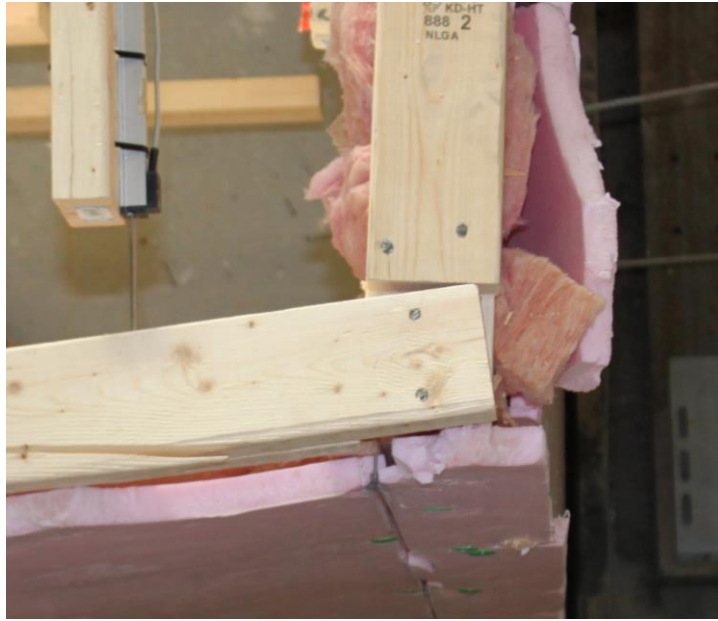
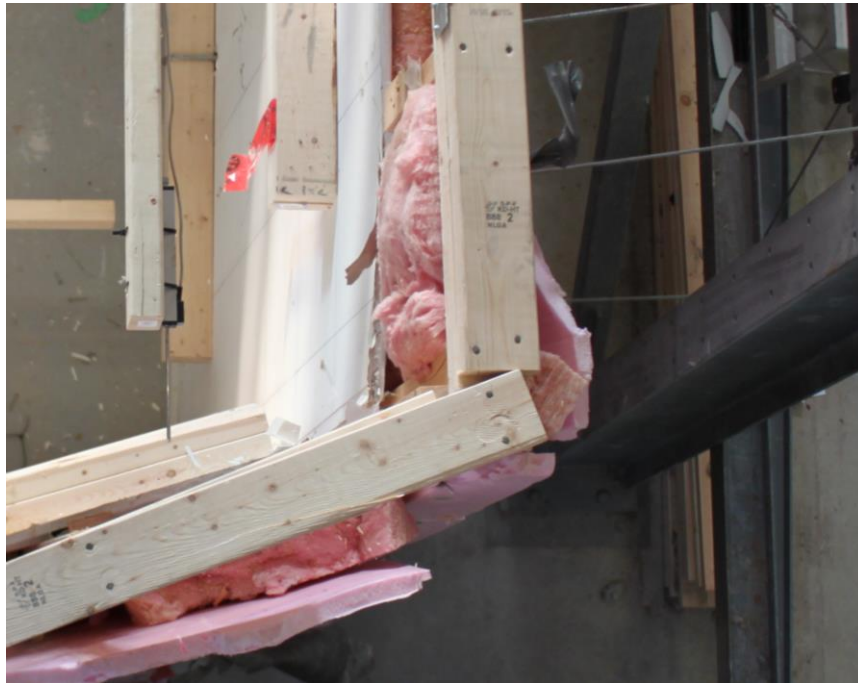
**Figure 7.1b and 7.1 c – From left to right, the corner located at A1, progressively throughout the test with no brick veneer. The far right picture is after failure.**

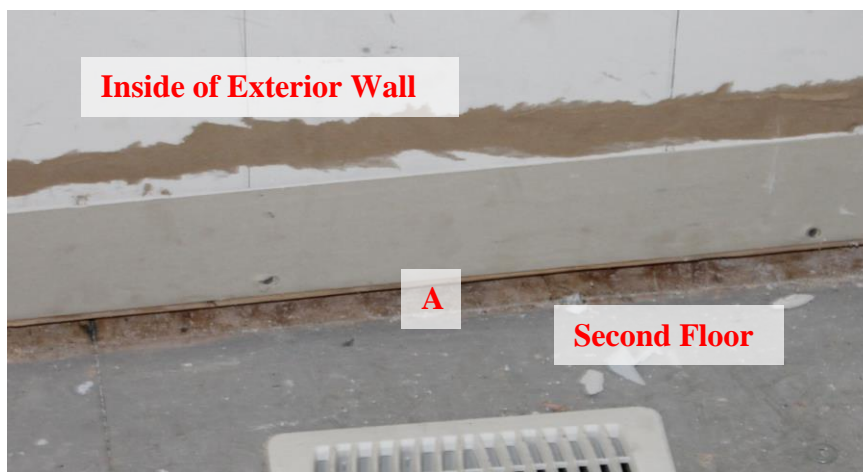
Figure 8.2 - Second storey floor-wall connection post failure

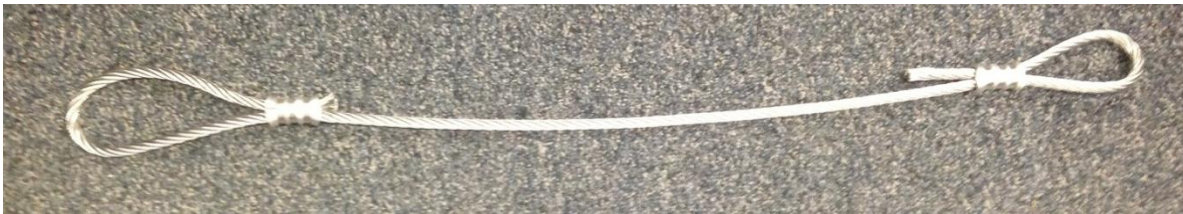
Figure G1 - The tested cable post failure
