Transgranular Stress Corrosion Cracking of 304L Stainless Steel Pipe Clamps in Direct Use Geothermal Water Heating Applications

Michael F. Hurley
Boise State University

Kent A. Johnson
City of Boise Geothermal Department

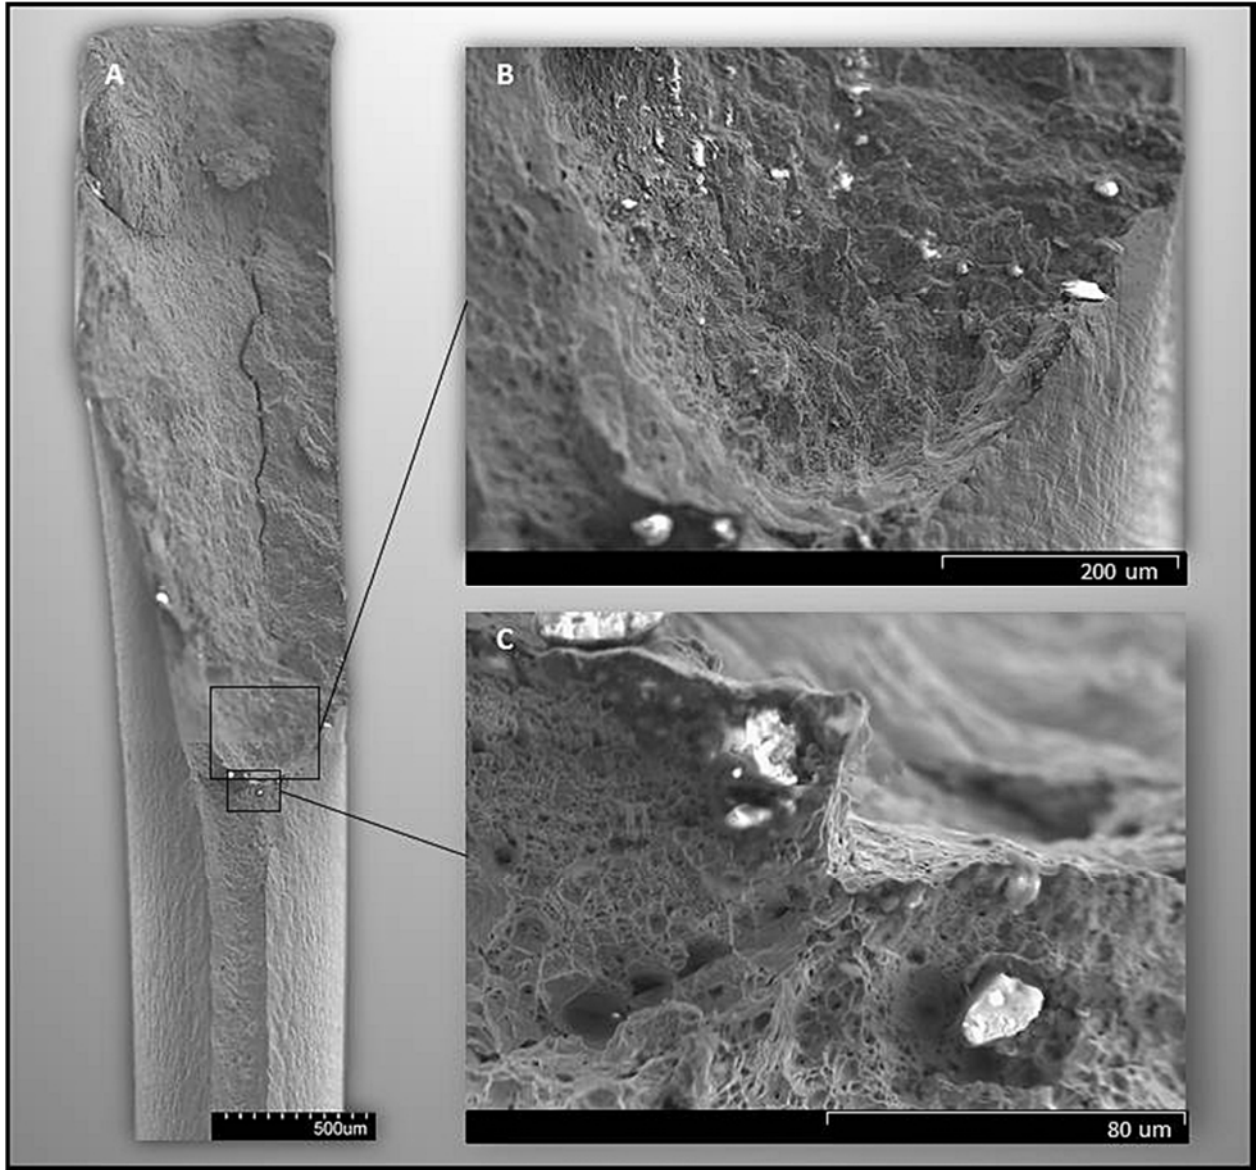
Figure 7. SEM images of the fracture surface following tensile testing to failure. The stress vs. strain data from this sample (which failed prematurely) can be seen in Figure 6. The sample fracture surface (A) showed two distinct regions of fracture behavior; brittle with no evidence of plastic deformation (top of A and B) and ductile with significant necking (bottom of A and C).
