# Expansive rocks in California : an engineering and geologic review

Lauren Jelks Doyel  
*San Jose State University*

**EXPANSIVE ROCKS IN CALIFORNIA:  
AN ENGINEERING AND GEOLOGIC REVIEW**

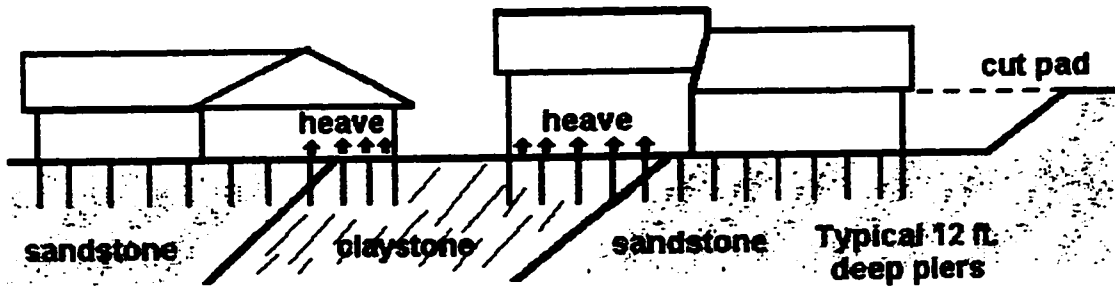
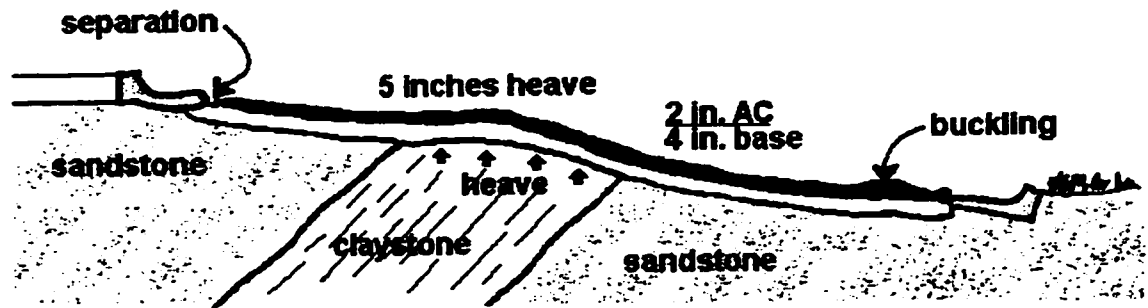
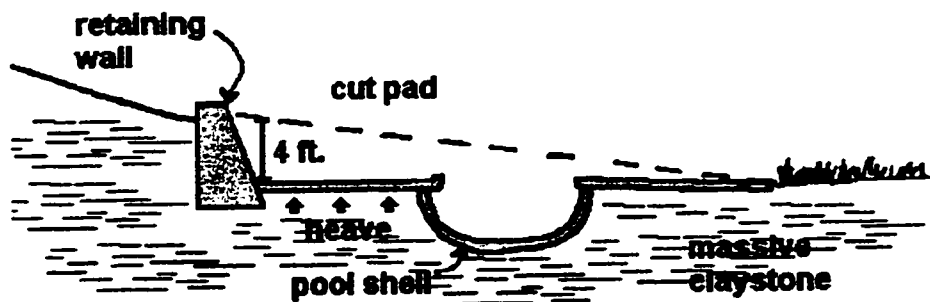
Fig. 3. Typical damage caused by expansive rock.

Fig. 3 illustrates typical damage that occurs to pools, roadways and foundations. The following case histories illustrate experience with expansive rocks in the two most heavily populated areas of California, the greater Los Angeles area and the San Francisco Bay area.

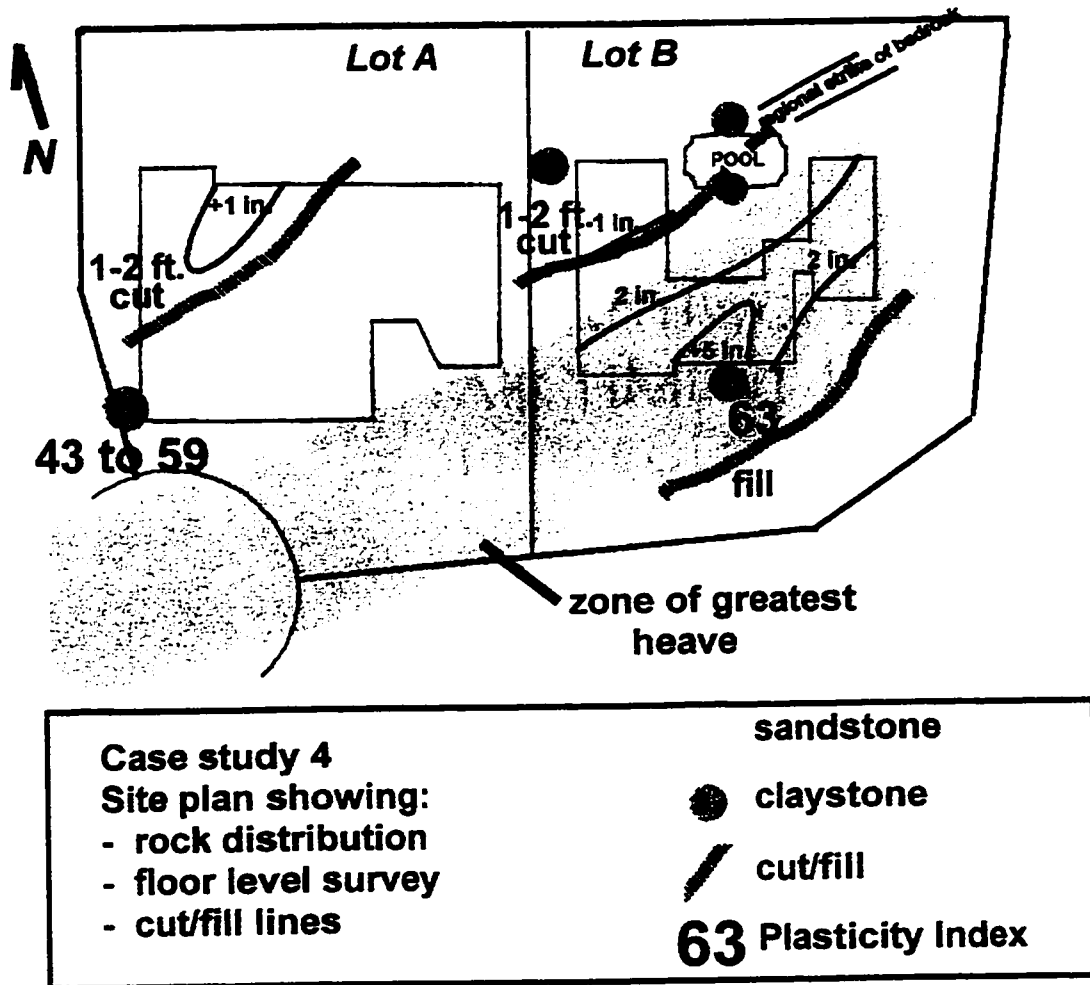
Fig. 7. Site plan case study 4. Water ponded beneath the floor in the area of the +5 in. floor level contour on lot B, causing the claystone to swell. On lot A, the greatest heave occurred in an area of cut.

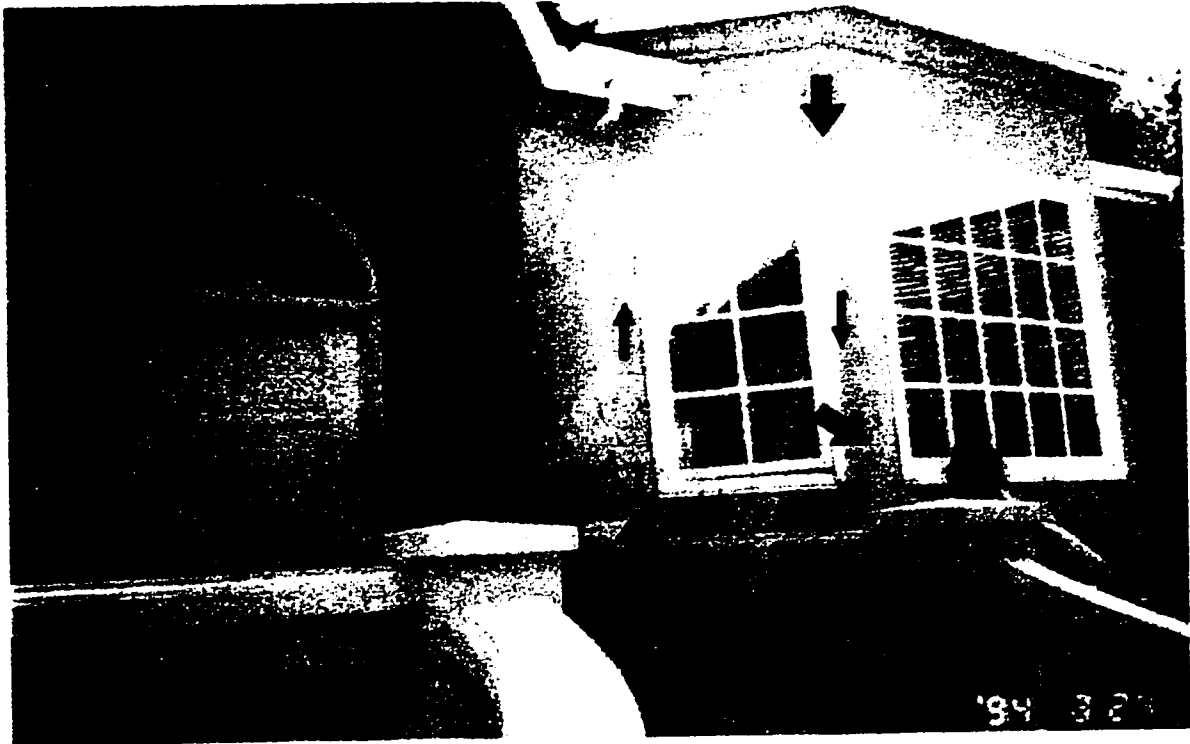
Shortly after the houses were occupied, the house on parcel B began to show signs of cracking in 1991. The kitchen and front entrance area on parcel B showed signs of racking and distortion (Fig. 9), and the hardwood floor in the house began to pull apart. Experts for parties involved in litigation concluded that the pool had leaked, or the pool contractor had left an opening in the formation through which water could enter and become trapped beneath the foundation, causing soils to swell, or fill to compress. In fact, a claystone bed was located beneath the center portion of the house, flanked by sandstone on either side. Several possible pathways for water to saturate the claystone existed, through the more permeable sandstone, through fractures and joints in the claystone (not uncommon) or through the colluvial soils that filled a subsurface topographic depression near the center portion of the house on lot B. The piers that originally were supposed to be eight feet deep were extended in depth through the fill and colluvial soils and founded in the top of claystone bedrock. They were deep enough to be affected by the swelling of the claystone, but not embedded far enough to resist uplift. Damage to the house on parcel A can be attributed to the presence of claystone, the tendency of the flat back yard at the base of a hill to collect water and a small one to two foot cut, the greatest cut corresponding to the area of greatest heave. In the litigation over damage to the house on parcel B, the engineers and geologists disagreed as to the mechanism of damage. Some thought perhaps a portion of the fill was settling, others held the opinion that the swelling was shallow, due to expansive soils. Other experts

**Fig. 9.** Lot B kitchen area exterior cracking. Wide arrows show cracks of greater than 0.25 inches, thin arrows indicate sense of shear.

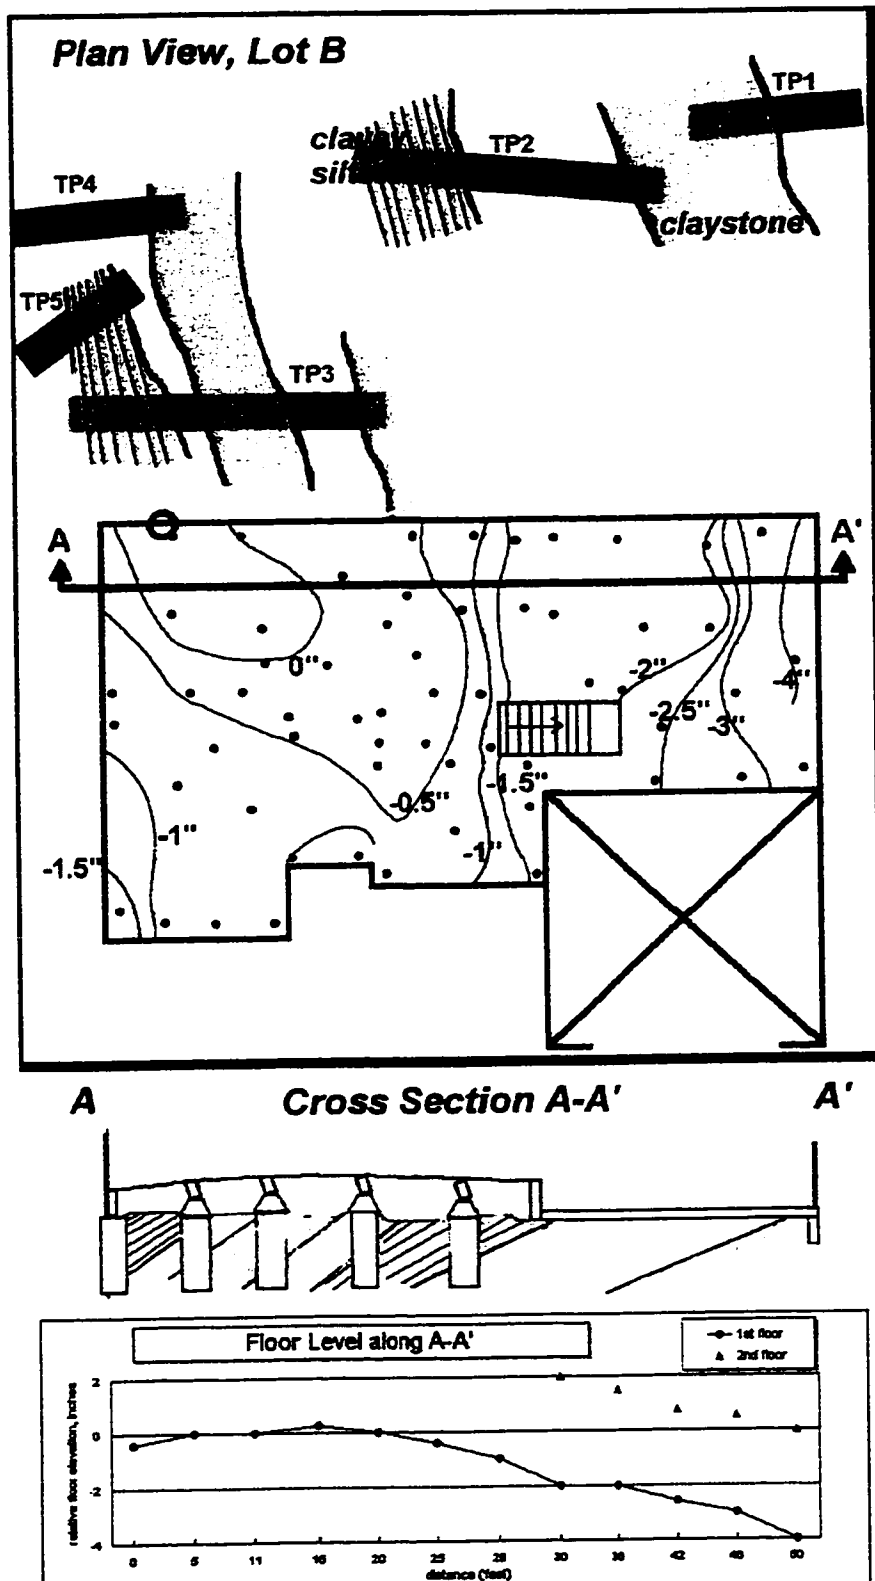
Fig. 12. Plan view and cross-section, case study 5, lot B, showing the location of the expansive claystone beds relative to the house and to the floor level contours.

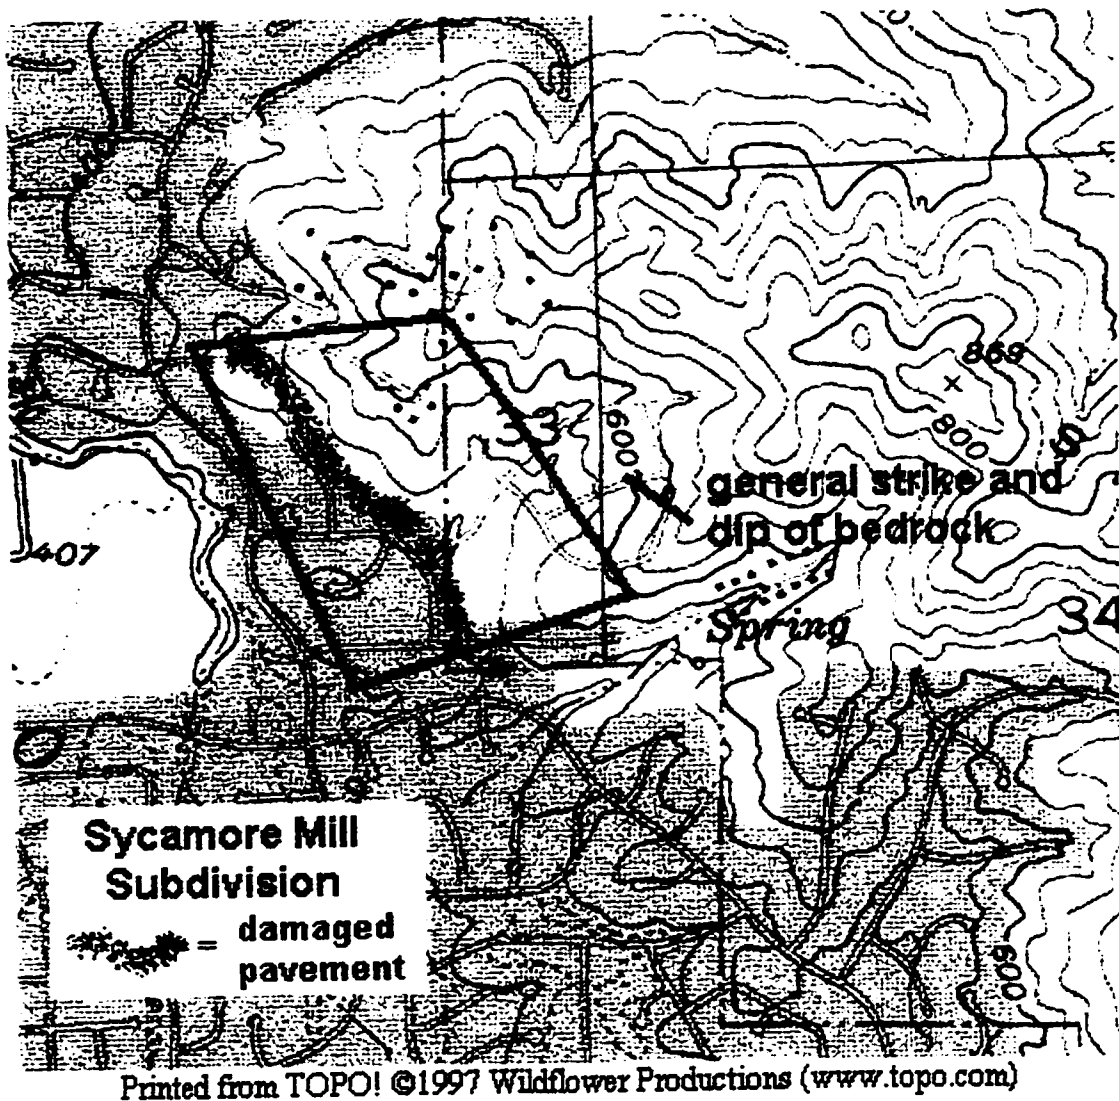
**Fig. 25.** Case study 7 site plan showing area of general pavement distress. Note that the general trend of pavement distress is almost parallel to the strike of bedding, indicating that one or possibly several closely spaced claystone beds are causing the damage.

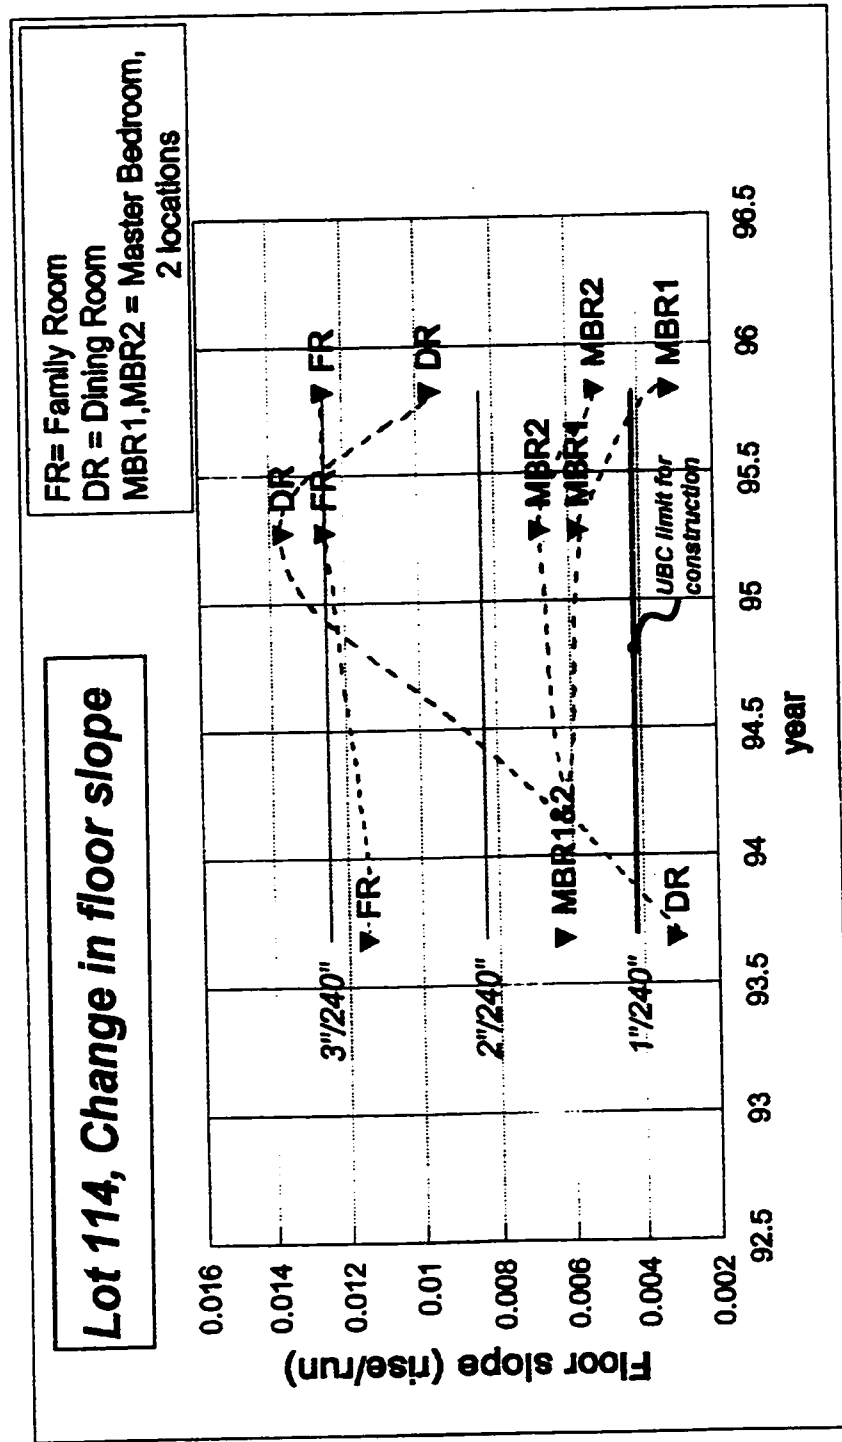
Fig. 32. Floor level measurements, case study 9a.

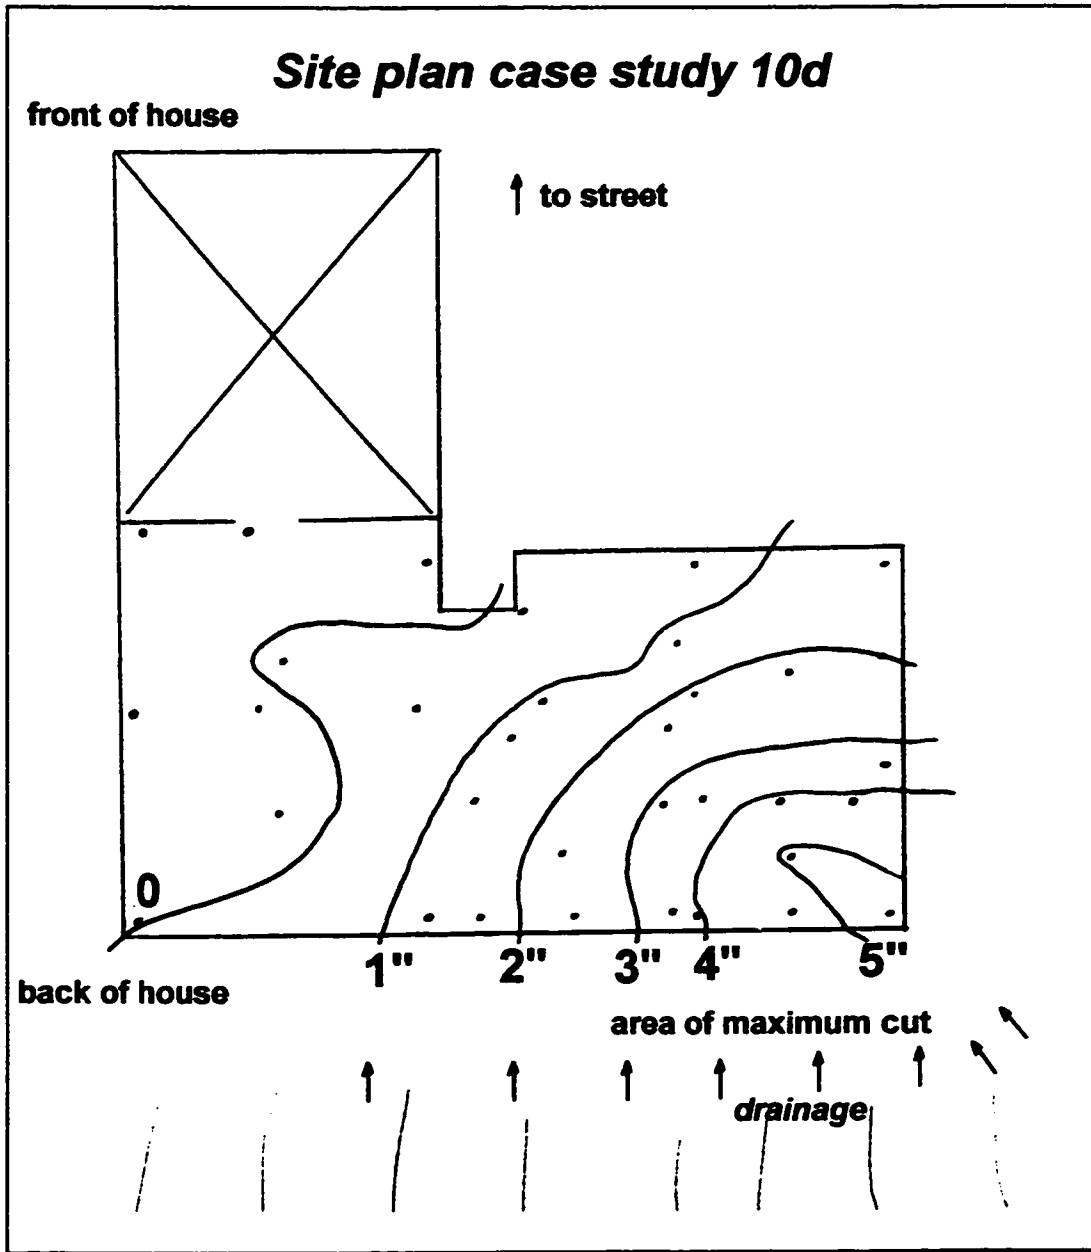
**Fig. 36.** Site plan, case study 10d, showing location of heave and general grading and drainage features.

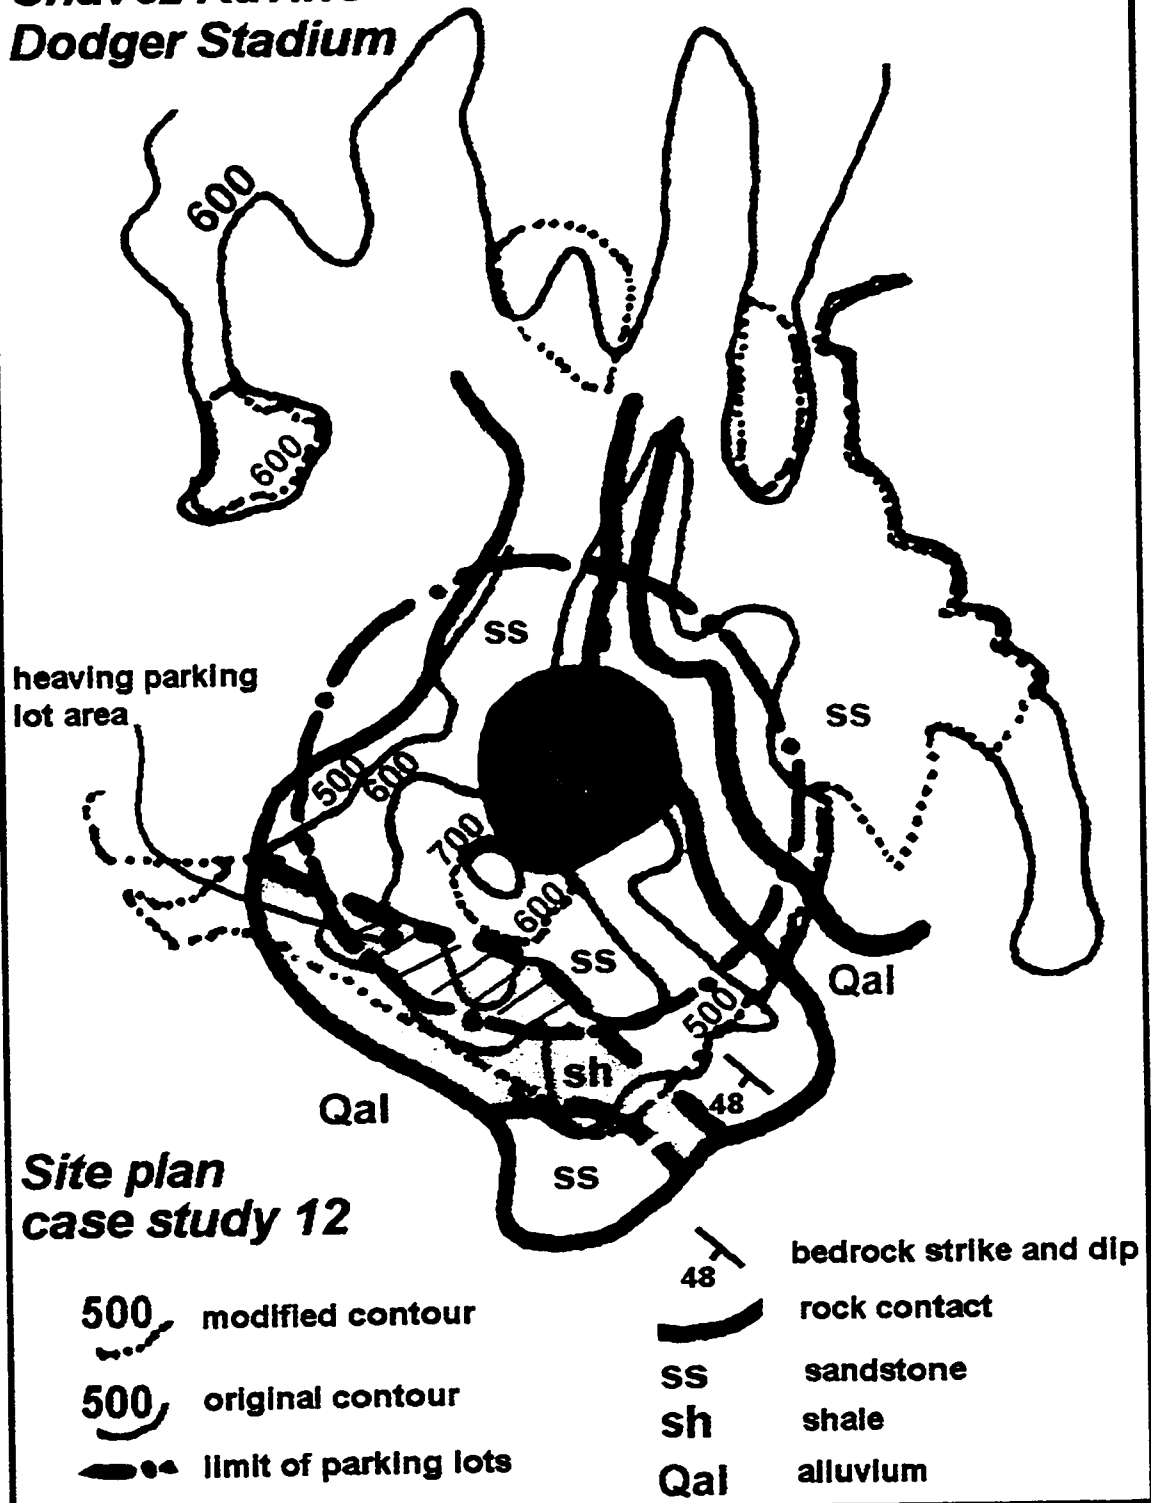
Fig. 37. Site plan case study 12. Hachured area shows where parking lot heave occurred.
