PEM Fuel Cells: Materials Ageing and Degradation

R.A. Silva, T.I.Paiva, C.M. Rangel

LNEG - Laboratório Nacional de Energia e Geologia, Fuel Cells and Hydrogen Unit,
Paço do Lumiar, 22 1649-038 Lisboa Portugal

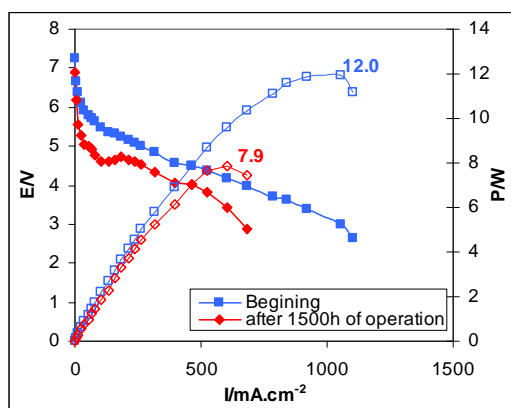
Figure 1 shows the polarization curves of the fuel cell before and after 1500h of operation. The polarization curve obtained after cell activation exhibited maximum current densities over 1000 mAcm⁻². Load duty cycles included open circuit, constant current and full polarization curves in a step by step fashion. Data were obtained at 500 mbar H₂ relative pressure, room temperature with the air flow rate of 7.56 L.min⁻¹ in a range of currents which varied from nearly zero (near the open circuit potential) to 3 A. The maximum power of the cell was found to be reduced in 34 % after operating for 1500h.

The degradation in performance after 1500h of operation is clearly evident in the activation, ohmic and mass transfer regions.

Fig. 1 Polarization curves for the 3.8 cm² stack operated at 0.4L.min⁻¹ hydrogen flow rate under constant air flow rate of 7.56 L.min⁻¹ at 500 mbar, at room temperature, after activation and after 1500h operation.

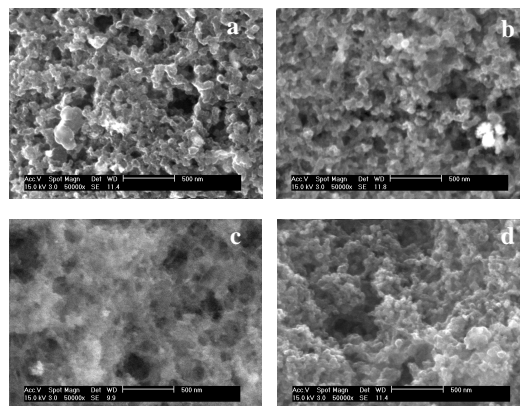
The surface morphology of the catalytic layers of cells (C1, C5 and C8) is markedly different from the unused sample, as we can observe in figure 2.

Surface area seems to be lost with cycling, this is particularly evident for C8. Images were taken at 50000 magnification.

Fig. 2 SEM anode surface morphology for cells (a) C1; (b) C5, (c) C8 and (d) unused.

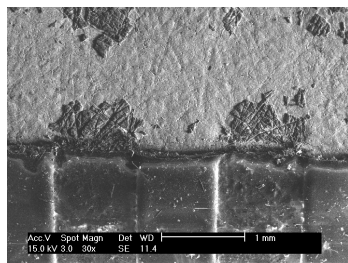
During the dismantling process, part of the GDL was peeled away and part of the GDL remained stuck on the catalyst layer. Figure 3 shows residues of GDL as light areas on the cathodic catalyst layer of C5. The residue actually shows that the compression force used in the assembly of the stack caused the bipolar plate to press the GDL into the catalyst layer. This compression will have an impact on the catalyst layer and GDL porosity underneath the ribs of the bipolar plate. It was observed, in all the cells, a GDL debris in both the anode and the cathode. In the case of C8, the anodic catalytic layer was totally covered with GDL; removal was accomplished after immersion in hot distilled water.

Fig.3 GDL debris on the cathodic catalyst layer surface of C5.

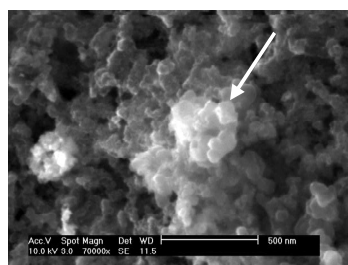
Another type of catalyst layer degradation found was **platinum clusterization**, which is evident in Figure 4.

Fig. 4 Typical Pt cluster on anodic catalytic layer of C1, as observed by SEM.

The high concentration of platinum could result from catalyst detaching from the carbon supporting surface. The catalyst particles agglomerate to form a catalyst cluster. Pt clusters were also observed on the unused sample. The catalyst agglomeration leads to a gradual decrease in the electrochemically active surface area, increasing by this way the activation loss.

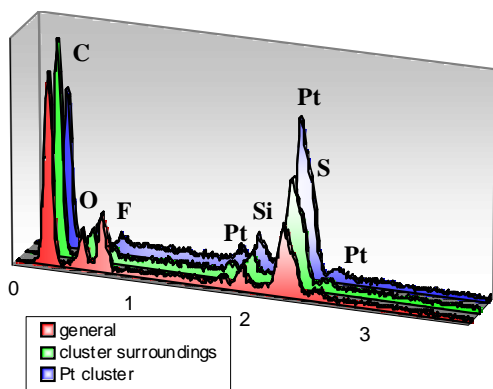
EDS analysis was performed on clustered areas, which were shown to be platinum rich. The results obtained on the Pt cluster and its surroundings are presented in figure 5 exhibiting agglomerates of catalyst. A spectra of an area where clusters were not observed is included for comparison.

Fig. 5 EDS of a Pt cluster and surroundings surfaces.

The presence Si has been identify in the EDS spectra in figure 5. The use of silicone piping and the sealing gasket are believed to have introduced silicon contamination in the MEA.

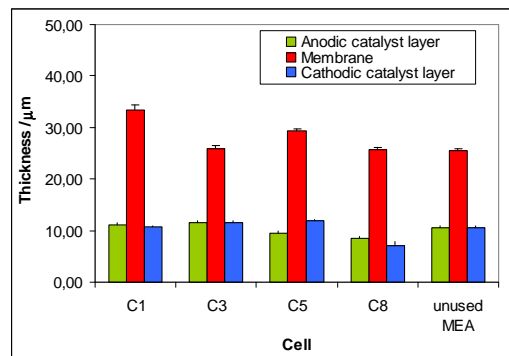
MEA **thickness variations** may occur from the manufacture process or from the assembling pressure. Figure 6 shows from three MEA components (membrane, anodic and cathodic catalyst layer) a thickness decrease comparatively with the unused MEA. The decrease is more evident for the cell that suffered the highest degree of degradation and for which the assembling pressure have more drastic consequences (C8).

The thickness variations have an effect on the resistance through the MEAs and on the susceptibility to the degradation. The thinner areas of the catalyst layer will have a lower electronic resistance, while the thinner electrolyte areas lower ionic resistance.

Fig. 6 Thickness variation of MEA components for cells C1, C5 and C8, relatively to the unused MEA.

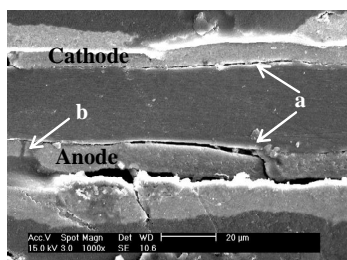
A very common feature among all of the analyzed MEAs is the **cracking** of the catalyst layer. As shown in figure 7 it involves the cracking of the catalyst layer, but leaves the Nafion™ membrane mechanically undamaged. Thus, the fuel cell can still operate, but performance and durability may be reduced.

Fig. 7 Cross section SEM view of the MEA for C8 cell showing delamination (a) and cracking (b).

The cracks will increase the total resistance of the catalyst layer and if it leaves parts of the membrane exposed, the contact resistance between the catalyst layer and the membrane will also increased. On the other hand, the cracks will provide areas where the water could accumulate preventing reactant gases to reach the catalytic sites and consequently, reduces the reaction rate.

Delamination describes a MEA failure feature whereby the catalyst layer has been separated from the polymer membrane electrolyte as shown in figure 7.

This type of defect may result from MEA manufacturing procedure but can also be induced by the degradation of the catalytic layer. It forces the current to flow away from delaminated zones, through neighboring regions in which heat is locally produced. As these neighboring zones are also prone to water accumulation, they may degrade faster than other parts of the catalytic layers.
