NBS MONOGRAPH 158

Corrosion and Protection of Steel Piles in a Natural Seawater Environment

This report describes the first eight years of a long term program in which twenty-three coating systems and five cathodic protection systems are evaluated on their ability to protect steel piles in offshore conditions. These systems are made up of nonmetallic coatings, metallic pigmented coatings, nonmetallic coatings on metal filled coatings, nonmetallic coatings on metallic coatings, metallic coatings, and cathodic protection on bare and coated piles.

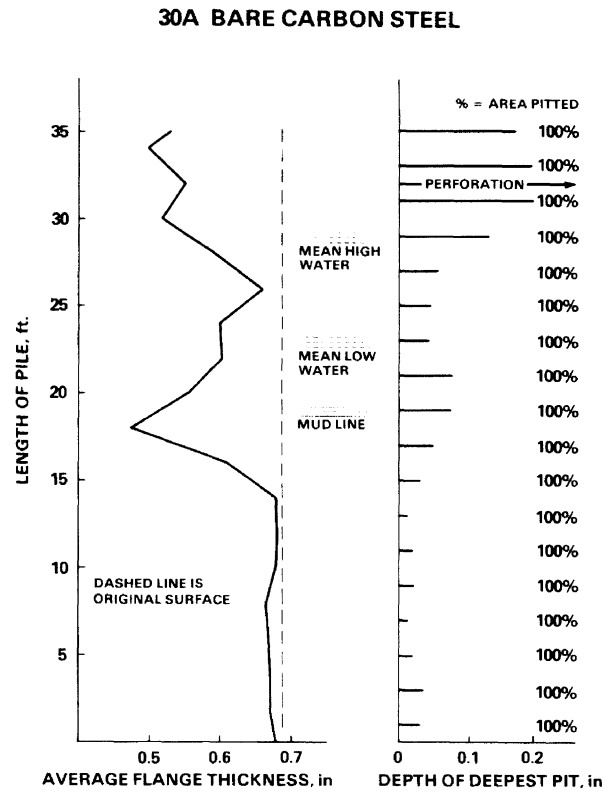
FIGURE 7

Specimen 30A is practically identical in behavior to 1A as illustrated in figure 7. This figure also displays data on the deepest pits found along the length of the pile. This data indicates that a perforation of the pile developed at about the thirty-two foot level within the six years of exposure. This perforation occurred in the web which is the portion of the pile between the two outer flanges. Pitting

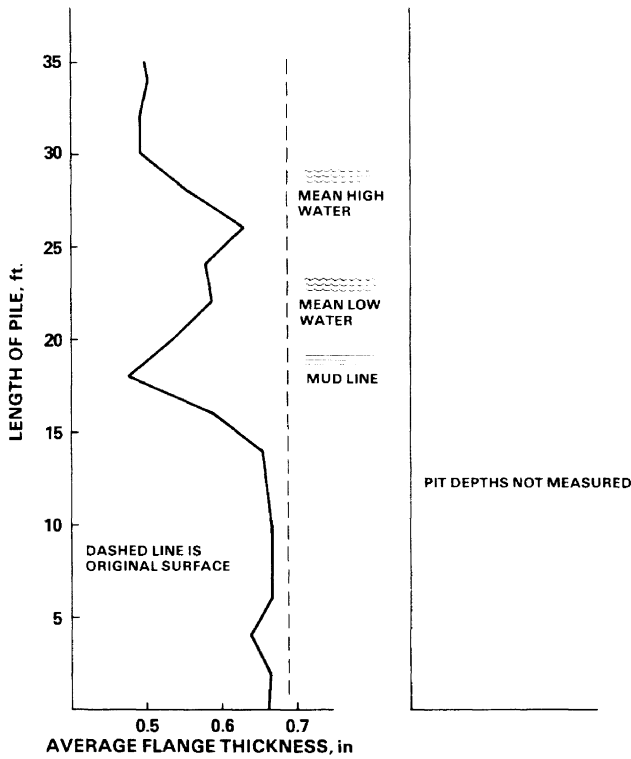
FIGURE 6

The actual observed corrosion as determined from the flange thickness measurements made after cleaning for pile 1A is illustrated in figure 6. The average flange thickness of the pile is plotted for the entire length of the pile. The dashed line indicates the location of the original surface. This thickness measurement reflects the corrosion on *both surfaces* of the flange. One can see from the diagram that a large part of the corrosion occurs above the high water line. The average corrosion rate in this region is on the order of 8 to 12 mils per year (45 to 65 mdd). The region below the high water mark has a relatively low corrosion rate. However, the corrosion damage increases as the erosion zone is approached. The corrosion rate between the high water mark and the mud line ranges from 4 to 8 mils per year (20 to 45 mdd) on the average. Within the erosion zone the observed corrosion is also high. Note that the changing mud line has caused deterioration between 14 and 21 ft (4.3 to 6.4 m) from the bottom of the pile. This effect will be seen on all piles. In this narrow band the average corrosion rate for pile 1A is approximately 9 mils per year (50 mdd).

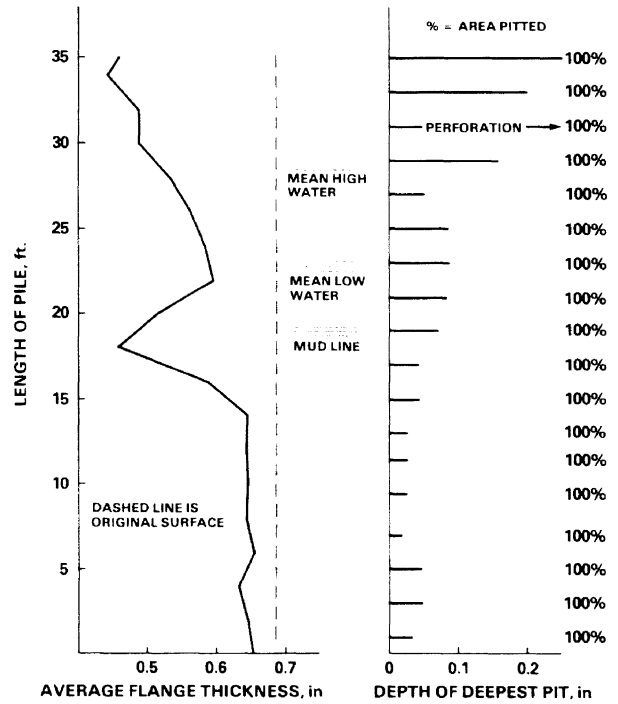
FIGURE 8

Figure 8 illustrates the corrosion deterioration observed on Specimen 31A. The bare carbon steel H-pile has developed more metal loss below the mud line than either 1A or 30A, and is of the order of 2 to 3 mils per year (10 to 15 mdd). Its pitting characteristics are very similar to those of 30A even to the perforation.

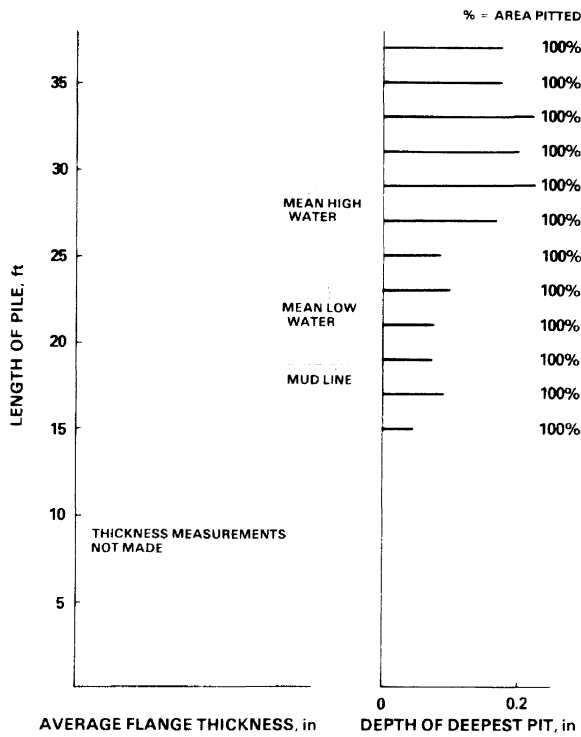
FIGURE 9

The bare pipe pile, 26A, developed pitting very similar to that found in the bare H-piles with the exception that pitting did not develop below the mud line (fig. 9). Electrochemical measurements were not made on this pile. However, measurements made on 26B indicate that the corrosion rate on the bare pipe piles is slightly higher (25%) than that of the H-piles. Because of the geometry of the pipe pile, thickness measurements could not be made.

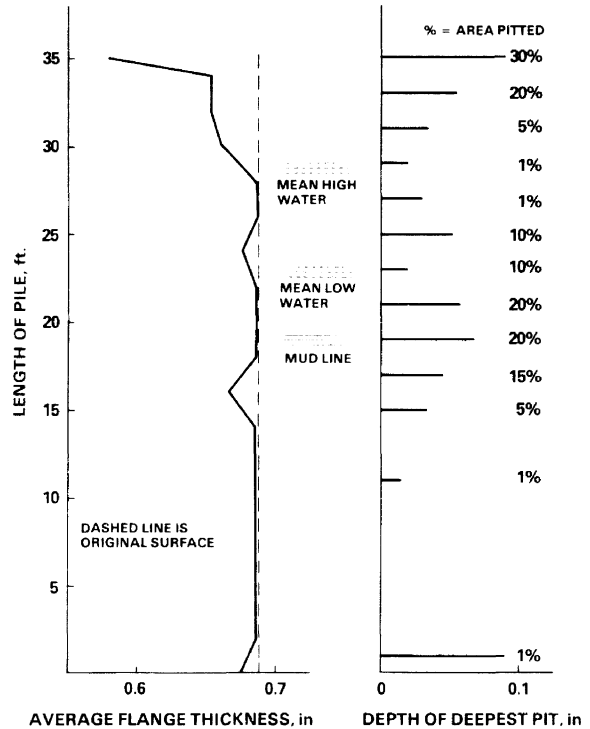
FIGURE 11

still has a coating effectiveness of 60 after five years of exposure. Figure 11 displays the average flange thickness of pile 6A with accompanying pitting. Specimen 6A is typical of the coal tar epoxies in that the greatest attack occurred above the high water line. The deepest pit in this region was less than 0.1 in (0.2 cm). Below the waterline, sand impingement in the erosion zone caused severe damage to the coating. In the atmospheric zone, undercutting of the windows in the coating system is difficult to appraise on this pile because of the extensive general failure of the coating as shown in figure 12. In the tidal zone, undercutting resistance is much improved, but general attack is still apparent (fig. 13). Below the mud line undercutting of the coating is minor. Mechanical damage to the coating during installation of the pile has caused most of the damage seen in figure 14.

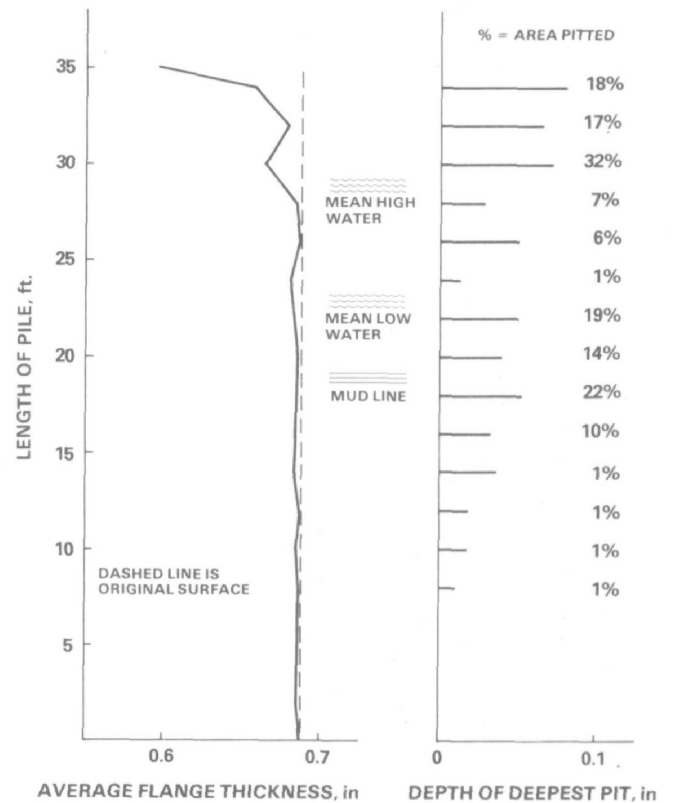
FIGURE 15

trochemical measurements. The physical measurements of these three piles are illustrated in figures 15, 16, and 17. The poor resistance of the coal tar epoxy coatings in the atmospheric and splash zones is well indicated in these drawings. Below the waterline, however, they have performed well. Pile 7A shown in figure 16 indicated that the armor coat did reduce the rate of coating deterioration in the erosion zone. Figure 18 is a photograph of the window in the atmospheric zone of pile 7A. Note the severe undercutting extending half the width of the pile. The window in the tidal zone, that zone between mean high water and mean low water, reveals only a slight amount of undercutting that extends 0.25 in (0.7 cm) as shown in figure 19. Pitting due to coating failure is evident. Below the mud line undercutting resistance is even better as shown in figure 20. Generally the coal tar epoxy looks good in this region.

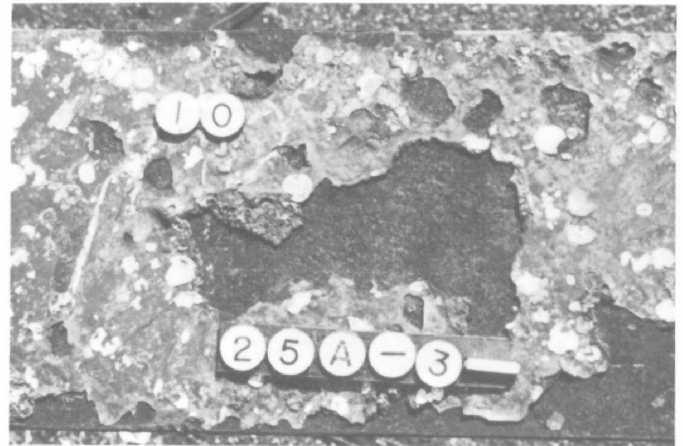
FIGURE 23

in the atmospheric zone of pile 4A is similar to that of 7A after six years of exposure as figure 21 shows. In the tidal zone, however, the window on 4A has undergone considerable damage not readily seen in figure 22. Undercutting in this area extends almost 1 in (2.5 cm) beneath the coating. General damage to the coating in the surrounding area is also apparent. Below the mud line the coating is in excellent condition with practically no undercutting as shown in figure 23.

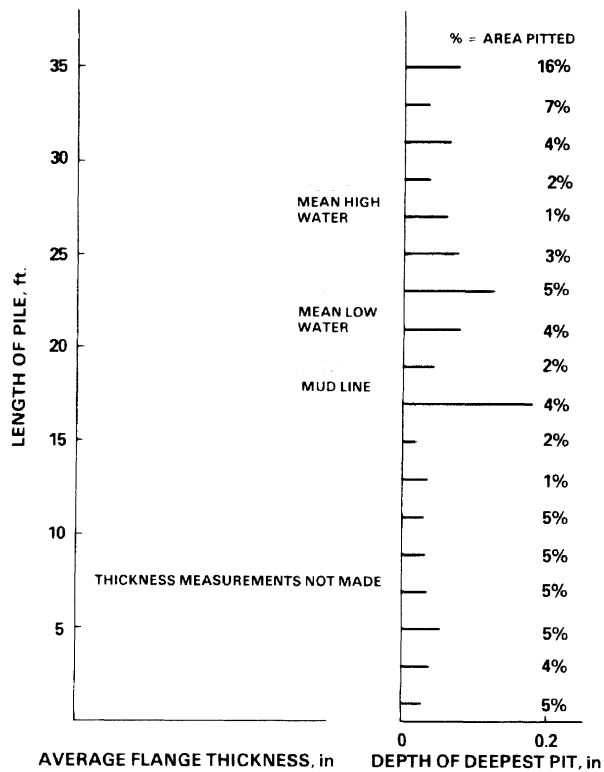
FIGURE 27

The physical measurements on the pipe piles consists only of pit depth measurements (figs. 27 and 28) as meaningful wall thickness measurements were not practical. These observations indicate that though there were fewer coating failures on the pipe piles, (% area pitted) as compared to the H-piles, the resulting pits were deeper on the pipe piles. The deepest pit in the erosion zone of 27A was almost 0.2 in (0.5 cm) deep. Undercutting of the coating on pile 27A extends about 2 in (5 cm) beyond the edge of the window as shown in figure 29, and is considered severe. In the tidal zone undercutting resistance is improved. Undercutting extends 0.5 in (1 cm) at the most (fig. 30). Figure 31 illustrates that below the

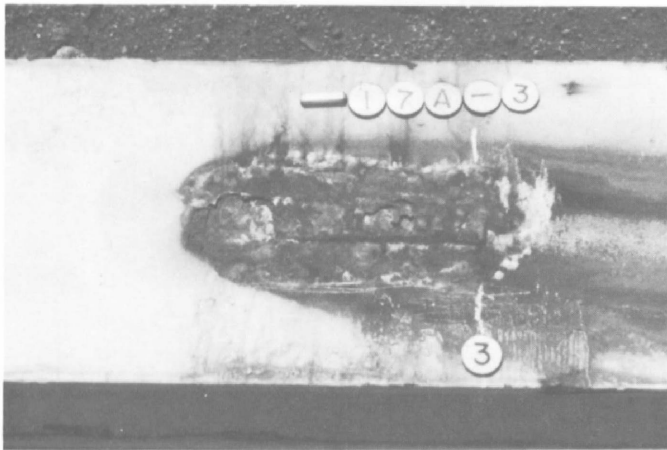
FIGURE 37

rosion observed on this system was just below the mean high water line with a rate of 0.15 mils per year (0.8 mdd). In the atmospheric zone, the window in the coating suffered only moderate undercutting as shown in figure 37 with a maximum penetration of 1 in (2.5 cm) or less. The same figure shows that the coating in the vicinity of the window is still in excellent condition. Most of the rusty color is surface staining of the coating. In the tidal zone (fig. 38) undercutting extends less than 0.25 in (0.6 cm) beyond the window. Some coating failure at the edge of the flange is visible in this photograph. Below the mud line undercutting was practically nonexistent as shown in figure 39. The dark globular material on the window is an adhering mud and sand mixture that apparently does not affect the phenolic mastic.

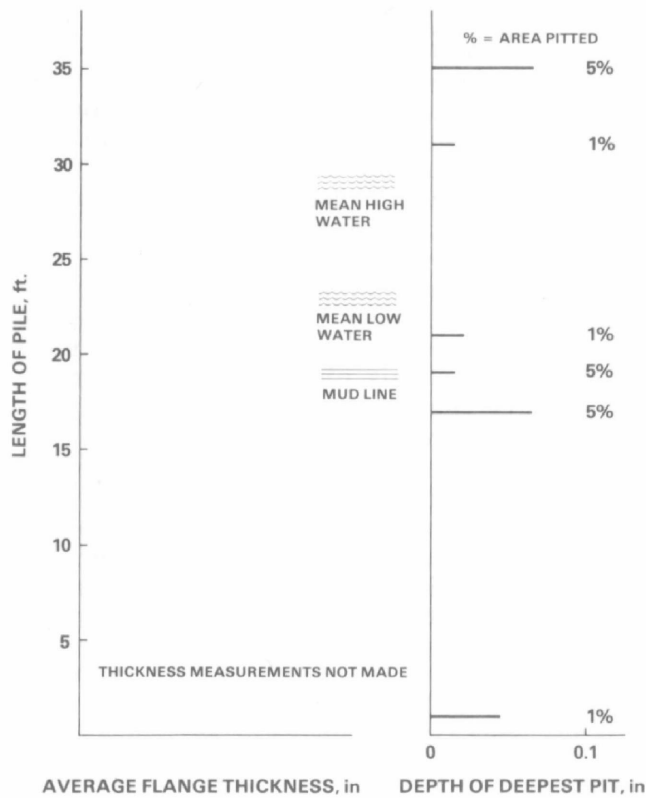
FIGURE 40

The polyester glass flake, System 29, has an average coating thickness of 32 mils (0.8 mm). This system has displayed very good resistance to deterioration. Figure 40 is a plot of the physical measurements made on this coating. It is apparent from this data that the degree of pitting is minor. Flange thickness measurements were not made for two reasons. First, coating breakdown was so minimal that little

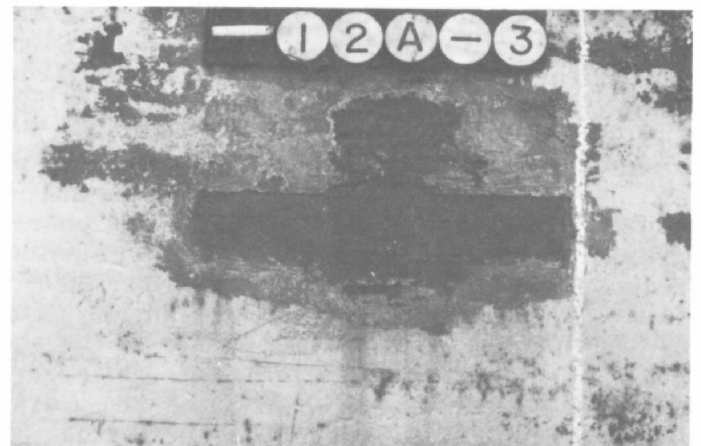
FIGURE 47

coating has been undercut almost two inches (5 cm) beyond the original edge of the window as shown in figure 47.

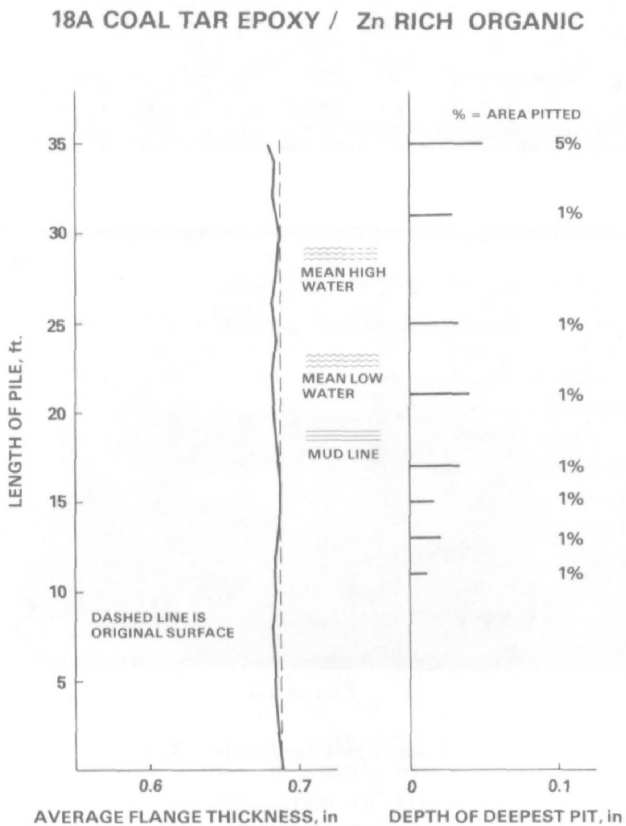
FIGURE 58

The physical measurements on System 18A are illustrated in figure 58. The deterioration of the steel pile has been slight. The coating system has performed well in all of the zones of exposure. Average corrosion rate for the pile has been less than 0.2 mils per year (1 mdd). In the atmospheric zone, damage of the coating at the window has been severe as shown in figure 59. Undercutting of the coating extends almost 2 in (5 cm) beyond the window. Undercutting of the coating in the tidal zone has been

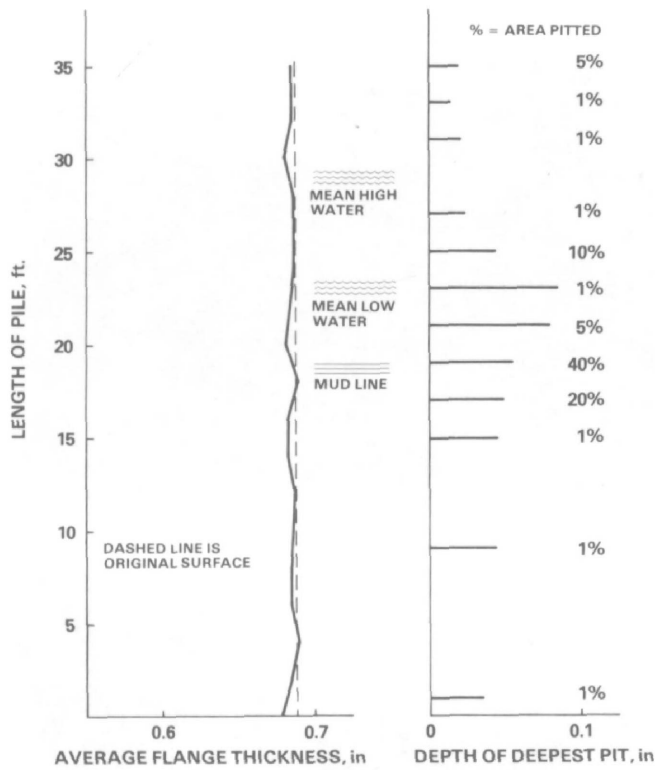
FIGURE 70

of both is slightly over 60. The physical measurement data for pile 19A is plotted in figure 70. Attack of the pile has been general over its length. However, there was more attack in the erosion zone than this data, taken 1 in (2.5 cm) from the edge, indicates. The corrosion extended from the 15-ft mark to the 20-ft mark on the inner surface of the flanges and 2 to 3 in from the edge. This attack is indicated by the pit depth measurements of figure 70. Its average corrosion rate is about 0.2 mils per year (1 mdd). Undercutting in the atmospheric zone shown in figure 71 extends less than 0.5 in (1.2 cm) beyond the window with some edge deterioration evident. General deterioration has been extensive in the tidal zone. Figure 72 is a photograph of the window in this region that reveals less than 0.1 in (0.2 cm) undercutting. Below the mud line undercutting was also less than 0.1 inches (0.2 cm) as shown in figure 73. The coating was damaged mechanically, but no undercutting was found under the surrounding encrustation.

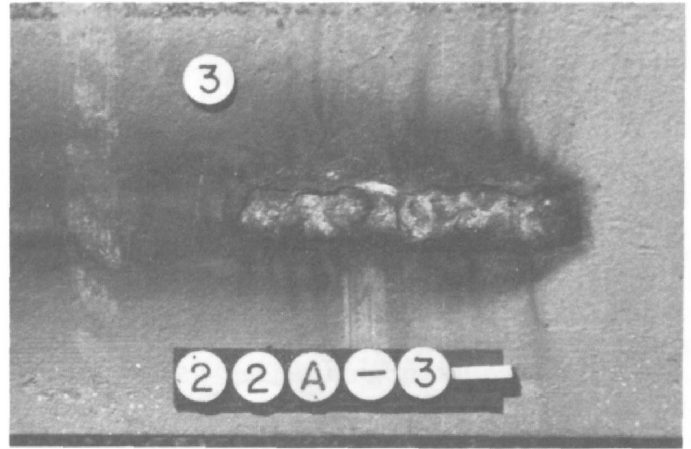
FIGURE 75

There is very little attack in the atmospheric zone. Undercutting in this area is less than 0.1 in (0.2 cm) as shown in figure 75. In the tidal zone general deterioration of the coating has taken place, but with very little actual metal loss. This is illustrated in figure 76. Undercutting here is also less than 0.1 in (0.2 cm). Below the mud line undercutting extends about 0.2 in (0.5 cm) beyond the window as figure 77 shows. Notice the blistering of the coating in the surrounding area. The overall average corrosion rate for pile 22A is less than 0.25 mils per year (1.4 mdd).

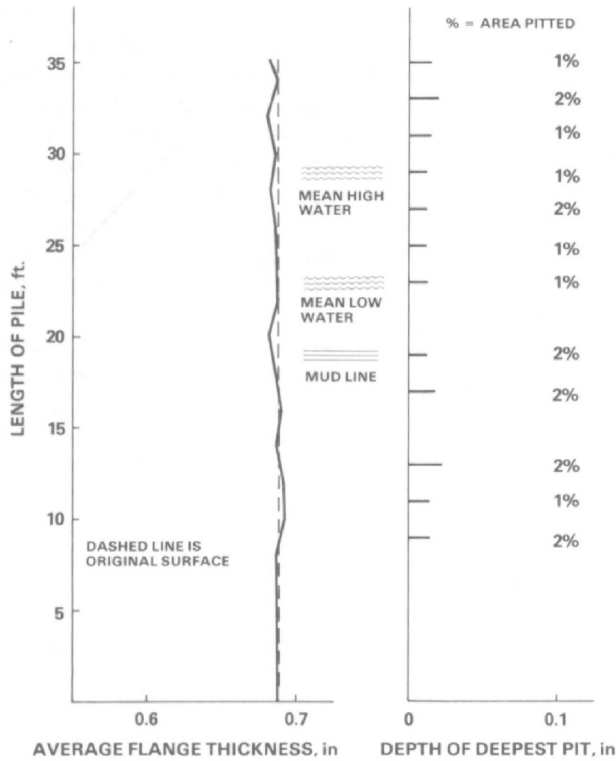
FIGURE 83

Pile 15A, polyvinylidene chloride over zinc flame spray, is unusual in that the electrochemical readings indicate that initially its coating effectiveness decreased as the non-metallic coating failed, but then the metallic zinc coating proceeded to provide protection. Consequently, the coating effectiveness of the system improved as illustrated in figure 78. Total coating effectiveness below the water line is well above 85. In general, the zinc seems to have developed some nonconducting film, probably an oxide, that has brought this improvement about. The average flange thickness measurements are plotted in figure 83. Total metal

loss is small and uniform over the surface of the pile. Similarly, pitting is scattered and of minor consequence. The average corrosion rate for the entire pile is about 0.1 mil per year (0.5 mdd). There were no windows in the coating of this pile. The following photographs are included to display its appearance in areas similar to those seen for the other pilings. The coating in the atmosphere is in very good condition with only minor damage in a few areas. Unfortunately the photograph of this area is of such poor quality that it will not be shown. In the tidal zone the nonmetallic coating is badly blistered as figure 84 shows, but the piling is still being protected by the zinc. Top coat blistering extends into the area below the mud line as figure 85 illustrates, but corrosion damage to the pile is minor.
