NACA RM E55J04

PRELIMINARY INVESTIGATION OF SEVERAL ROOT DESIGNS FOR  
CERMET TURBINE BLADES IN TURBOJET ENGINE

III - CURVED-ROOT DESIGN

December 28, 1955

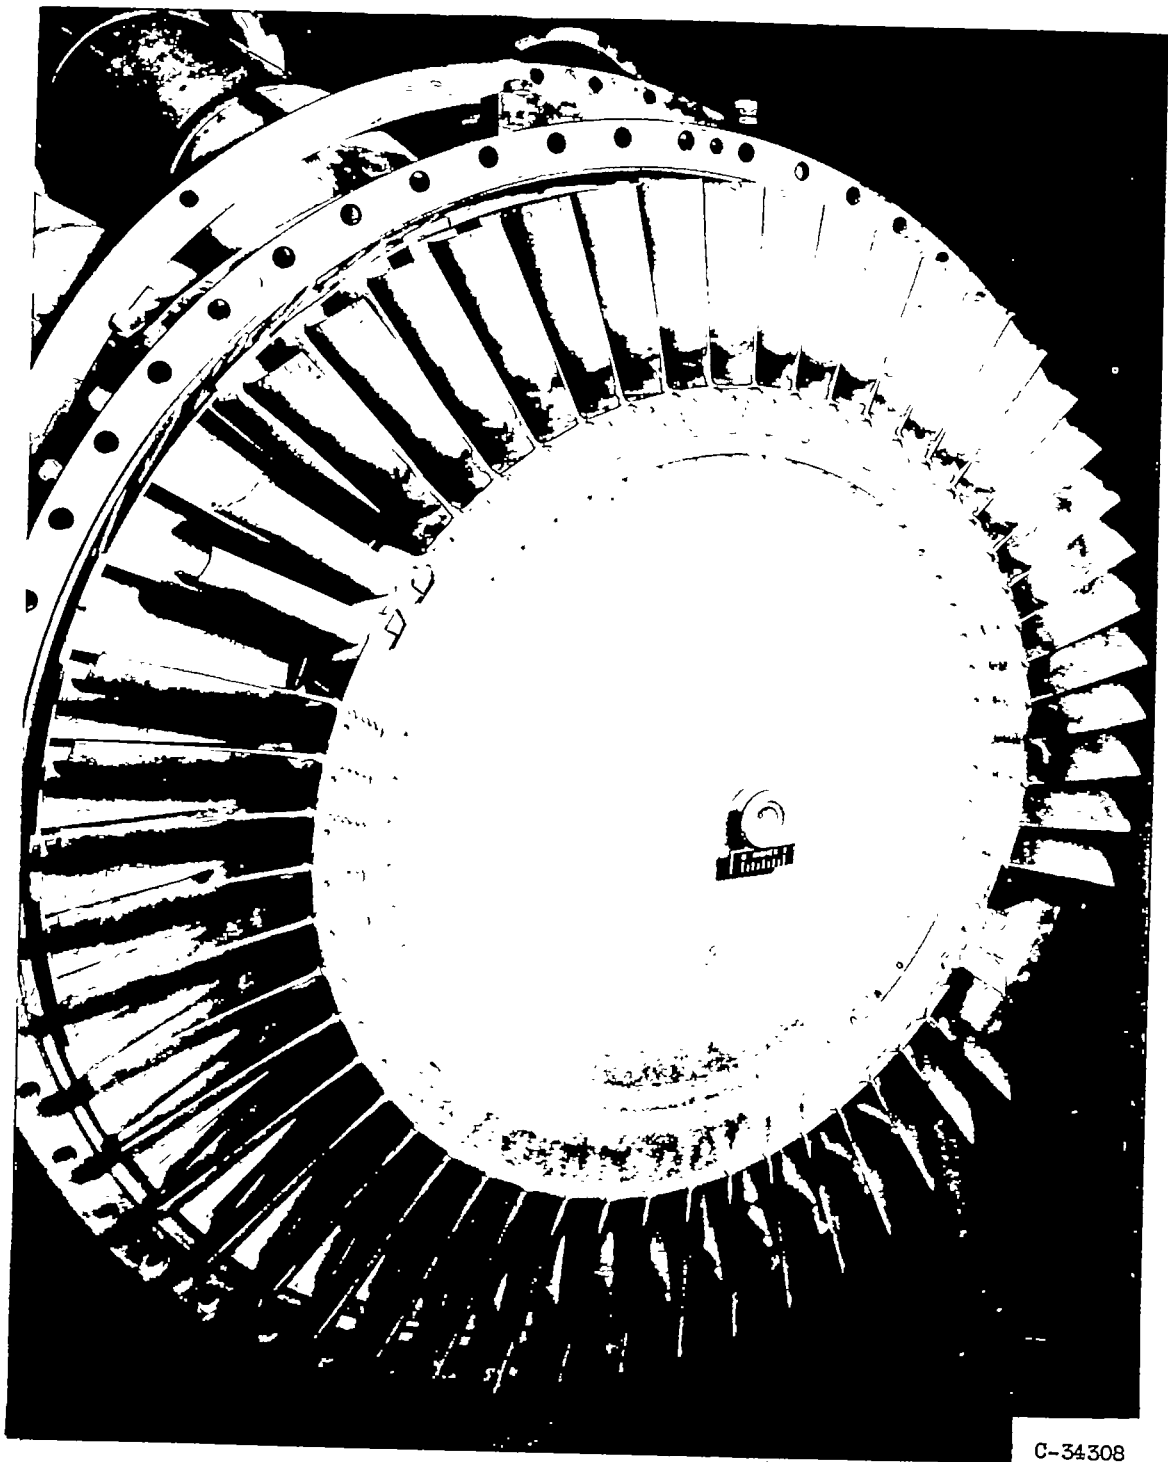
(b) Damage to entire wheel.

Run 2. - The second set of curved-root blades had accumulated 77 hours and 4 minutes at rated speed when an airfoil failed, as shown in figure 4(a), and damaged the other cermet blades (fig. 4(b)). While no definite cause for the failure was established, the blades were severely corroded along the leading edge. The enlarged view of the leading edge of the failed blade (fig. 5) is typical of the appearance of the leading edges of all the cermet blades in this run. X-ray diffraction of flakes chipped from the edges of the blades did not indicate the presence of foreign material; only the constituents or their oxides were detected. Since this corrosion was not evident in the many previous engine runs with this composition, it is not considered characteristic of either the nominal composition or the normal operating environment.

Figure 4. - Concluded. Failure of curved-root cermet turbine blades after 77 hours and 44 minutes at rated speed. Run 2.

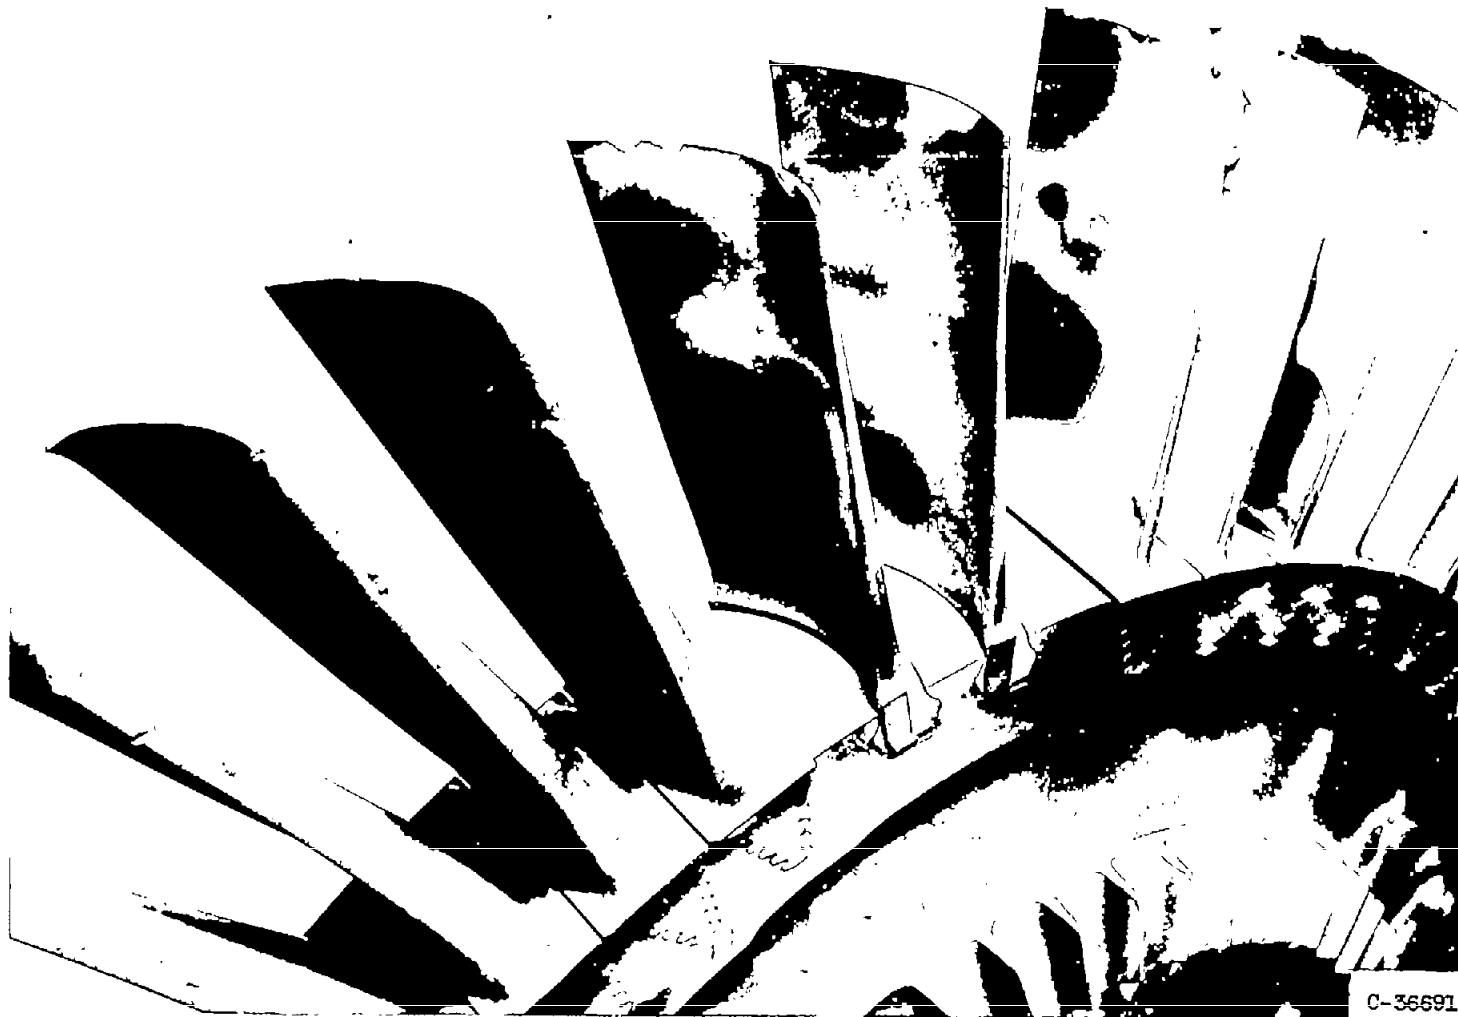
Run 4. - A curved-root blade (fig. 8(a)) failed in the root after 142 hours and 58 minutes at rated speed, damaging the adjacent cermet blade but inflicting only minor damage to the opposing pair of blades (fig. 8(b)). The failure has the spalled appearance that has previously been attributed (ref. 4) to the presence of high compressive stresses,

(b) Blades damaged by diametrically opposite blade with root failure.

Figure 8. - Concluded. Failure of curved-root cermet blades after 142 hours and 58 minutes at rated speed. Run 4.
