Sealed Source and Device Design Safety Testing

Technical Report on the Findings of Task 4

Investigation of Failed Radioactive Stainless Steel Troxler Gauges

Prepared by
D. J. Benac, W. R. Schick

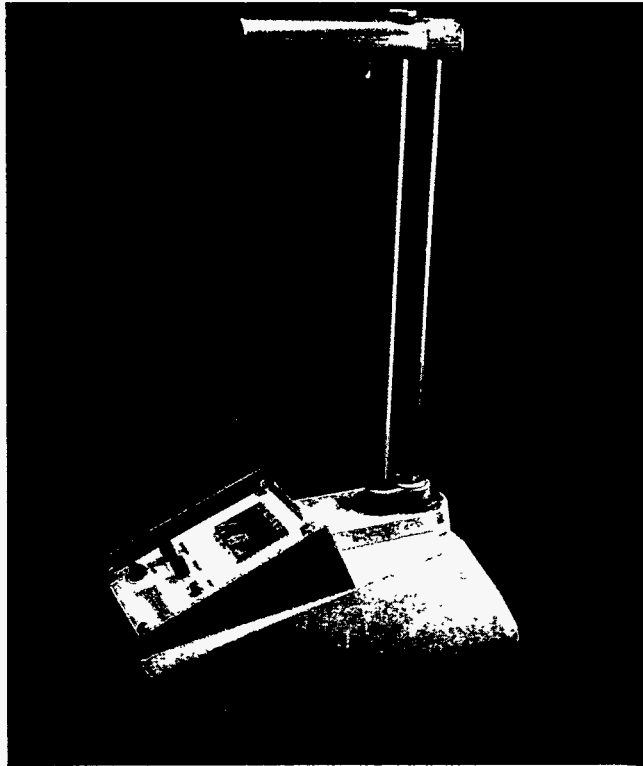
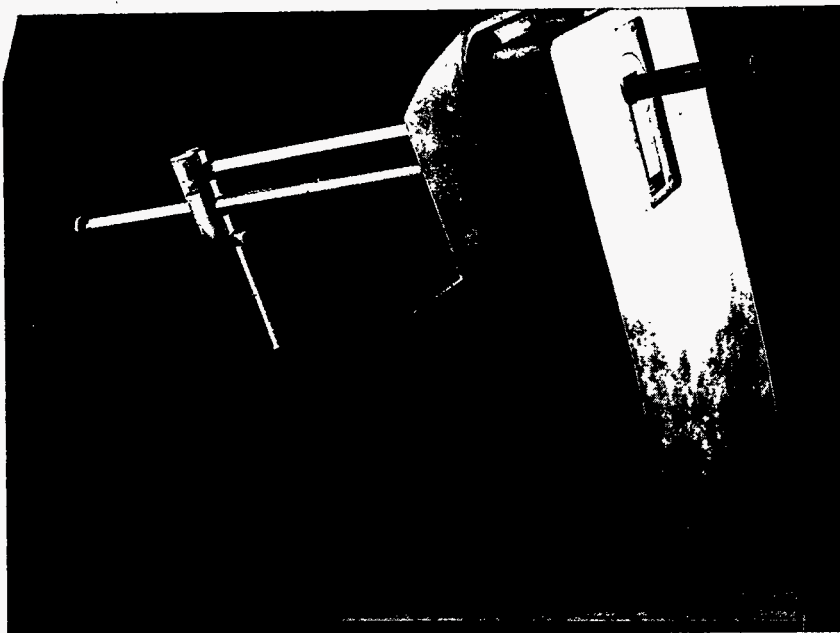
FIGURE 1-1. PHOTOGRAPHS OF THE AS-RECEIVED TROXLER GAUGE NO. 12711 (a) AND THE EXTENDED FRACTURED ROD (b).

The Ohio Department of Transportation (ODOT) reported on August 8, 1993 during a routine use of a Troxler Model 3401 nuclear gauging device that the radioactive tip fell off. The tip of the source tube contained 8 millicuries of cesium 137. The Troxler gauge, shown in Figure 1-1, is used to measure the density of asphalt, soils, and other mediums. The radioactive rod is inserted into a drilled hole in the asphalt, then the radiation at the gauge is measured. For density, the cesium 137 emits gamma radiation which enters the test medium. The denser the test material is, the more radiation is absorbed, thus, less radiation reaches the detector. Troxler Gauge No. 12711, shown in Figure 1-1, had the broken rod, shown in Figure 1-2. It was determined by ODOT that the break had occurred in the vicinity of the weld that secured the encapsulated source to the probe. Five gauges were submitted to Southwest Research Institute (SwRI) to determine the extent of the problem and mechanism of failure. Table 1-1 shows a list of the gauges and the status as identified by ODOT.

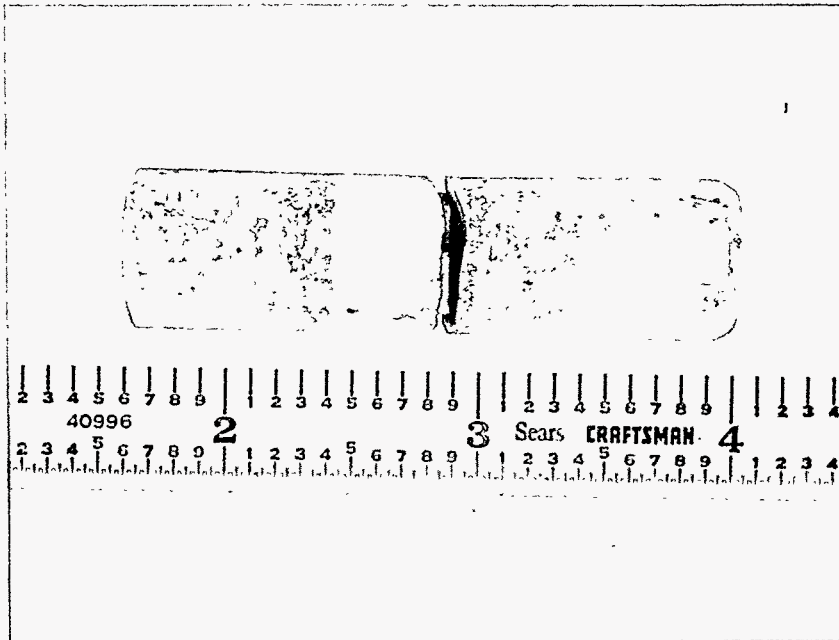
FIGURE 3-1. PHOTOGRAPHS OF THE TIP AND LOCATION OF FAILURE.
 Arrow shows abrasive mark on OD surface.

- (2) At some time during usage of the gauge in the field, the rod was impacted as indicated by abrasive markings. This caused a bending condition on the rod at the hard zone which resulted in a crack.

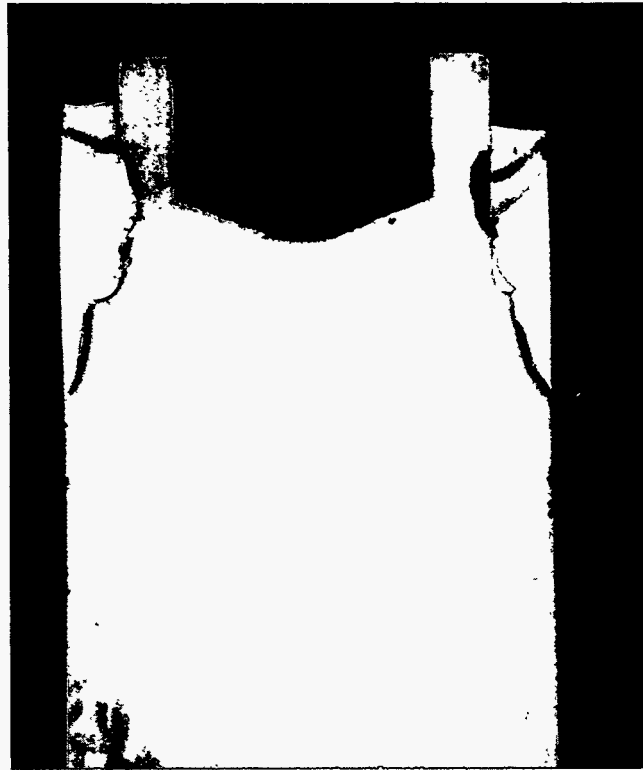
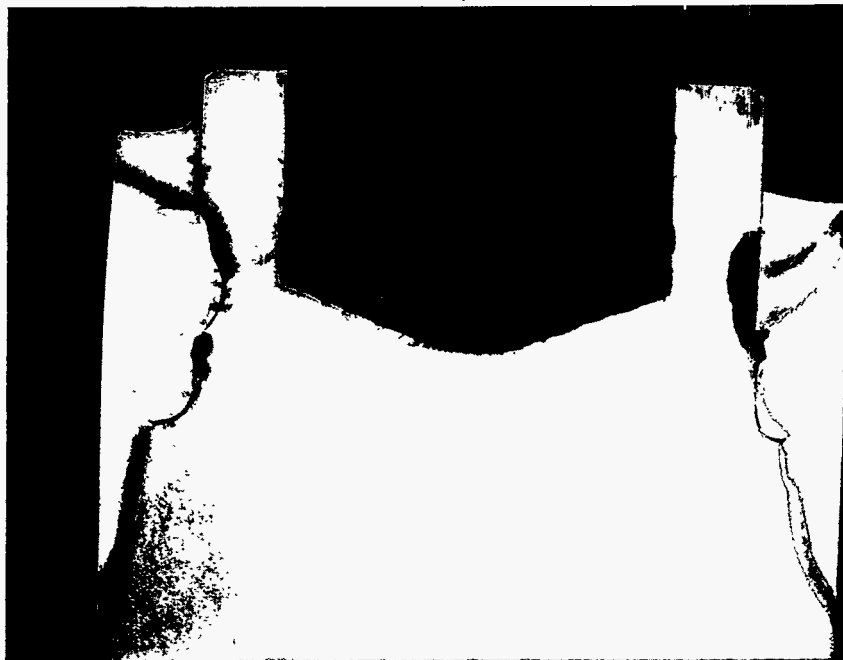
FIGURE 5-1. PHOTOMICROGRAPHS OF THE ROD CROSS SECTIONED AT THE FRACTURE.

Both halves of the fracture surface were sectioned in the vicinity of the origin to examine the weld and to determine if any microstructural anomaly caused the failure. Figure 5-1 shows the position of the weld relative to the fracture. Figure 5-2 shows a close-up of the weld heat affected zones (HAZ) and hardness indentations. The fracture plane was about 0.034 inch from the edge of the weld metal at the surface of the rod. The fracture origin location had no anomaly, however, the base metal was more typical of an untempered martensite, which is hard. The weld had a lack of fusion between the weld metal and the rod. But, this did not contribute to failure, see Section 8 - Weld Evaluation, for more details. Figure 5-3 shows the OD surface had corrosion pits. The corrosion pits were about 0.0025 inch deep. No cracks extended from the pits.

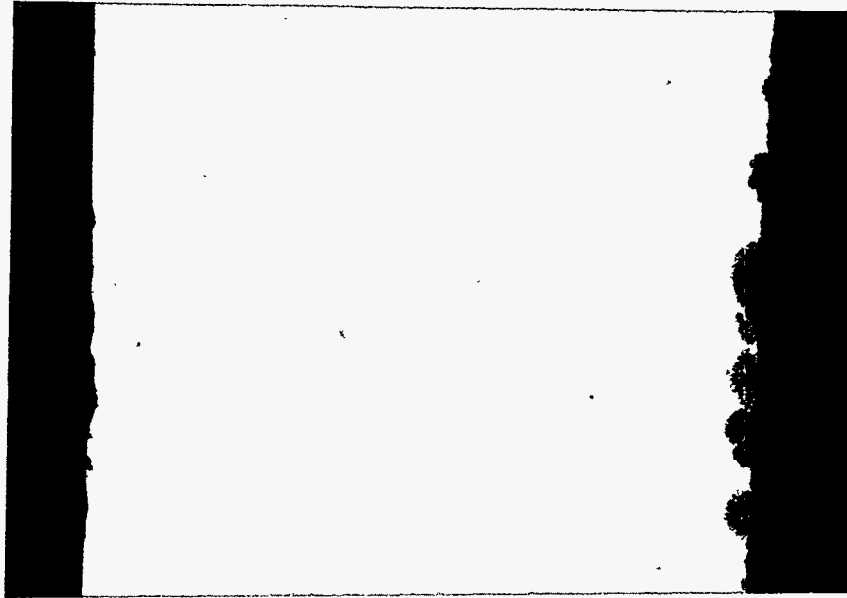
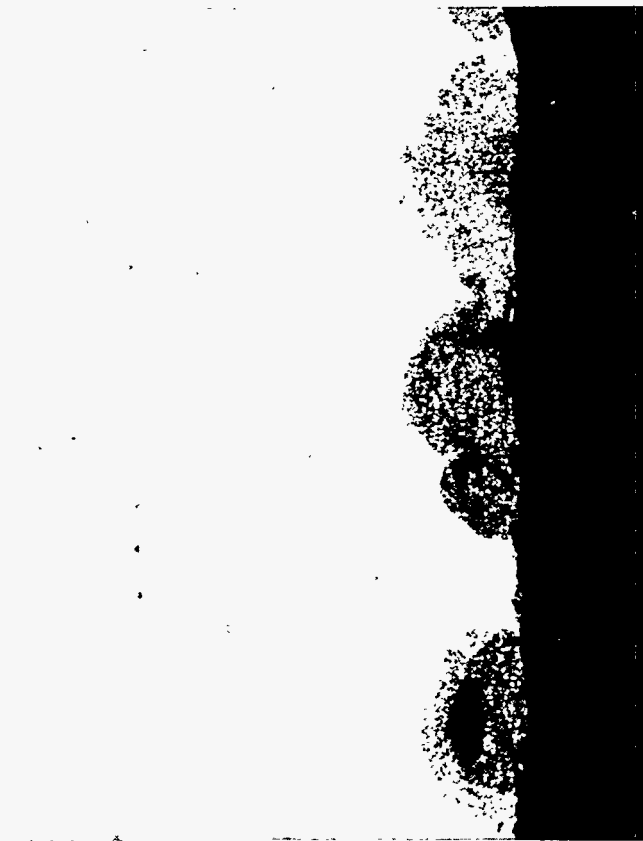
- (3) Corrosion pits were present on the surface. Although the corrosion pit provided a preferred location to initiate a crack, the corrosion was not the cause for failure.

FIGURE 5-3. PHOTOMICROGRAPHS OF THE OD SURFACE SHOWING CORROSION ATTACK. Notice no microcracks extend from the pits.

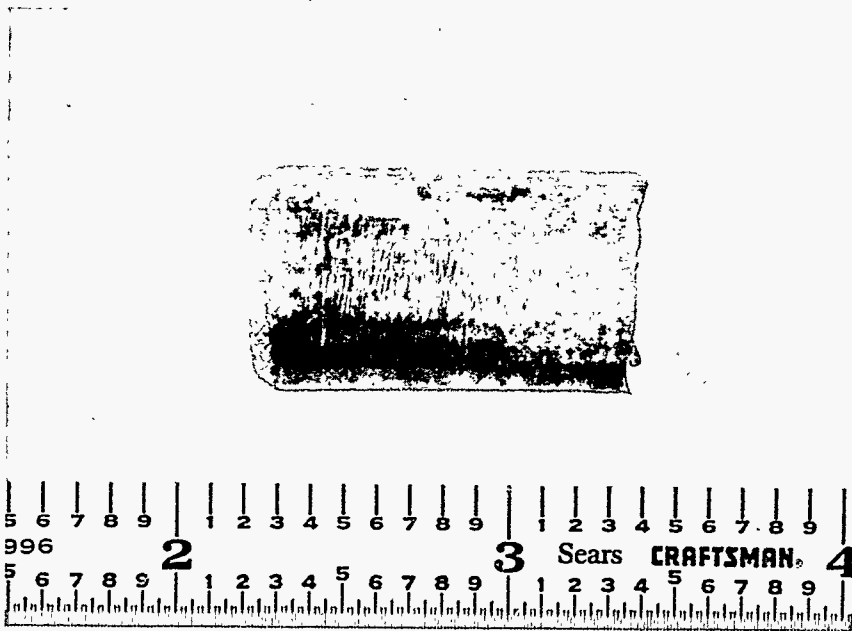
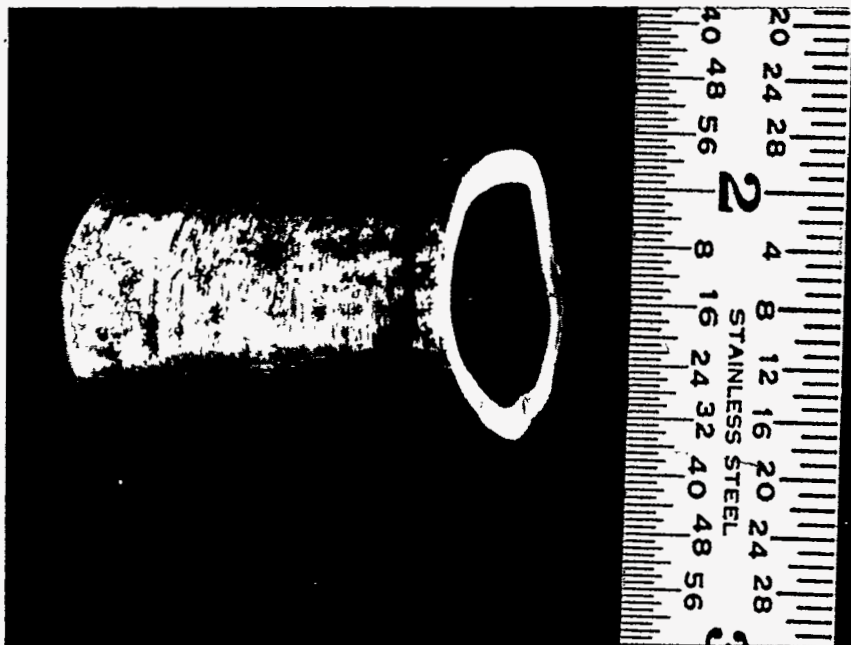
FIGURE 6-1. PHOTOGRAPHS OF THE FRACTURED TIP.

The fracture surface from Gauge No. 12711 was examined using the stereomicroscope and the scanning electron microscope (SEM). Figure 6-1 shows the fracture surface viewed towards the end of the rod. Figure 6-2 shows the fracture surface viewed towards the housing. The fracture plane was nearly transverse to the axis of the rod. A unique feature found on the fracture surfaces was a discolored zone, shown in Figures 6-2 through 6-4. The discolored region extended about 0.25 inch around the circumference. The clamshell features and radial markings, shown in Figure 6-4, indicate this region was the origin. Crack initiation occurred on one side of the rod coinciding with the elliptical region. The transverse crack extension and the initiation on one side suggests that the rod was loaded in a bending condition.

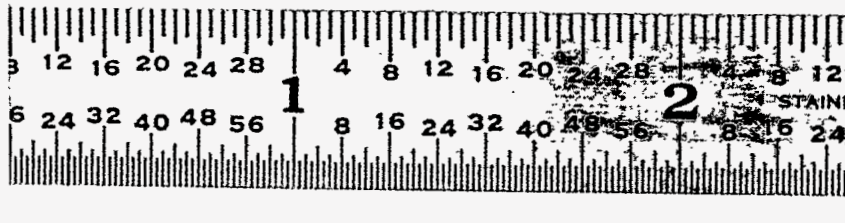
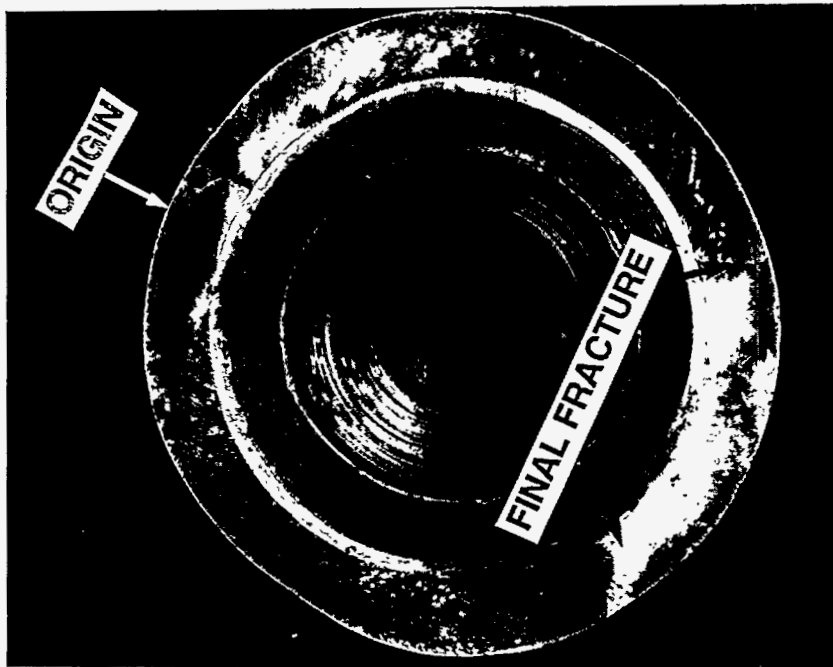
FIGURE 6-2. PHOTOGRAPHS OF THE FRACTURED SURFACE TOWARDS THE GAUGE. Arrow shows discolored region.

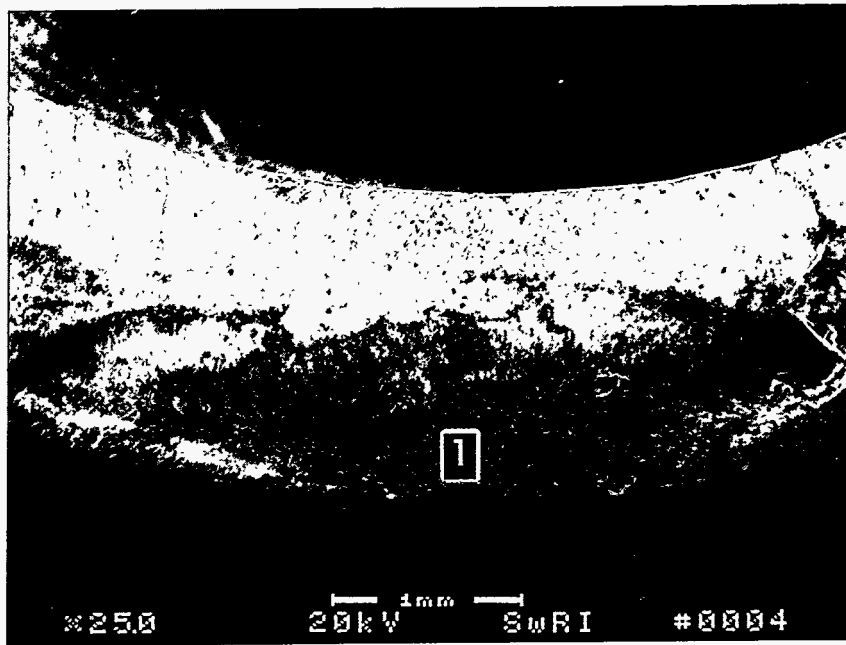
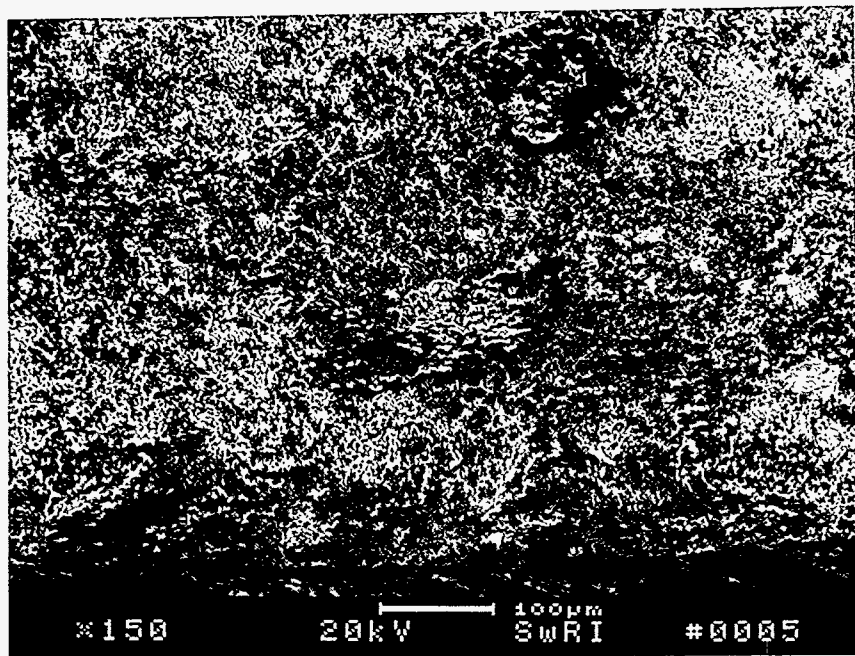
FIGURE 6-3. SEM FRACTOGRAPHS OF THE TIP END SHOWING ELLIPTICAL REGION.

- 1) The discolored region was elliptical in shape and had a heavy oxide present, see Figure 6-3.
- 2) Corrosion pits were evident in the vicinity of the origin, see Figures 6-4 and 6-5, however, pitting was not limited to the origin.

- 3) Fractographic features in the discolored region consisted of a heavily oxidized fracture surface and crack arrest bands. These features indicate that a small crack had existed for some time. The surface corroded, then during usage the crack extended, then arrested until the next usage.

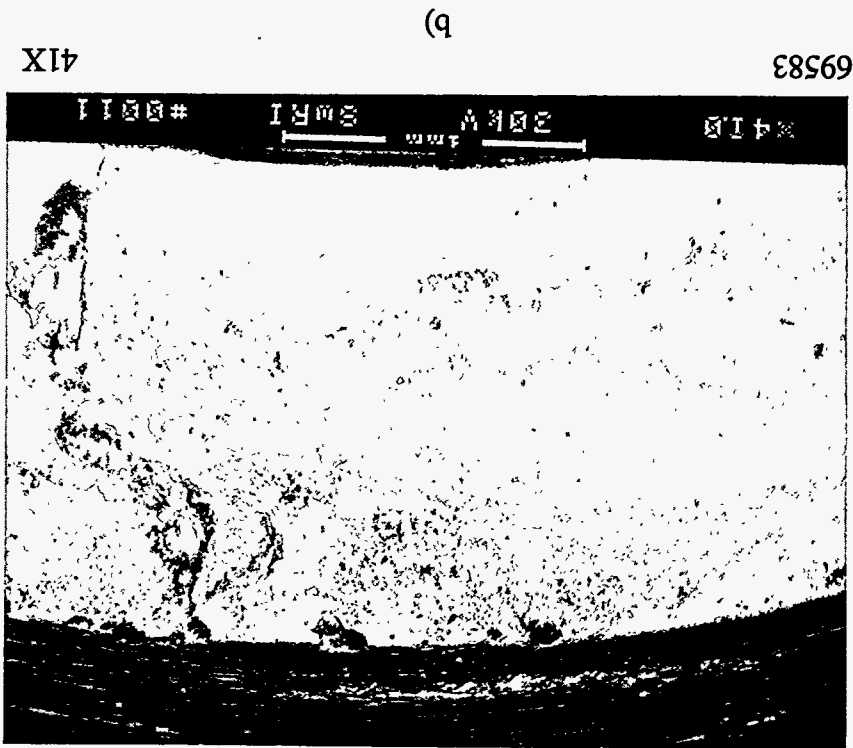
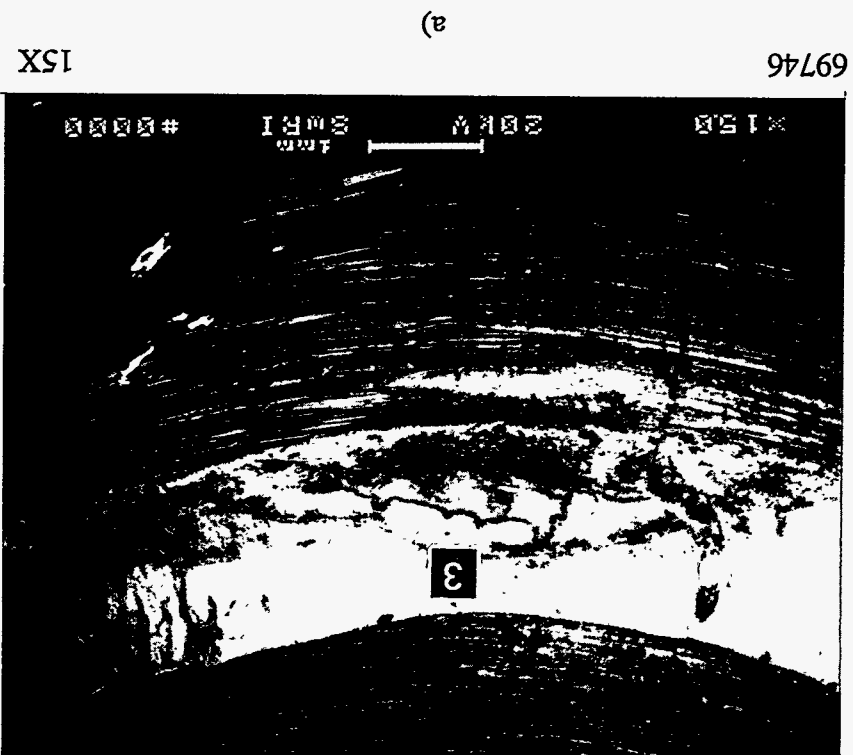
FIGURE 6-4. SEM FRACTOGRAPHS OF ORIGIN ON GAUGE SIDE. Notice corrosion pits on the OD surface. Arrow indicates clamshell pattern.

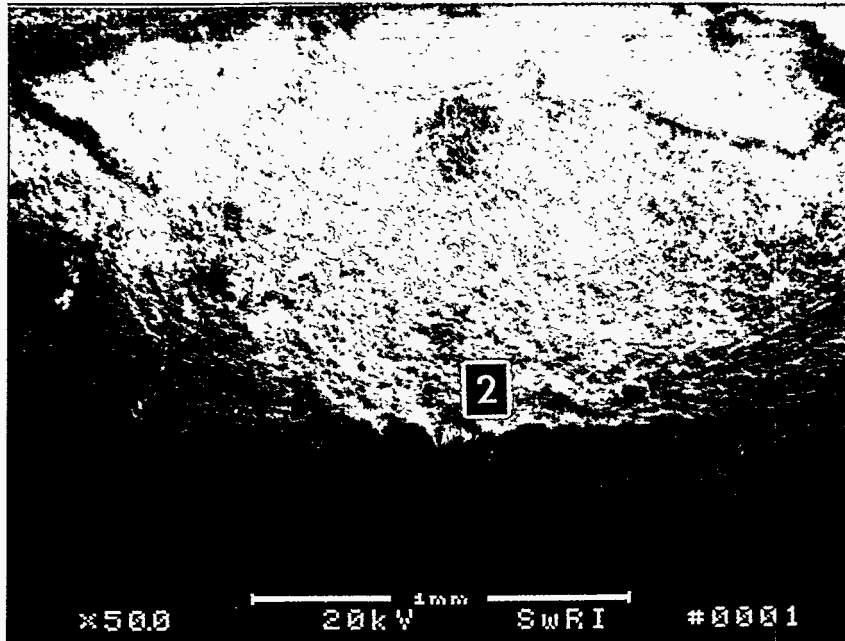
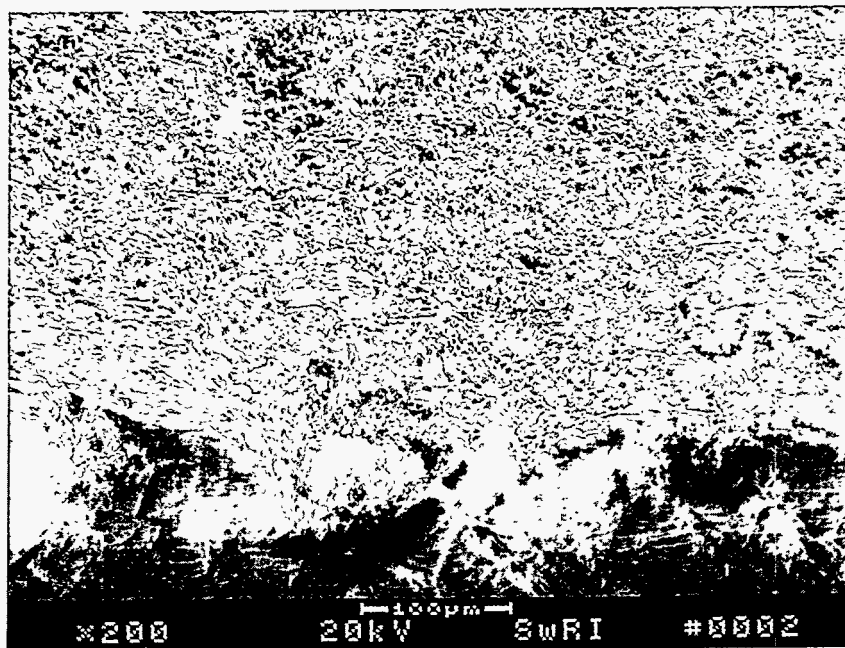
FIGURE 6-5. SEM FRACTOGRAPHS IN THE ELLIPTICAL REGION, LOCATION 2.

- 5) There were no signs of tensile overload dimples, or cleavage facets in the origin location indicative of brittle impact overload, or even intergranular facets indicative of environmental attack, see Figures 6-5 and 6-7.

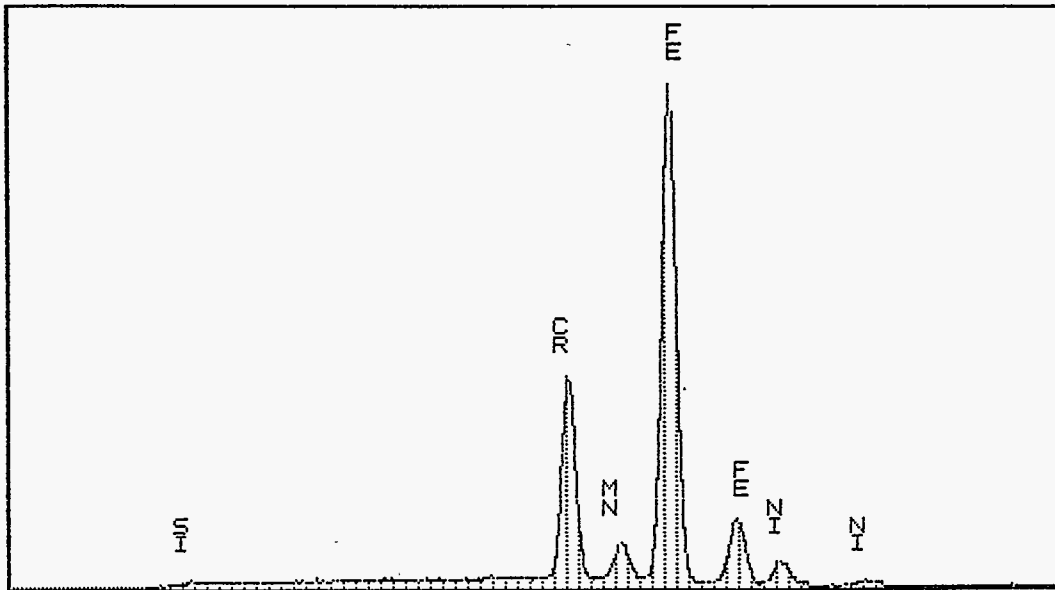
FIGURE 7-4. ENERGY DISPERSIVE X-RAY SPECTRA FOR THE WELD.

However, the weld metal was not the same metal as the rod. The weld metal was comparable to an austenitic stainless grade (probably Type 308).

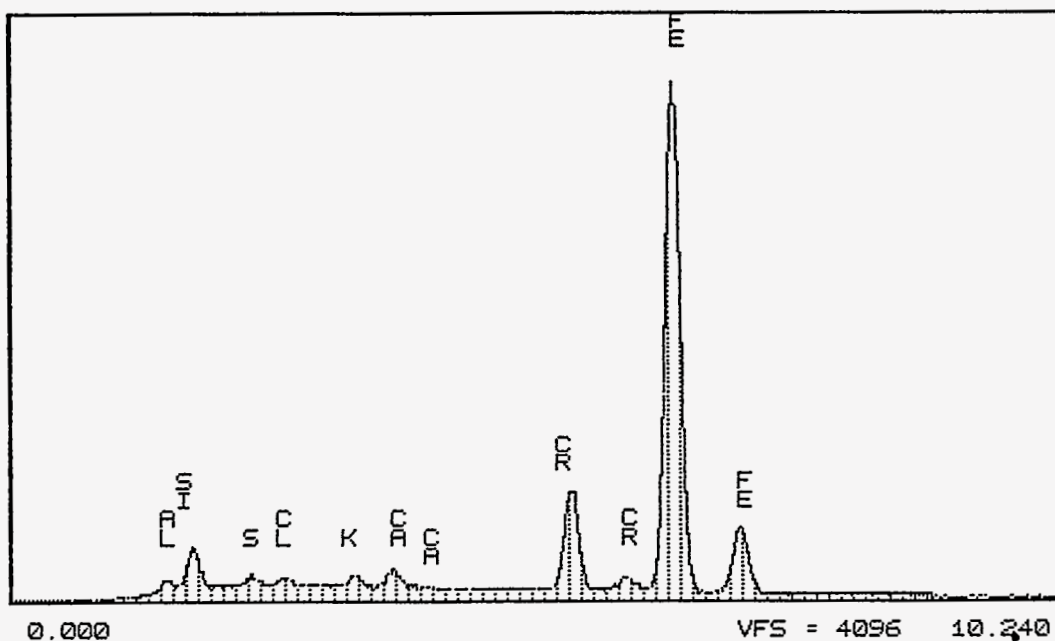
FIGURE 7-5. ENERGY DISPERSIVE X-RAY SPECTRA FOR THE ROD CORROSION.

The corrosion product analysis identified elements of calcium, chlorine, and potassium. These elements are typical for the application of the rod.
