ICANS-XIII  
13th Meeting of the International Collaboration on  
Advanced Neutron Sources  
October 11-14, 1995  
Paul Scherrer Institut, 5232 Villigen PSI, Switzerland

## EXAMINATION OF DISKS FROM THE IPNS DEPLETED URANIUM TARGET

This paper describes the results of visual, gamma ray scanning, and destructive metallurgical examination of two disks from the depleted uranium target of the Intense Pulsed Neutron Source.

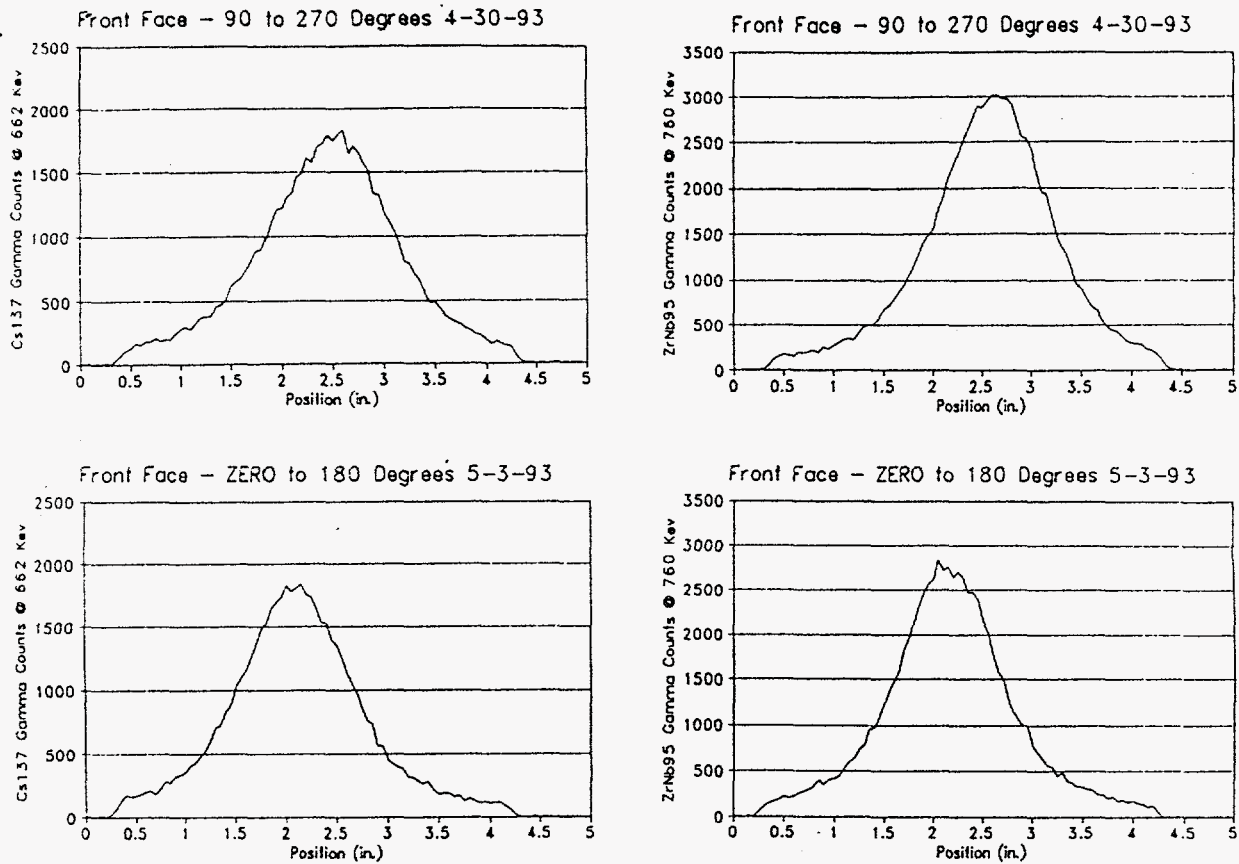
Gross beta and gamma activity measurements at the front and back face of each disk show peak values at the back face of disk #1 (120 R/hr) with slightly lower values at the front of disk #1 and both faces of disk #2 (110 R/hr). The activity diminished progressively in the remaining disks (from 105 to 4 R/hr). Diametral scans across the disks were performed at four orientations and for several nuclides. Scans for  $^{137}\text{Cs}$  and  $^{95}\text{Nb/Zr}$  fission products at the front face of disk #1 are shown in Fig. 2. The shape of these curves reflects the distribution of fission events and shows that most of the damage occurred near the center of the disks (but not perfectly centered) in a roughly circular pattern. The activity outside a radius of about 20 mm was less than half the peak activity. The area of measurable gamma activity is in general agreement with the observation of distortion of the cladding in disks #1 and #2.

Figure 2. Gamma Activity Across the Diameter of Disk #1, Typical Shapes.

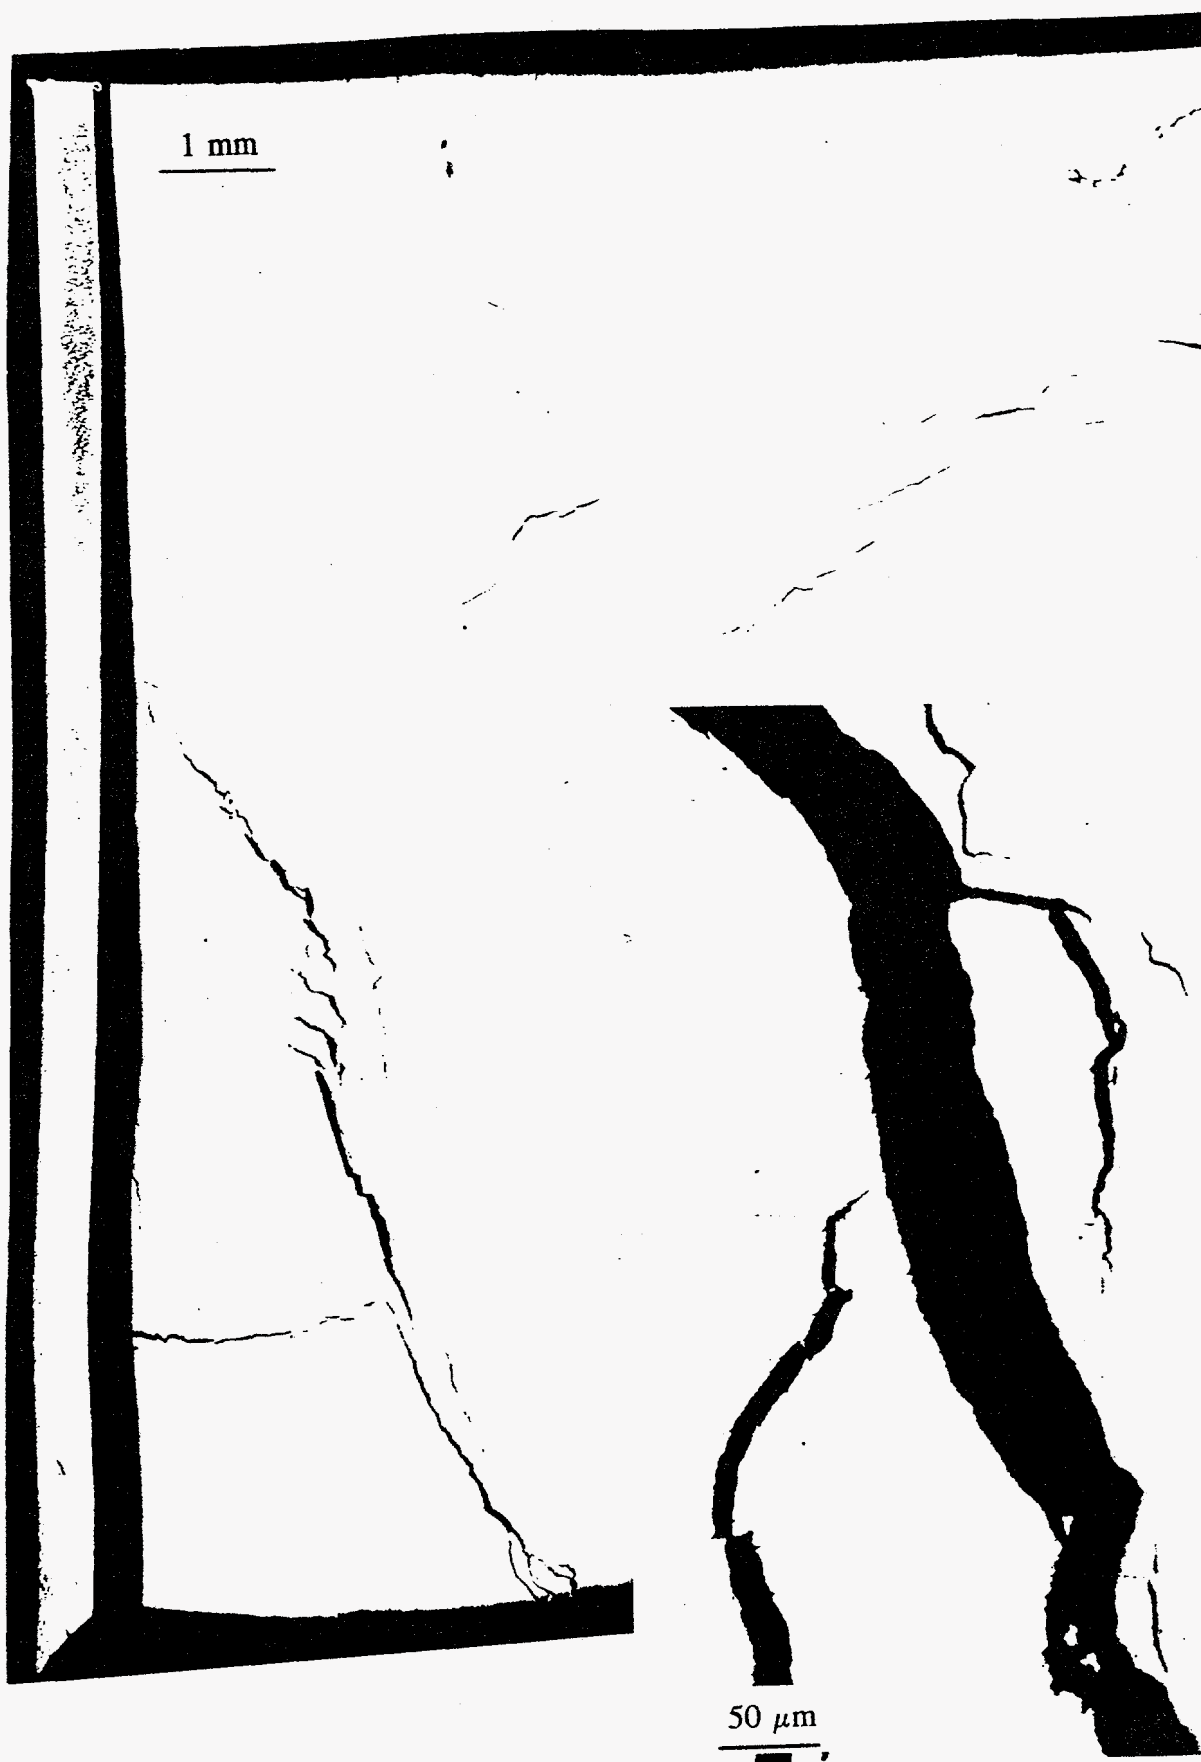
Figure 4. Micrographs of a Sample from Disk #1.

A sample for optical microscopy was cut at a location 12 to 25 mm from the center of the disk. This sample was chosen because it included several smaller cracks, but was away from the major crack filled with corrosion product. Low magnification composite photographs of the sample from disk #1 show that the cladding has separated from the core material and a network of cracks is present in the uranium. Higher magnification photographs show that every crack examined contained a gray-colored material (Fig. 4) that is assumed to be corrosion product as a result of reaction between the uranium core material and the coolant water. In most areas the corrosion product appears to be a single phase, medium gray, monolithic material that is assumed to be uranium dioxide. At the end of cracks (where the crack is extending into the core material) the corrosion product appears to consist of two phases (the medium gray phase and a lighter gray phase). The lighter gray phase may be uranium hydride (if its not an optical illusion). The formation of hydride is promoted by high hydrogen partial pressure. The crack tip would tend to trap hydrogen and is a logical location for the formation of the hydride.

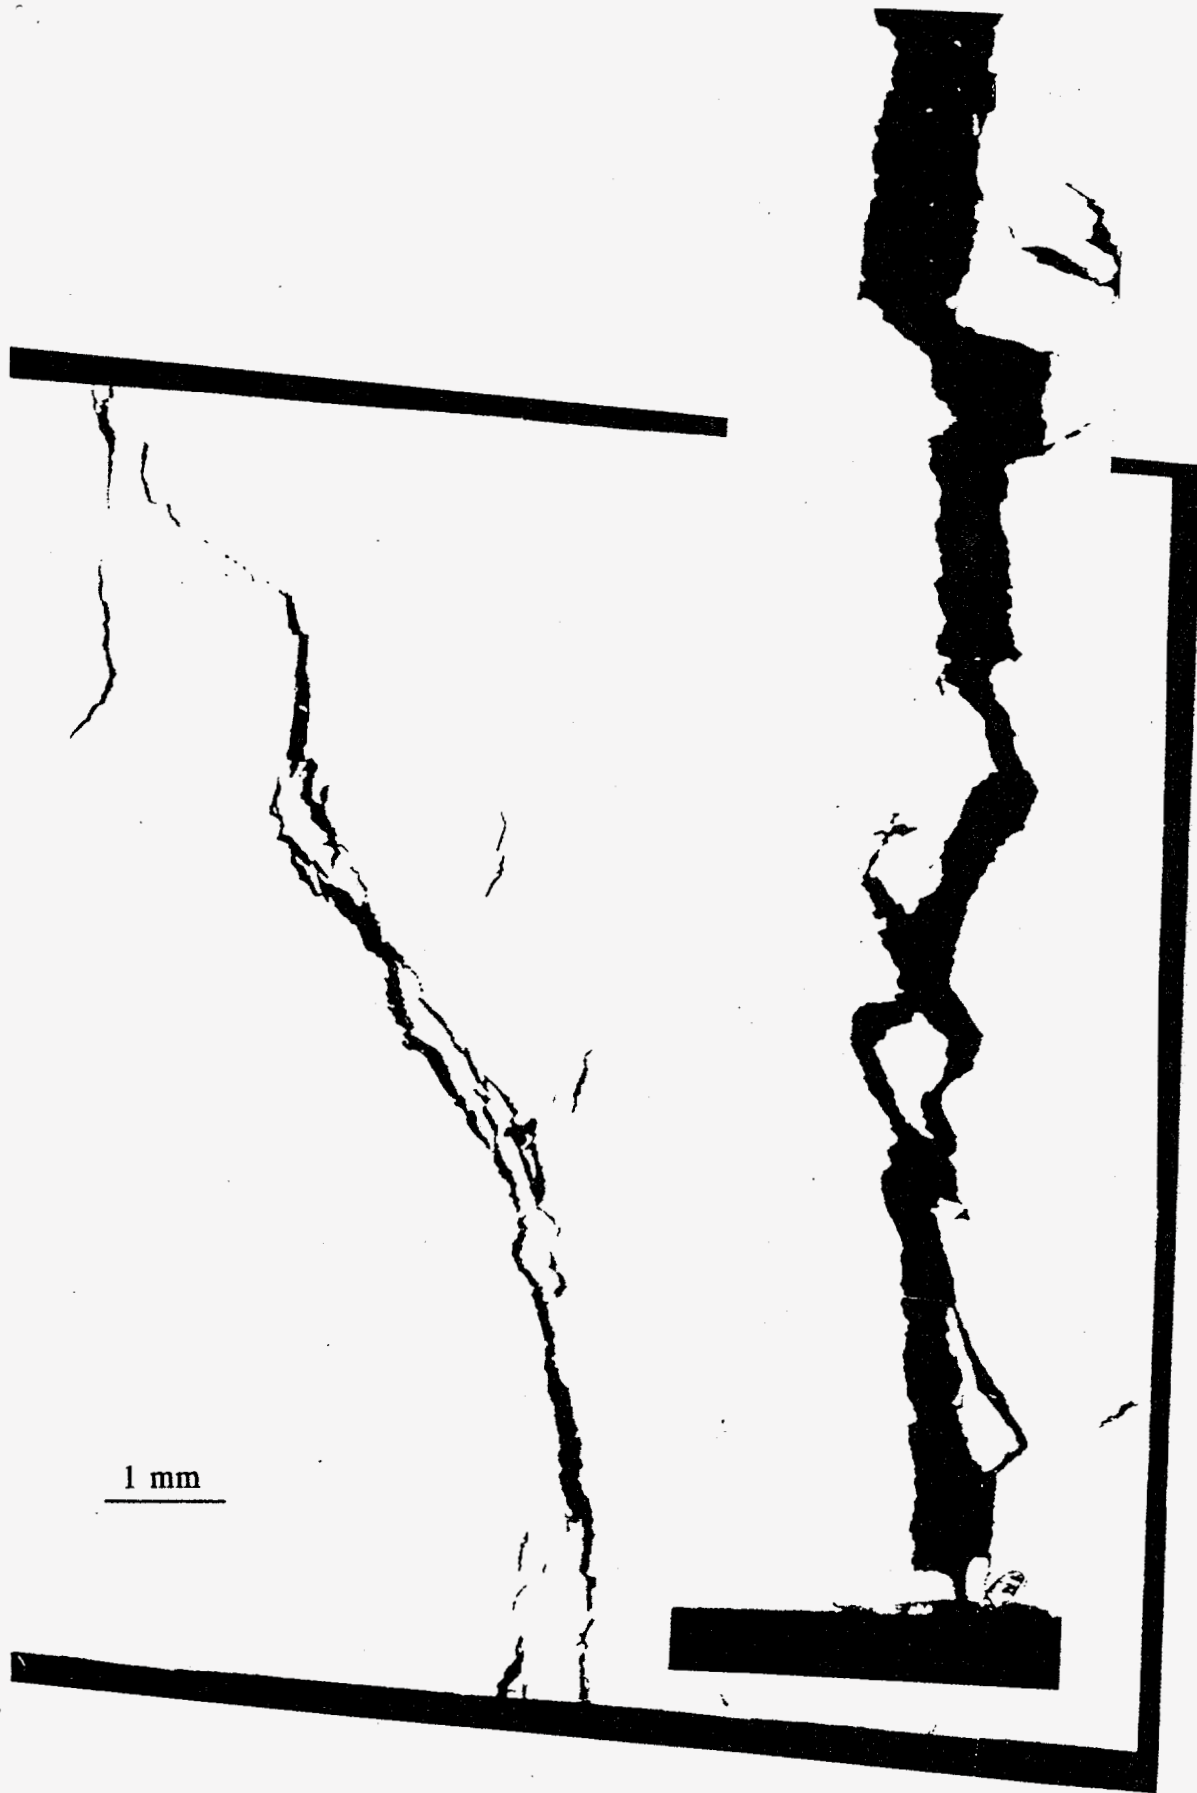
Reasoning that because corrosion had not taken place in the disk adjacent to the failed disk it must show cleaner evidence of the cause of failure than the failed disk, we performed a thorough destructive examination of disk #2. Disk #2 was initially sectioned through its center. Visual examination of the cut surfaces showed readily observable cracks in the core material at a distance of about 25 mm from the center. Two samples were cut from this area. A low magnification composite photograph of the first sample shows one large crack system in the uranium and several short cracks some distance from the main crack. Higher magnification micrographs (Inset in Fig. 5) revealed no evidence of corrosion products or other material in these cracks (the material that appears in the micrographs is epoxy that was used to fix the sample in a mount). The cracks in the uranium indicate that the failure of the cladding on the first disk initiated in the uranium. We conclude that the cracks in the uranium were the result of anisotropic swelling from a combination of thermal cycling and irradiation.

Figure 5. Cracks in the Core Material of Disk #2

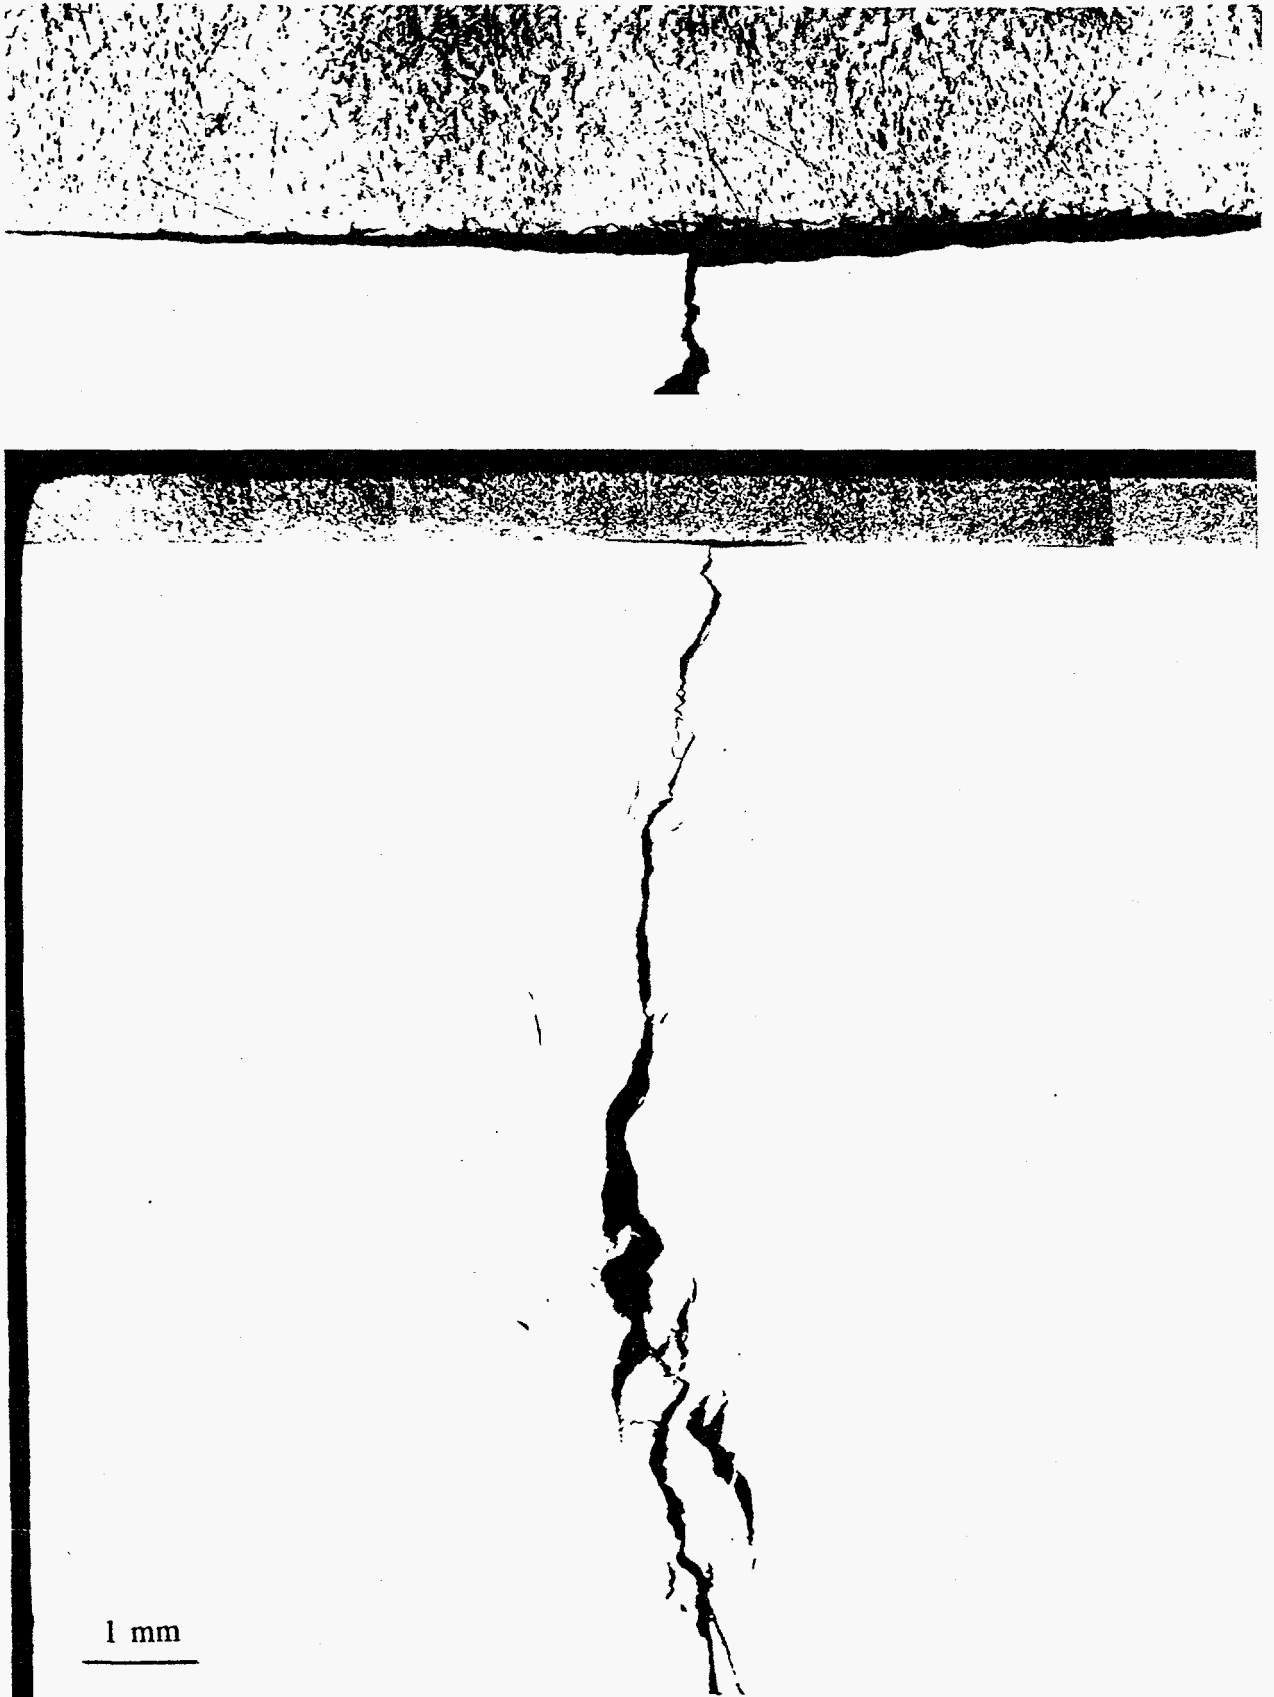
A second sample was cut that included the back face of disk #2. A low magnification composite micrograph, Fig. 6, of this sample shows that the main crack system extended through the entire thickness of Disk #2 to the back face. Again the cracks contained no corrosion product. At the intersection of the main crack with the cladding on the rear face of Disk #2, the core material appears to have pulled away from the cladding. The uranium on the two sides of the crack appear to be displaced from each other parallel to the direction of the crack. There appears to be a second phase present at the inner surface of the cladding in the region where the core material has separated from the cladding. Etching of the cladding indicates that the microstructure of the cladding is altered (the addition of fine precipitates) to a depth of about  $150 \mu\text{m}$  in the region of the separation.

Figure 6. Intersection of a Crack in the Core Material with the Cladding, Disk #2.
