**Contamination Source Review for Building E5032,
Edgewood Area, Aberdeen Proving Ground, Maryland**

ANL/ESD/TM-102

September 1995

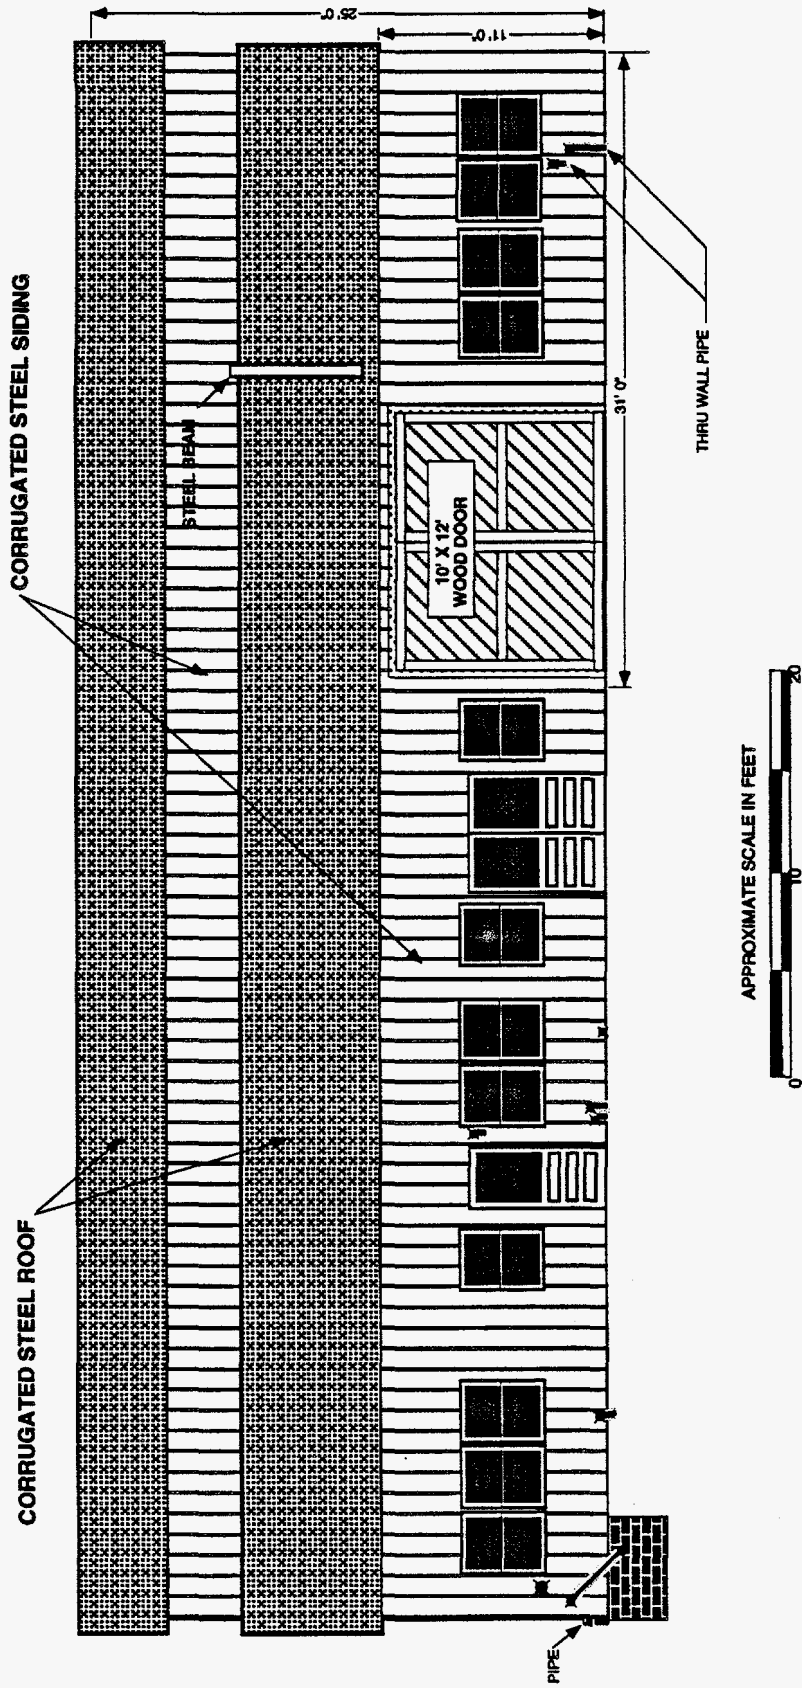
FIGURE 6 Building E5032 North Exterior Elevation

Remnants of pipes were observed along the north elevation (Figure 6).

Grass and weeds are growing up from cracks in the pavement north of the building.

The north exterior wall of the building (corrugated metal sheet) is severely deteriorated and, in some areas, rusted through. The doors and windows have also deteriorated.

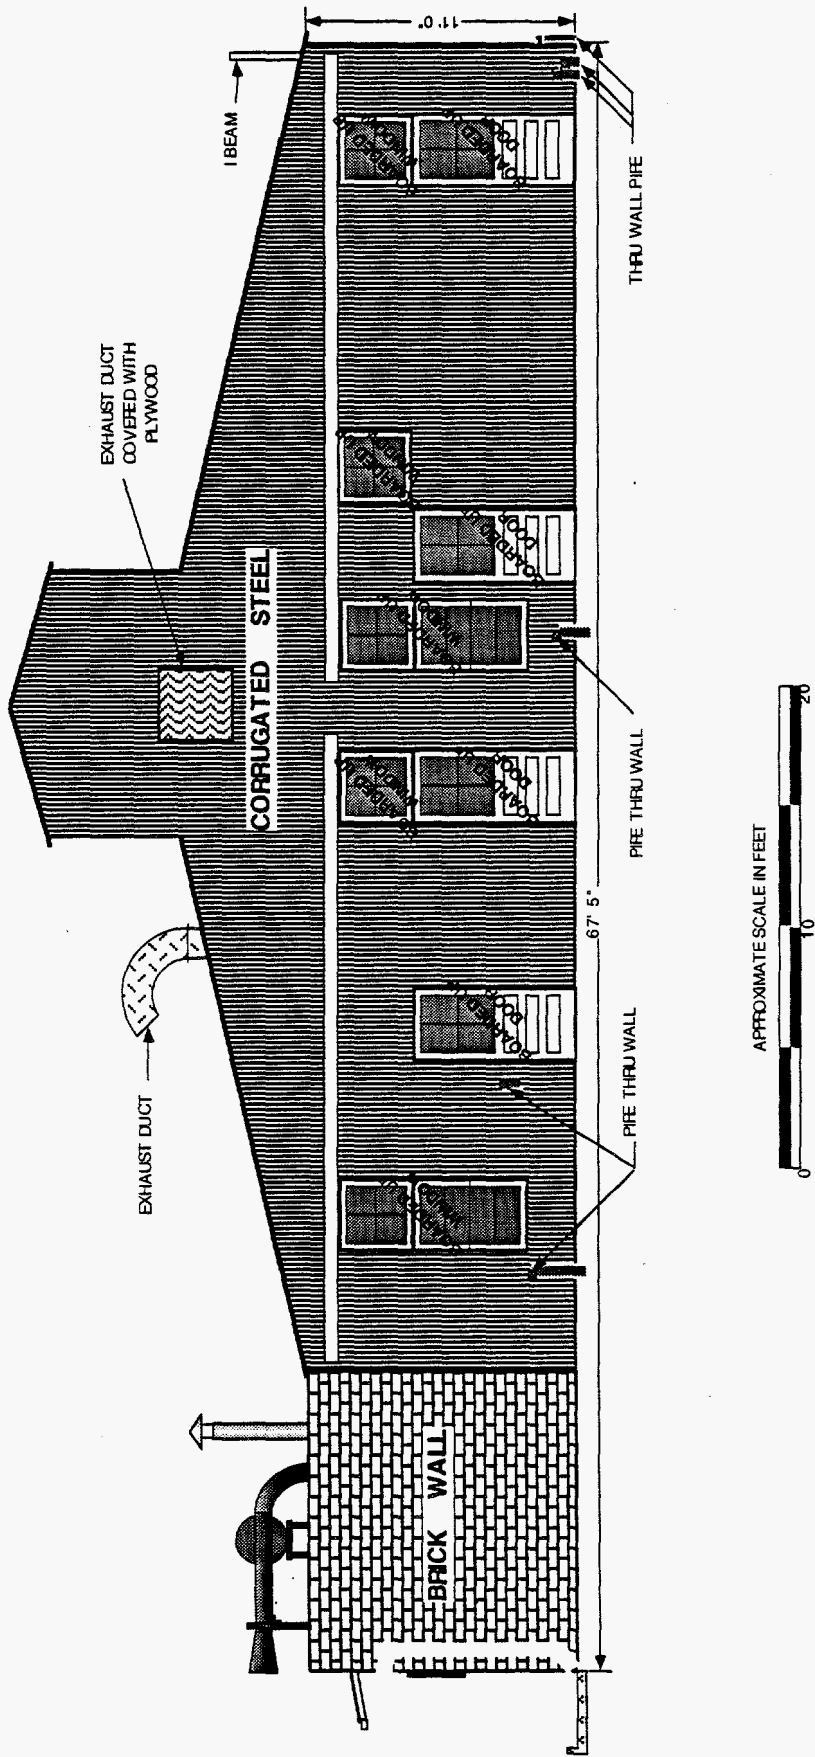
FIGURE 7 Building E5032 East Exterior Elevation

Remnants of pipes were observed on the east elevation (Figure 7).

The east exterior wall of the building (corrugated metal sheeting) is severely deteriorated and, in some areas, rusted through. The doors and windows have also deteriorated.

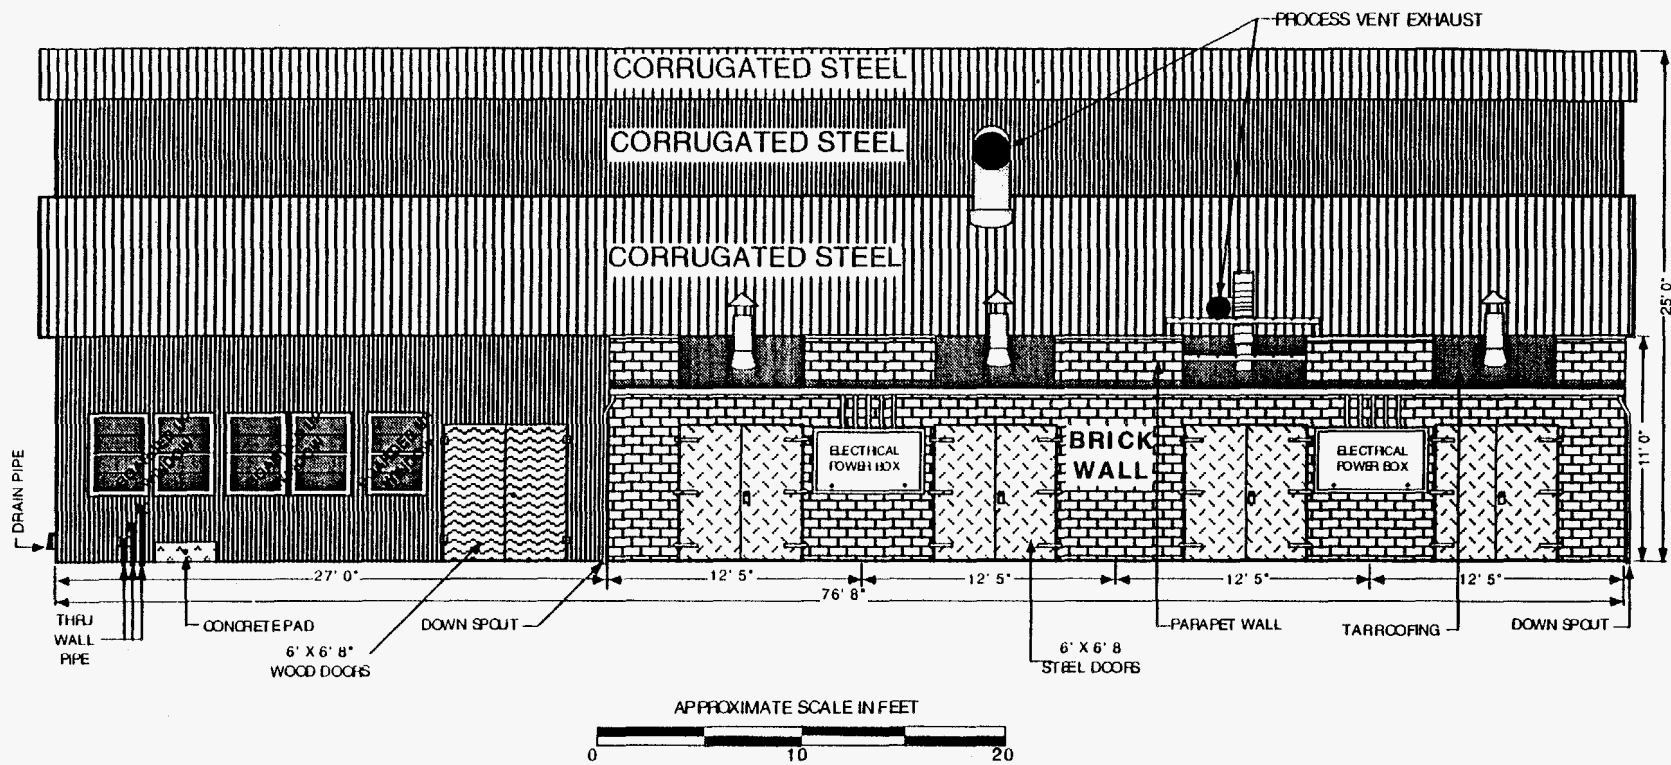
FIGURE 8 Building E5032 South Exterior Elevation

Remnants of pipes were observed on the south elevation (Figure 8).

The south exterior wall of the building (corrugated metal sheeting) is severely deteriorated and, in some areas, rusted through. The doors and windows have also deteriorated.

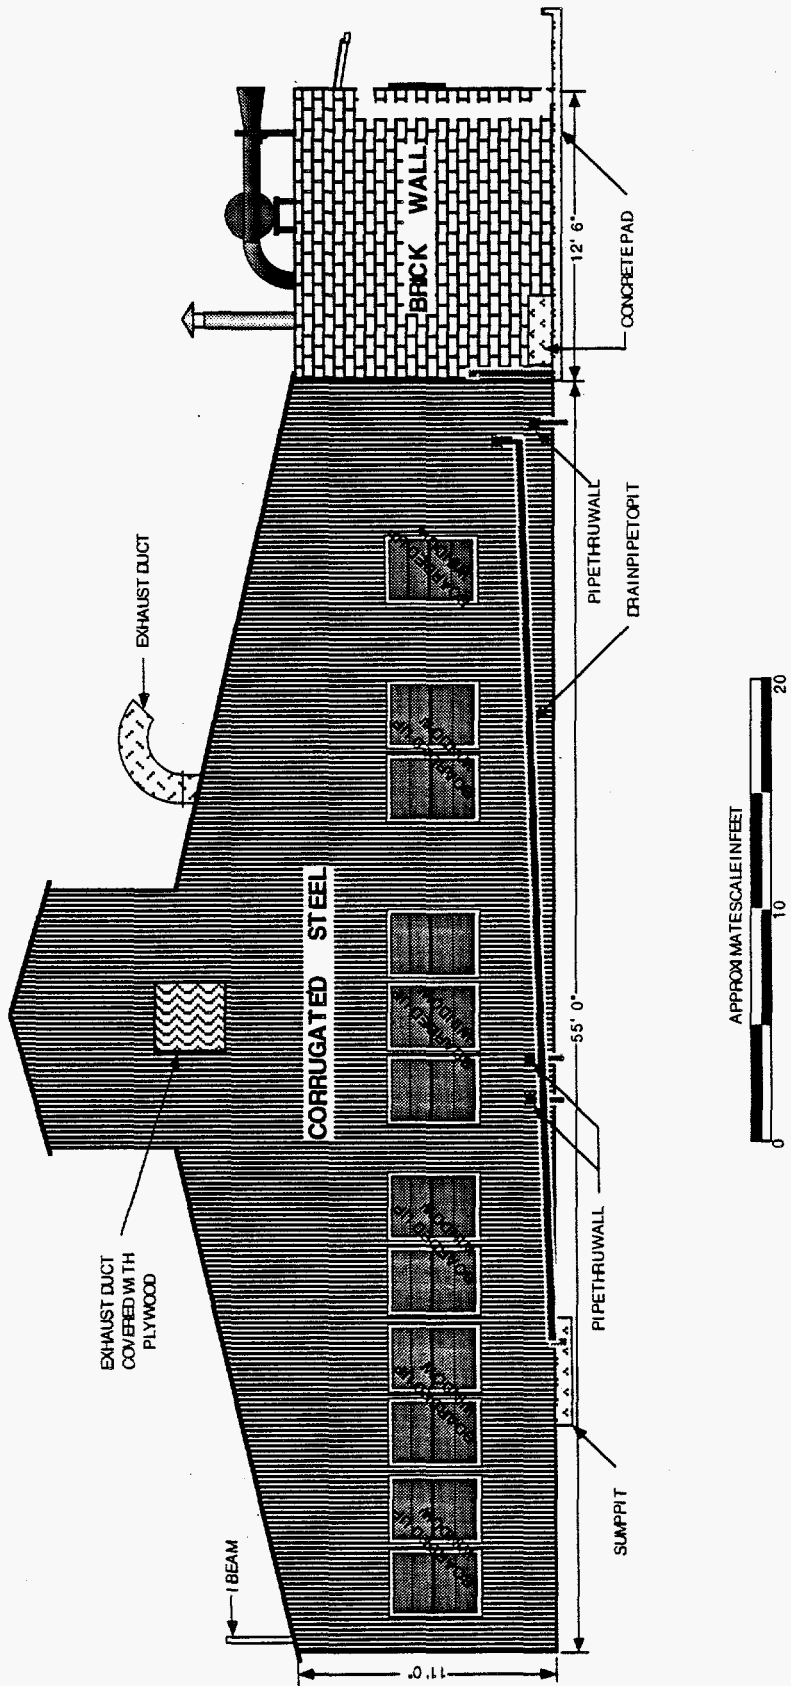
FIGURE 9 Building E5032 West Exterior Elevation

One drainage pipe leads to the sump pit. Other remnants of pipe were also observed (see Figure 9).

The west exterior wall of the building (corrugated metal sheeting) is severely deteriorated and, in some areas, rusted through. The windows have also deteriorated.

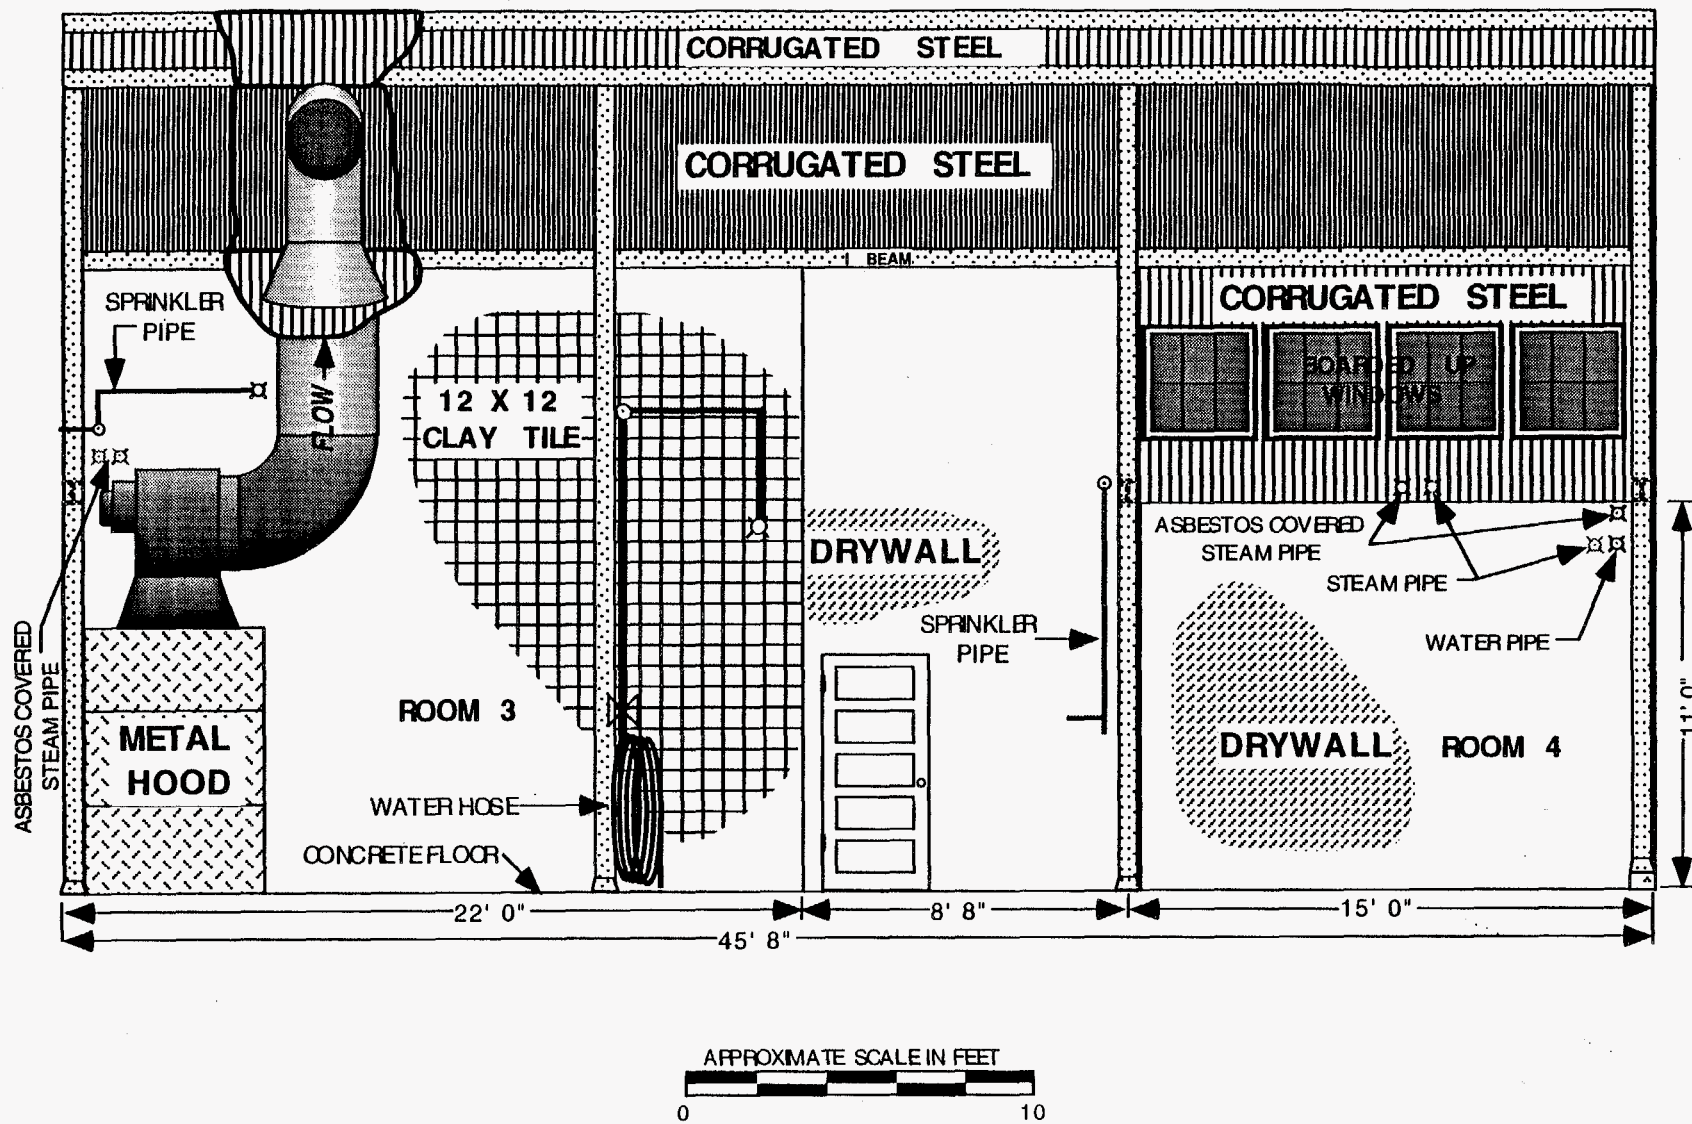
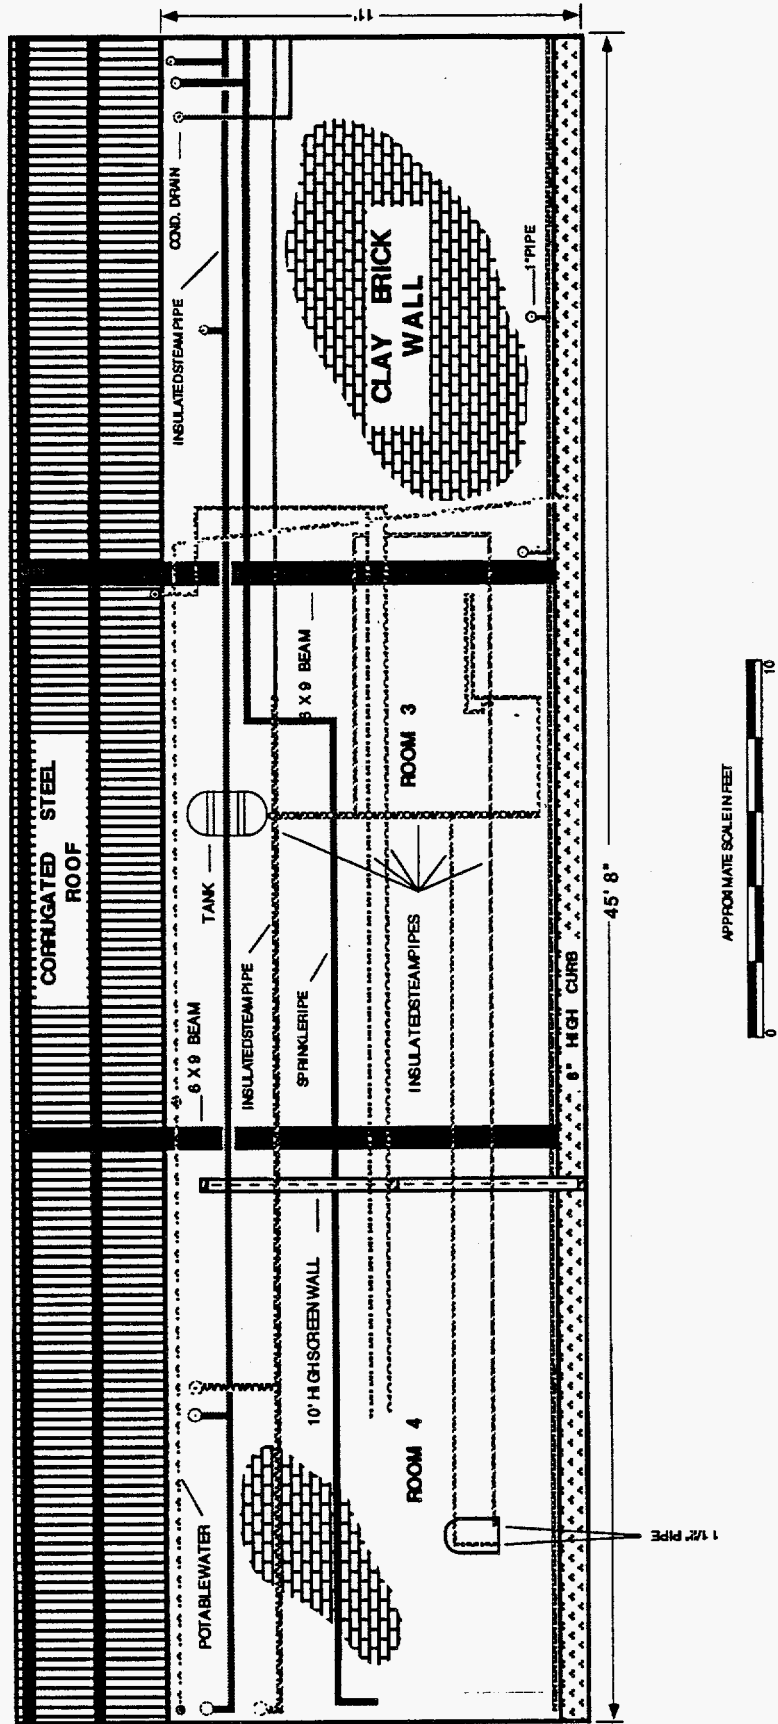
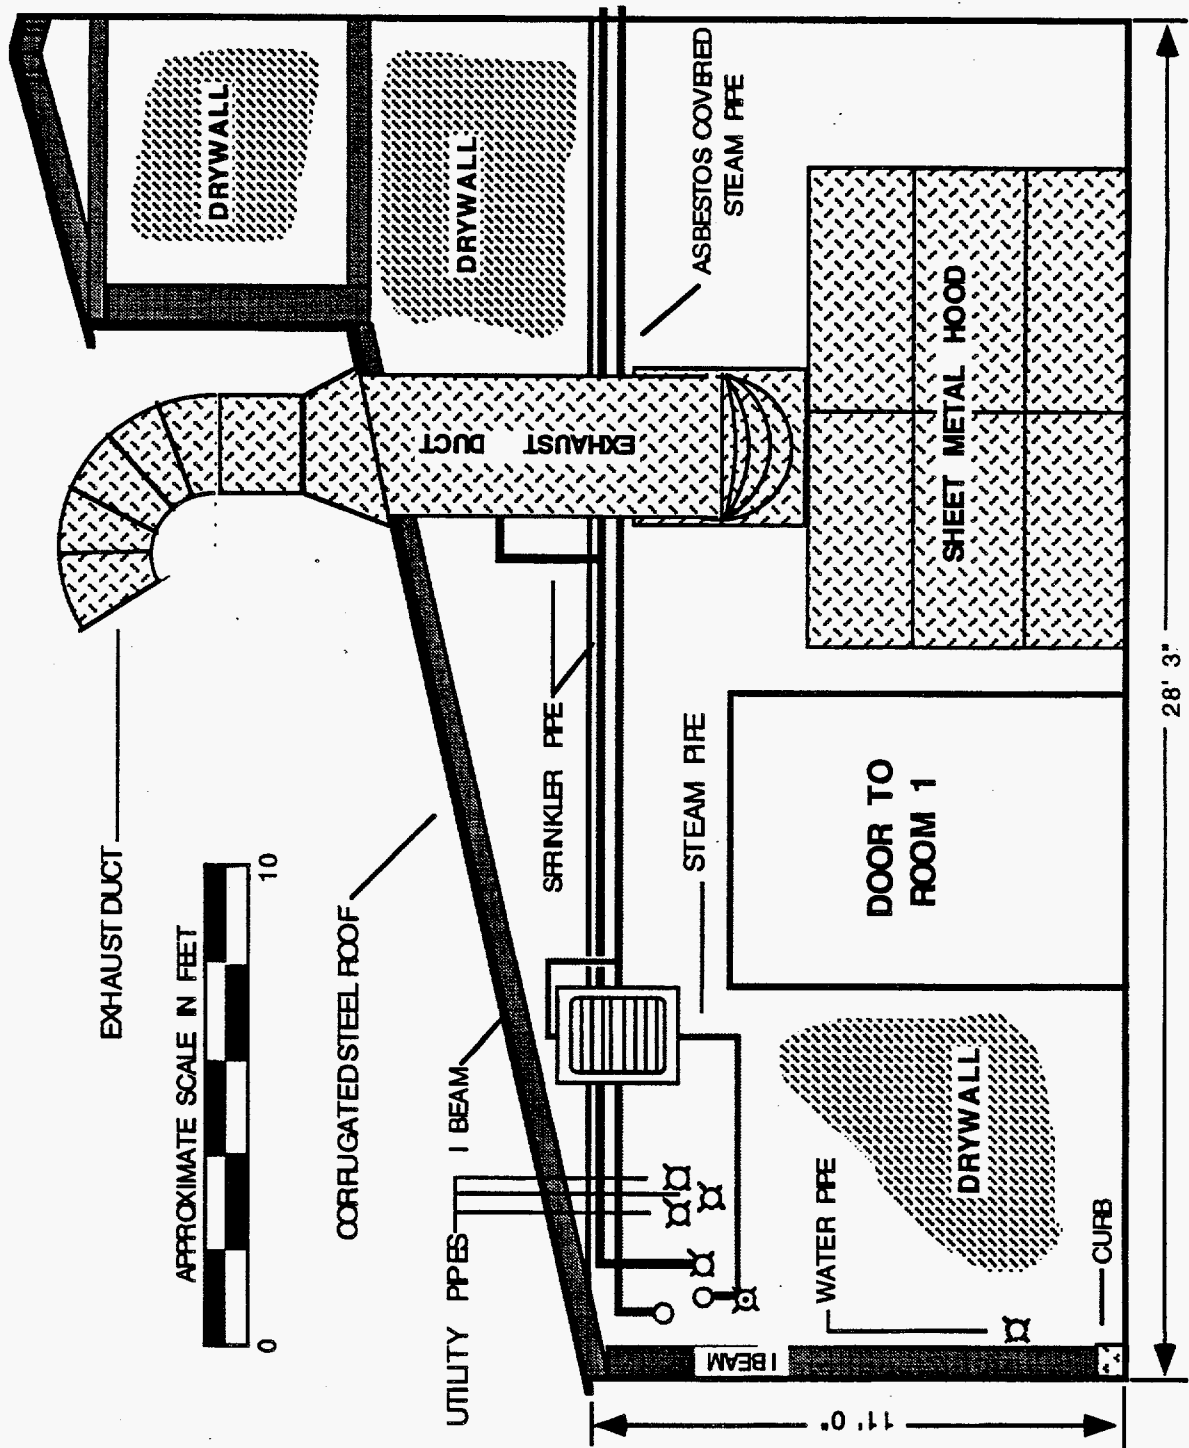
Room 3 contains various piping systems; many of the pipes were observed on the south wall (see Figures 22 through 24).

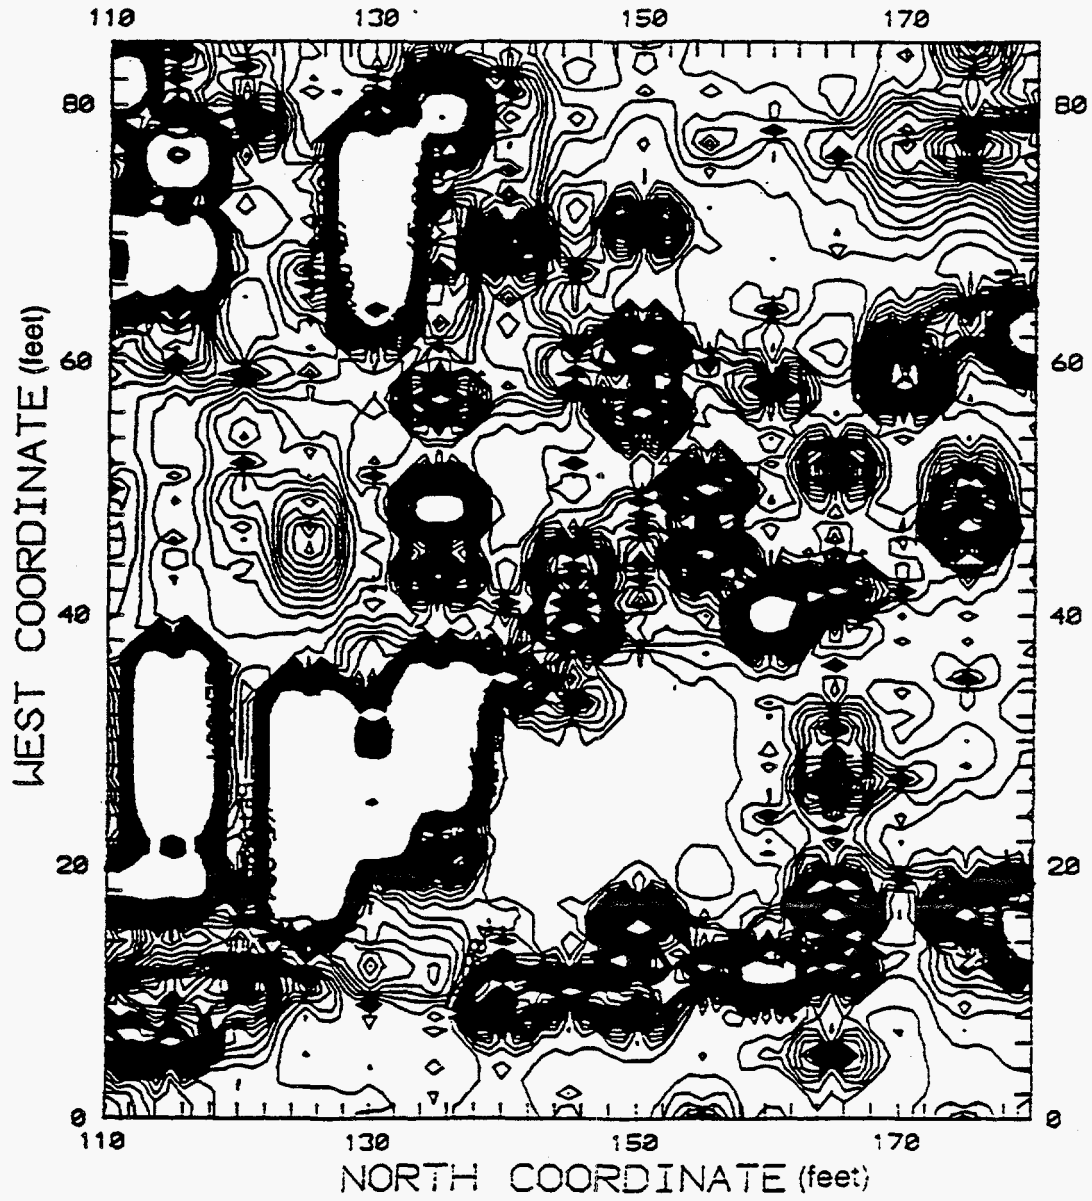
FIGURE 3 Magnetic Map of the Flat Area North of the Building

Strong magnetic anomalies, observed over much of the region north of the building, are attributed to iron pipes, buried tanks, remnants of a former railroad line, and other metallic debris (Figure 3). One strong anomaly approximately 130 ft north of the building appears to be caused by a large iron tank or vault (located at coordinates 220N,65W). GPR data indicate a strong reflector at the location (Figures 4 and 5). Other magnetic anomalies centered at coordinates 130N,70W; 135N,30W; 128N,30W; and 115N,30W also appear to be caused by buried tanks. However, a concrete slab with steel reinforcement around the anomalies makes positive identification difficult.

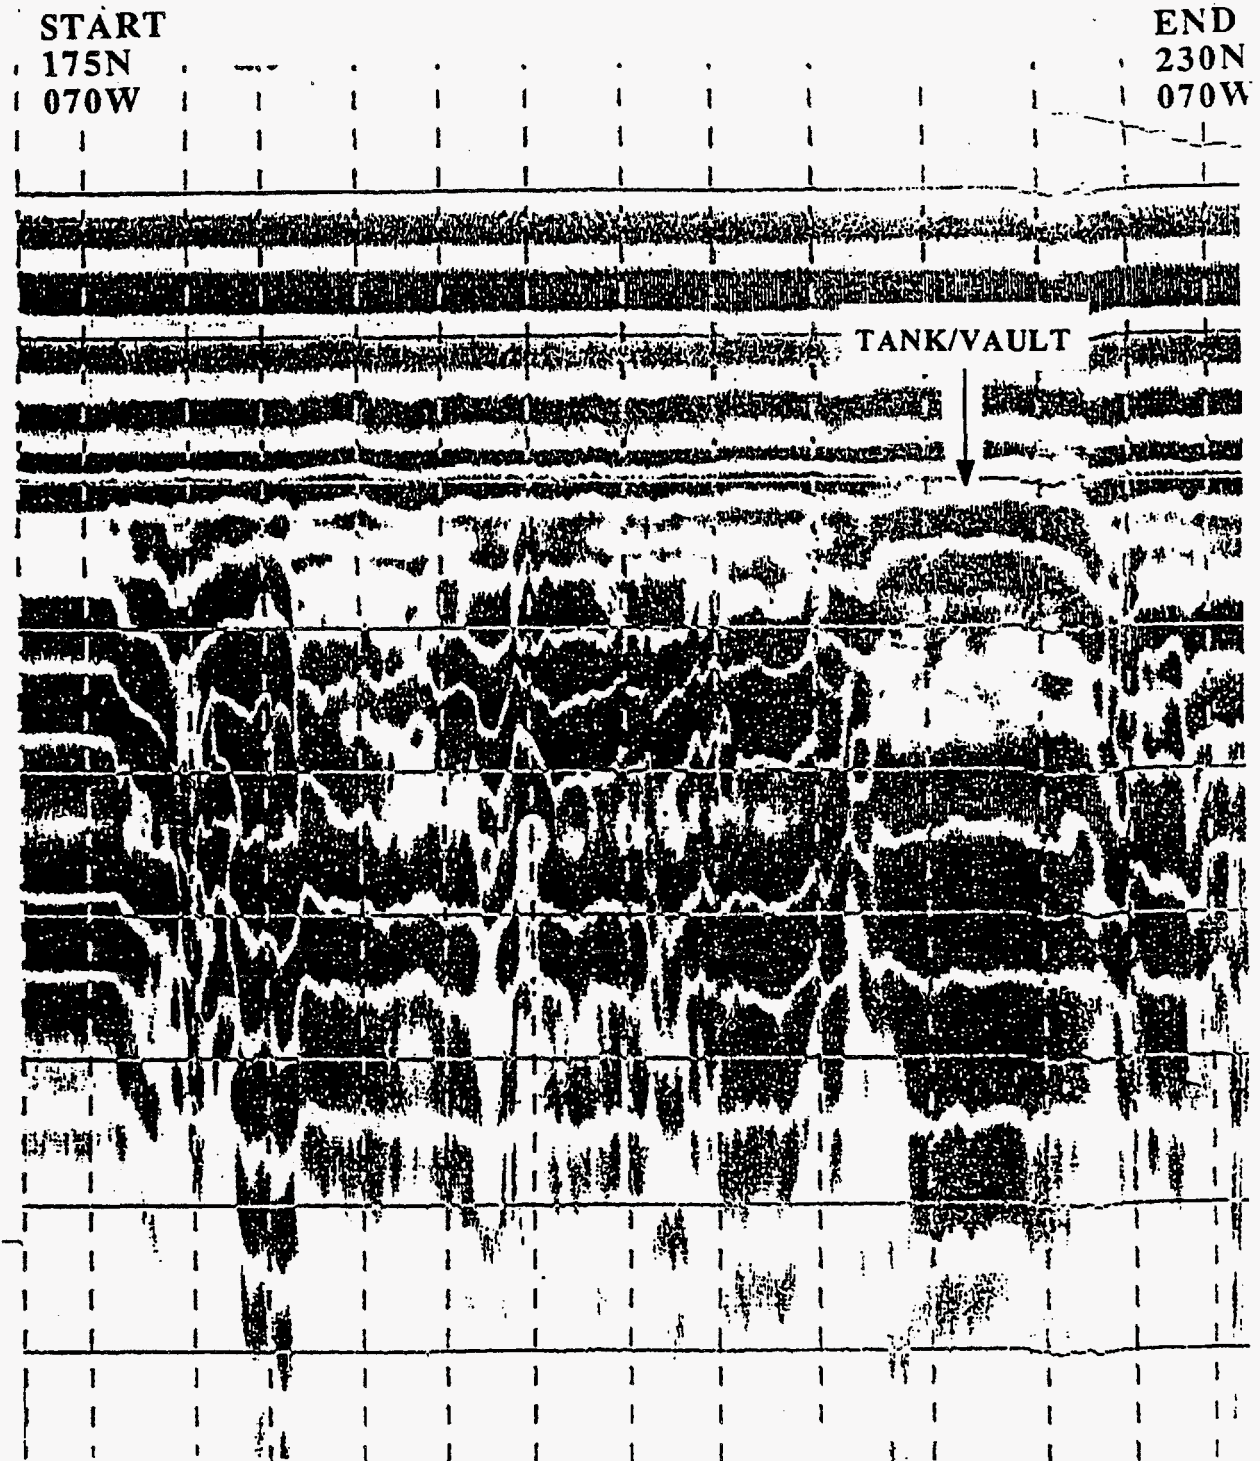
FIGURE 4 Ground-Penetrating-Radar (GPR) Signature over Buried Tank or Vault Centered at Coordinates 220N,065W along North-South Axis of the Object

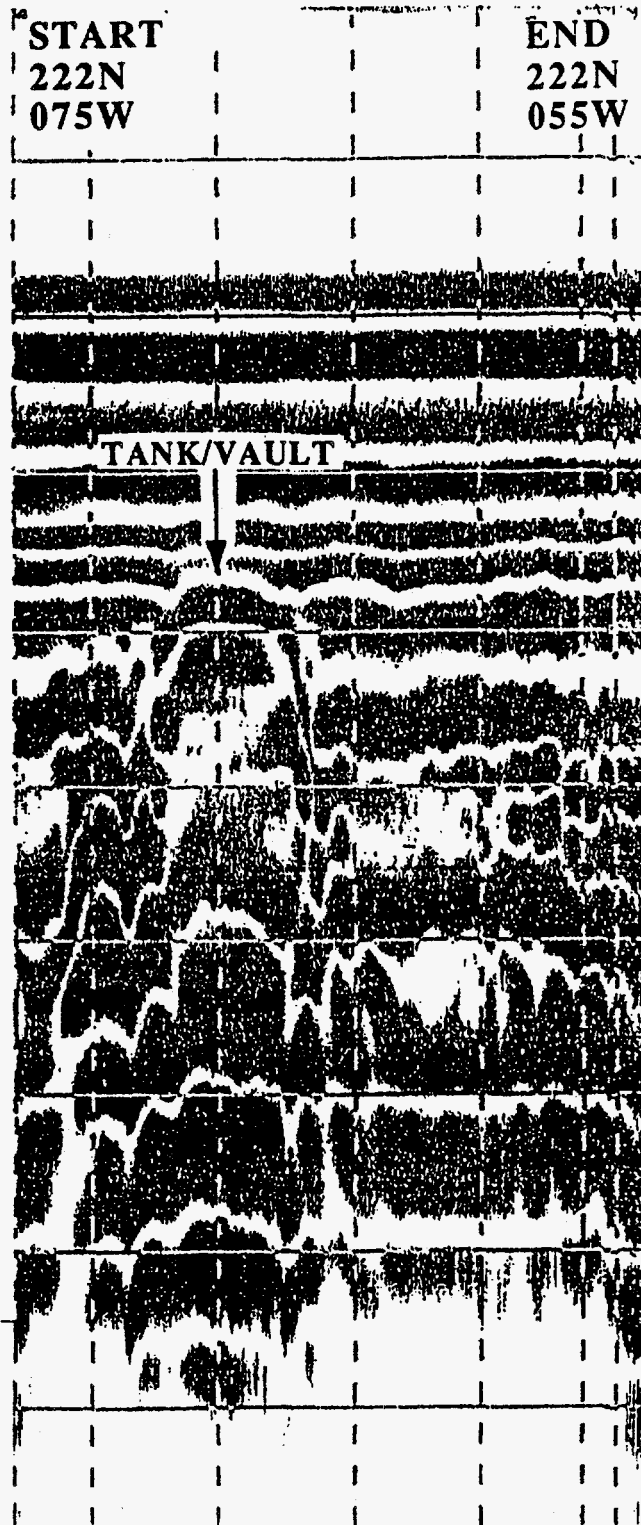
FIGURE 5 GPR Signature over Buried Tank or Vault along East-West Axis of the Object
