**Contamination Source Review for Building E3642,
Edgewood Area, Aberdeen Proving Ground, Maryland**

Contamination Source Review for Building E3642, Edgewood Area, Aberdeen Proving Ground, Maryland

September 1995

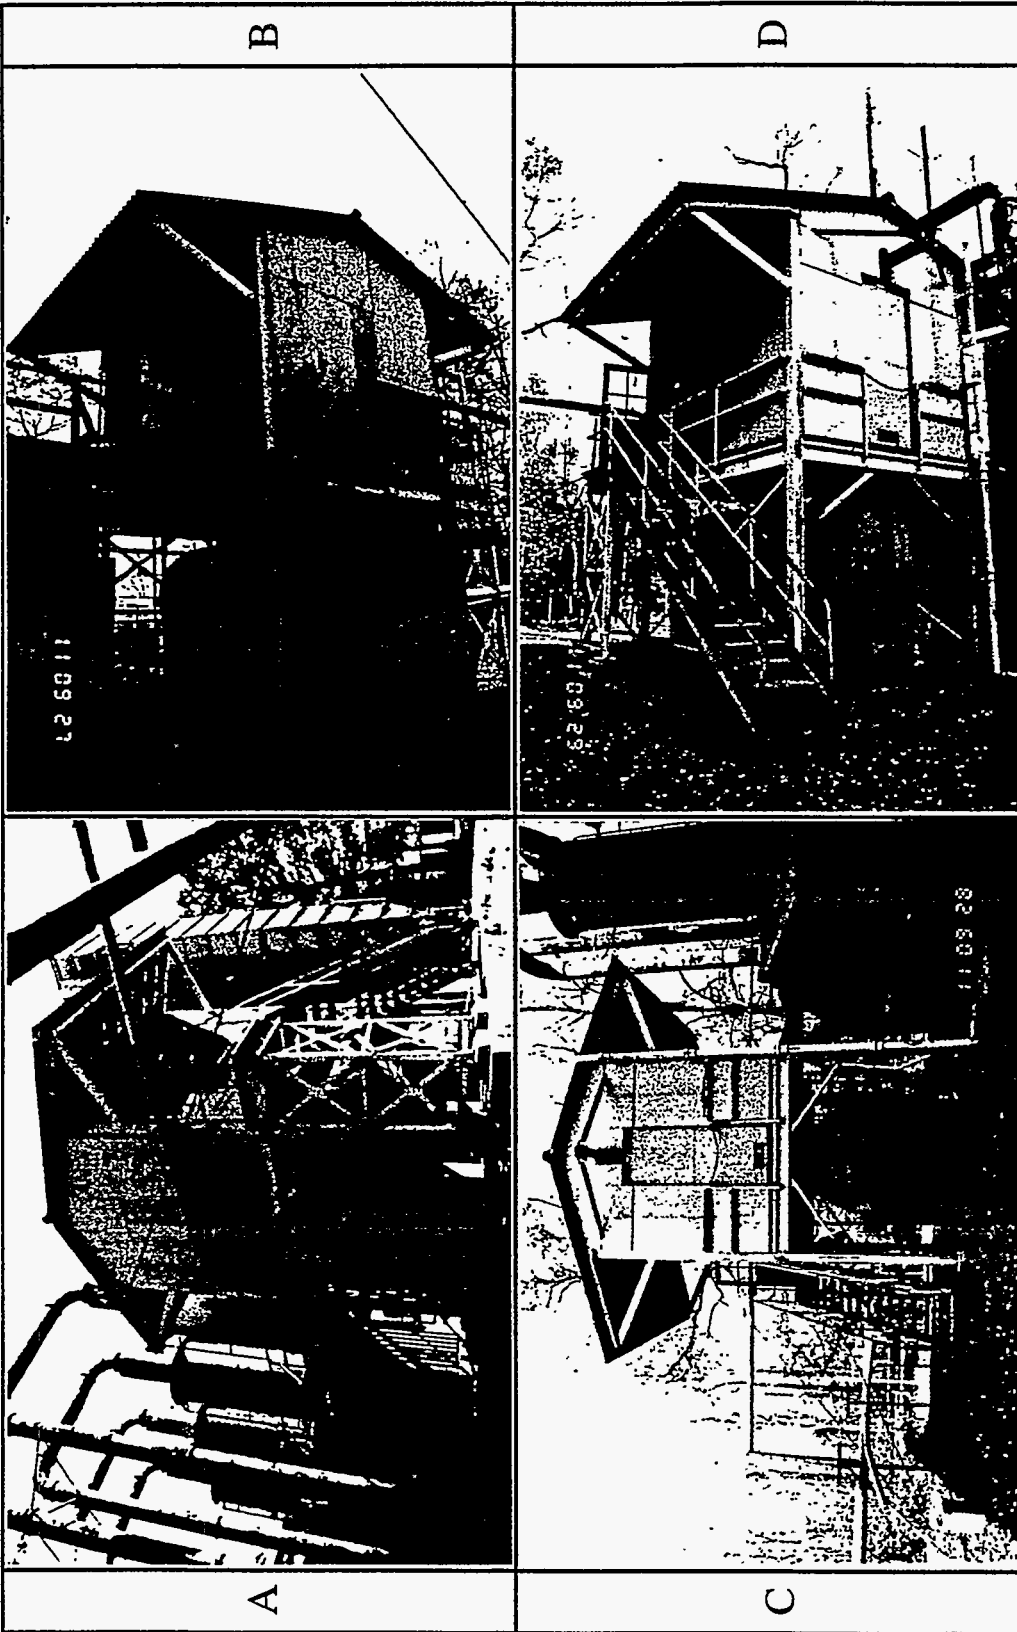
FIGURE 5 Photographs of Building E3642 Exterior

Because of a lack of building maintenance, the north elevation shows signs of deterioration and weathering. Oxidized metals were observed at the time of the investigation.

Because of a lack of building maintenance, the east elevation shows signs of deterioration and weathering. Oxidized metals were observed at the time of the investigation.

The south exterior elevation of Building E3642 contains one pipe extending upward from the concrete foundation at the southeast corner to approximately 12 in. below the roof (Figure 5).

A steel I-beam centered above the doorway extends through the wall on the second floor. The beam may be associated with the hoist device (Figure 5).

Because of a lack of building maintenance, the south elevation shows signs of deterioration and weathering. Oxidized metals were observed at the time of this investigation.

Because of a lack of building maintenance, the west elevation shows signs of deterioration and weathering. Oxidized metals were observed at the time of the investigation.

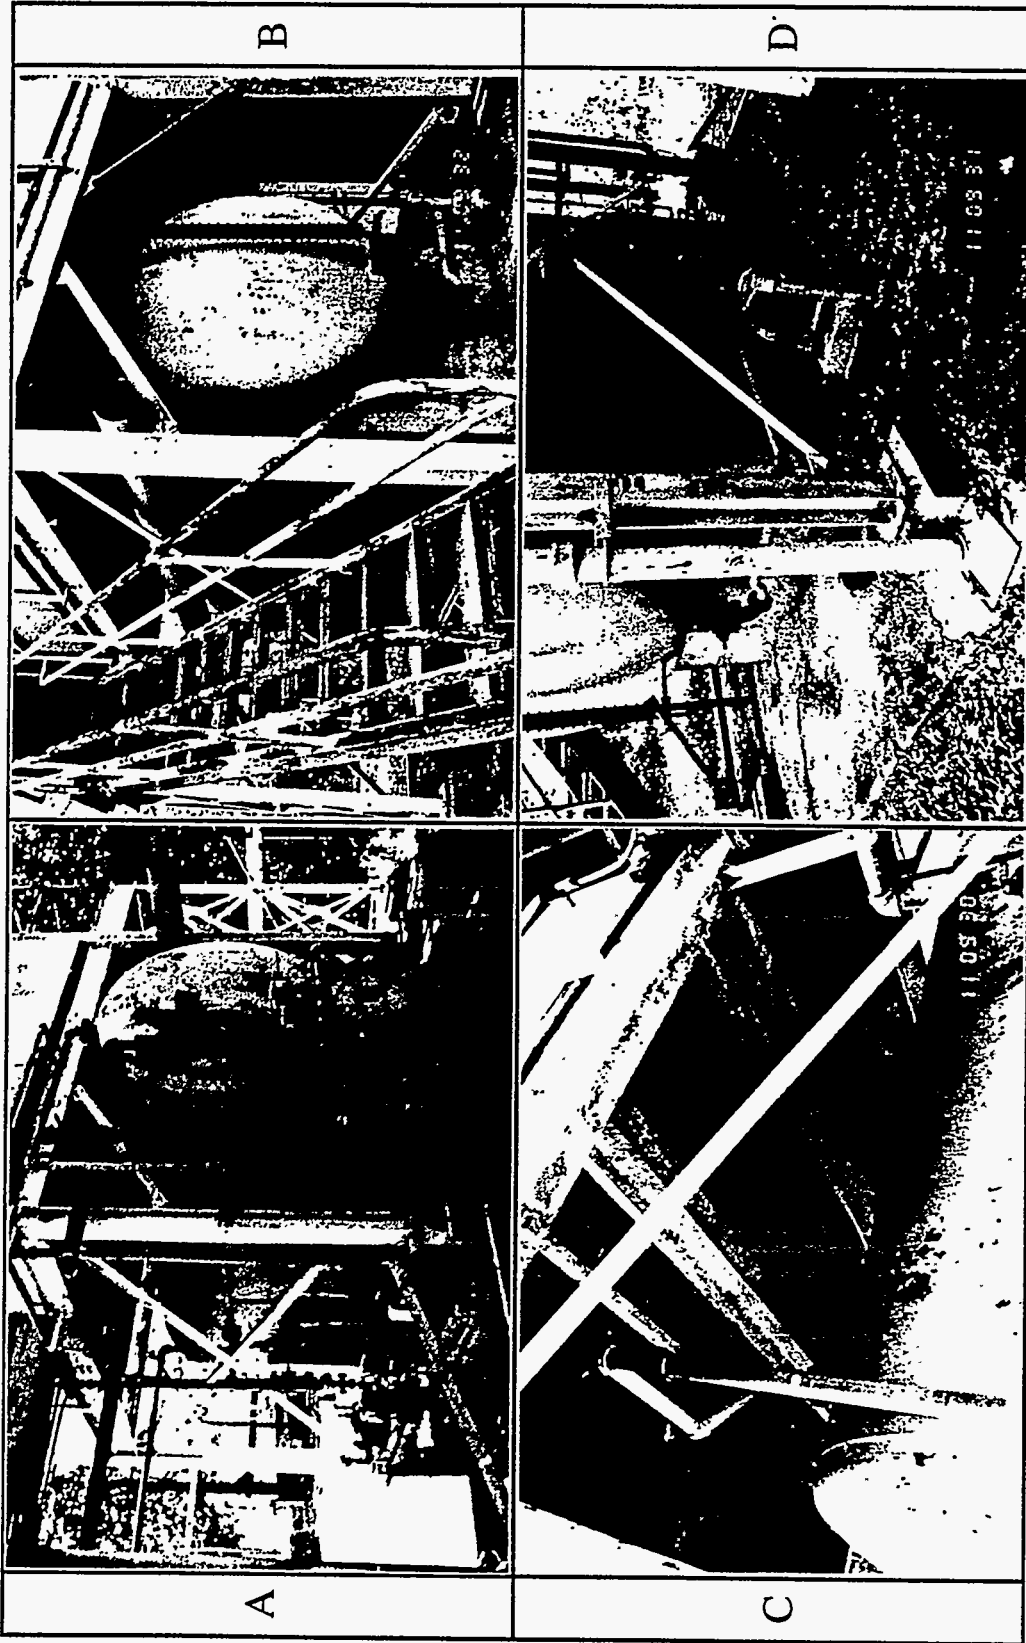
FIGURE 6 Photographs of First Floor, Room 1

Piping was observed east of the aboveground storage tank at the time of the ANL inspection.

No floor drains are located in room 1. A raised metal cylinder was observed on the floor near the west side of the room. The ceiling (the underside of the second floor room 1) consists of wooden planks supported by a structural steel frame.
