**FIELD PERFORMANCE OF
CAVITATION EROSION RESISTANT ALLOY
ON PUMPED-STORAGE HYDROTURBINE**

**TENNESSEE VALLEY AUTHORITY
RACCOON MOUNTAIN UNIT-3**

OCTOBER 1992

Prepared by
**TENNESSEE VALLEY AUTHORITY
RESOURCE GROUP
RESEARCH AND DEVELOPMENT
GENERATIONS PROJECTS DEPARTMENT**

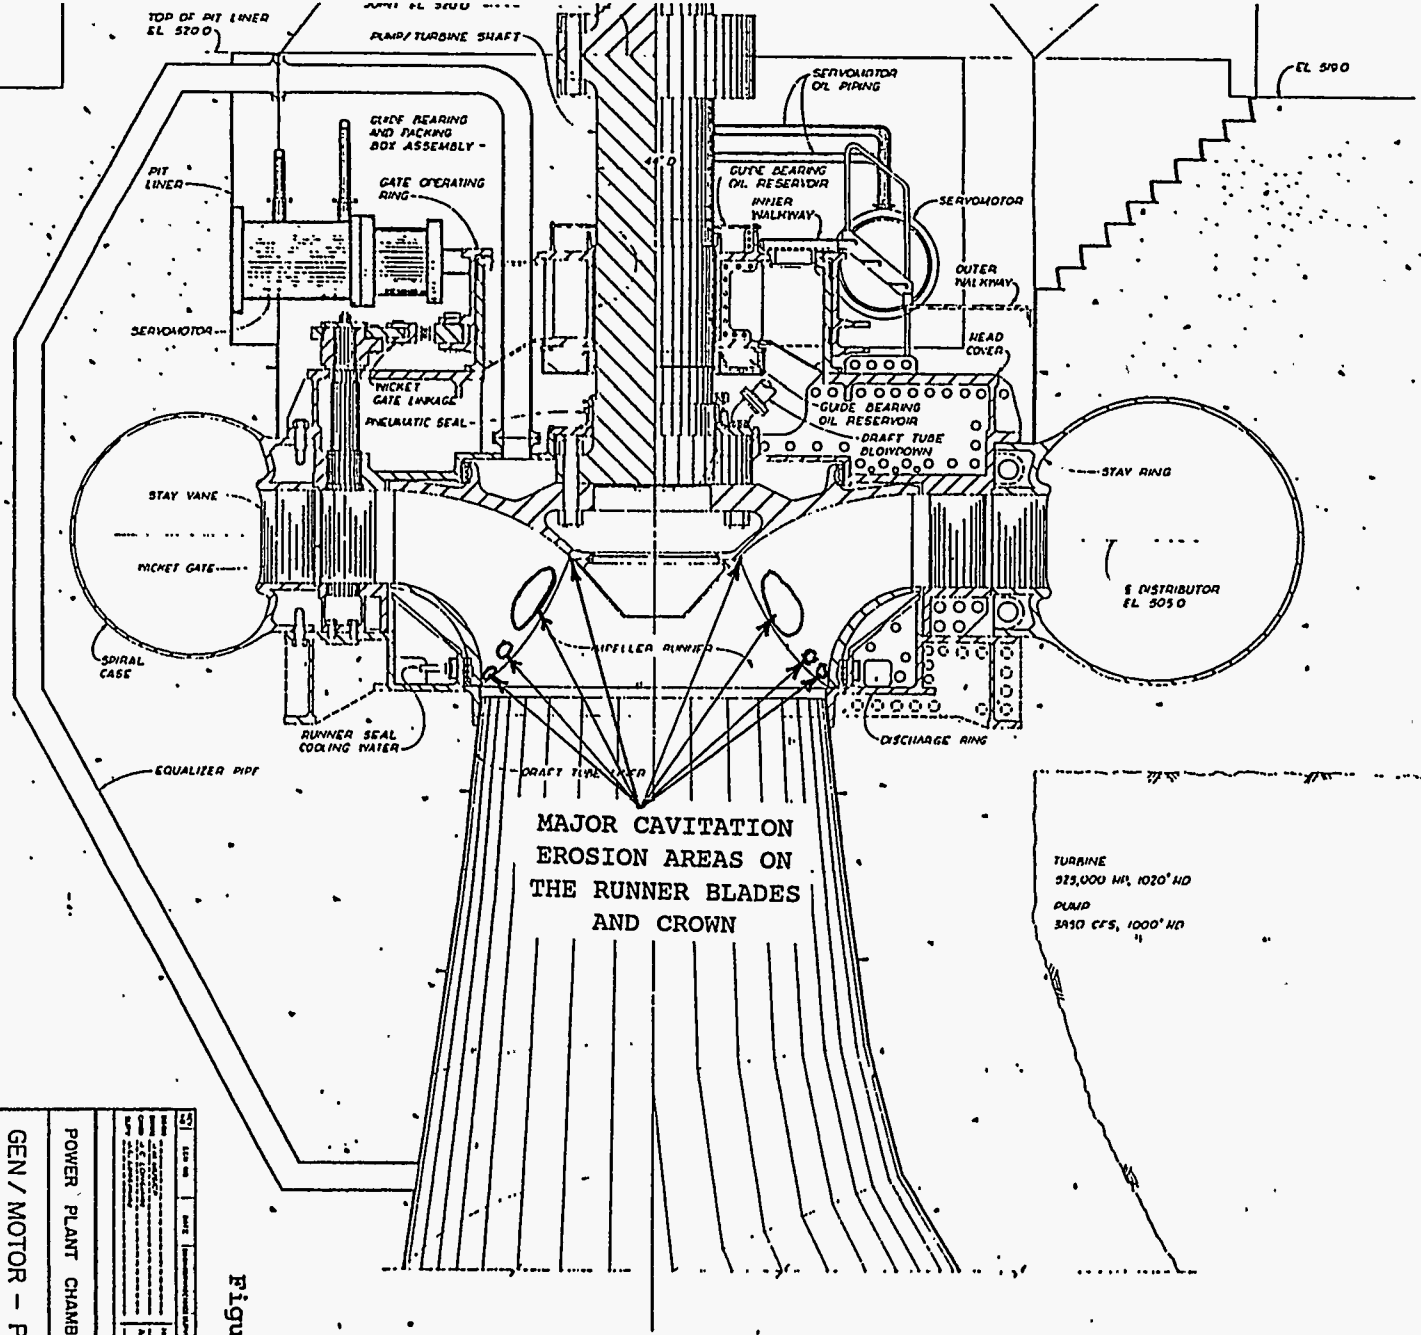
Figure 1.

This report describes results of a 27 month exposure in a full scale demonstration of Stoodly Hydroloy HQ913 (HQ913) weld overlay installed on the Raccoon Mountain Unit 3 hydroturbine runner. This installation was the logical extension of laboratory work and field testing completed prior to 1989. Laboratory tests had shown HQ913 to be several times more resistant to cavitation erosion than 309, 308, and 309L Stainless Steels previously used for repairing cavitation damage. In addition, field test patches installed at Raccoon Mountain had demonstrated the superior cavitation resistance of HQ913. The runners at Raccoon Mountain experience excessive cavitation damage ranging from mild to severe. Therefore, it was decided in 1988 to use HQ913 to repair all cavitation damaged areas of the runners in all units at their next scheduled cavitation repair outages. All the cavitated areas in the unit 3 runner were arc-air gouged out during the 1990 spring outage and repaired with HQ913 weld overlay. Figure 1 shows the principal cavitation erosion areas where HQ913 weld overlay was used. Figures 2 and 3 show details for weld repairs made on deep cavitation eroded areas.

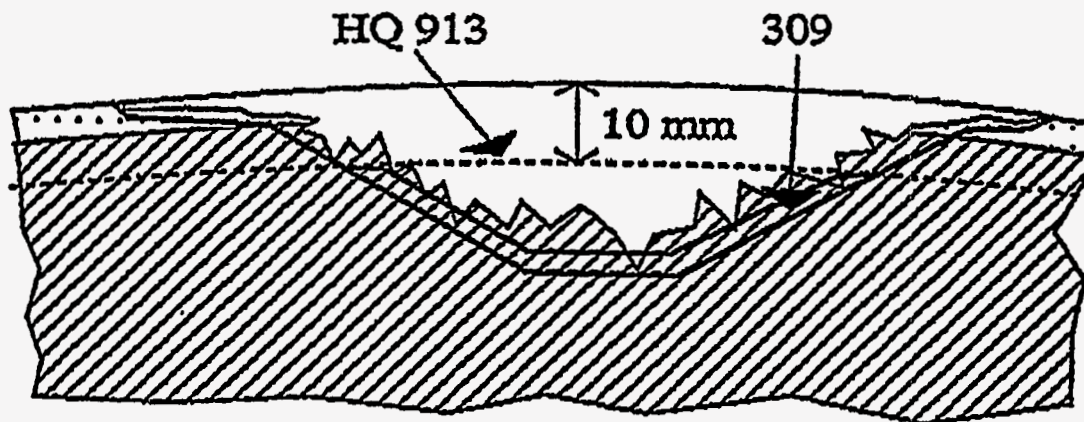
Figure 2. Cross section view shows an area that has cavitation erosion deeper than 10 mm as is often found in the crown areas of the hydroturbines at the Raccoon Mountain Pumped-Storage Plant.
