Potential for Hepa Filter Damage From Water Spray Systems in Filter Plenums

W. Bergman
J.K. Fretthold
J.W. Slawski

This paper was prepared for submittal to the
24th DOE/NRC Nuclear Air Cleaning and Treatment Conference
Portland, OR
July 15-18, 1996

POTENTIAL FOR HEPA FILTER DAMAGE FROM WATER SPRAY SYSTEMS IN FILTER PLENUMS*

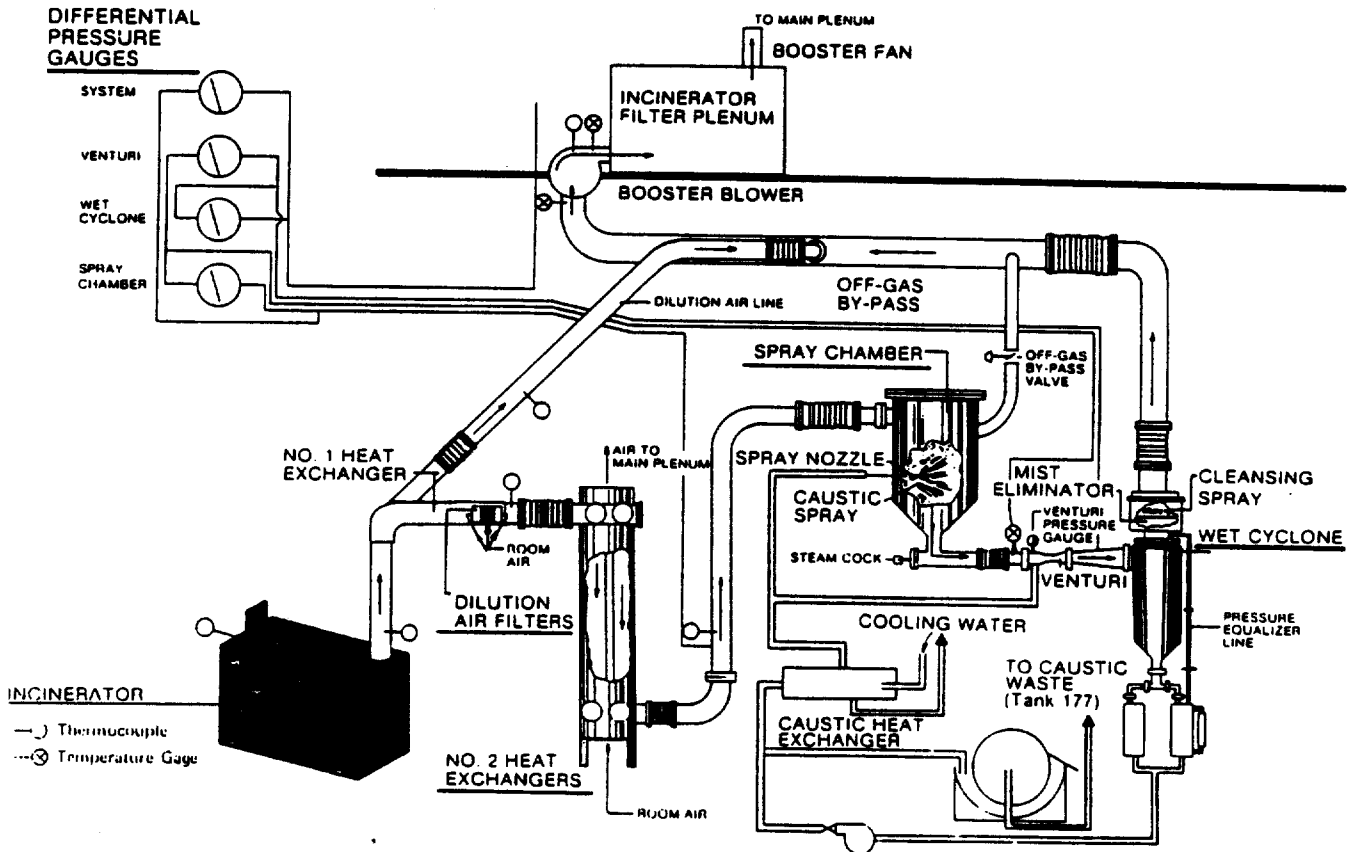
Figure 6. Schematic of the incinerator off-gas treatment system

The investigation following the fire concluded that the primary cause of the fire was the deteriorated off-gas bypass valve on the spray chamber shown in Figure 6.⁽²⁾ The untreated hot exhaust was able to bypass the off-gas treatment and enter directly into the HEPA filter plenum. This raised the gas temperature at the plenum inlet to a maximum 180°C (356°F). In addition the investigators speculated that nitric and hydrochloric acids in the exhaust may have reacted with the urethane foam sealant used on the HEPA filters and raised the temperature even further.⁽²⁾ The investigators also found metal oxide powders consisting of Cr, Fe, and Ni and as well as chlorates and nitrates on the filter media. Because the metal on the filter suggest their origin was stainless steel, the investigators concluded "This is an indication that the stainless steel duct work is being corroded by the acidic environment." From this, the investigators concluded that "All of these very fine metal particles collected on the filter media are capable of supporting combustion" and was responsible for igniting the HEPA filters.⁽²⁾

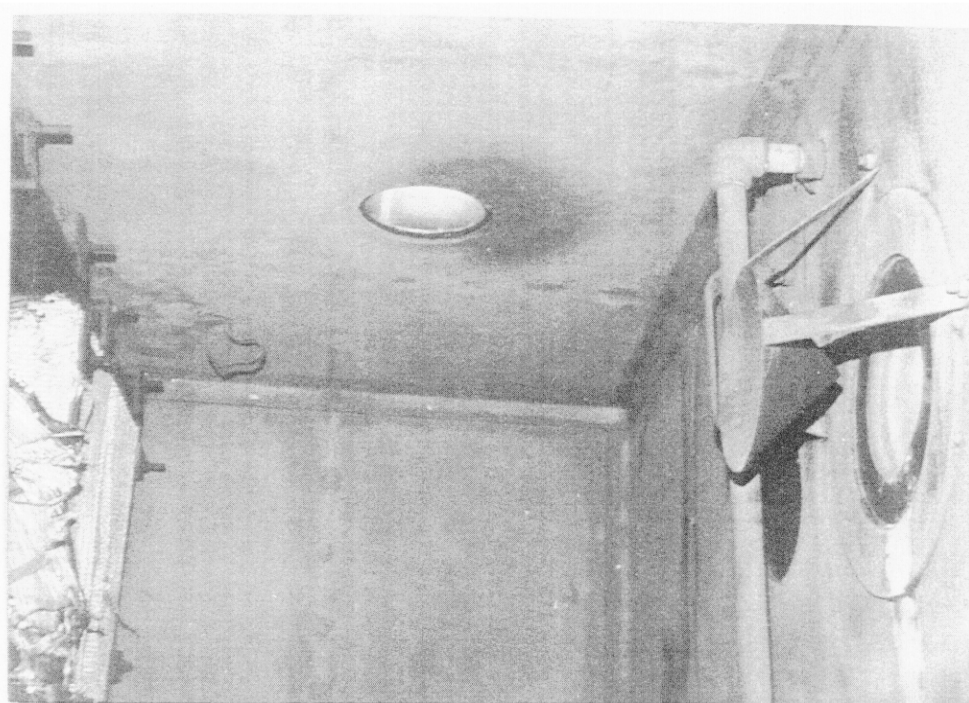
On July 2, 1980, a fire had occurred in the incinerator filter plenum and had extensively damaged the first three stages of HEPA filters and caused the fourth stage to severely bow.⁽²⁾ A continuous recording of the plenum inlet temperature showed the temperature was constant at 100°C for several hours prior to 11:00 A.M.. At that time the inlet temperature increased linearly with time until it reached a maximum 180°C at about 12:40 A.M.. At 11:30 A.M., the production foreman inspected the filter plenum and noted the plenum inlet temperature was 70° C, the differential pressure across the HEPA filters was 0.7 inches of water, and the plenum vacuum was 7 inches of water. These were normal readings. (The automatic temperature recording at 11:30 A.M. showed the inlet temperature was 110°C, not 70°C.) At 12:34 P.M., the alarm for the incinerator filter plenum sounded as well as the main filter plenum. The deluge spray also was automatically activated in the main plenum. Responding to the incinerator fire alarm, the utilities manager observed a red glow within the incinerator plenum and then activated the manual deluge sprinklers. Shortly thereafter, firemen arrived and also noticed a red glow in the plenum and that the manual water spray had been activated. They then attempted to enter the plenum with building water hoses, but could not open the airlock doors due to the high vacuum. After reducing the air flow, the firemen entered the incinerator plenum and sprayed the HEPA filter banks with a fine water mist. Photographs of the filter plenum in Figures 8-14 showed extensive HEPA damage.

Figure 8. Photograph inside the front chamber of the filter plenum showing the air inlet with deflector cone and the damaged first stage HEPA filters.

The second fireman arrived later and stated that he had entered the upstream plenum room (Figures 8 and 9) and saw the entire filter bank had been destroyed.⁽¹⁸⁾ He did not spray any water on the first stage filters because there was no remaining fire. On entering the second door (Figures 10-13), he saw HEPA filters on fire and sprayed them with the water fogger. He stated that his spraying caused no further structural damage to the filters. He then entered the exhaust plenum, but since there was no fire and the HEPA filters were not damaged (Figure 14), he did not spray the filters.⁽¹⁸⁾

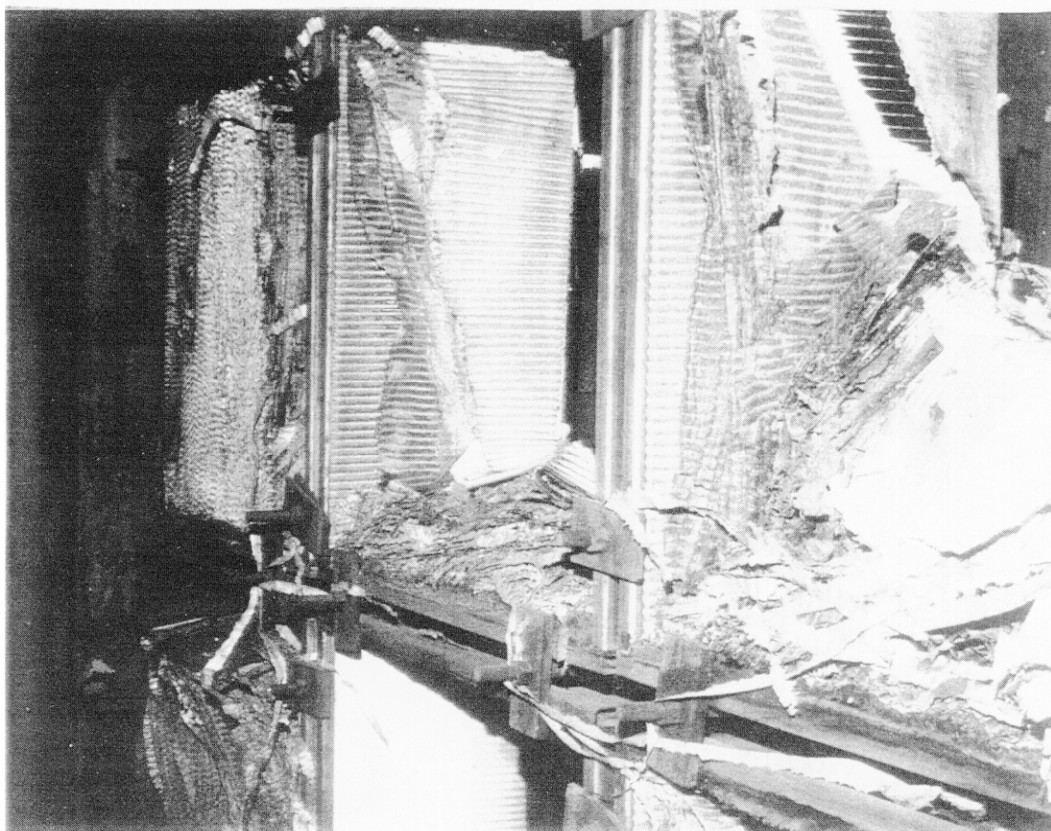
Figure 9. Photograph showing the front side of the first stage HEPA filters.

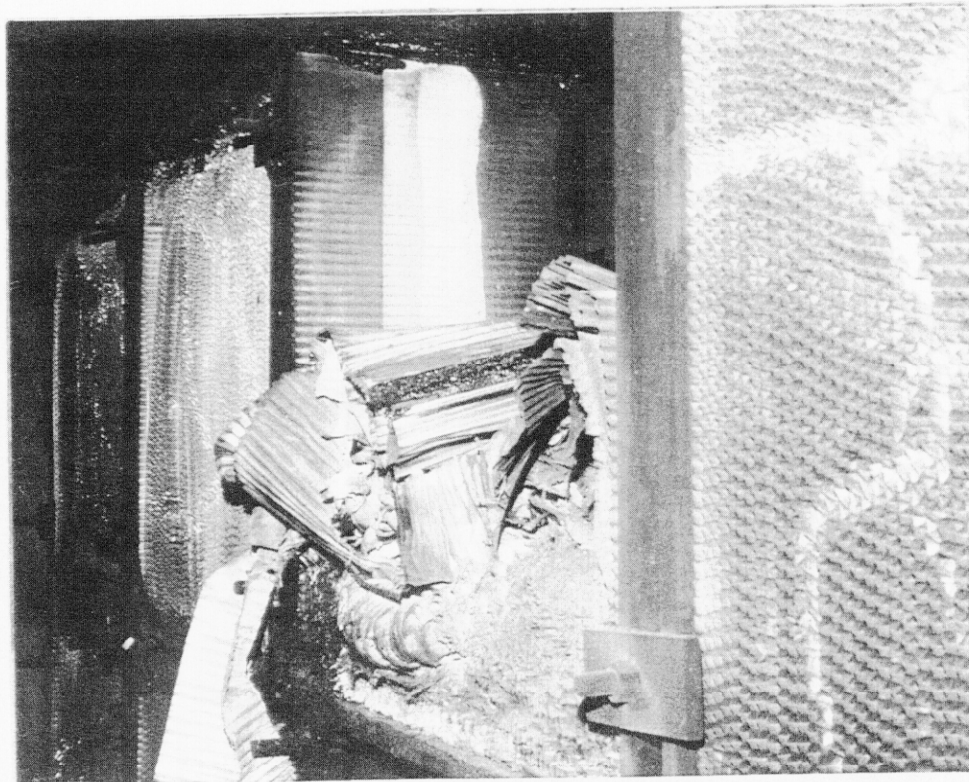
Figure 10. Photograph inside the middle chamber of the filter plenum showing the rear side of the 2nd stage HEPA filters.

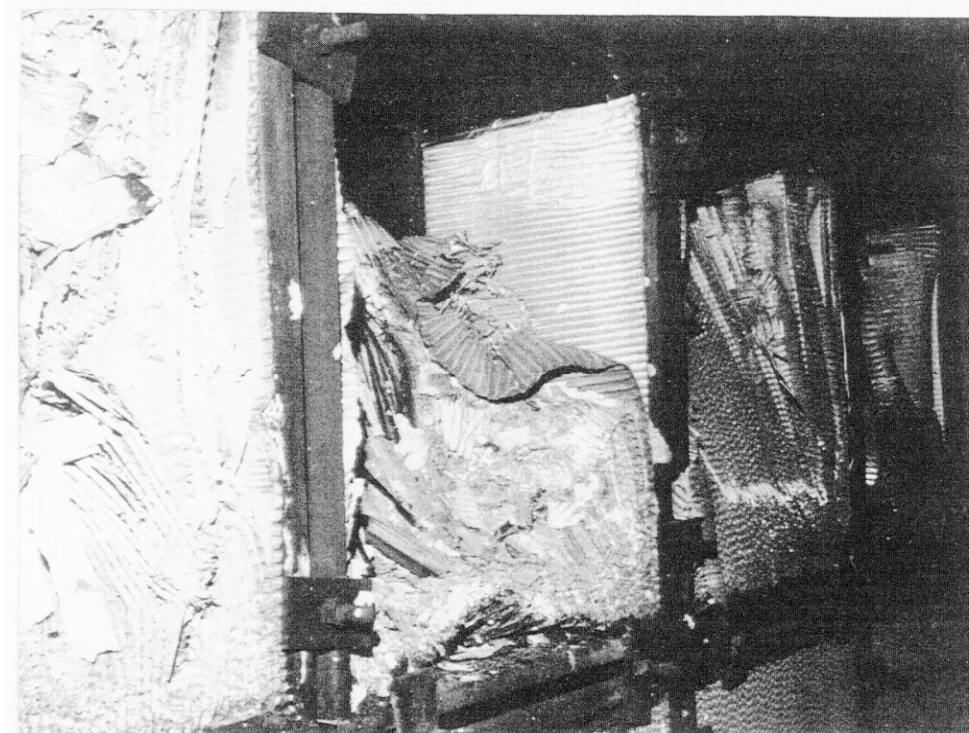
Figure 11. Photograph inside the middle chamber of the filter plenum showing the front side of the 3rd stage HEPA filters.

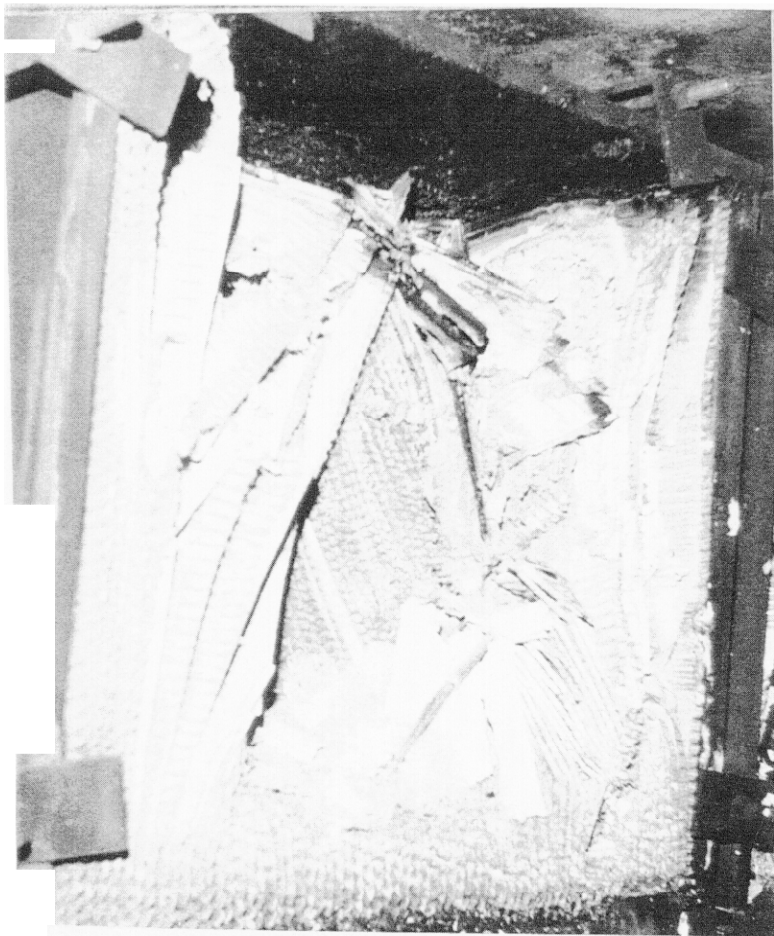
Figure 12. Photograph of the front side of a 3rd stage HEPA filter.

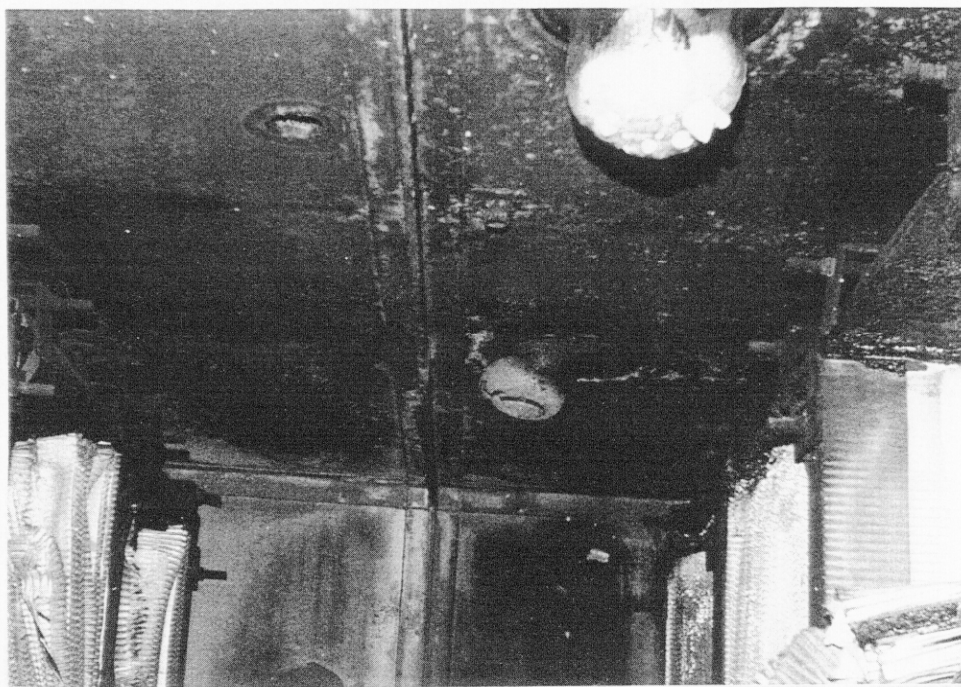
Figure 13. Photograph inside the second chamber of the filter plenum between the 2nd and 3rd HEPA stages. Note the partially melted plastic light fixture on the ceiling of the plenum.

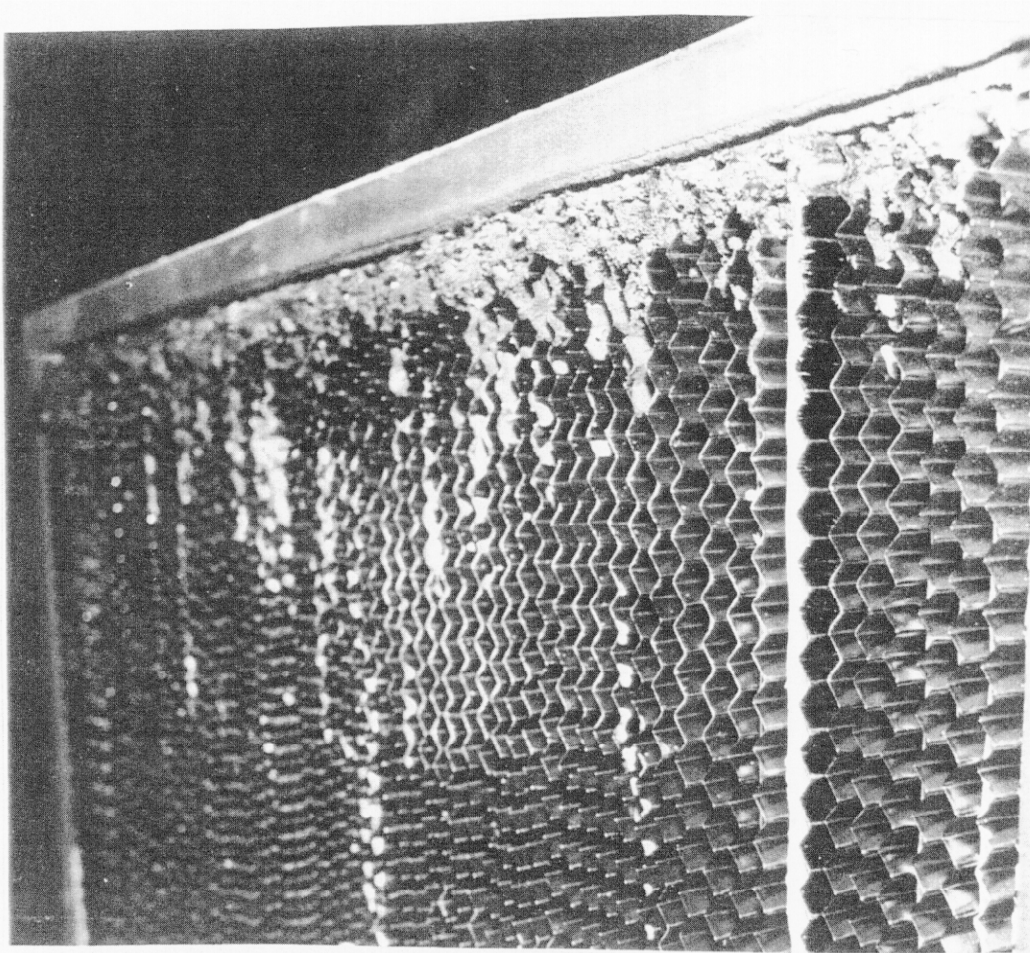
We have previously shown that the urethane sealant in current HEPA filters will char and in some cases burn during the heated air qualification test.⁽¹⁶⁾ Figure 15 shows a photograph of a new HEPA filter similar to widely used HEPA filters in DOE facilities following the standard heated air and overpressure test.^(16,17) The urethane sealant had completely burned through from the inlet to the exit face of the HEPA filter during the heated air test. In this test, the HEPA filter is exposed to the rated air flow heated to 700 °F (371°C) for five minutes.⁽¹⁷⁾ During the test, the burning urethane was seen as a red glow with only a small flame. Following the heated air test, the burnt filter had a DOP penetration of 1.24% and therefore passed the qualification test. However with the sealant burnt through, the filter pack was loose within the frame and could easily move forward or backward. The burnt filter was then placed in the overpressure test apparatus where the pressure drop across the HEPA filter was ten inches of water.⁽¹⁷⁾ That pressure had displaced the HEPA filter pack about one inch in Figure 15 and was very close to blowing out the entire pack.

Figure 15. Photograph of the exit side of a new HEPA filter after the heated air and overpressure test. The burned urethane sealant created a separation between the filter pack and the filter frame.⁽¹⁶⁾
