Materials Design Considerations and Selection for a Large Rad Waste Incinerator

A paper proposed for presentation at the
NACE Corrosion '97 Conference
New Orleans, LA
March 9-14, 1997

MATERIALS DESIGN CONSIDERATIONS AND SELECTION FOR A LARGE RAD WASTE INCINERATOR

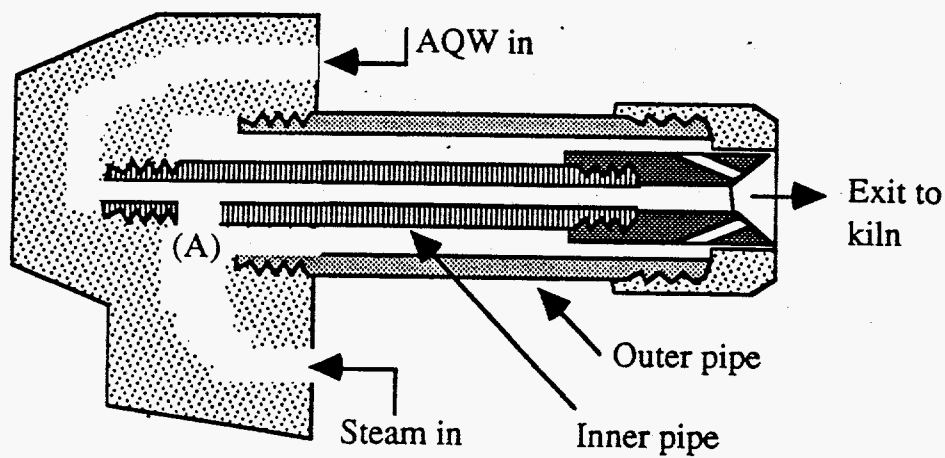
Two kinds of failure were experienced at the injector during early trial runs. These were due to corrosion and steam erosion. Steam erosion occurred within the manifold as a consequence of wet steam and a 90° change in direction, Figure 4. In the figure, impingement was at position B on the OD of the inner pipe and a leak did occur. At the time of this failure, waste liquid pump pressure exceeded the steam pressure and acids were forced into the annular space, i.e. into the steam system. This led to corrosion in the condensate piping and failure at a nearby steam trap.

Figure 3. Injection gun arrangement. Location (A) identifies the area of steam impingement and location of the failure in the carbon steel pipe. Not to scale.

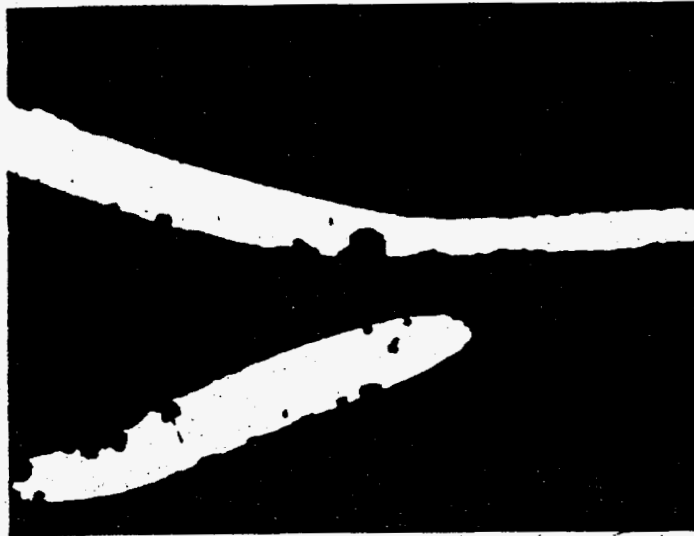
Pieces of the pre-filter wire were examined optically and in the scanning electron microscope. Wire lengths ranged from 0.32 to 5 cm (0.125 to 2 in.). Figure 6 shows an individual fiber with substantial pitting corrosion. Large round bottomed pits grew completely across the wire (Figure 7), or fracture occurred through the reduced cross sections. Deposits on the wire were primarily NaCl, KCl, and small quantities of iron oxide. The pitting is related to the high chloride environment.

Figure 6 Pitting corrosion in HEPA pre-filter wire. (0.1 mm wire, stainless steel)

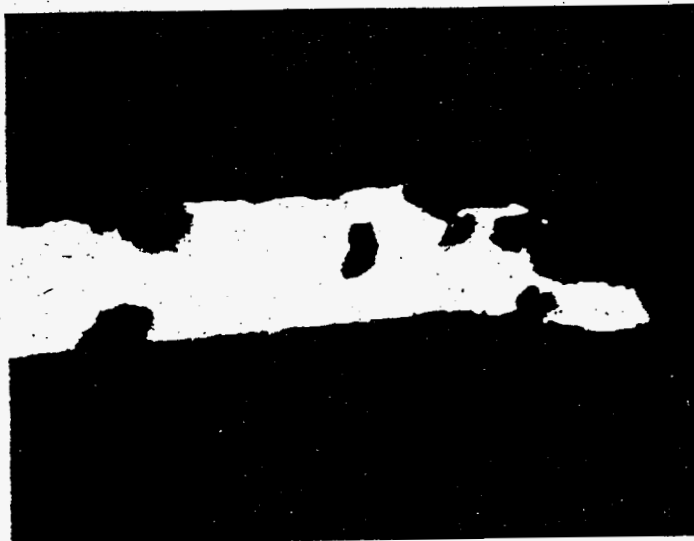
Figure 7 HEPA pre-filter wire. Note that corrosion pitting extends across the thickness of the stainless wire (0.1 mm).

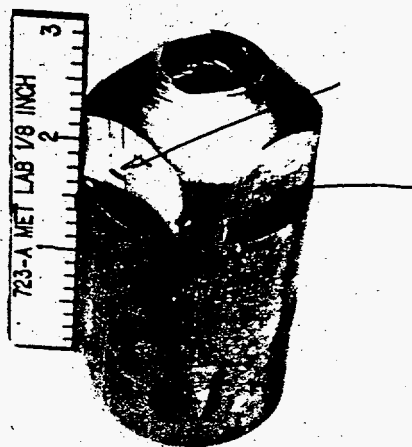
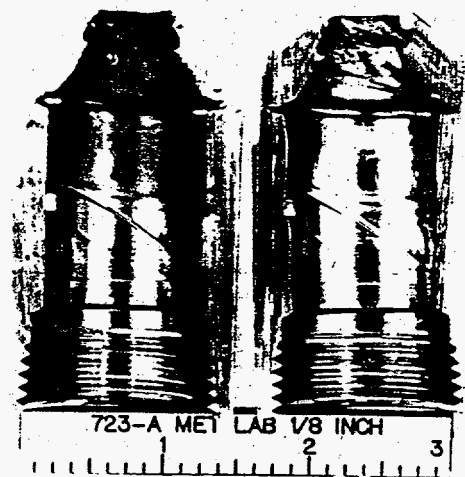
As previously mentioned, the quench tower contains several spray nozzles for reducing gas and quench liquid temperatures from 1095°C (2000°F) to less than 120°C (250°F). Several of these alloy C-276 nozzles were plugged with a black substance after the trial, and holes appeared on the outer surface of the nozzles. Sectioning revealed that severe erosion had taken place (Figure 10). There was no indication of stress corrosion cracking. Analysis of the black product by energy dispersive x-ray spectroscopy indicated high quantities of silicon and lesser amounts of potassium, calcium, chlorine and iron (Table 4). A limited amount of fly ash is contained in the recycled cooling water. Most of the elements can be accounted for based on the feed material. The iron is the result of corrosion in the system but silicon had to be part of the solid feed (clay absorbant) to the incinerator. High silicon values were also found in the blowdown system.

Figure 10. Quench spray nozzles showing through wall holes in (a). Inside appearance (b) shows channels eroded on the wall. Thinning in the channels led to the penetrations in (a)
