The Effect of Humidity on the Reliability of a Surface Micromachined Microengine

Danelle M. Tanner, Jeremy A. Walraven, Lloyd W. Irwin, Michael T. Dugger, Norman F. Smith, William P. Eaton, William M. Miller, and Samuel L. Miller

Sandia National Laboratories, P.O. Box 5800, MS 1081, Albuquerque, NM 87185-1081
<http://www.mdl.sandia.gov/Micromachine>
 email: tannerdm@sandia.gov

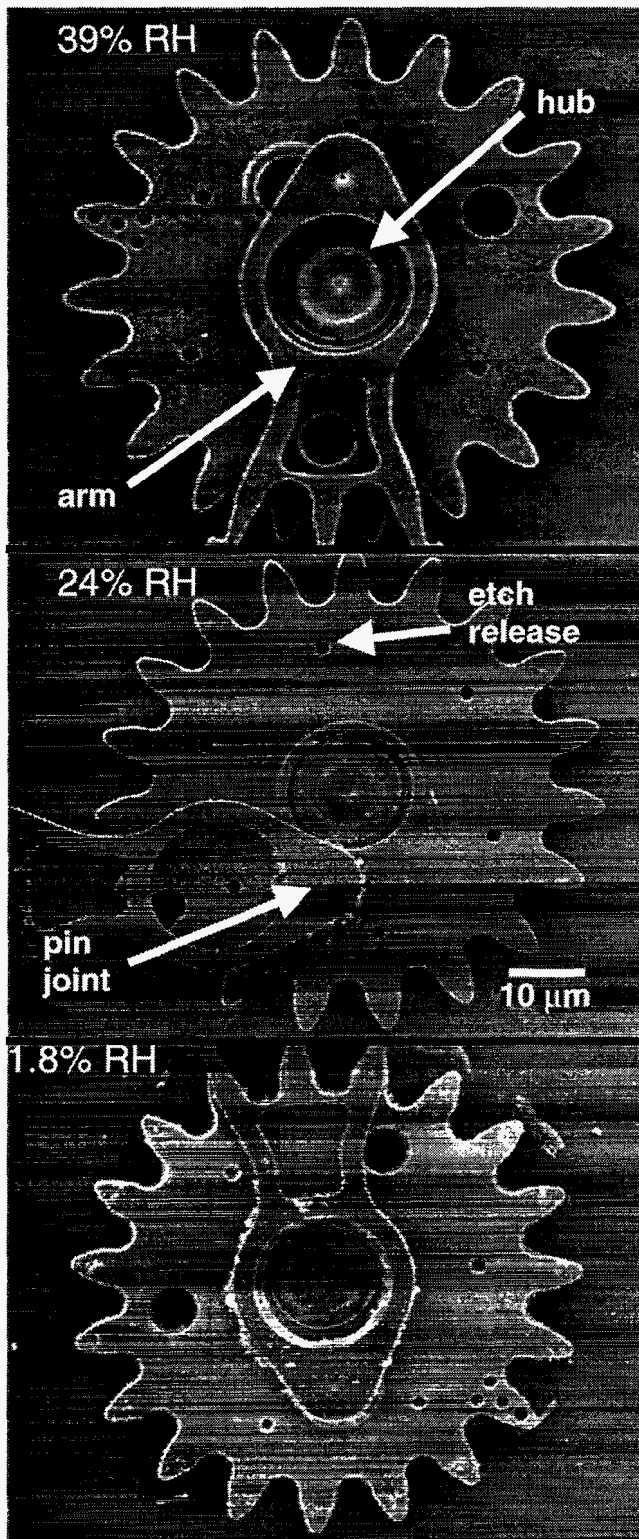
FTS Treatment: The dominant failure mechanism for these microengines has been identified as wear. The major effects of the wear process were either pin joint wear-out causing the linkage arm to break away from the gear or accumulation of wear debris causing the microengine to seize. The overwhelming effect of the humidity was demonstrated by the amount of wear debris observed. The volume of debris increased dramatically as we lowered the humidity. In Figure 5, we show a comparison of the gears of microengines stressed in air environments of 39%, 24%, and 1.8% RH at 25°C. These microengines were stressed to failure at 862,000, 746,000, and 742,000 accumulated cycles, respectively, yet the microengine with the most accumulated cycles has the least amount of wear debris. In the 39% RH case, there is a small amount of debris located around the hub. The 24% RH case shows more noticeable wear debris around the hub and on the linkage arm. The debris in the 1.8% case includes large slivers near the gear teeth. Debris has been thrown out and collected on the hub face, at the tips of the gears, on the linkage arm, in the etch-release holes, and onto the substrate area outside of the gear face. These images are characteristic of observations at different humidity levels.

Figure 5. SEM images of various microengine gears stressed under different humidity conditions 39%, 24%, and 1.8% RH at 25° C. The microengines were stressed for roughly the same number of cycles, but the amount of wear debris for each humidity was dramatically different. (FTS)

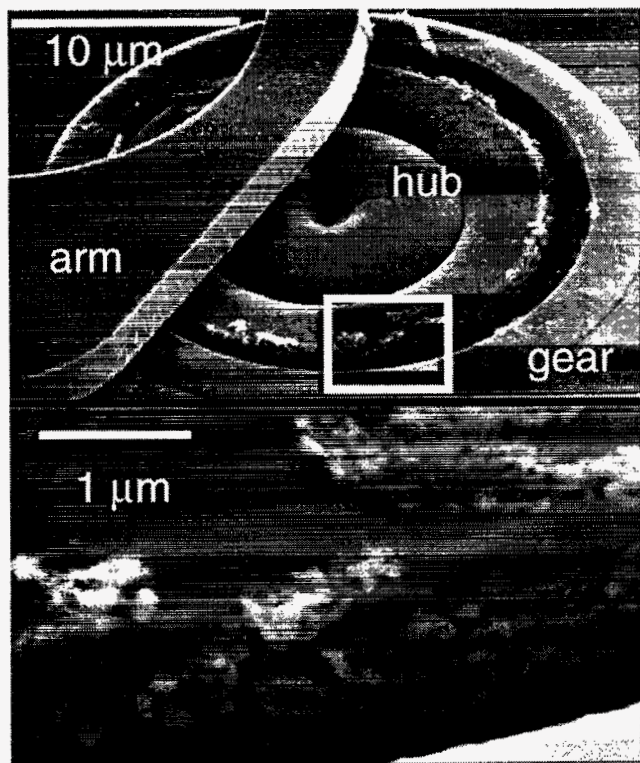
Using a field emission SEM to further magnify and characterize the wear debris, we again noticed a difference between the 39% and the 1.8% RH case. Figure 6 shows a magnified view of the hub of a microengine that failed at 510,000 cycles at 39% RH. The box region has been magnified further to illustrate the debris morphology. The wear debris appears to be 200 to 500 nm agglomerates which string together with other agglomerates to form chains of 1 μm or longer.

Figure 6. SEM magnified view of the hub region on a microengine that failed at 510,000 accumulated cycles during the 39% humidity test shows the morphology of the wear debris. (FTS)

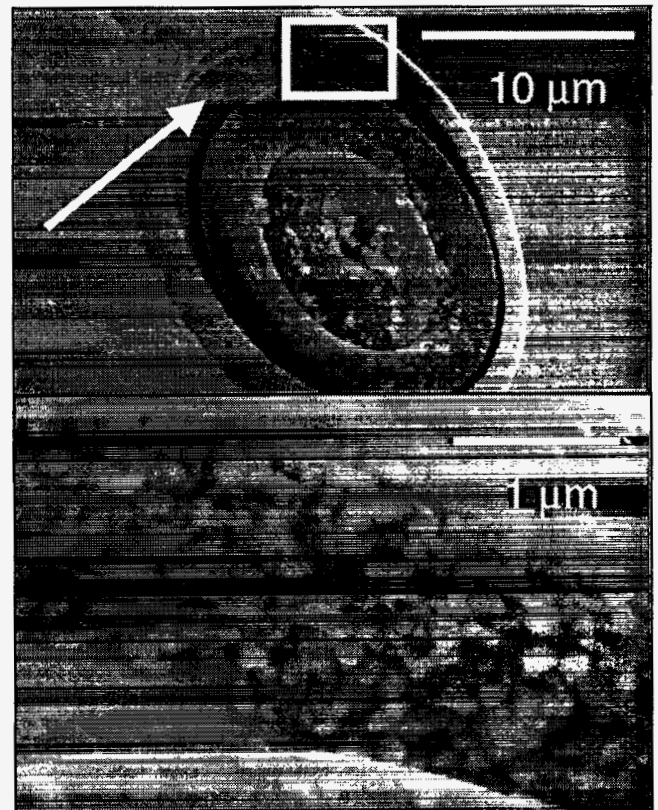
For comparison, we investigated the hub of a microengine stressed to failure after 642,000 cycles in 1.8% RH at 25°C. This hub is shown in Figure 7. The first item to note (indicated by an arrow) is the radial offset in the gear and hub due to the large amount of wear between the hub and the mating gear. The offset caused a wobble in the motion of the gear at the inspection frequency of 1 Hz. Note also that the entire hub is covered with particulate wear debris. This is shown more fully in the lower image of Figure 7, which is a higher magnification of the box region. There are no stringy agglomerates in the 1.8% RH case.

Figure 7. SEM magnified view of the inner gear region on a microengine stressed to failure after 642,000 cycles at 1.8% RH. The wear debris formed particulate matter, each smaller than 100 nm. (FTS)

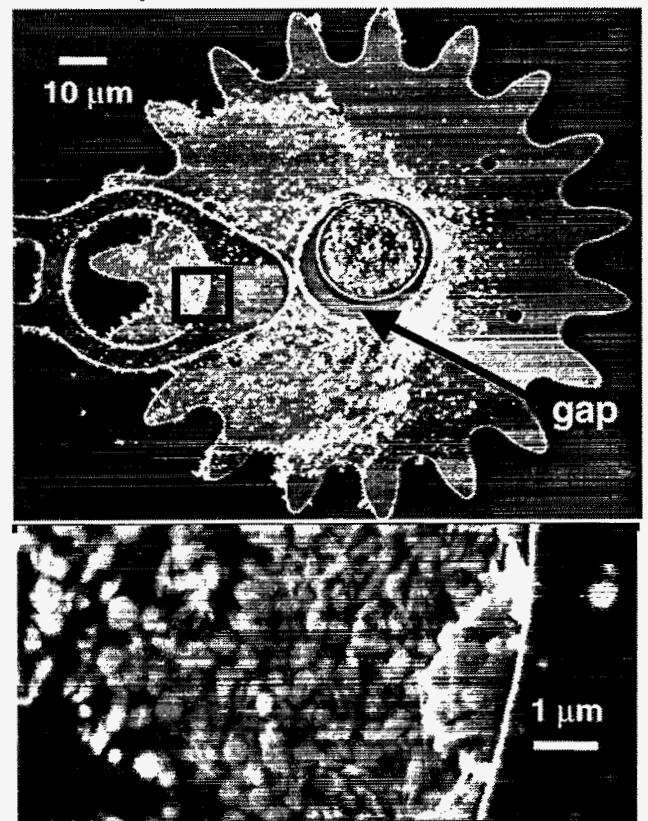
SCCO₂ Treatment: Just as in the FTS treatment, the dominant failure mechanism was associated with wear. As shown in Figure 8, the amount of wear debris on the face of the gear far exceeded that observed in the FTS case at the humidity level of 1.8% RH. This engine failed at 600,000 cycles. The gap around the hub was an indication of severe wear.

Figure 8. SEM image of a microengine that failed at 600,000 cycles at 1.8% RH illustrates the wear debris produced. The gap near the hub is an indication of severe wear. Note the morphology of the wear debris in the lower magnified image. (SCCO₂)

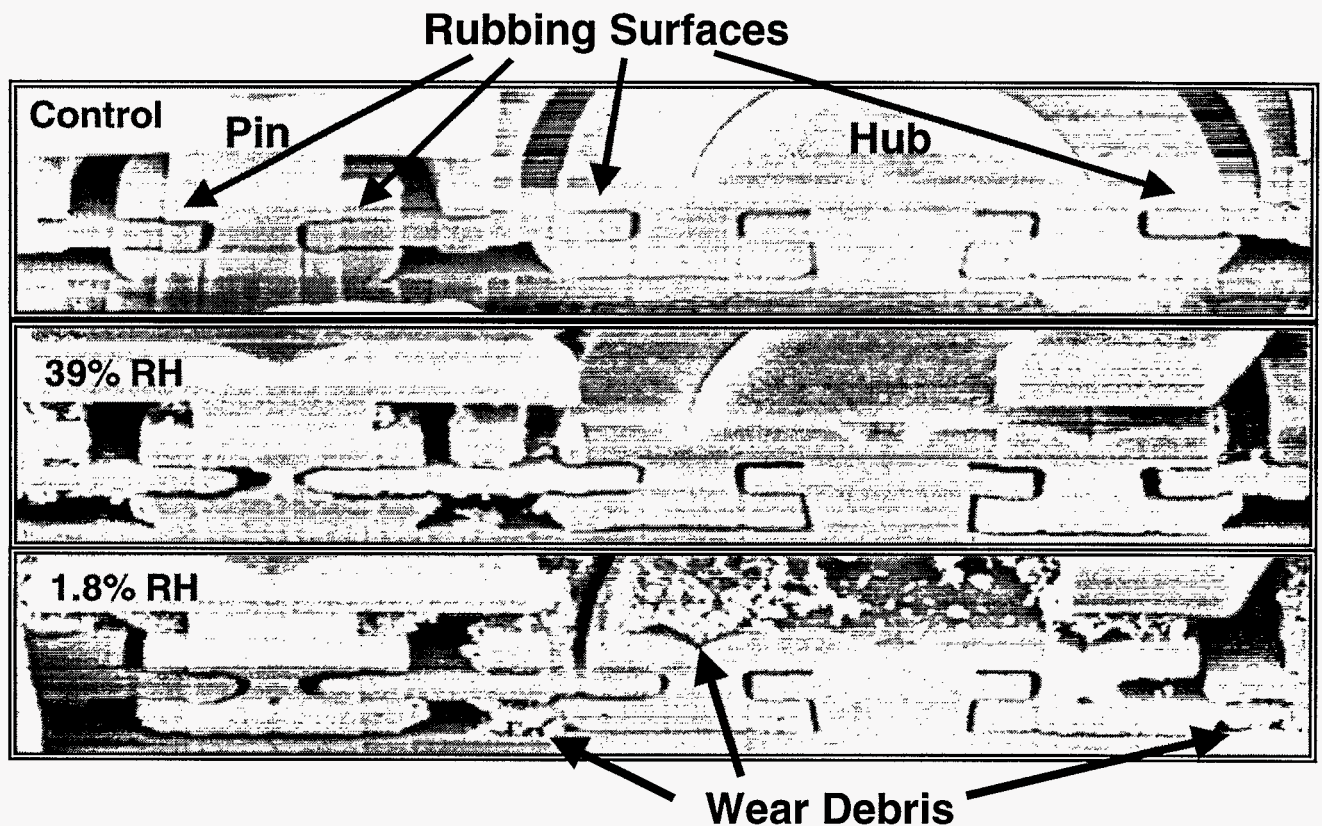
FTS Treatment: To investigate the effect of wear, FIB cross sections were performed on a sample from each humidity level. Shown in Figure 9 are cross sections taken from a control (top), 39% RH (middle), and 1.8% RH (bottom) samples. The control sample was tested for functionality, but was not stressed. Because debris is not shown in the control sample we believe the debris was caused by wear, not the FIB cut. The 39% RH microengine was stressed to failure at 606,000 cycles and the 1.8% RH microengine was stressed to failure at 542,000 cycles. In the 39% RH case, we observed mostly pin joint wear as shown with the notched diameter. The wear of the pin joint was accompanied by a reduction in the pin joint opening, probably due to a buildup of debris. For the 1.8% RH experiment the wear was observed in both the pin joint and the hub. The pin joint diameter eventually broke in the majority of samples tested (32 times out of 50 samples) for the 1.8% case.

Figure 9. SEM images of the control, the 39% RH sample and the 1.8% RH sample illustrate the amount of wear debris created in each experiment. Arrows indicate the rubbing surfaces. In both stressed samples, the pin joint has been worn down from its fabricated 3 μm diameter. (FTS)

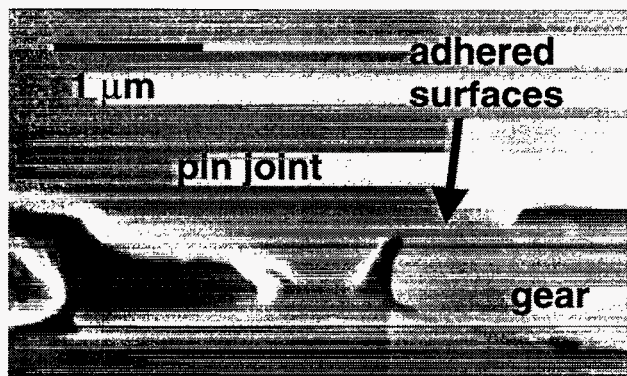
Figure 10. SEM magnified view of the pin joint region in a FIB cross section shows the area where the two surfaces adhered causing the microengine to seize. This microengine was tested at 10% RH at 25°C. (FTS)

veals adhesion of the wearing surfaces (Figure 10). This was our first observation of adhered surfaces, which yielded clear evidence of the cause of failure. As indicated on the right hand side of Figure 10, the adhered region is approximately 0.7 μm long.

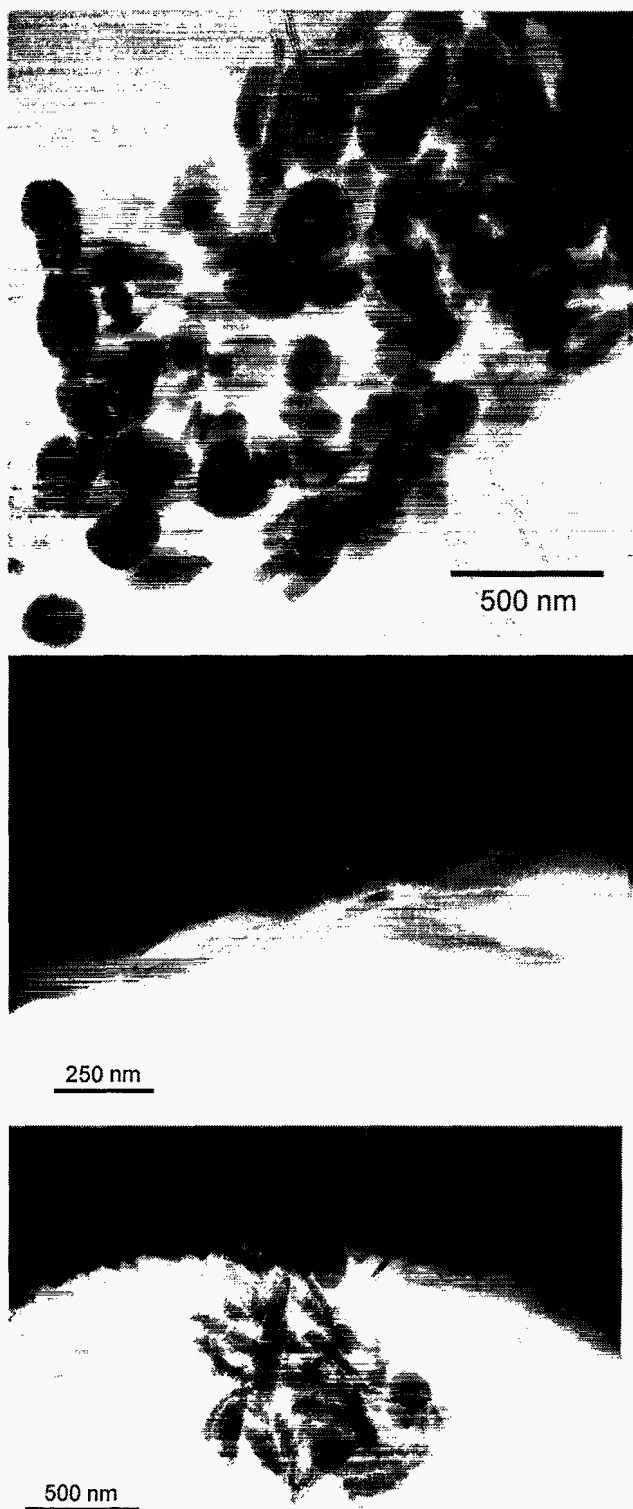
Gears from two microengines tested to failure at 1.8% RH were examined in plan-view. These engines accumulated 642,000 and 742,000 cycles prior to failure. As illustrated in the SEM micrograph of Figure 5, large amounts of wear debris are produced in this environment. The analysis of wear debris found outside the gear, adhering to the gear teeth, and inside etch release holes of both gears showed the debris to be either spherical or rod-like in geometry. Figure 11 shows spherical particles ranging from 100 nm to ~250 nm in diameter. Also shown are rod-like debris particles with diameters ranging from 20 to 50 nm and lengths up to 0.5 μm . The morphology of both the spherical and rod-like structures was determined by tilting the wear debris along its axis through angles of 50° to 60°. These images (not shown) did not illustrate significant deviation from either the spherical or rod-like shapes.

Figure 11. Spherical and rod-like debris morphologies from outside the gear (top), adhering to the gear tooth (middle) and inside an etch release hole (bottom). Note the region inside the spherical debris. (FTS)

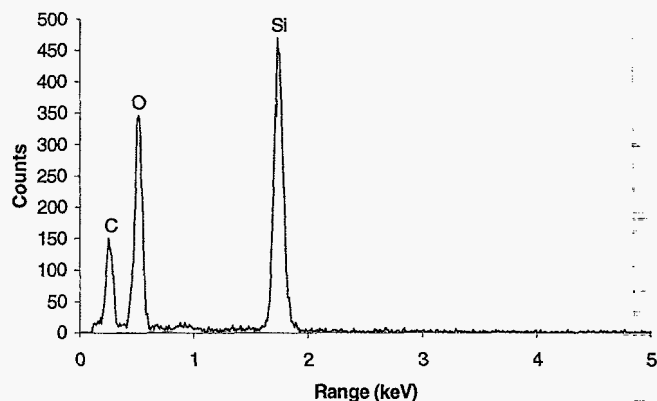
Using TEM in conjunction with EDS, the wear debris has been identified as amorphous oxidized silicon with either spherical or rod-like morphologies. EDS spectrums taken from wear debris found outside the gear, adhering to the gear teeth, and inside etch release holes revealed high concentrations of carbon, oxygen and silicon. Diffraction patterns (not shown) taken from these locations showed broad ring-like patterns typical of amorphous materials. The lack of diffraction spots or speckled rings from these areas indicate no polysilicon was worn directly away from the hub or pin joint regions during testing. Figure 12 illustrates an EDS spectrum typical of debris analyzed from all three regions. High concentrations of carbon result from the thin carbon film used for sample preparation.

Figure 12. EDS spectra of wear debris found outside the gear. Note the strong presence of oxygen and silicon.
