Failure Analysis for Micro-Electrical-Mechanical Systems (MEMS)

Kenneth A. Peterson, Paiboon Tangyunyong, and Daniel L. Barton

Sandia National Laboratories MS1081 P.O. Box 5800 Albuquerque, NM 87185-1081

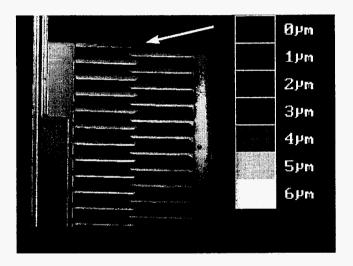
Scanning Laser Microscopy (SLM) The scanning laser microscope (SLM) has been used to obtain confocal images. Confocal imaging helps resolve elements which have abnormal vertical displacements by limiting the depth of focus of the optical microscope during a particular scan. This has proven to be valuable in identifying out of plane attachments. An example is shown in Figure 4, where the out of plane stuck finger is

clearly resolved in an image where height above the substrate is represented by false color (shown here in grayscale). The dark contrast of the tip of the finger indicated by the arrow shows that it is closer to the substrate than the adjacent fingers. This finger is in a set of fixed fingers that received a high voltage signal. A fixed finger which is stuck to the electrically grounded plane beneath it would be expected to interfere with the operation of the engine.

Figure 4. Confocal image showing finger which is displaced out of plane (arrow, darker contrast) and is in contact with the substrate.

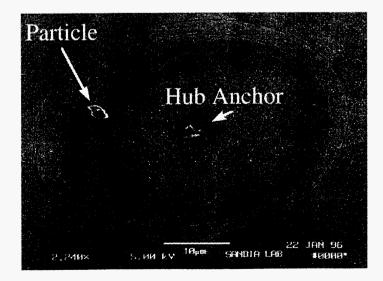
Secondary electron imaging in the SEM was helpful in identifying the only wear track ever identified on the microengine, as shown in Figure 6. This wear track is likely to have resulted from an anomaly involving the particle shown at the left. The non-concentric track could only have been made by a gear/hub assembly which had a broken point of attachment to the substrate (shown at center). In another example, Figure 7 shows the comb finger imaged in Figure 4 to be in contact with the substrate. Electrical measurements indicate that the comb shorted to ground through a 9 k Ω path and yet, when this finger was lifted with a xenon laser cutter, the short persisted. This short has not been pinpointed by FA techniques employed to date.

Figure 6. SEM image of a wear track related to a particle on the substrate. Concentric circles show the relationship of the track to the gear geometry. Note that the hub attachment is fractured (shown at center).

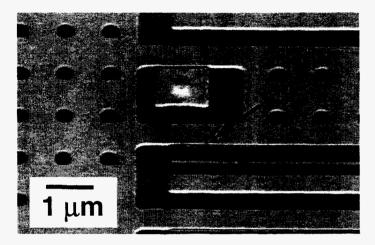
the same IC. Another example of physical contact which does not constitute electrical contact is shown in Figure 10 where opposing comb fingers of an accelerometer are in contact, but not at the same potential. Figure 11 shows voltage contrast between opposing sets of combs which was not seen in control samples (all pins on the device were grounded). The dark comb fingers are charging positively at a beam energy of 1 keV as though disconnected from ground. Tracing the interconnect for the comb led to a region of defective line containing the open shown in Figure 12. This was a condition affecting a process lot of these devices. Subsequent lots of this device showed no such opens.

Figure 10. Electrically isolated fingers in physical contact.

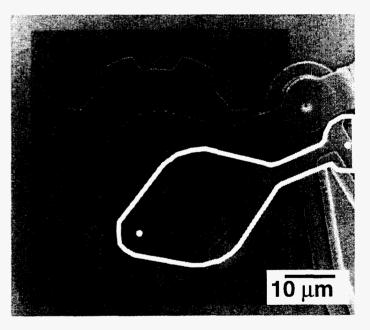
examination. One interesting result is the observation of motion of the structures during irradiation by the ion beam. Figure 13 shows a gear which, as submitted for FA, behaved as though stuck on the hub. The gear moved freely, however, after initial FIB examination using charge neutralization.

Figure 13. Evidence of the effect of charge from the ion beam on MEMS structures. The "stuck" position of the X link is outlined in white.

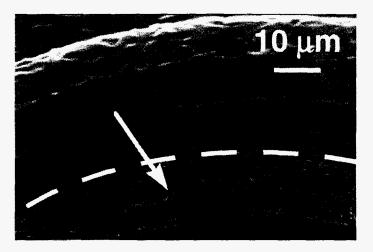
After separation, the bearing surfaces of the gears were carefully examined in the SEM. Figures 17 and 18 show the front and back bearing surfaces of a gear which was operated until failure due to non-uniform rotation. These show a typical result which is the lack of physical indications of wear. While artifacts were observed on certain bearing surfaces, similar artifacts were seen on microengines which were never operated. The intermittence of operation of this engine can not be associated with any evidence of physical wear.

Figure 17. Top and inner surface of gear operated to failure. Arrow and dashed line indicate bearing surfaces.

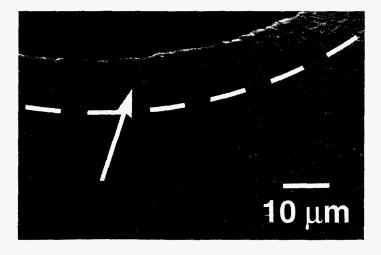
Figure 18. Back surface of gear operated to failure. Arrow and dashed line indicate bearing region.

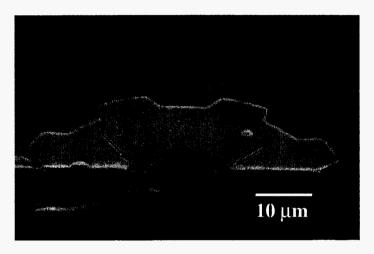
One complication from using the FIB has been observed. Sputtered material can redeposit from the area being milled in a line of sight fashion on the undersides of suspended members. This can create the appearance of a separate layer, such as the light contrast layer visible in FIB sections of Figures 14 and 15. This material is thickest at the milled edge, tapering back into the sample. Because this redeposited material is masked from the bearing surface by the flange of the hub, it might be confused with a wear track on the gear. An example of this is shown in Figure 21.

Figure 21. Micro-sectioned gear bottom surface showing FIB re-deposited material (arrows)

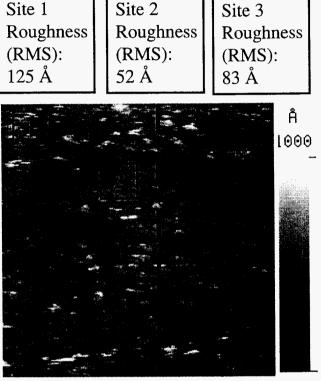
Figure 22. AFM topology image of wear track. The dashed line indicates the position of line scan of Figure 23.

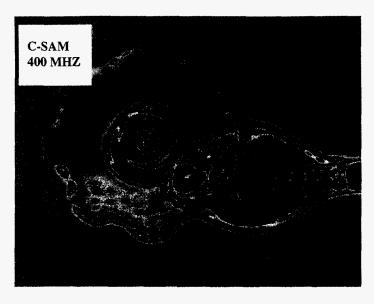
Figure 26. Acoustic microscopy resolves gear, tilt of gear, but no contact.
