Stress Corrosion Crack Detection on HU-25 Guardian Aircraft

David G. Moore - Phil D. Walkington
 Sandia National Laboratories
 Federal Aviation Administration
 Airworthiness Assurance NDI Validation Center
 Albuquerque, New Mexico 87185
 (505) 844 - 7095 (505) 844 - 1501

LCDR Charles W. Mello - AMT2 Rob Blackmon
 Jake Huffman
 United States Coast Guard
 Aircraft Repair & Supply Center
 Elizabeth City, North Carolina 27909
 (252) 335 - 6887

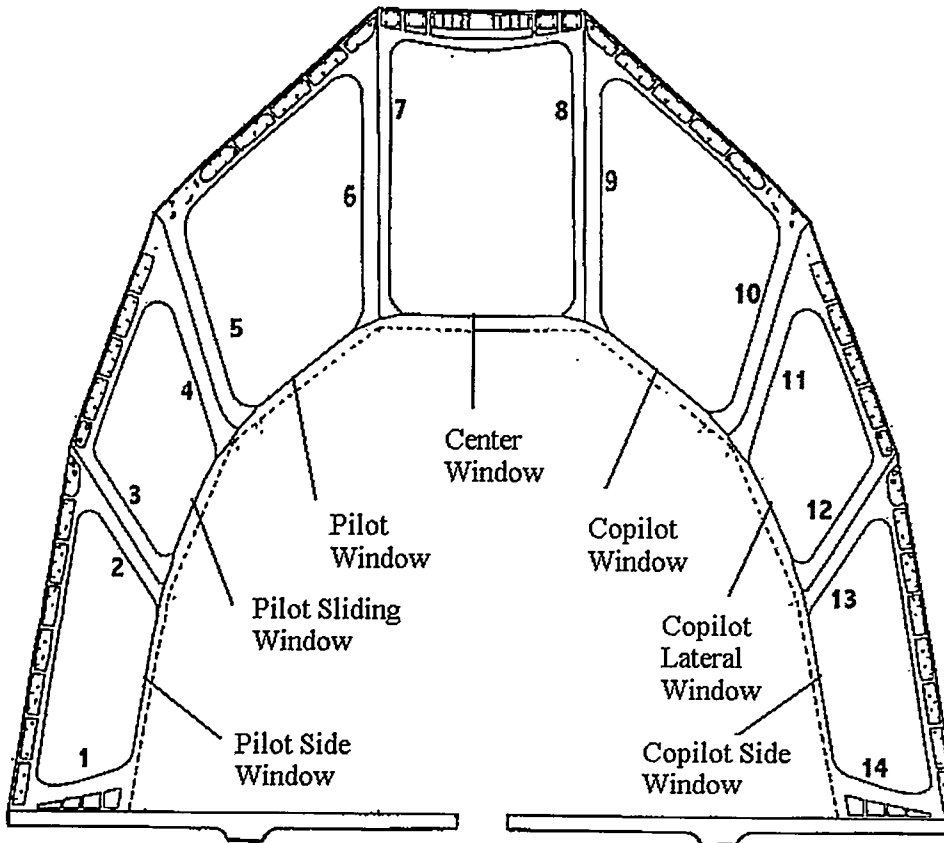
Window Post Number	Frame Angle (degrees)
1, 14	98
2, 3, 12, 13	84
4, 11	67
5, 10	88
6, 9	61
7, 8	89

Figure 1. Window post frames in the HU-25 Guardian aircraft.

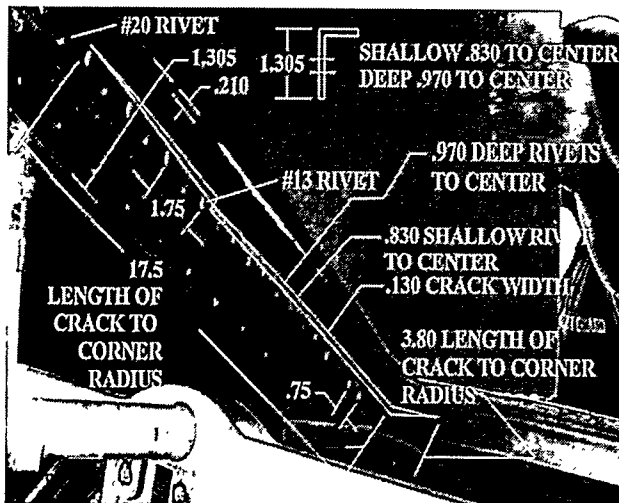
During a routine functional cabin pressure check, maintenance personnel could not achieve the correct pressure differential. A visual inspection was conducted on the outside of the aircraft. The maintenance crew found a large air leak in a center window frame. Figure 1 displays the aircraft window section. During the removal of the center windshield, ARSC discovered exfoliation corrosion and several stress corrosion cracks in the vertical widow post (Figures 2 - 3).

Figure 2. Center window frame with stress corrosion cracks present. Note: All dimensions are in inches.
