**Evaluation and Analysis of the Performance of
Masonry Infills During the Northridge
Earthquake**

**Final Report for Submission
to the National Science Foundation
Grant No. CMS-9416262**

Evaluation and Analysis of the Performance of Masonry Infills During the Northridge Earthquake

Report submitted to:
The National Science Foundation

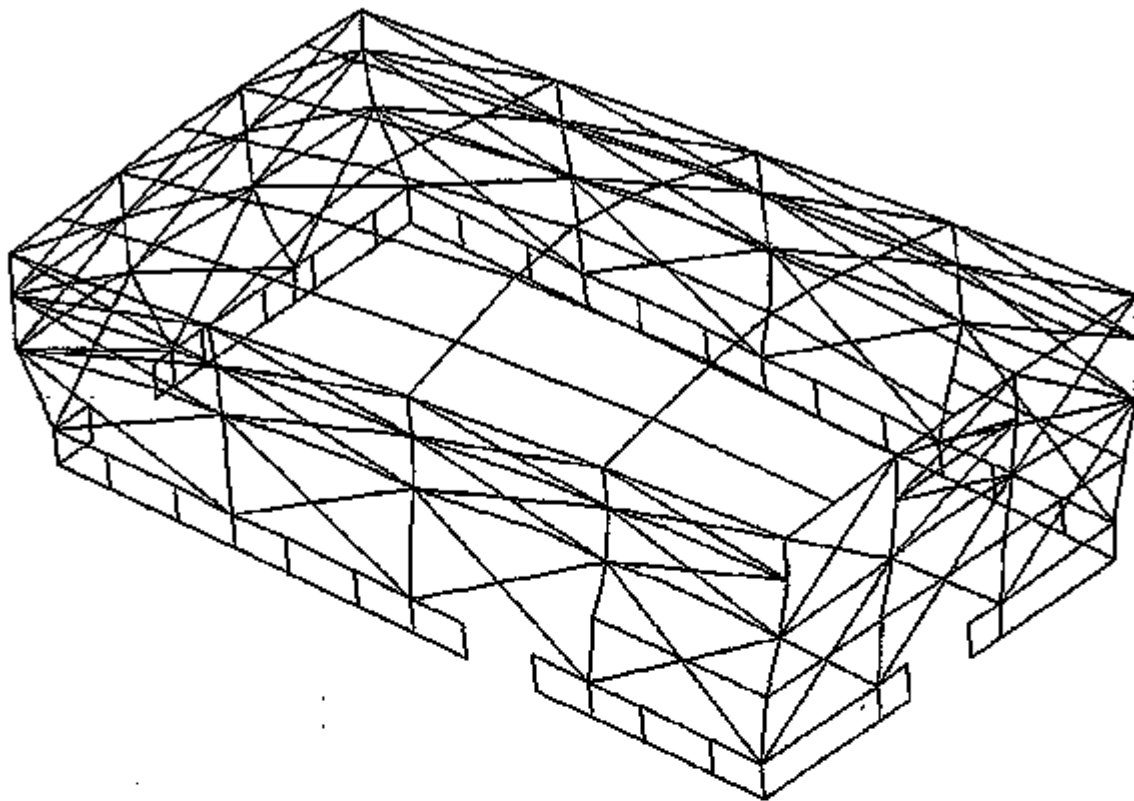
Figure 4.5 Deformed Shape of Building 40

The results can also be viewed in terms of strut/infill behavior. There is a band of solid infills around the top of the structure, which adds a significant amount of stiffness. The drift in these infills was on the order of 0.1-0.2", with C generally being 4. Possibly some minor cracking would exist in these infills. Drifts at the middle level varied between 0.4-0.8". Thus, these infills were reaching their capacity, and corner crushing was starting to occur. As expected, the largest drifts were in the lowest level, with the drift on the east side being approximately 4.1". All of the lower level infills had reached their capacity, and with the large drifts that some experienced, quite visible damage would be expected.

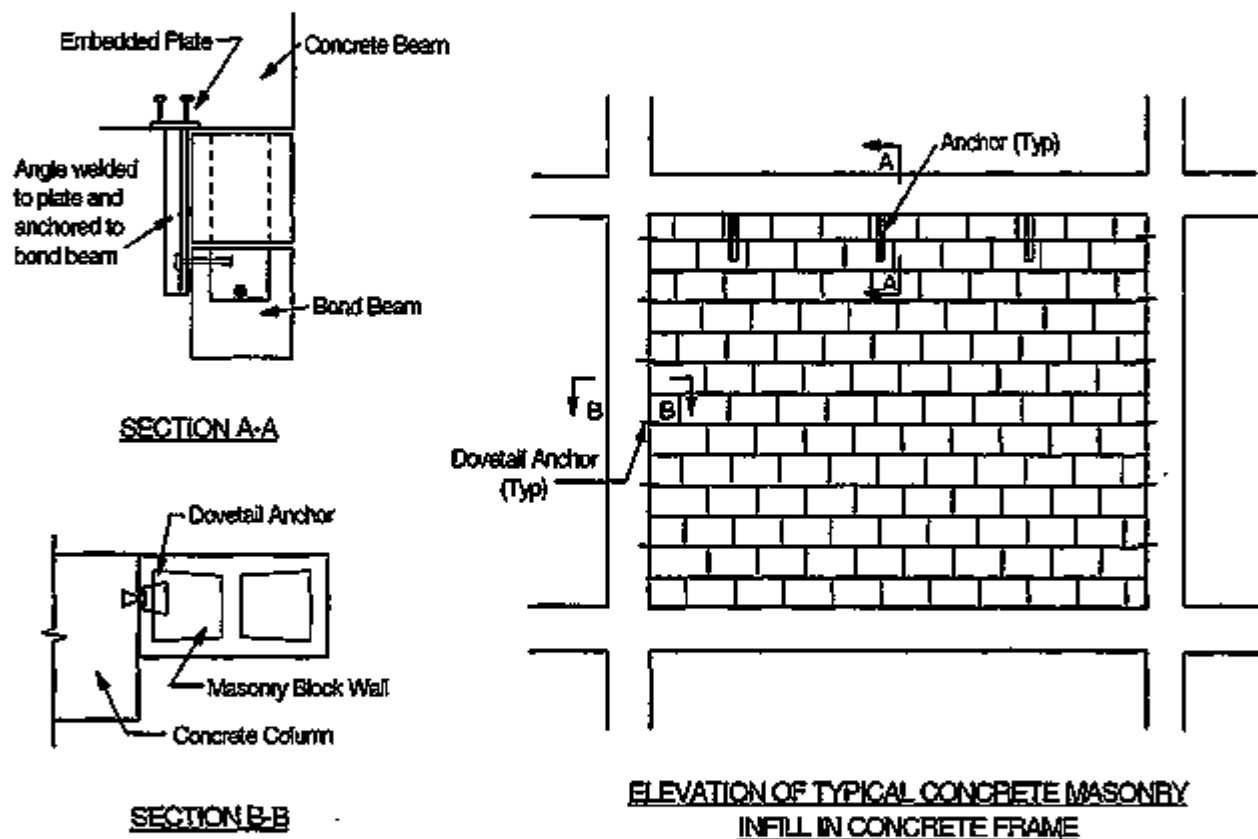
Figure 6.1 Typical Infill Construction

The researchers have observed the construction of tightly fitted infills that used some details that added to the expense of the structure without adding any beneficial behavior, and in some cases detrimental behavior. Figure 6.1 shows a typical infill construction. The infill was anchored to the columns using dovetail anchors. Presumably this is done to anchor the panel against out-of-plane

motions. The primary out-of-plane resisting mechanism is arching, for which the anchors do not contribute. The anchors can lead to premature in-plane cracking, which can reduce the panel capacity. It is therefore recommended that these anchors be eliminated. A similar situation exists at the top of the infill. For example, Figure 6.1 illustrates a steel plate embedded into the underside of the concrete floor slab, an angle field welded to the plate after completion of the masonry wall, and an anchor installed to anchor the wall to the frame. As with the side anchors, this does little to enhance the out-of-plane stability of the wall. The anchors can also lead to localized failures of the infill under in-plane loading, which can cause a premature out-of-plane failure, or a partial height infill and premature shear failures of the columns. Again, it is recommended that these anchors be eliminated. A tightly constructed infill has in general a large factor of safety against out-of-plane loads due to arching, and can add to the in-plane stiffness and strength.
