Seismic Induced Architectural Damage to Masonry Structures at Mercury, Nevada

J. F. Wall, Jr.

June 1966

Selected masonry structures in Mercury were inspected for cracking before and after certain nuclear detonations and during periods of no significant nuclear activity. Detonations gave peak particle velocities whose magnitudes approached those experienced in Mississippi during the Salmon event. Findings include evidence that peak particle velocities of 0.1 to 0.3 cm/sec caused more cracking than normal; however, cracks at these low levels of motion are not more severe than those occurring naturally.

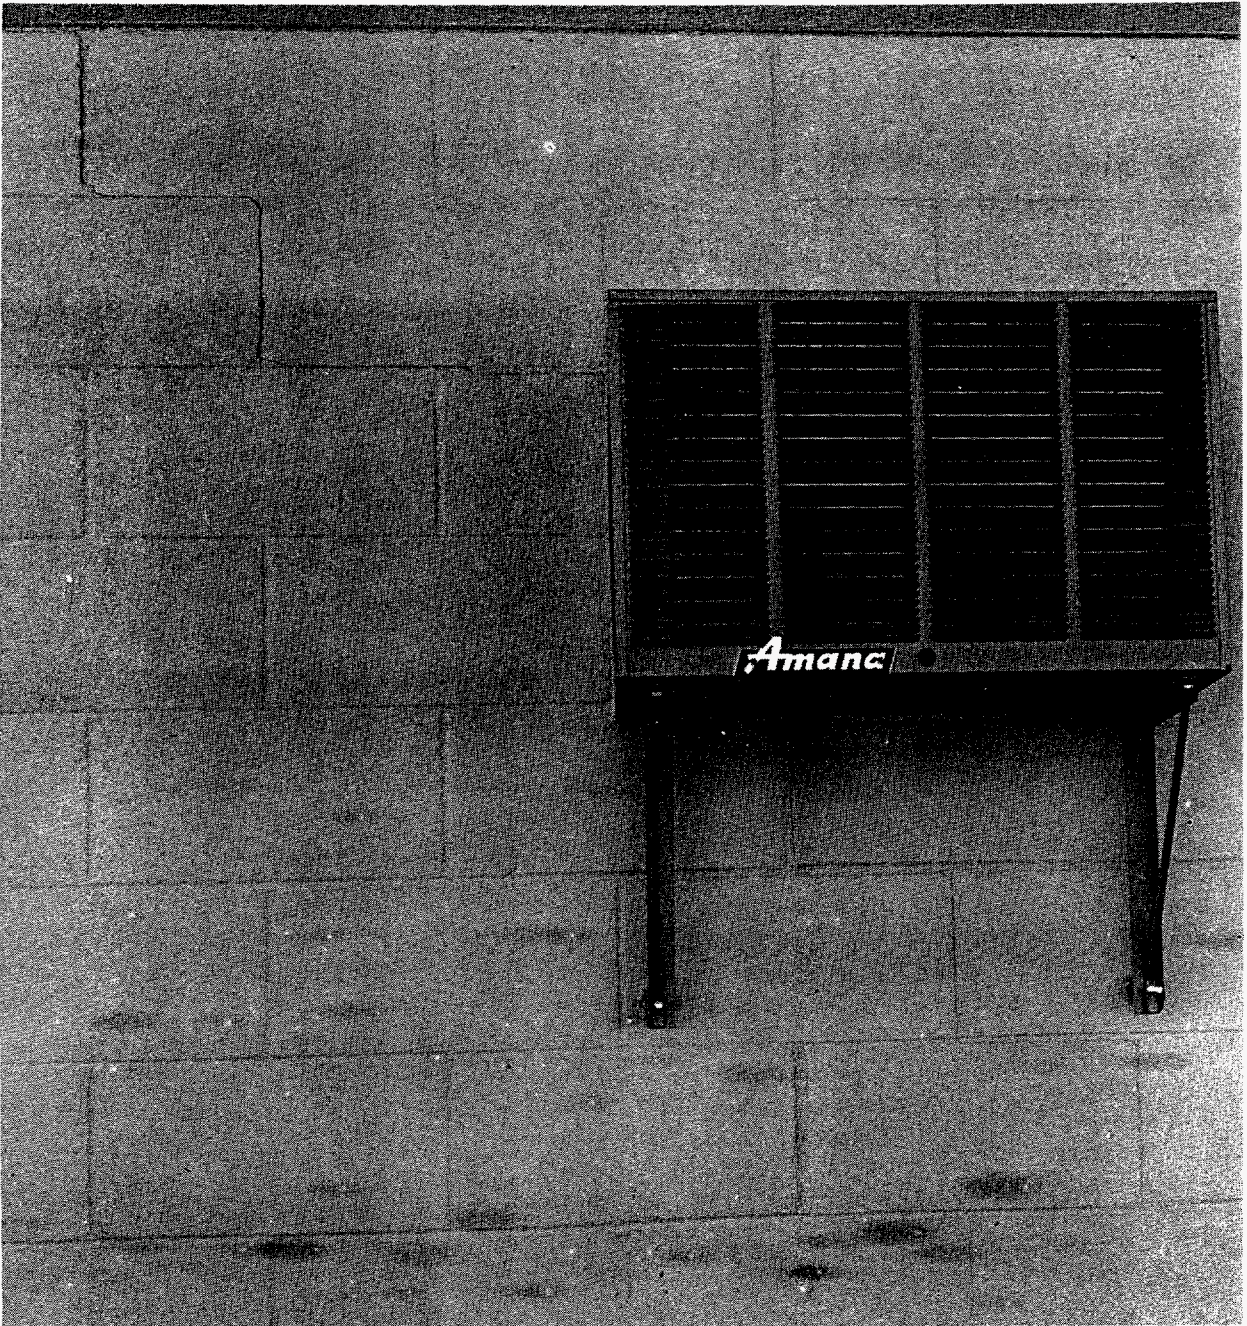
Fig. B-5. Typical existing crack, 1 Dec. 1965.

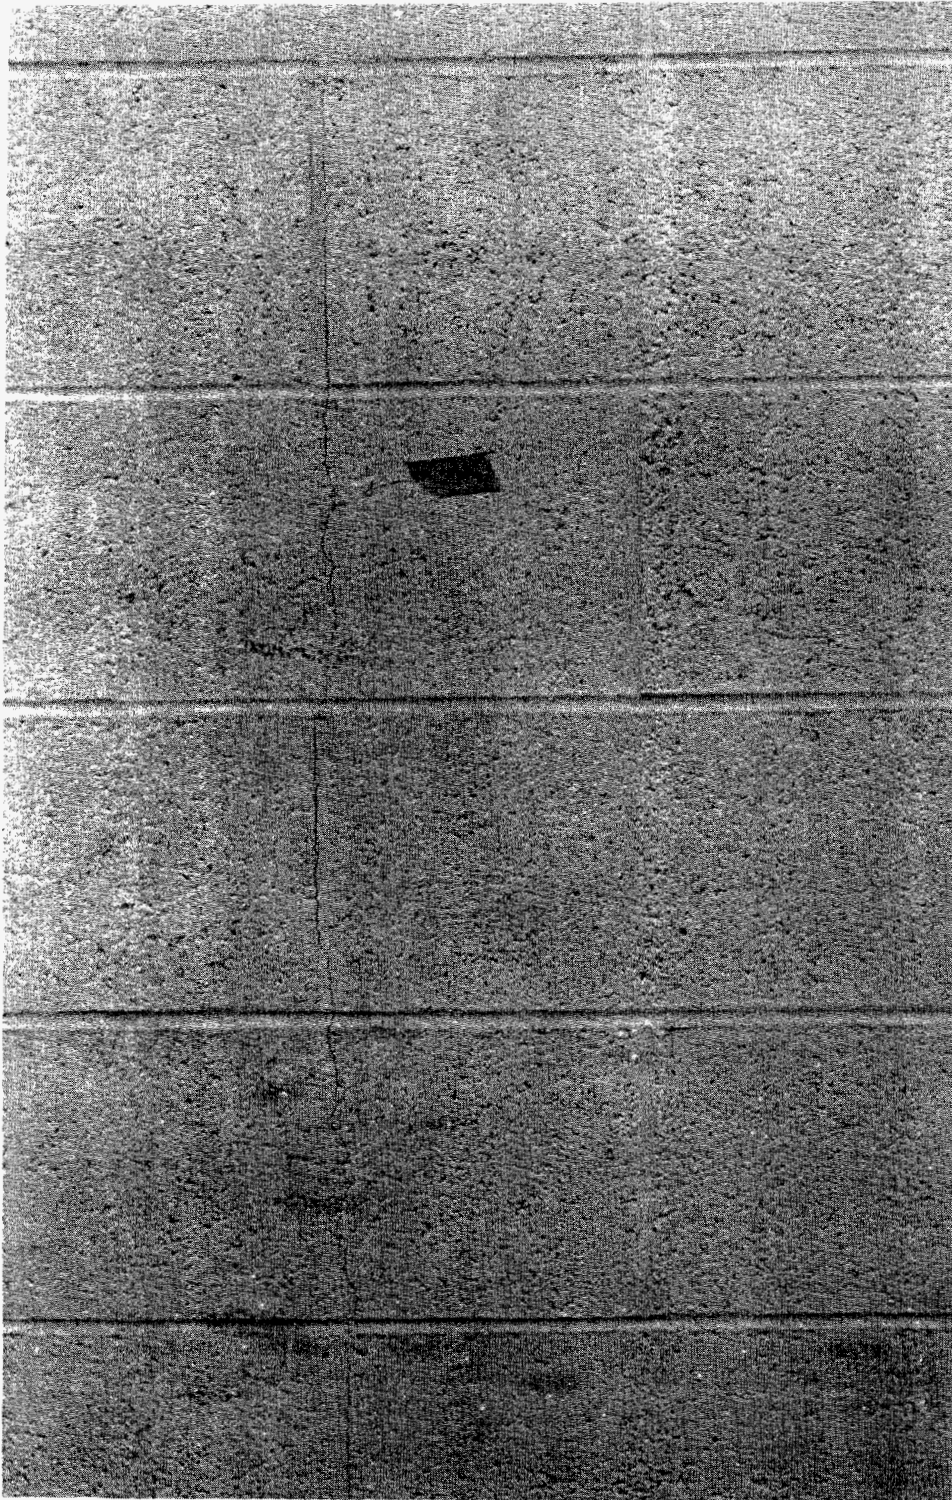
Fig. B-6. Building 751, north side, 0.18 cm/sec.

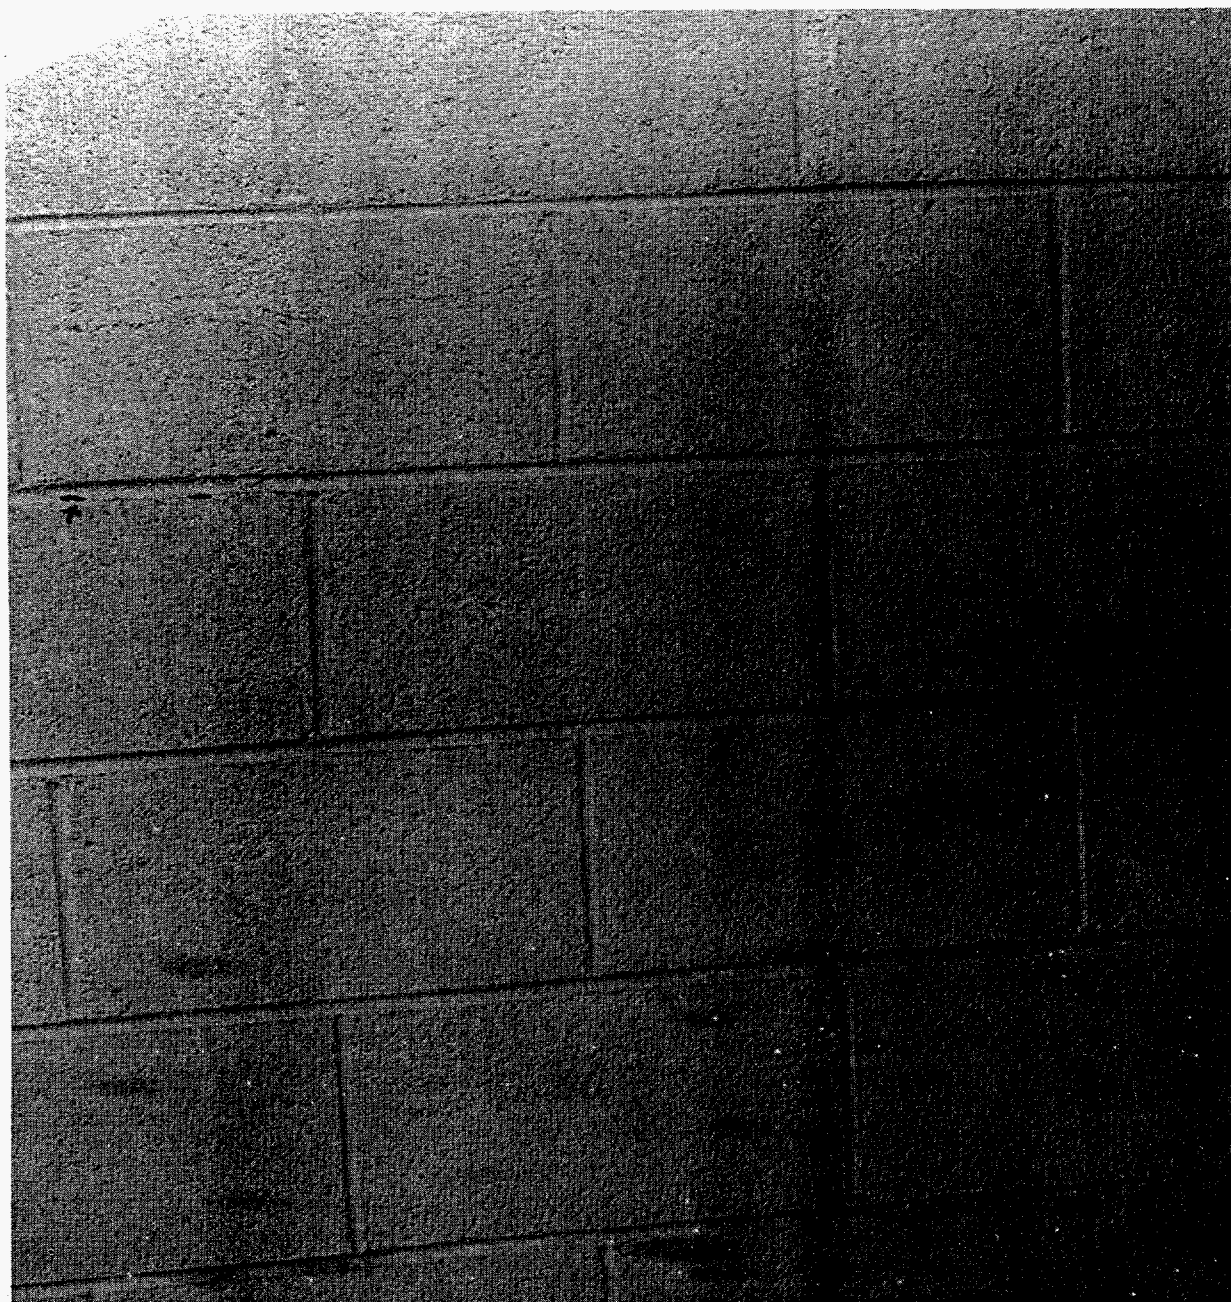
Fig. B-7. Building 681, west end, 0.18 cm/sec.

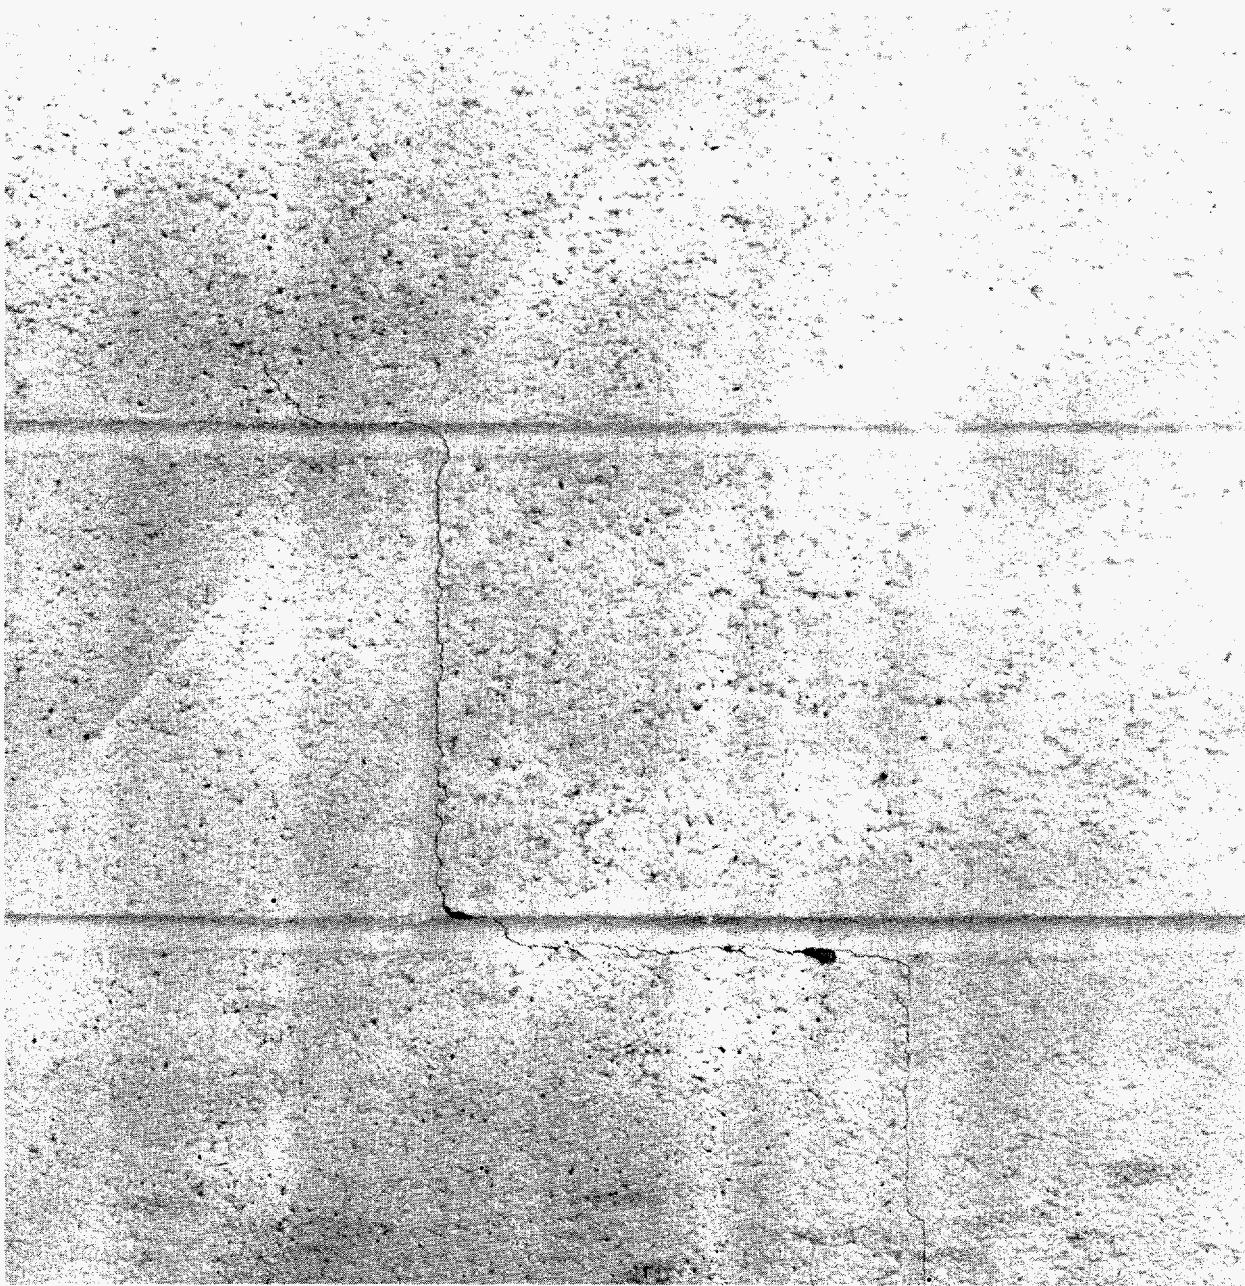
Fig. B-8. Building 752, north end (fresh flakes were found on ground)
0.18 cm/sec.

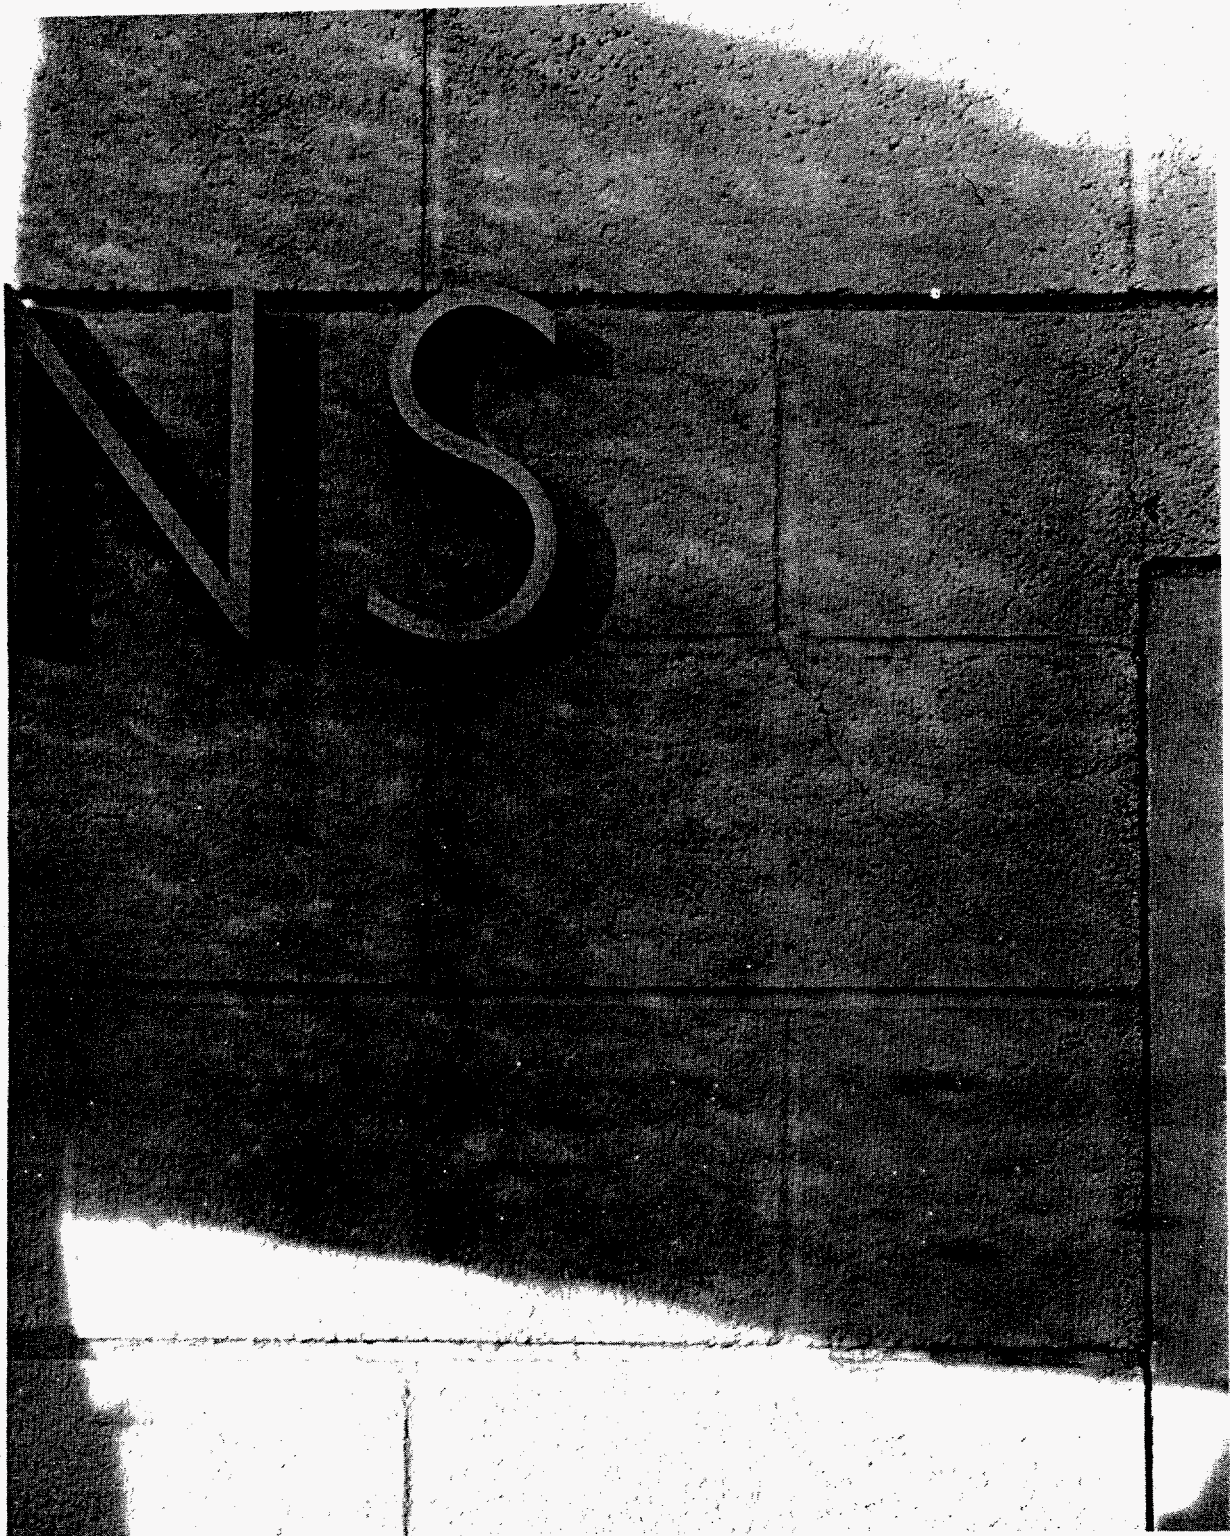
Fig. B-9. Building 726, 40-in. crack above "S" present on 1 and 7 Dec.; 16-in. extension of crack through "S" and a new 19-in. crack to the right present on 16 Dec., 0.21 cm/sec.

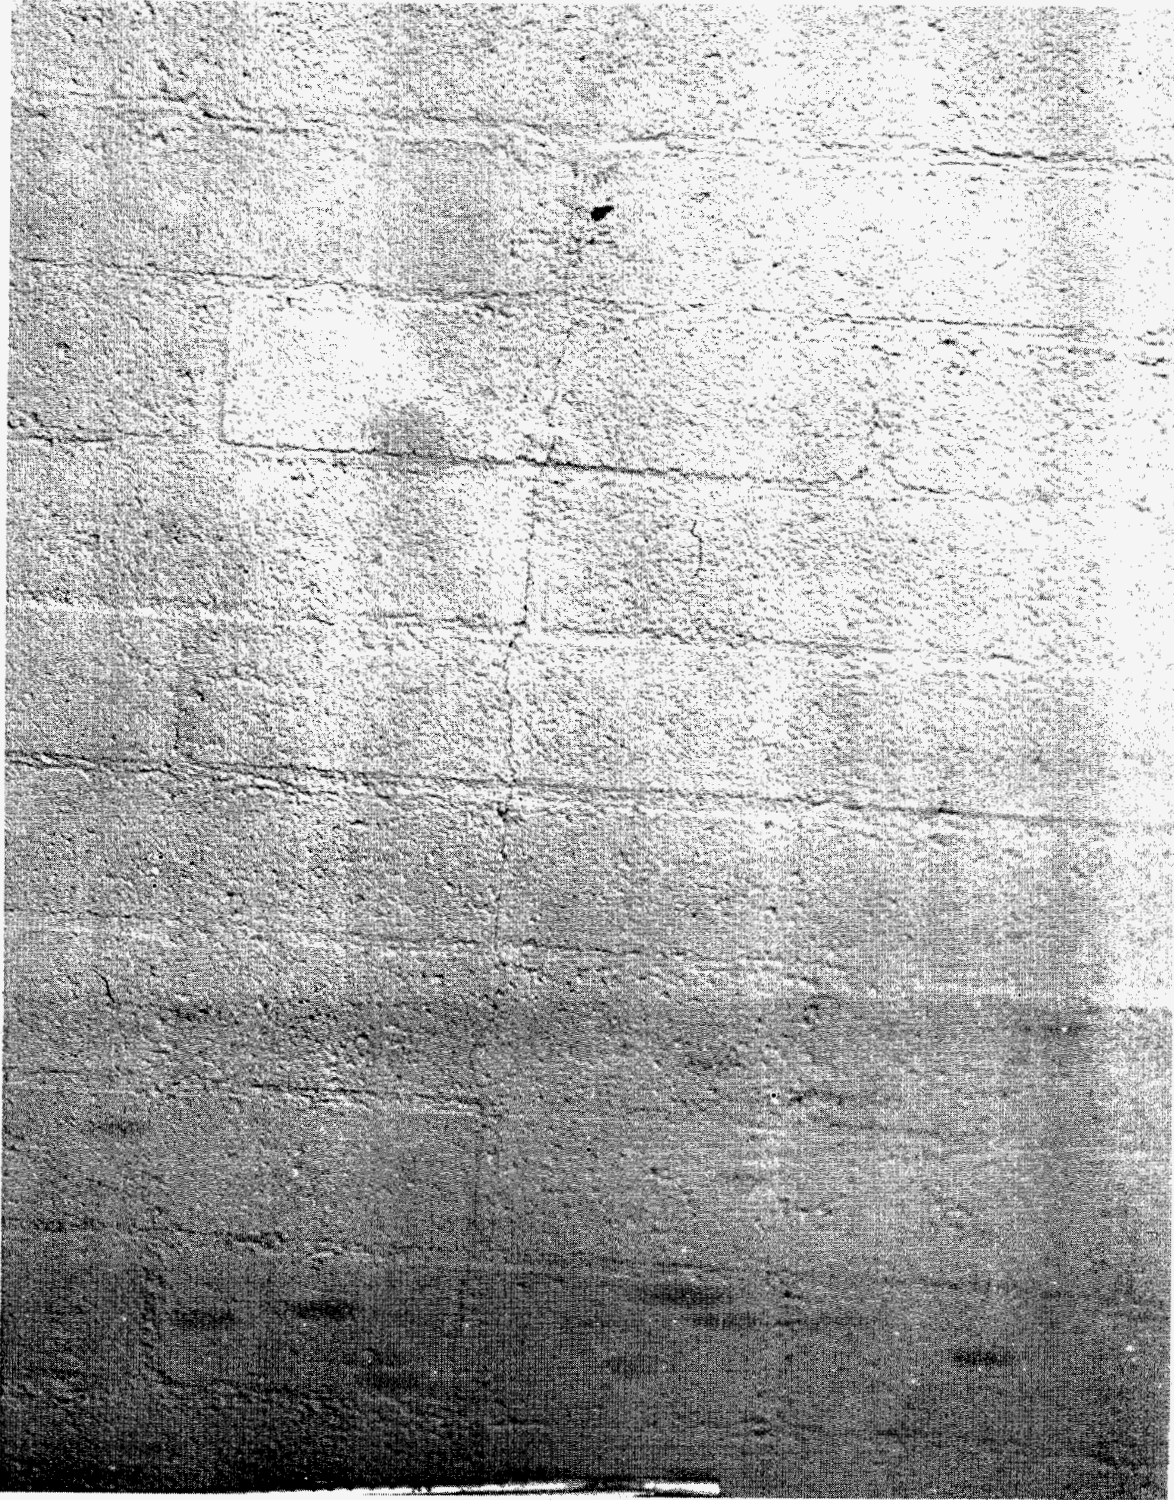
Fig. B-10. Building 155, east side, 0.21 cm/sec.

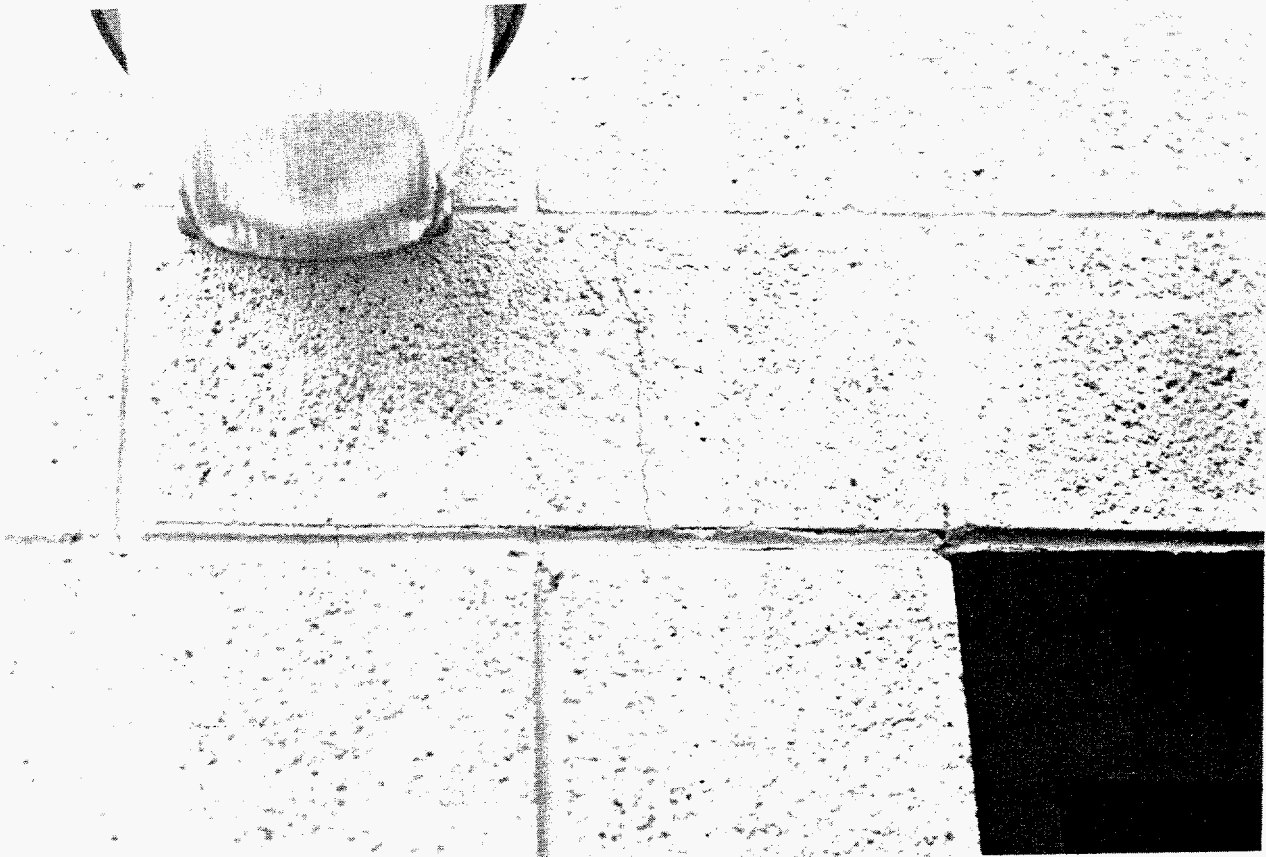
Fig. B-11. Building 1002, horizontal hairline over south door present on 1 and 7 Dec.; 16-in. vertical extension of crack present on 16 Dec., 0.21 cm/sec.

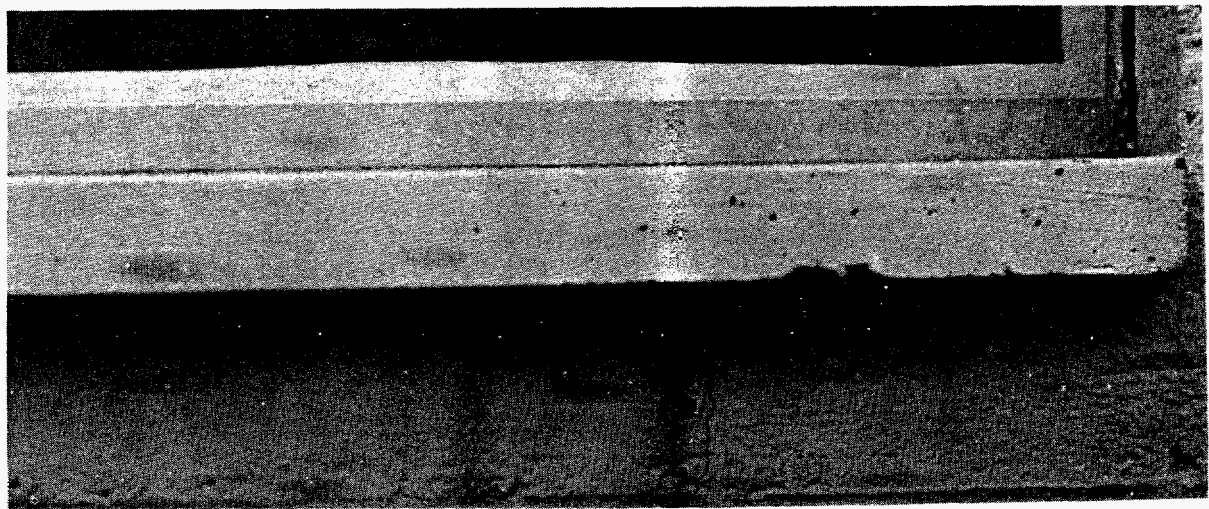
Fig. B-12. Building 700, vertical hairline under front window ledge, 0.21 cm/sec.

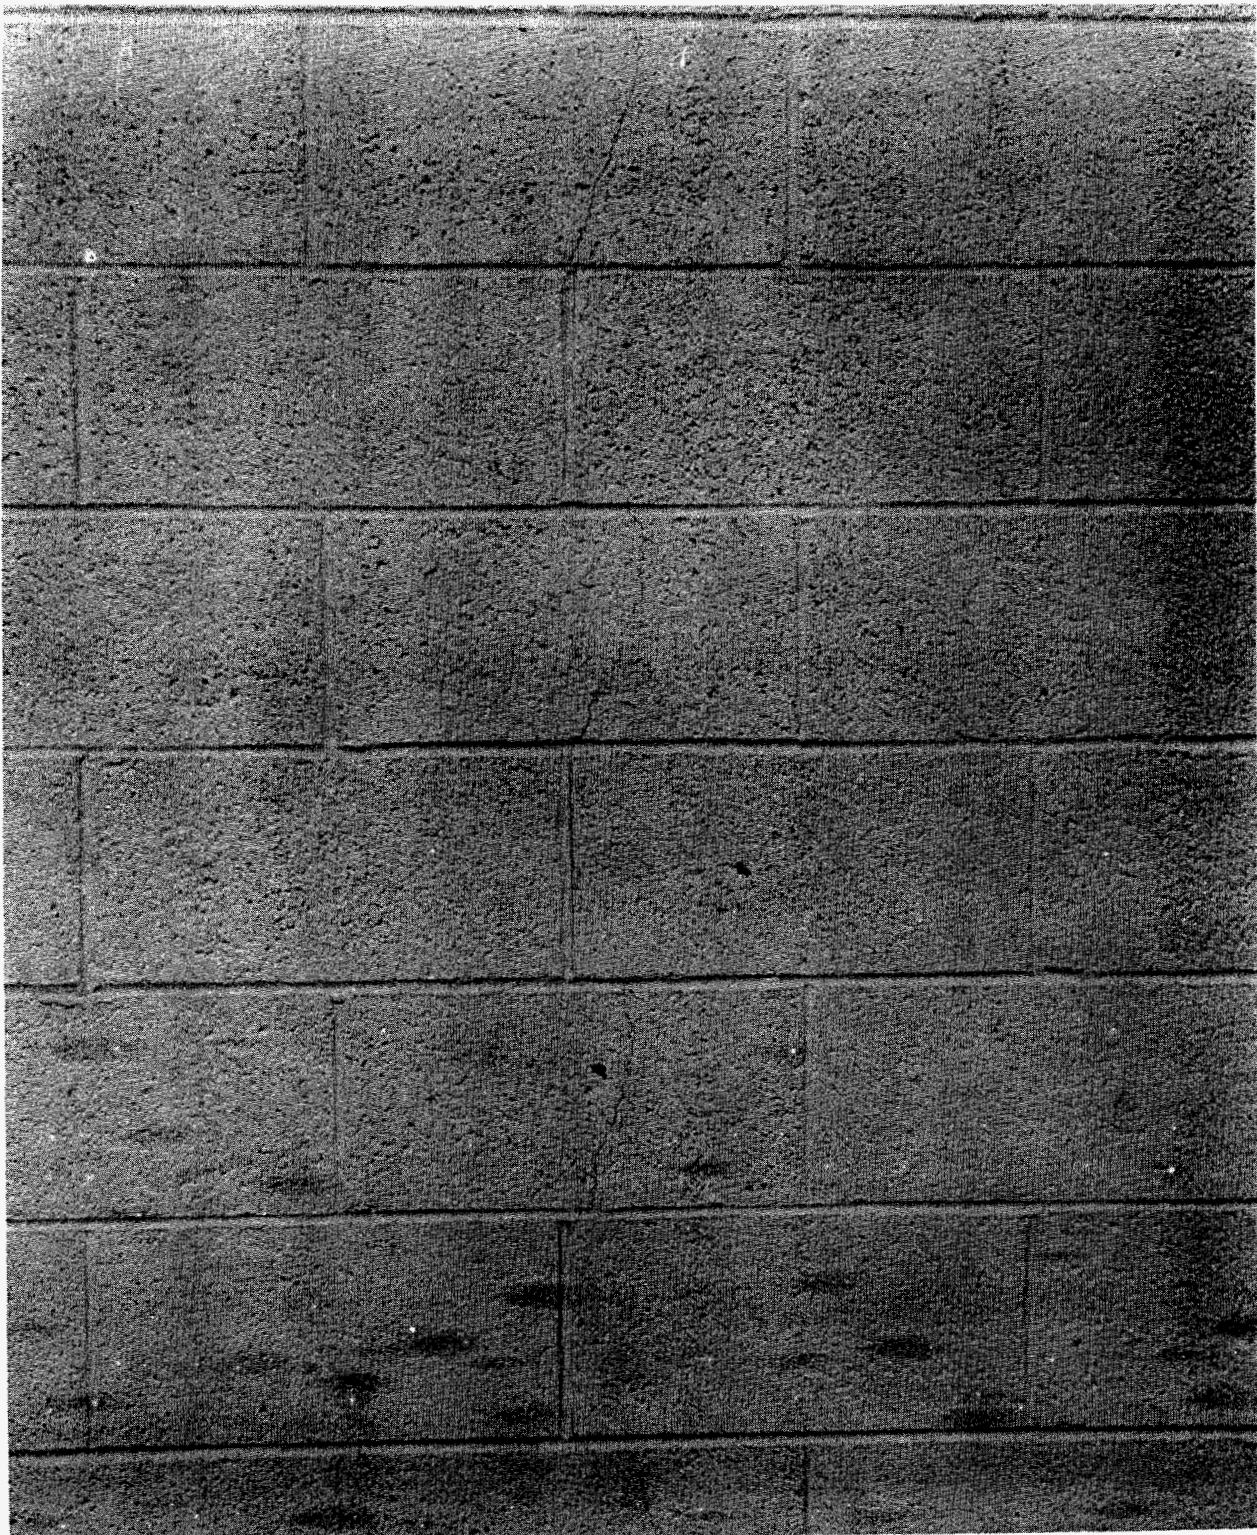
Fig. B-13. Building 700, south wall, 0.21 cm/sec.

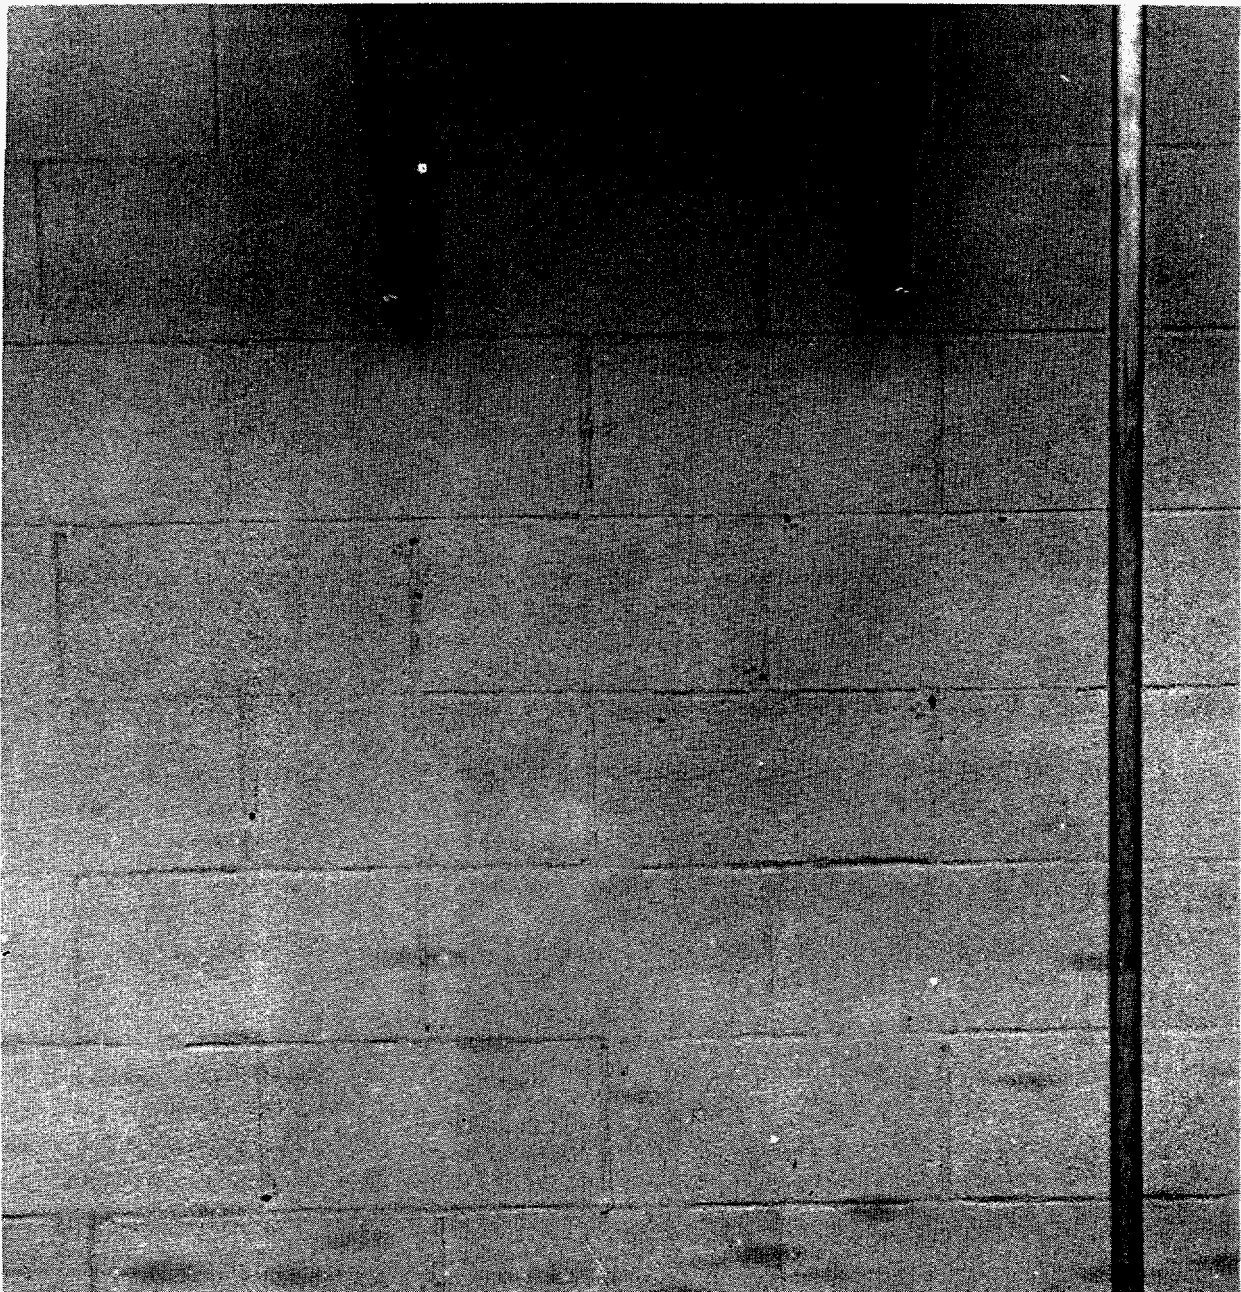
Fig. B-14. Building 479, extensive cracking under air conditioner, 0.21 cm/sec.

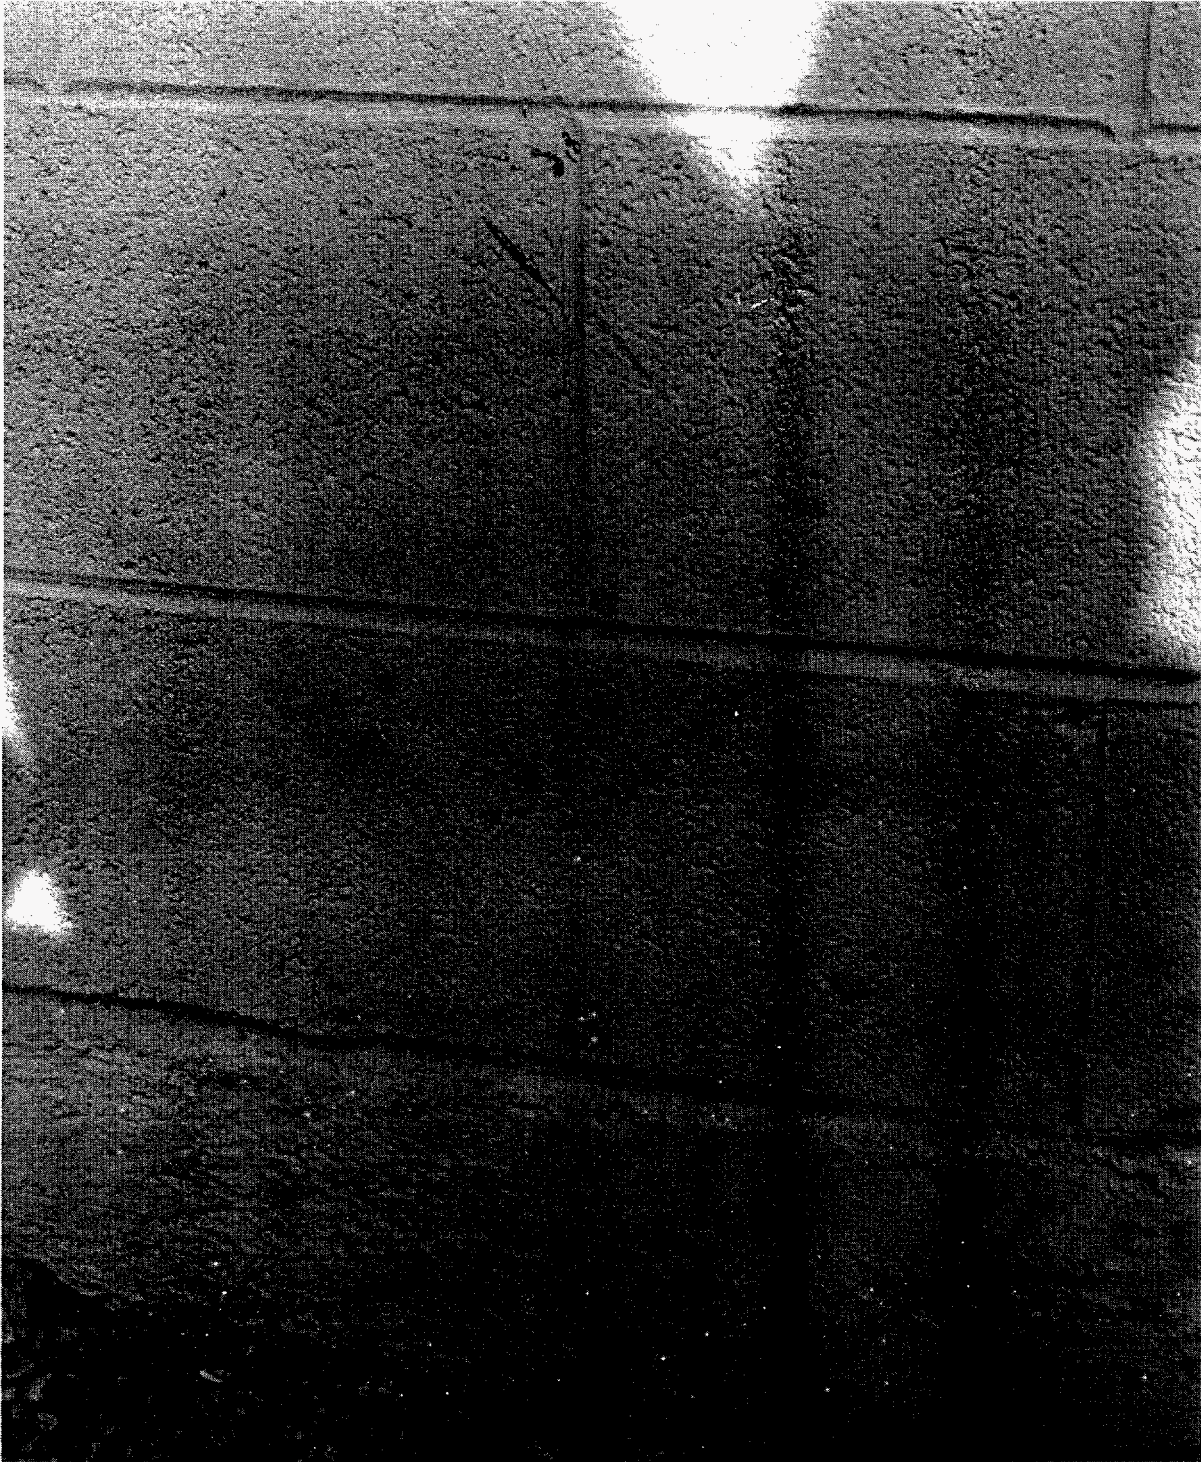
Fig. B-15. Building 710, south side, 0.13 cm/sec.

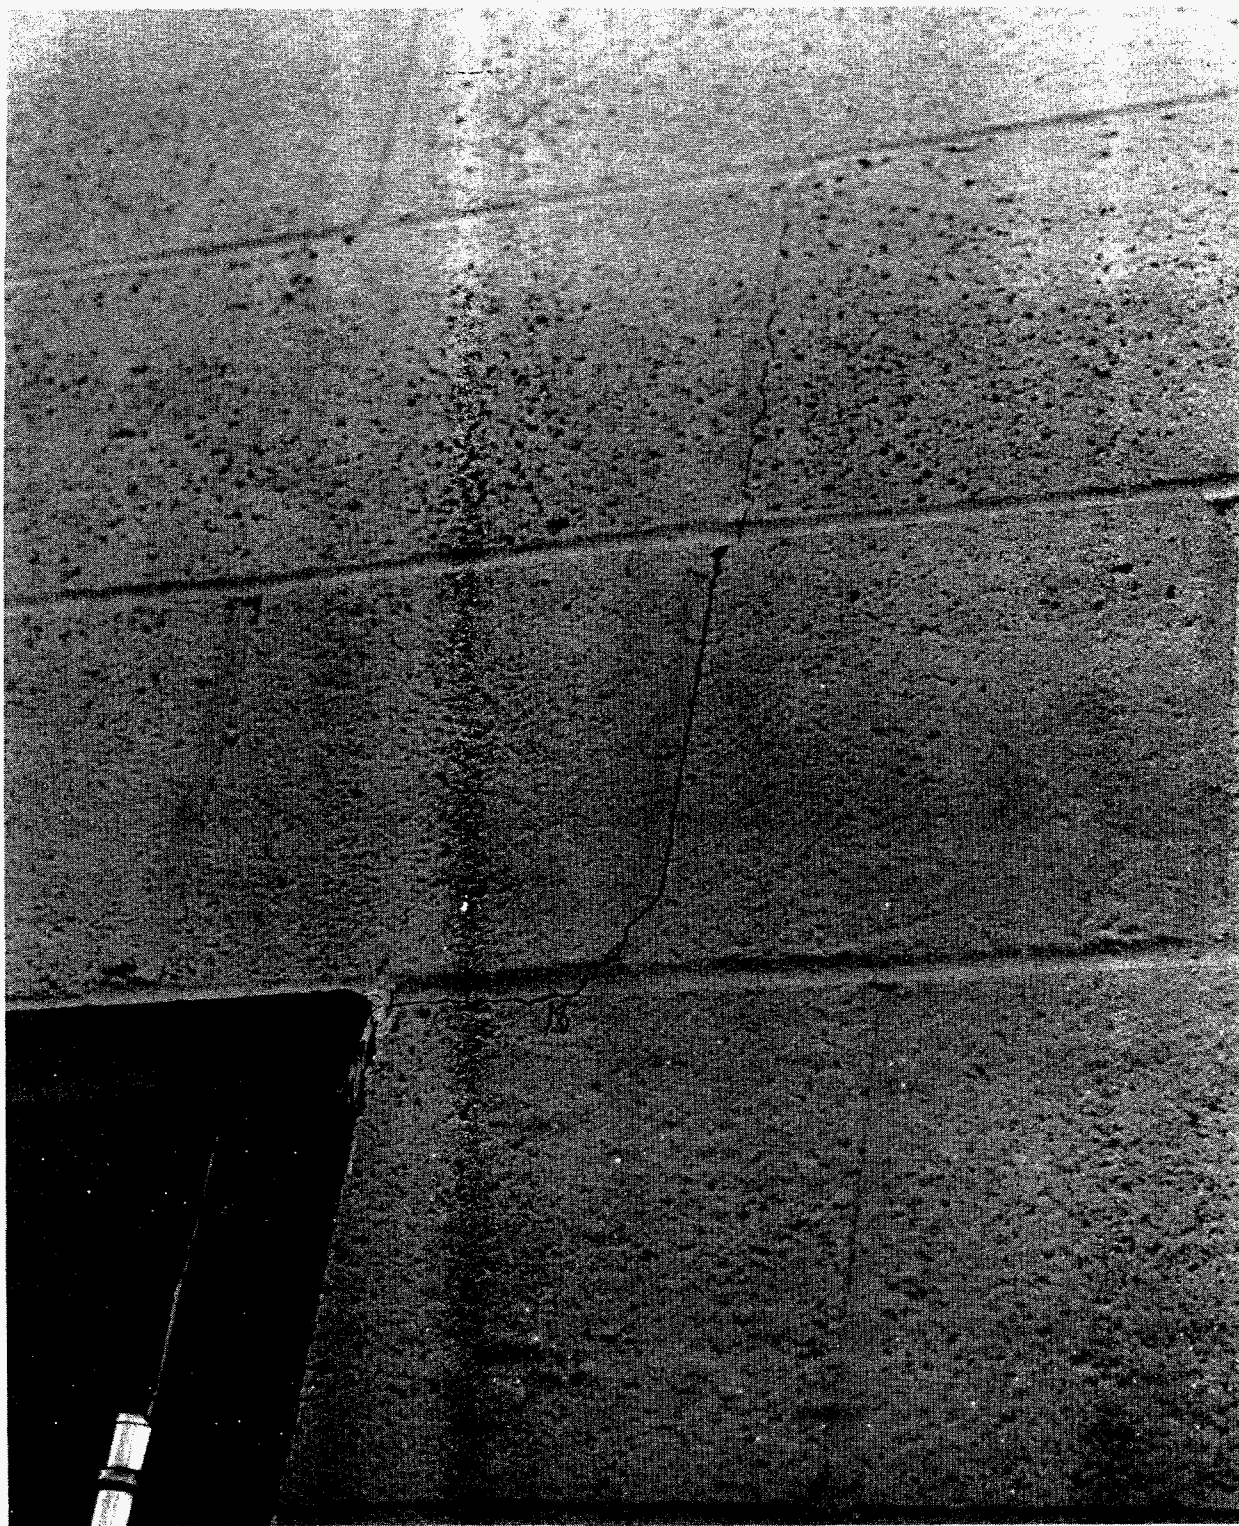
Fig. B-16. Building 701, north end of east side, crack over fan room door, 0.13 cm/sec.

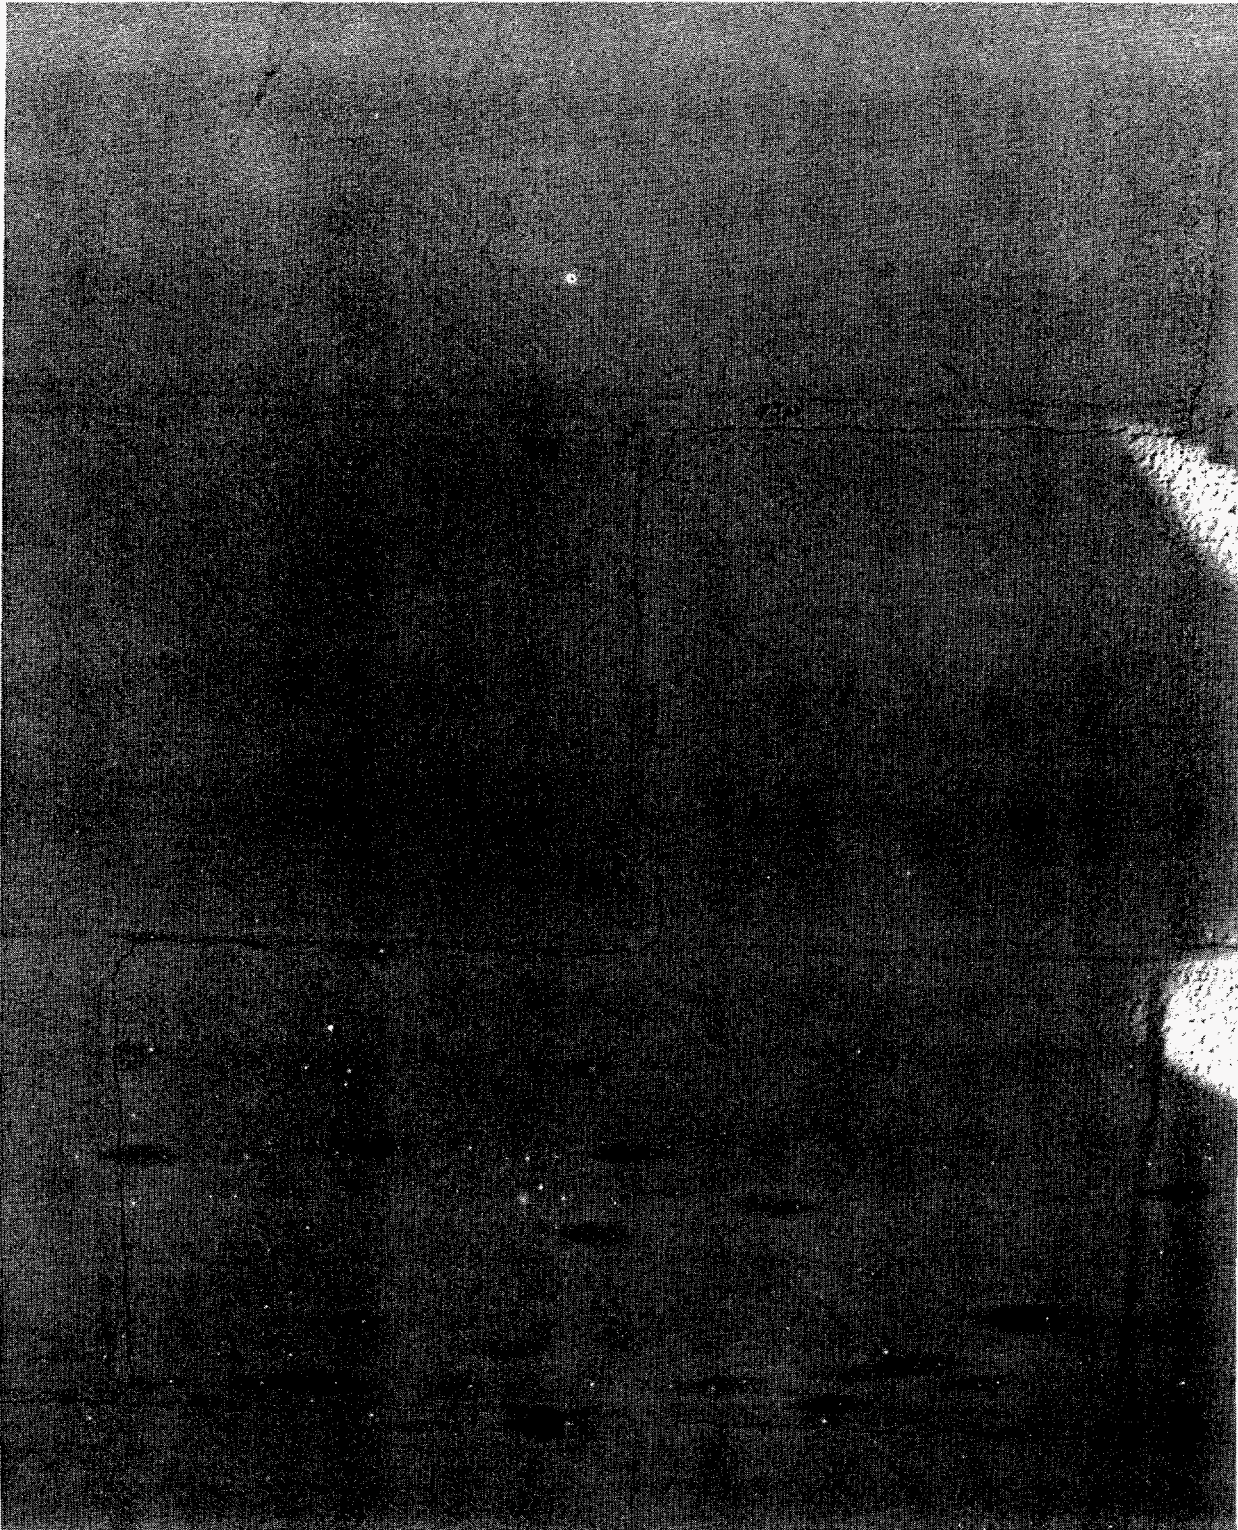
Fig. B-17. Building 479, 80-in. hairline crack at northeast corner, 0.13 cm/sec.

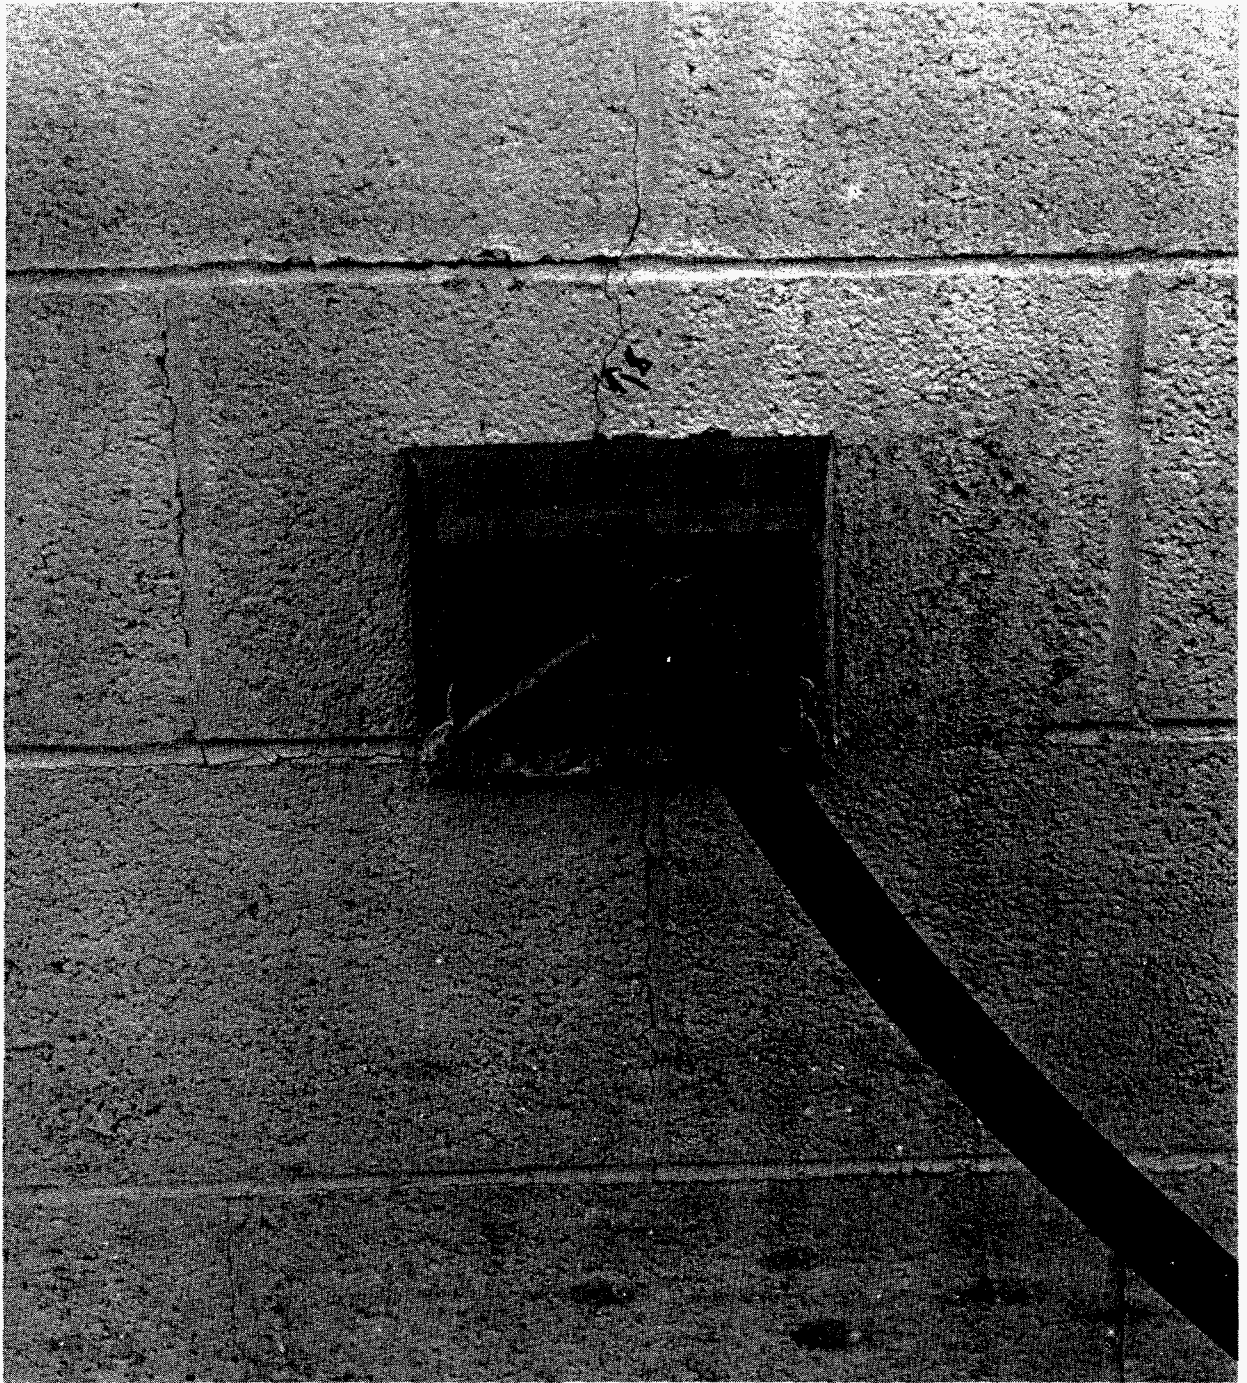
Fig. B-18. Building 790, west side, 0.13 cm/sec.
