Seismic Induced Architectural Damage to Masonry Structures at Mercury, Nevada

J. F. Wall, Jr.

June 1966

Selected masonry structures in Mercury were inspected for cracking before and after certain nuclear detonations and during periods of no significant nuclear activity. Detonations gave peak particle velocities whose magnitudes approached those experienced in Mississippi during the Salmon event. Findings include evidence that peak particle velocities of 0.1 to 0.3 cm/sec caused more cracking than normal; however, cracks at these low levels of motion are not more severe than those occurring naturally.

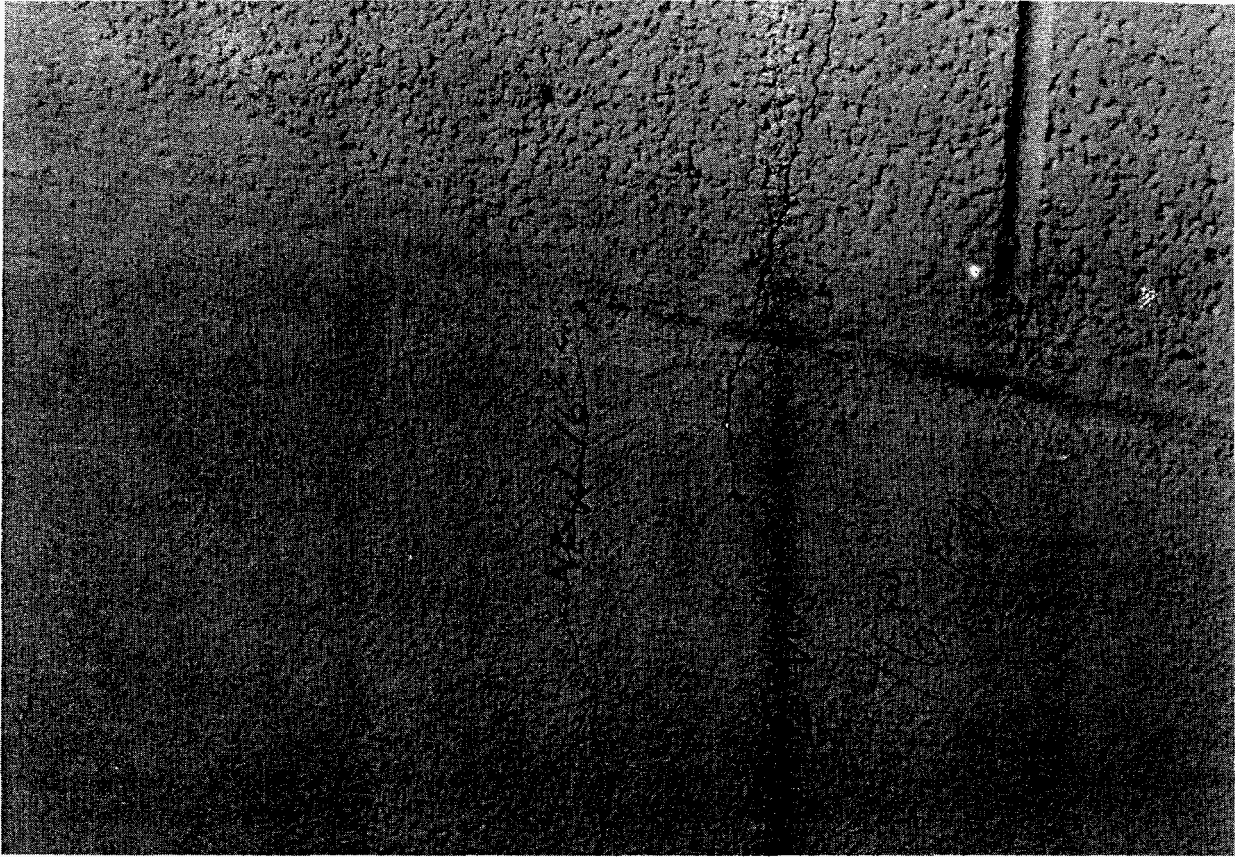
Fig. B-21. Building 1000, east side, intermediate inspection.

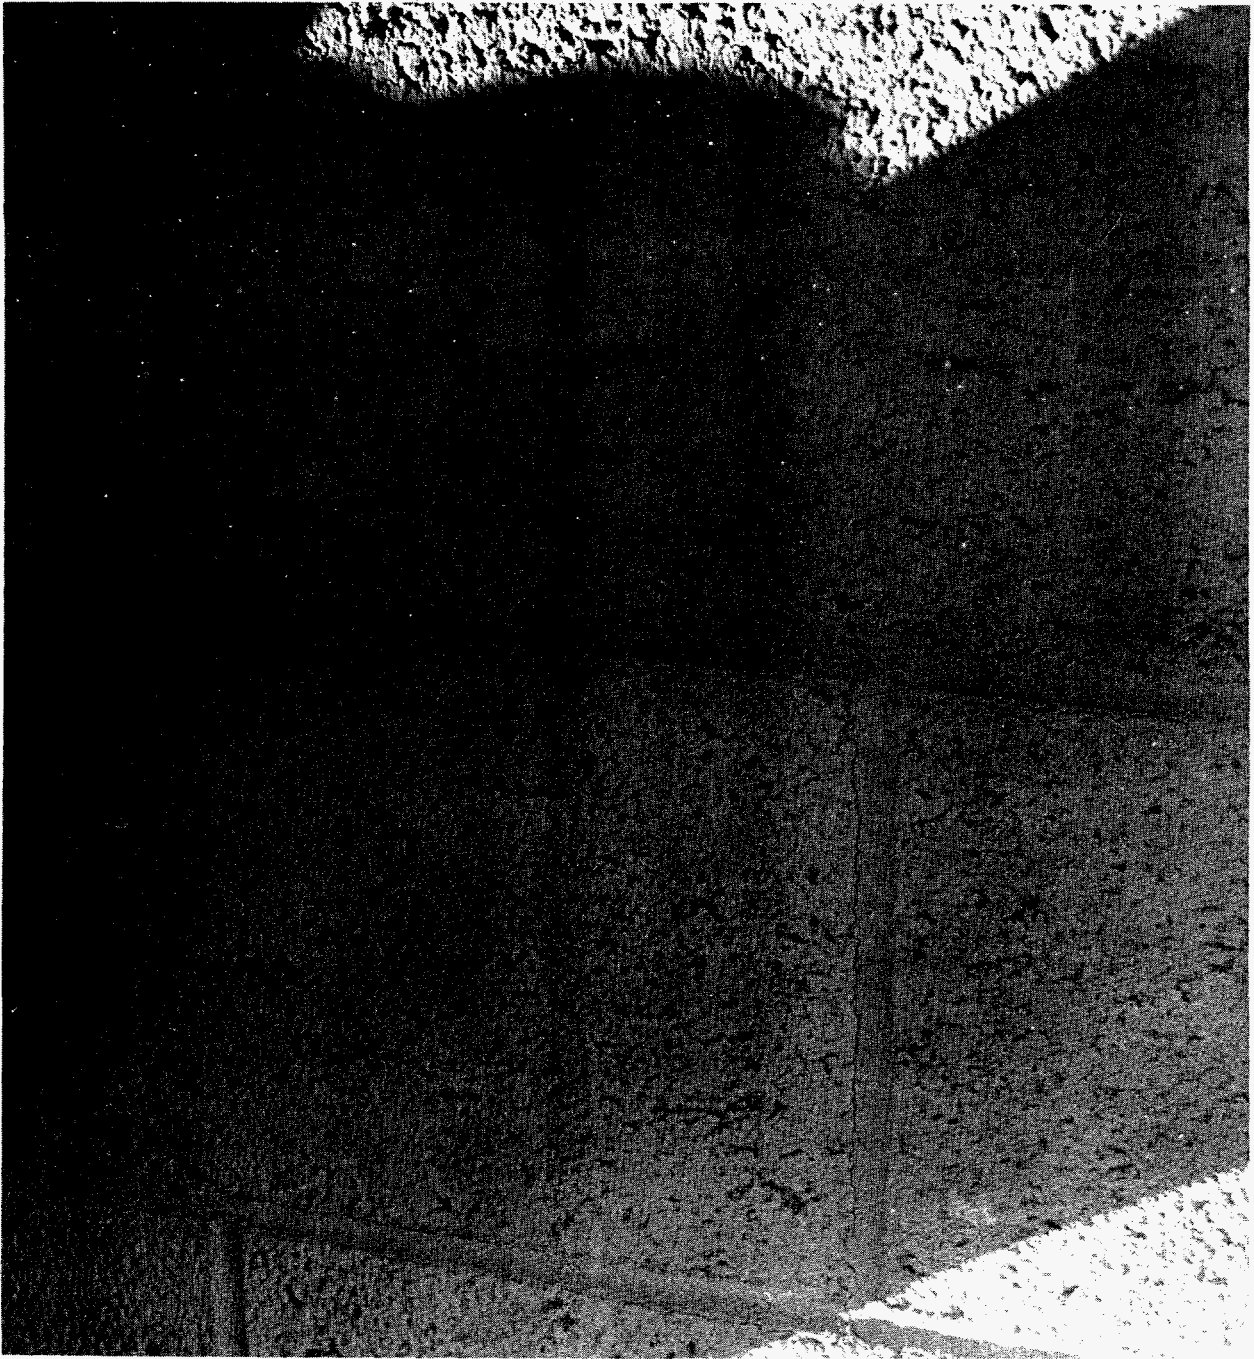
Fig. B-24. Building 725, south side, additional spalling at panel-post junction, intermediate inspection.

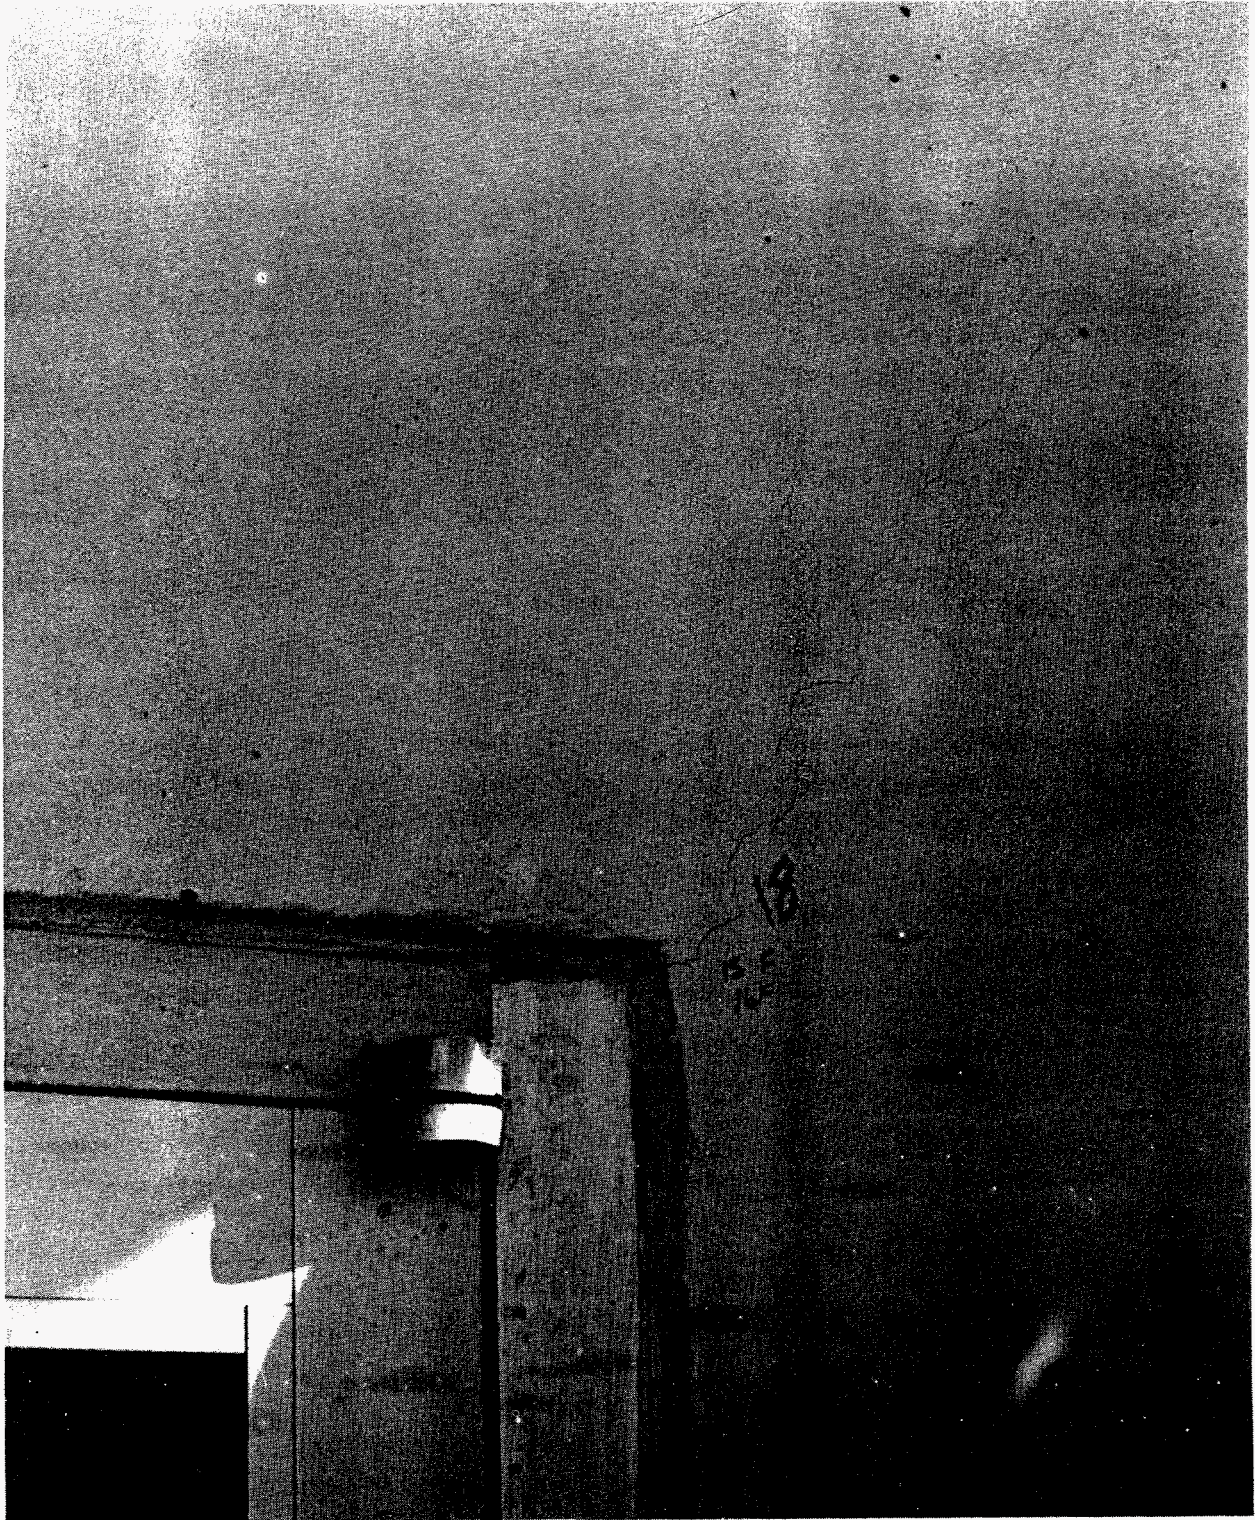
Fig. B-25. Building 725, minute diagonal crack over main door, intermediate inspection.

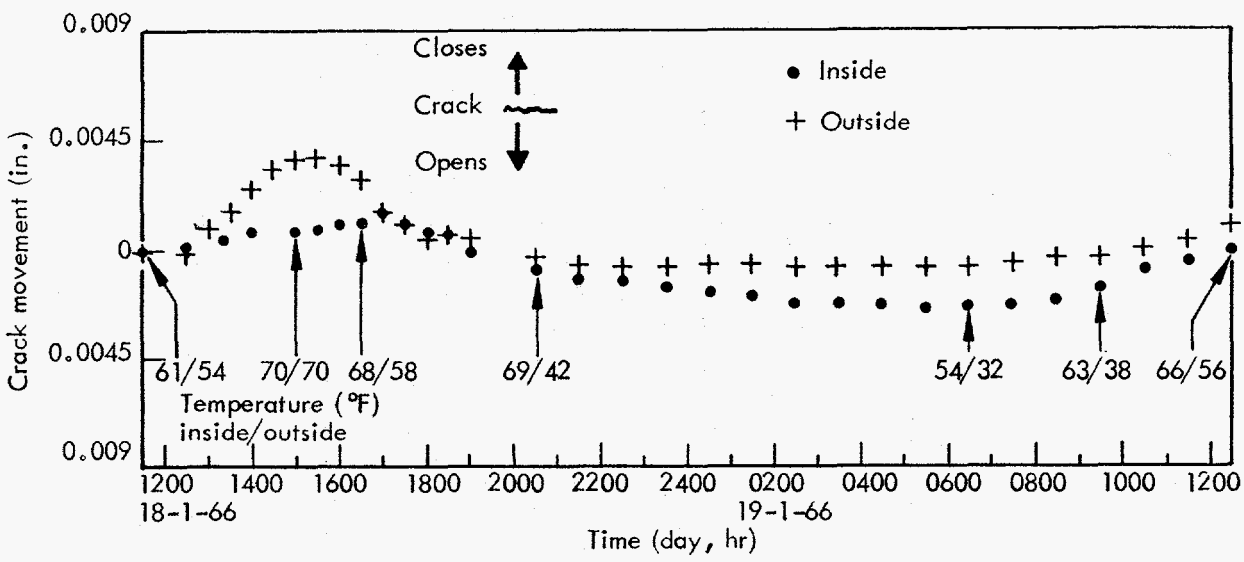
Fig. C-8. Movement of crack in Building 681 over a 24-hr period during Jan. 1966.

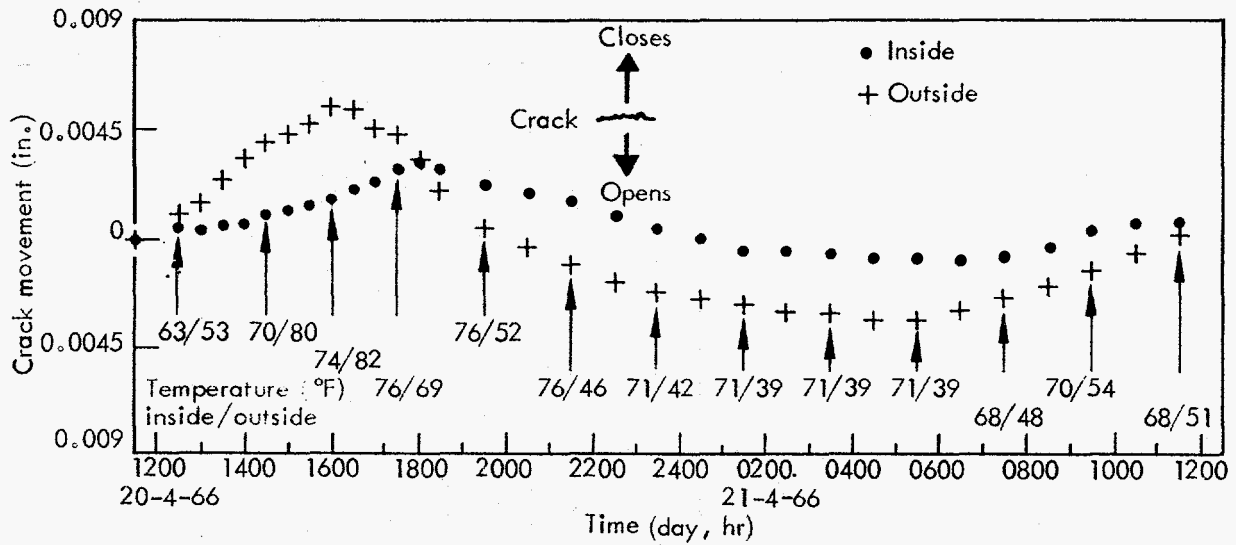
Fig. C-9. Movement of crack in Building 681 over a 24-hr period during Apr. 1966.
