Morphologies of Laser-Induced Damage in Hafnia-Silica Multilayer Mirror and Polarizer Coatings

F. Y. Génin
C. J. Stolz

This paper was prepared for submittal to the
Third International Workshop on Laser Beam and Optic Characterization
Quebec, Canada
July 8-10, 1996

August 22, 1996

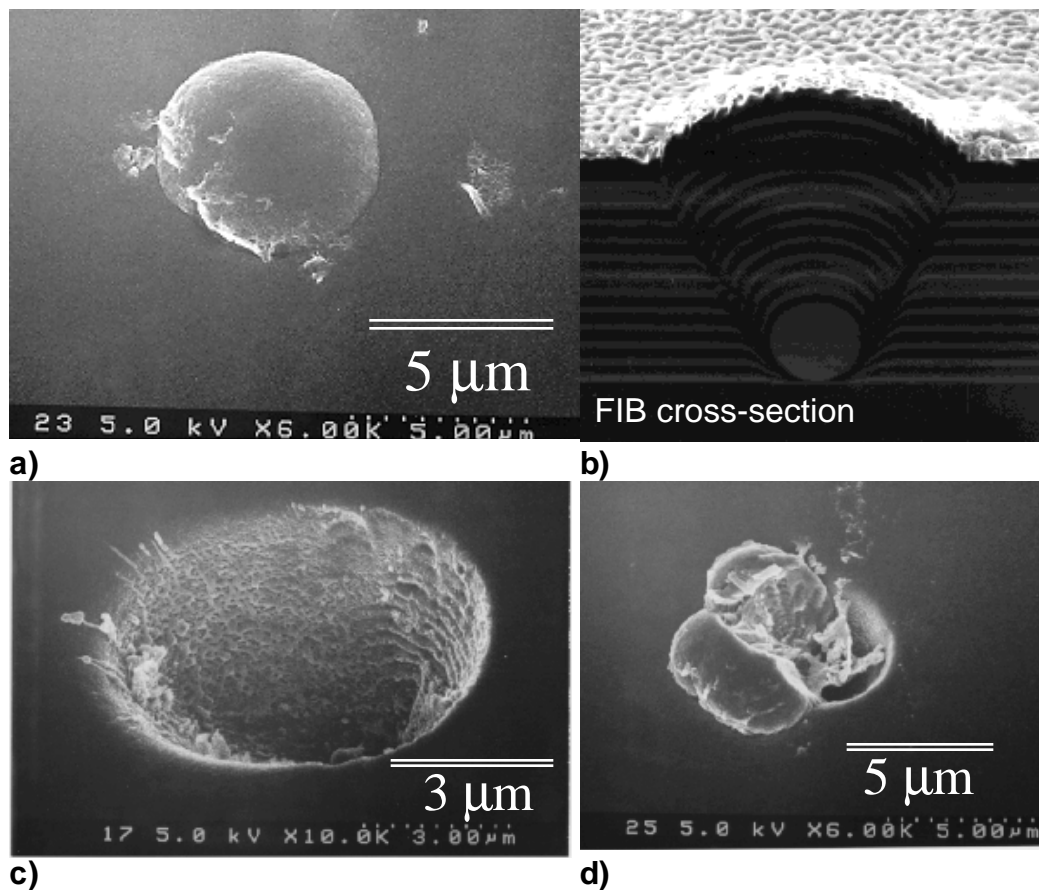
Fig. 1: SEM micrographs of a) a nodular defect in a multilayer mirror, b) a focused ion beam cross-section of a defect. The pit morphologies of the surface after nodular ejection is shown for c) shots at 47.2 J/cm^2 at 45° , in “P” polarization and d) after a single shot at 20.4 J/cm^2 . These micrographs illustrate cases where the nodules have been fully and partially ejected.

It has been well established that pit formation results from the ejection of nodular defects in coatings.³⁹ Figs. 1.c) and 1.d) show the typical morphologies of nodules fully and partially ejected after laser illumination. The formation of pits can occur at very low fluence; such damage usually determines the conventional damage threshold of HRs and polarizers. At LLNL, the damage threshold is conventionally defined as the average between the lowest fluence which produces damage and the next lower fluence which does not produce damage. Such definition is simple but can have the disadvantage of not being representative of large area behavior since it can significantly depend on the number of sites tested. In general, the larger the tested area and the better the microscope resolution, the lower the measured damage threshold. When observed by back light optical microscopy with a 1 μm detection limit, pinpoints can be observed when the site has been irradiated at 5 J/cm^2 and above. As shown in Fig. 5, the size of pits does not strongly depend on the fluence of the shot up to 40 J/cm^2 . Above 40 J/cm^2 , substantial collateral damage can occasionally occur. The plot shown in Fig. 5 is typical of the behavior of the mirrors. Similar plots were reported by Bliss et al.⁷ for $\text{TiO}_2\text{-SiO}_2$ and $\text{ZrO}_2\text{-SiO}_2$ mirrors. The insensitivity of pit size on fluence at lower fluences can have a significant impact on how to improve the coatings' damage threshold by laser conditioning if no other damage morphologies are produced. From a functional stability perspective, no real benefit is added by conditioning if the pit morphology which determines the damage threshold does not grow with repetitive illumination and the total area of damage is insufficient to cause important losses of reflectivity. On the other hand, it is often difficult to produce coatings that satisfy this criterion.

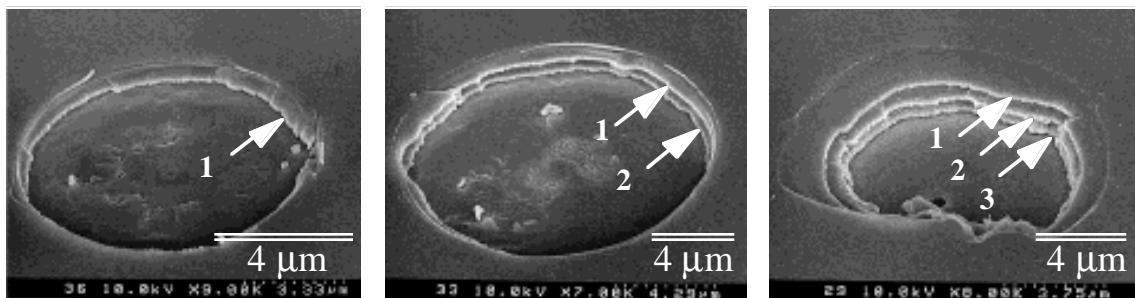
Flat bottom pits have been reported in a variety of multilayer systems^{36,43,44} used at different wavelengths.⁴⁵ Similar morphologies have also been reported for single layers on glass substrates.⁴³ Fig. 2 shows a typical flat bottom pit morphology. Damage seems to propagate by delamination along the interface between two adjacent layers. Their cause is not yet fully understood and their formation does not always seem to correlate to defects detectable by optical microscopy. Like pits, the size of flat bottom pits does not strongly depend on the fluence of the shot below 35 J/cm^2 (see Fig. 5). A study by Walton et al.⁴⁴ has shown that the pit damage size depends on the overlayer thickness. Above 35 J/cm^2 , collateral damage is possible, in particular when pits are very large.

Fig. 2: SEM micrographs of various flat bottom pit morphologies after a single shot on a mirror at 15.2 J/cm^2 at 56°, in “P” polarization. The damage seems to propagate along the interface between silica and hafnia within the first three top layer pairs. Because of the contrast between the two oxides, hafnia appears lighter and silica darker.

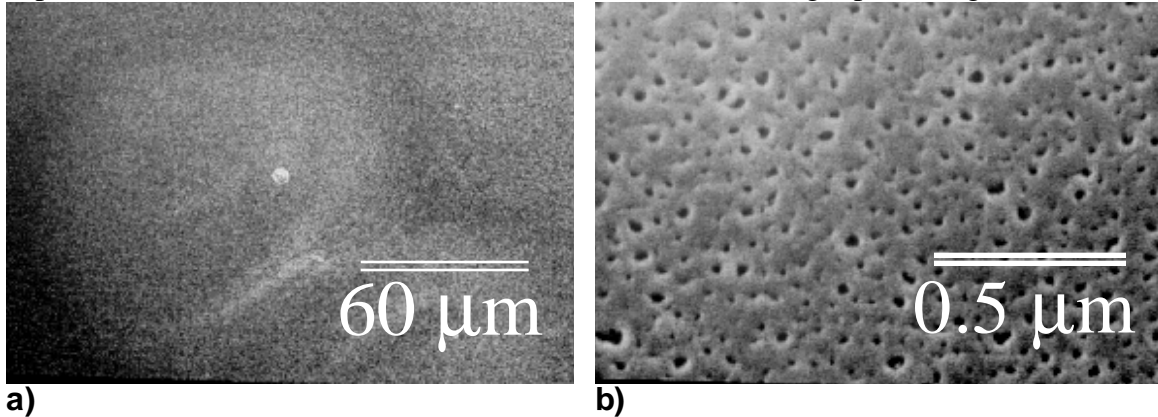
Scalds can be observed above 13 J/cm^2 . Fig. 3 shows a typical scald morphology. The scalds seem to be related to plasma formation. The surface of the coating appears to have “burnt”. It is believed that electric field enhancements (e.g. at nodular defects or dust particles) can cause material and (or) air breakdown which produces a plasma. The plasma

expands during the shot and may lead to very high temperatures on the surface. The diameter of the scald increases almost linearly with the fluence (see Fig. 5). Other experiments⁴⁶ have also shown that their size increases with longer pulse lengths.

Fig. 3: SEM micrographs of a typical scald after a single shot at 45° on mirror irradiated at 41.6 J/cm² in “P” polarization. The micrograph on the left shows the details of the structure of the scald. The scald seems to have originated at a pit which is visible in the center of a).

The surface roughness of a coating is increased in a scald as seen in Fig. 3.b). It has been shown that surface roughness affects the scatter of incident radiation.⁴⁹ The increase in surface roughness results in an increase in scatter and reduction in reflection. Scalds can be observed under dark field optical microscopy; they therefore scatter more light than the background coating. To determine the influence of scalds on HRs, low spatial resolution reflectivity measurements were made of a large optic with numerous small scalds. A high spatial resolution scan of a large scald is shown in Fig. 5. The reflectivity of the coating is 99.8% and the standard deviation of the measurement is 0.12%. In both cases there was no detectable reduction in reflectance of the optic. Scalds will therefore not reduce the reflectivity below the 99.5% specification. Although the plasma scald in Fig. 5.b) does not degrade the coating below the reflectance requirements for a high reflector, the massive damage site in the center has a significant effect on the reflectance (about 75%) of the coating. This damage site was so large and unstable that the optic was removed from the laser system to prevent further damage to the coating and laser.

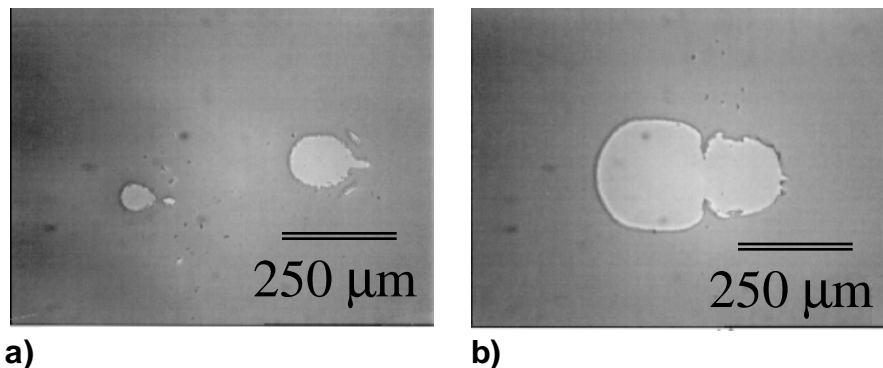
Delaminates (i.e. removal of the overlayer) are very similar in size and shape to scalds. They are also found above 13 J/cm² when plasmas are observed to ignite and their size increases with higher fluences and longer pulse lengths (see Fig. 5). Like scalds, only the overlayer is damaged. However, while the silica overlayer remains attached to the coating for scalds, it is removed for delaminates. Fig. 4 shows a typical delaminate morphology. A pit is often found within the delaminated region. The failure mechanism is likely related to large gradients of temperature and stress in the top layers. Lowdermilk et al.³⁴ and other authors¹⁵ have reported that the addition of a silica half-wave overcoat can substantially increase the damage threshold of HRs. A future article⁴⁷ will show that these findings also apply to polarizers and that the main factor contributing to such improvement is the prevention of delamination.

Fig. 4: Nomarski optical micrographs of delamination on the surface of a polarizer after a single shot at 56° in “S” polarization at a) 35.9 J/cm² and b) 38.7 J/cm², respectively.

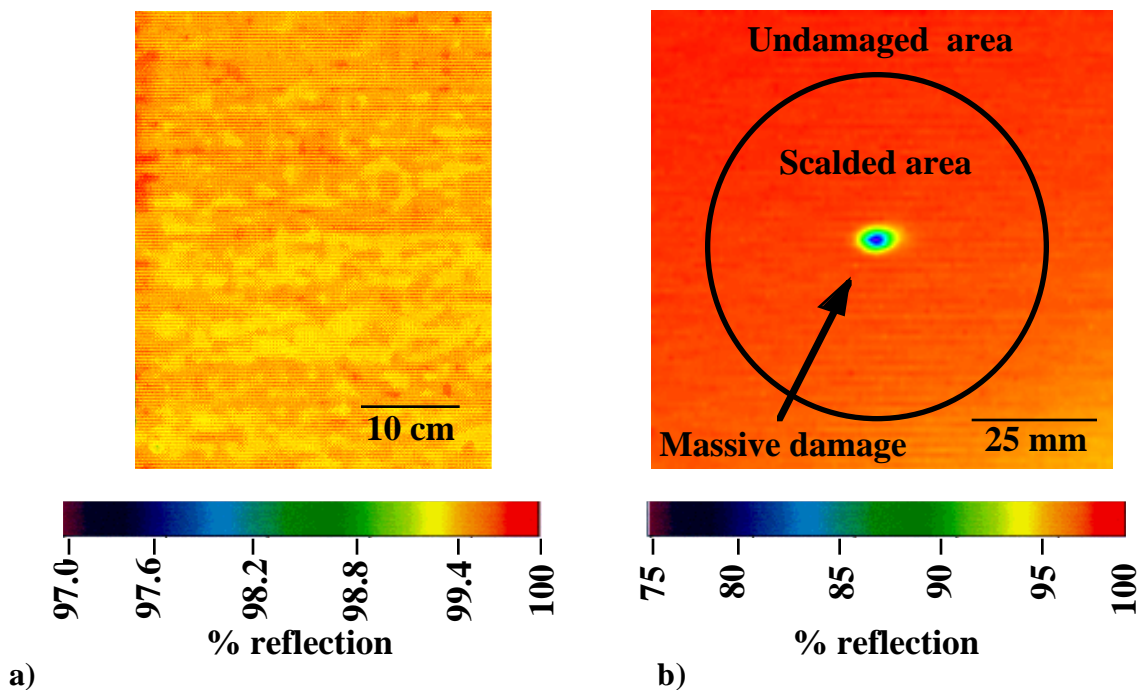
Fig. 5: Photometer scan of scalds a) low resolution reflectivity measurement of a laser conditioned mirror with numerous small scalds ($<300 \mu\text{m}$ diameter) $R_{\text{ave}} = 99.83\% \pm 0.12\%$, b) high resolution reflectivity measurement of a single large (about 5 cm diameter) scald with no observable reflectance degradation in the scalded area.

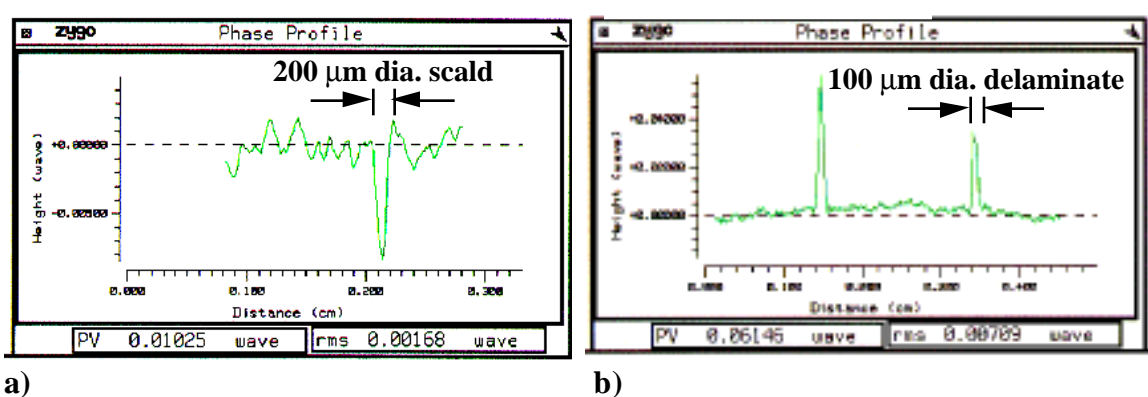
To understand changes to the coating's surface, scalds were measured using a Zygo GPI-XP phase modulating interferometer with a 33 mm beam compactor (see Fig. 7.a)). To estimate the effect of the scald damage morphology on beam propagation, a typical scald was modeled as a $200 \mu\text{m}$ diameter micro-lens with a 6 nm sag. The diffraction limited spot size from an incident collimated beam with the same diameter as the scald is calculated from the relation $2.44 \lambda (f/\#) = 1 \text{ cm}$ for $\lambda = 1053 \text{ nm}$. The diffracted beam is significantly larger than the incoming beam and acts as a weak scatter site. In order for a $200 \mu\text{m}$ plasma scald to focus light that could damage optics downstream, the sag must be larger than 270 nm ($\lambda/4$) which is 45 times greater than what was observed for SiO_2 overcoated multilayers.

Measurements by interferometry of pits and delaminates, as shown in Fig. 7.b), illustrate the difficulty of measuring a phase discontinuity or step function greater than half of the measuring wavelength. Possible methods to overcome this problem could include the use of dual or longer wavelength interferometers; they were not utilized in this study since the wavelength of interest was 1053 nm. To understand the impact of pits and delaminates on the beam, the damage sites were treated as circular obscurations as modeled by Hunt et al.⁵⁰ According to Hunt, the interaction of a wave scattered from an opaque obscuration with a background wave will produce holographic imaging, leading to increased fluences at image planes of the damaged optic. The magnitude of the intensity modulation is proportional to the size of the obscuration. Obscurations smaller than 280 μm create intensity modulations that do not exceed the NIF specification, therefore become the upper bound for the maximum tolerable damage size. As mentioned earlier, future articles^{1,2} will address the stability of damage under repetitive illumination. This will better define the maximum tolerable damage size of the NIF coated optics.

Fig. 7: Interferogram of a a) scald and b) delaminate with erroneous phase discontinuities.
