## Common Causes of Material Degradation in Buried Piping (U)

A document prepared for ASME PRESSURE VESSEL & PIPING CONFERENCE at Orlando, FL, USA from 7/27/97 - 7/31/97.

**Common Causes of Material Degradation in Buried Piping**  
by  
**Charles F. Jenkins**

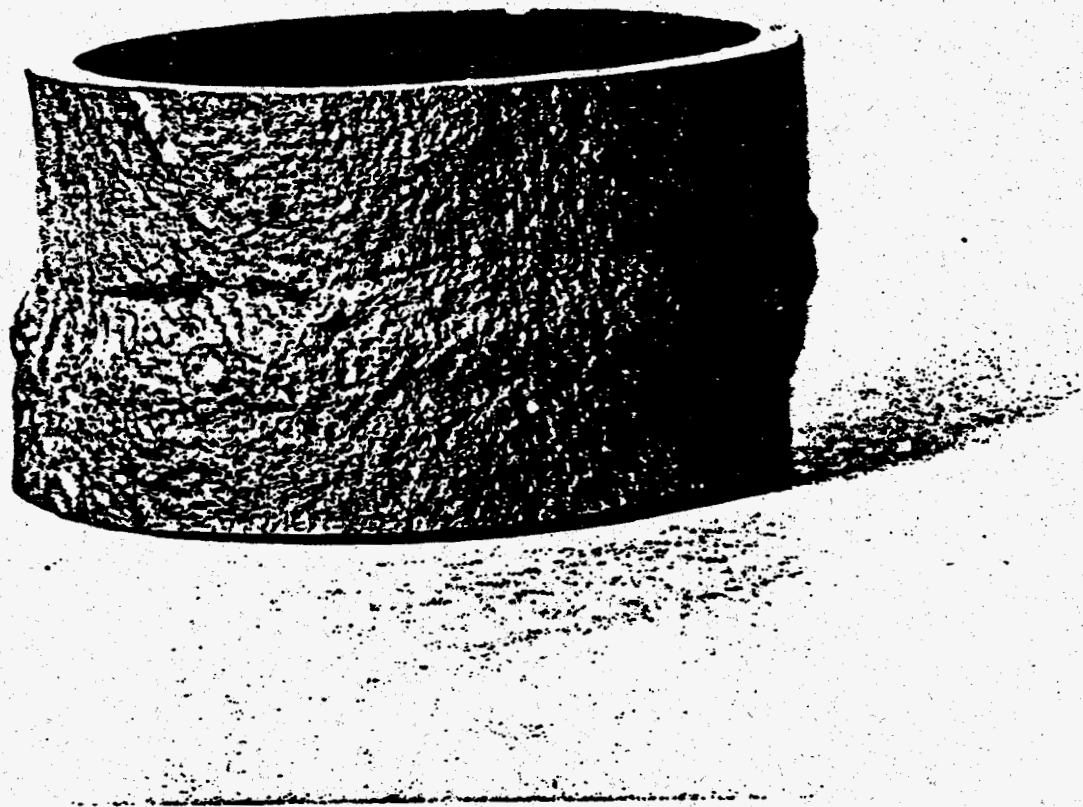
1. A 2-inch, schedule 40 pipeline, 150 psi steam, buried in a powdered insulation, failed at an elbow. The hole occurred at a weld joint due to erosion from the inside. Significant misalignment and a step in the weld joining the elbow and pipe (Fig. 2) led to the erosion. The outside surface exhibited considerable corrosion, possibly due to entrapment of the escaped steam in the insulation envelope. The line was buried for about 2 1/2 years, but was in steam service only 14 months, indicating that corrosive attack had been very rapid.

Figure 2. Misalignment of pipe and elbow segments in a failed steam line. Wet steam erosion occurred at the resulting step on the inside. Exterior was blast cleaned to reveal corroded surface.

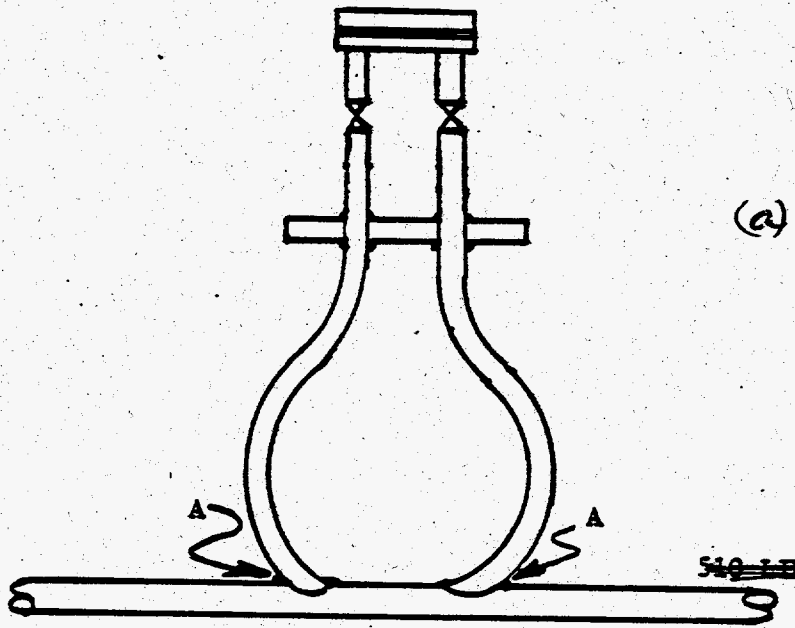
4. A 1-inch, sch. 10 stainless steel pipe contained within a 2-inch carbon steel pipe developed a leak. Monitoring of the annular space detected the leak. Investigation revealed chloride stress corrosion cracking (CSCC) in a cold formed, long radius elbow section of the pipe (Figs. 4, 5), and for 3 to 4 feet along the horizontal extension from the long elbow. Although the hydrotest water was drained, the pipe was not put into service for several years and some water remained trapped in small pockets in the section. Moreover, for 6 months during the lay up period, a steam leak from a nearby underground pipe elevated the temperature in the vicinity, thus enhancing the corrosion process. The carbon steel jacket pipe was contained in a powdered thermal insulation backfill. It showed some corrosion but was generally acceptable for continued use.

Figure 4. (a) Cleanout port detail, illustrating crack (CSCC) locations in stainless steel catheter pipes.  
(b) Outside surface of failed catheter, showing CSCC leak site.

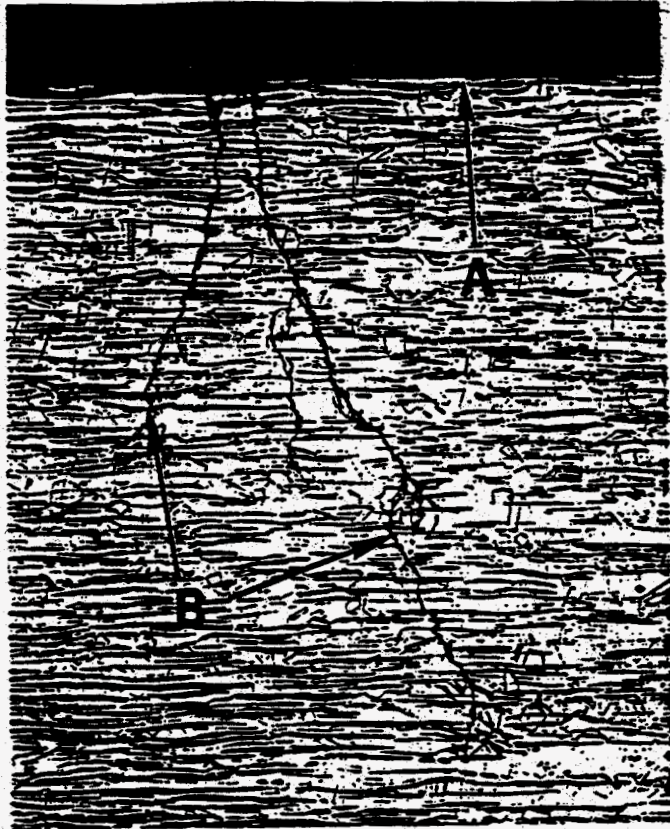
Figure 5. CSCC in second catheter, illustrating origin at inside surface.  
Magnification: 50X.

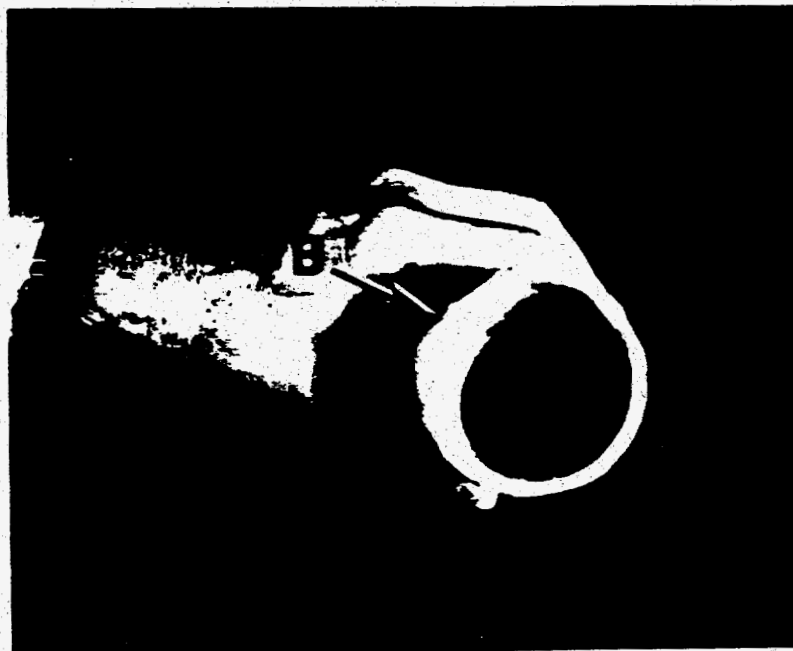
Figure 8. Cross sectional view of pipe in Figure 7 shows pit depth is approximately equal to full wall thickness.

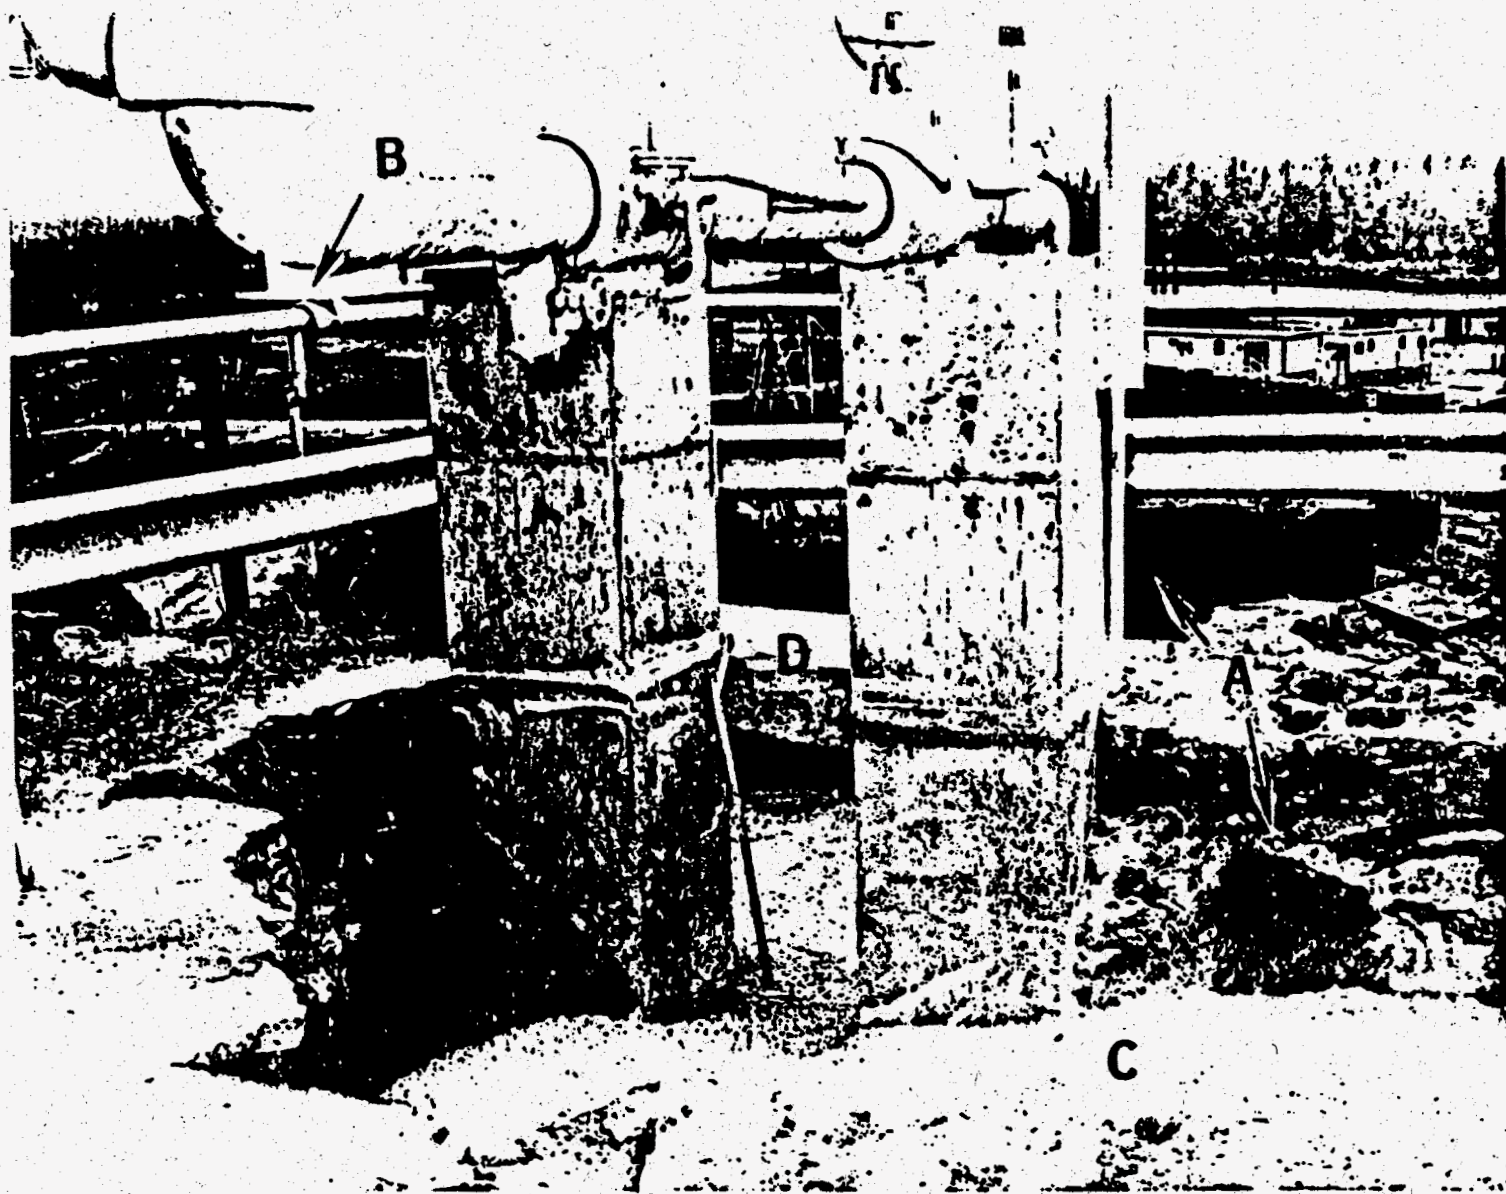
11. A 3-inch cast iron pipe broke and water washed out a hillside (Fig. 9). A crack occurred in the pipe as a result of heavy traffic on grade and variable soil support. A concrete slab beneath the pipe probably contributed to the break. Pits on the outside surface along the crack (Fig. 10) are associated with seepage at the crack before it encircled the pipe and opened up.

Figure 9. Steam equipment at edge of hill. Large washout (A) occurred due to broken underground water pipe 300 ft. away. The pillar supporting the steam pipe at B fell into the hole and is buried in the aggregate C. Slab D bridges a gap created by the washout. Several buried pipes on the hillside were exposed.

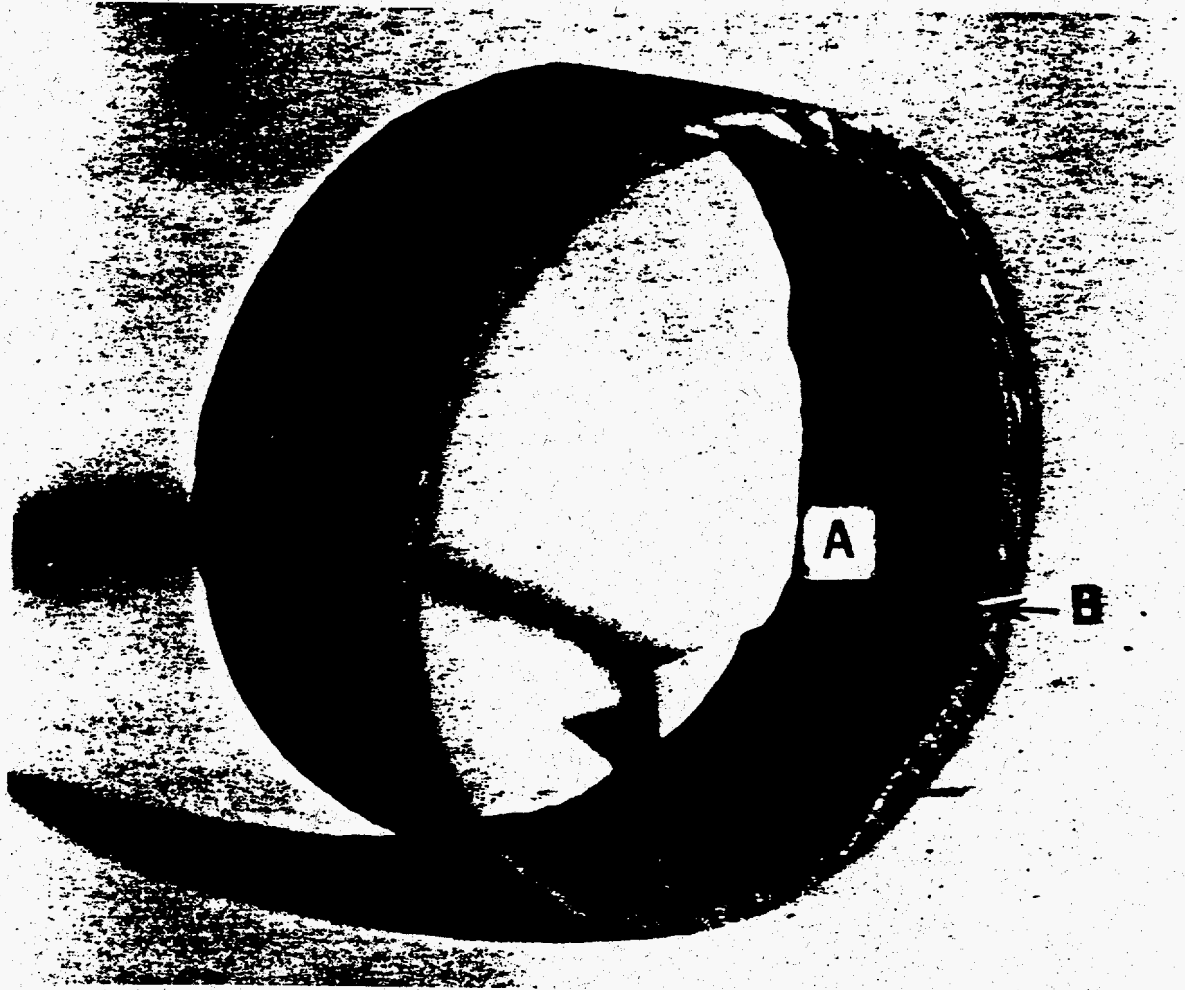
20. A 2-inch, sch. 40 steel pipe teed to a 6-inch cooling water supply failed by erosion/corrosion. Leaks occurred at the impact location on the downstream surface at the turn. Severe wall thinning occurred (Fig. 14).

Figure 14. Severe erosion (A) and erosion-corrosion in a 2 in. water pipe at its connection to a 6 in. header. Metal loss due to water impact at the junction. Location B shows full wall thickness.

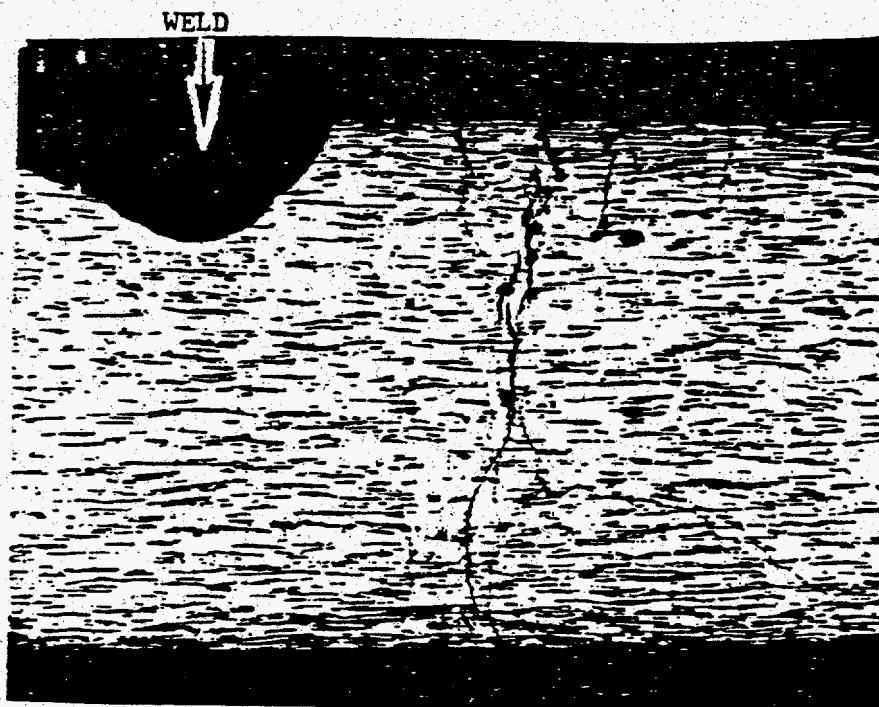
21. An insulated stainless steel pipe failed by CSCC from the exterior (Figs. 15, 16). Although this case did not involve buried pipe, it is included because the problem relates to use of insulation containing leachable chloride ion, and the application could just as well have been underground. Moreover, the same phenomenon has been observed with carbon steel pipe. Water penetrates the insulation, extracts chlorides from the material, and exposes the pipe surfaces to the wet chloride environment. Chloride cracking of the stainless resulted.

Figure 16. Chloride stress corrosion cracking in stainless steel pipe initiated under an ID tag on the external surface. Source of the chloride was external thermal insulation. Magnification: 20X.
