**FAILURE ANALYSIS OF MARK IA
LITHIUM/IRON SULFIDE BATTERY**

**V. M. Kolba, J. E. Battles,
J. D. Geller, and K. Gentry**

ARGONNE NATIONAL LABORATORY, ARGONNE, ILLINOIS
Prepared for the U. S. DEPARTMENT OF ENERGY
under Contract W-31-109-Eng-38

October 1980

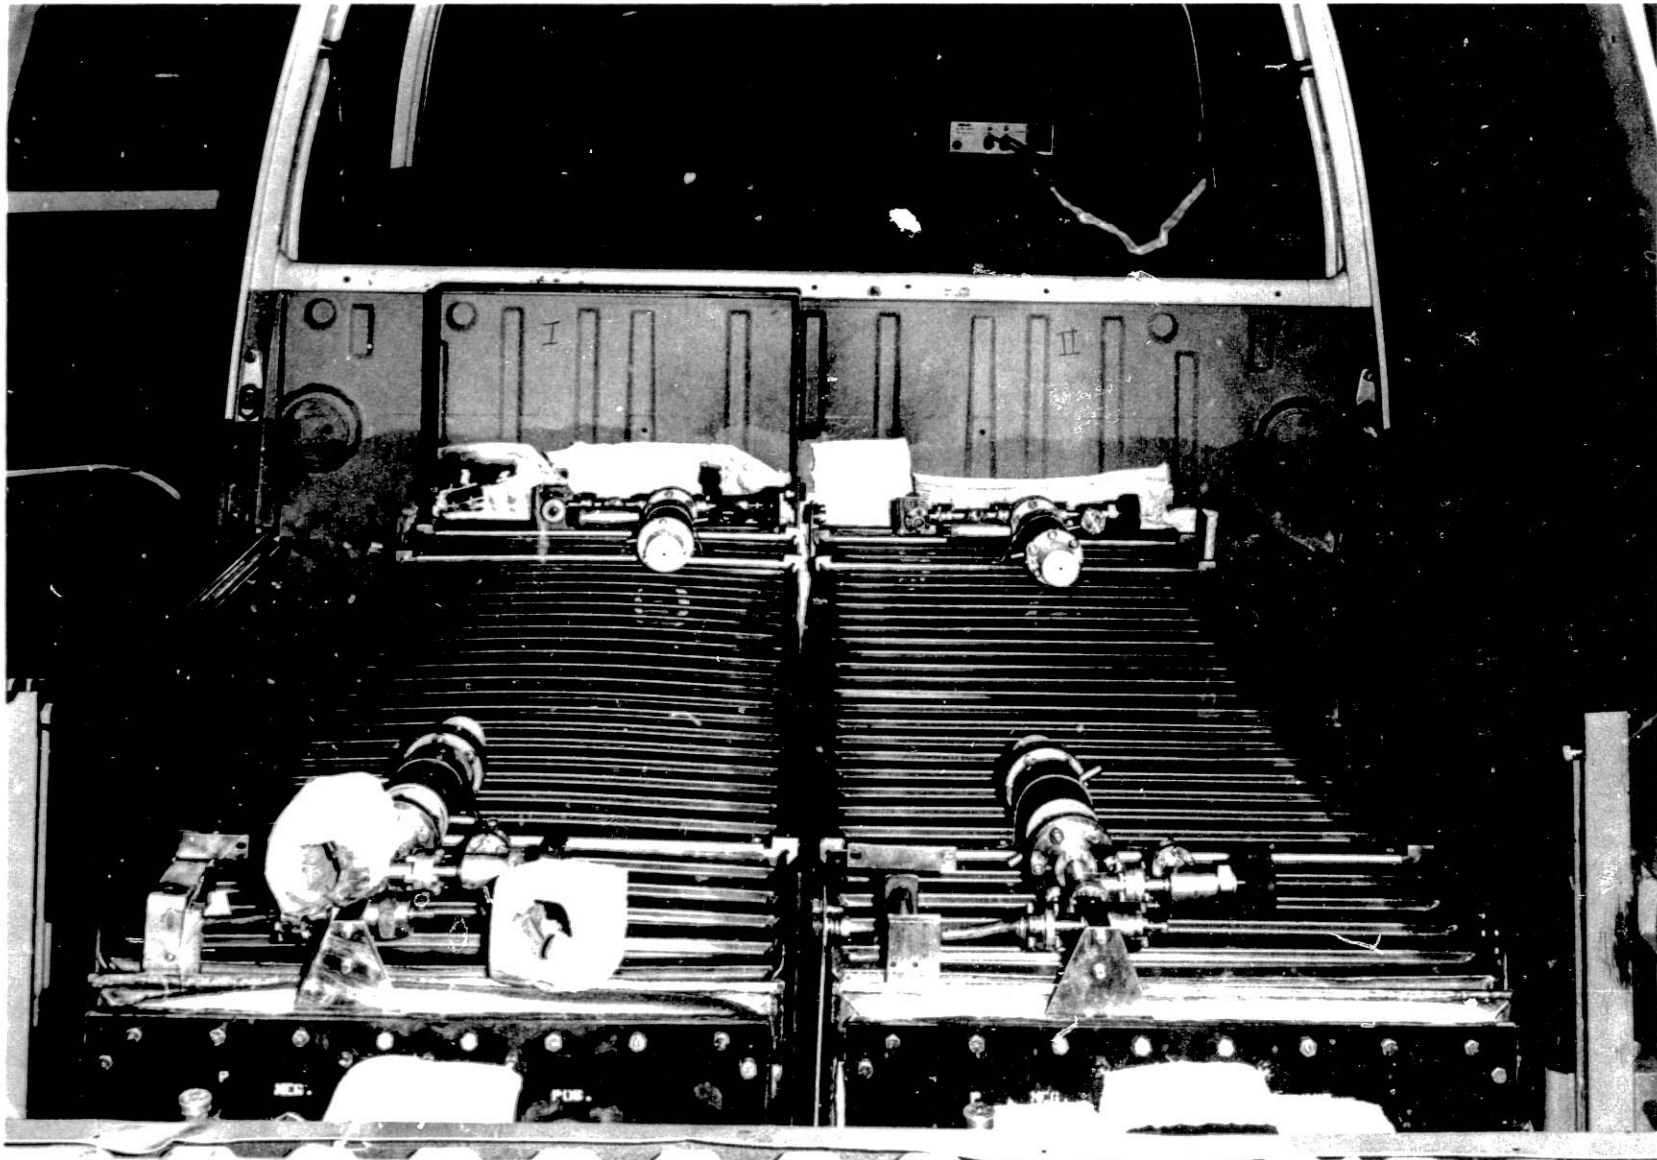
Fig. Jif-10. Modules in Van after Event

Figure 11-10 is a view of the modules after the short circuit. In this figure, the insulation caps for the power leads, which are above Module D-001 (left side of photograph), show some charring of the low-temperature tape used

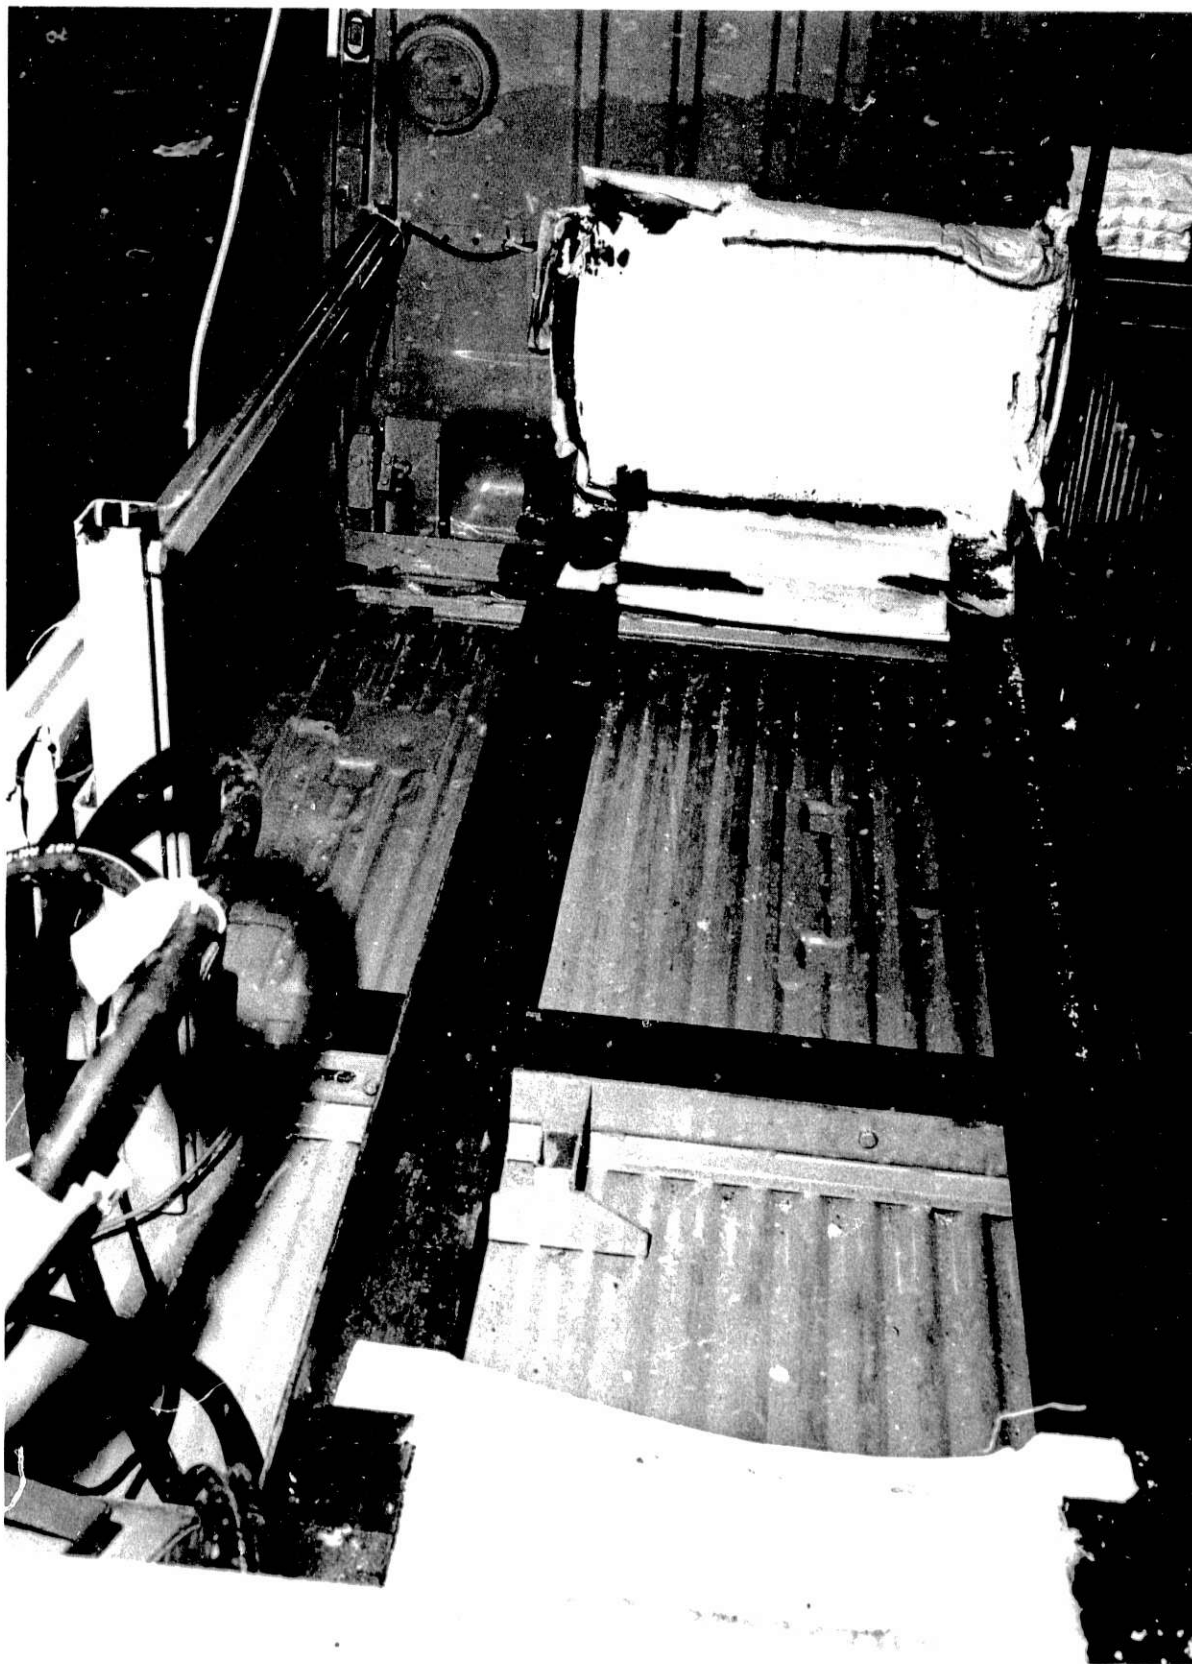
Fig. III-11. Van Floor after Removal of Module D-001

to hold the insulation material in place and to seal the edges of the insulation pads. A view of the cavity in the van after removal of Module D-001 is shown in Fig. III-11. Charring of the tape is noted, but there is no other effect evident from the failure. Module D-001, after removal from the van, is shown in Fig. III-12. There was no discoloration of the Module D-001 case, nor any other visible change in its appearance other than a bowing, which indicated a loss of vacuum in the annulus. (The top and bottom of the outer case were designed to be bowed as fabricated and to be flat when the annulus was evacuated.) Resistance measurements showed that both terminals of the module were in electrical contact with the case. Module D-002 appeared to have been totally unaffected by the failure.

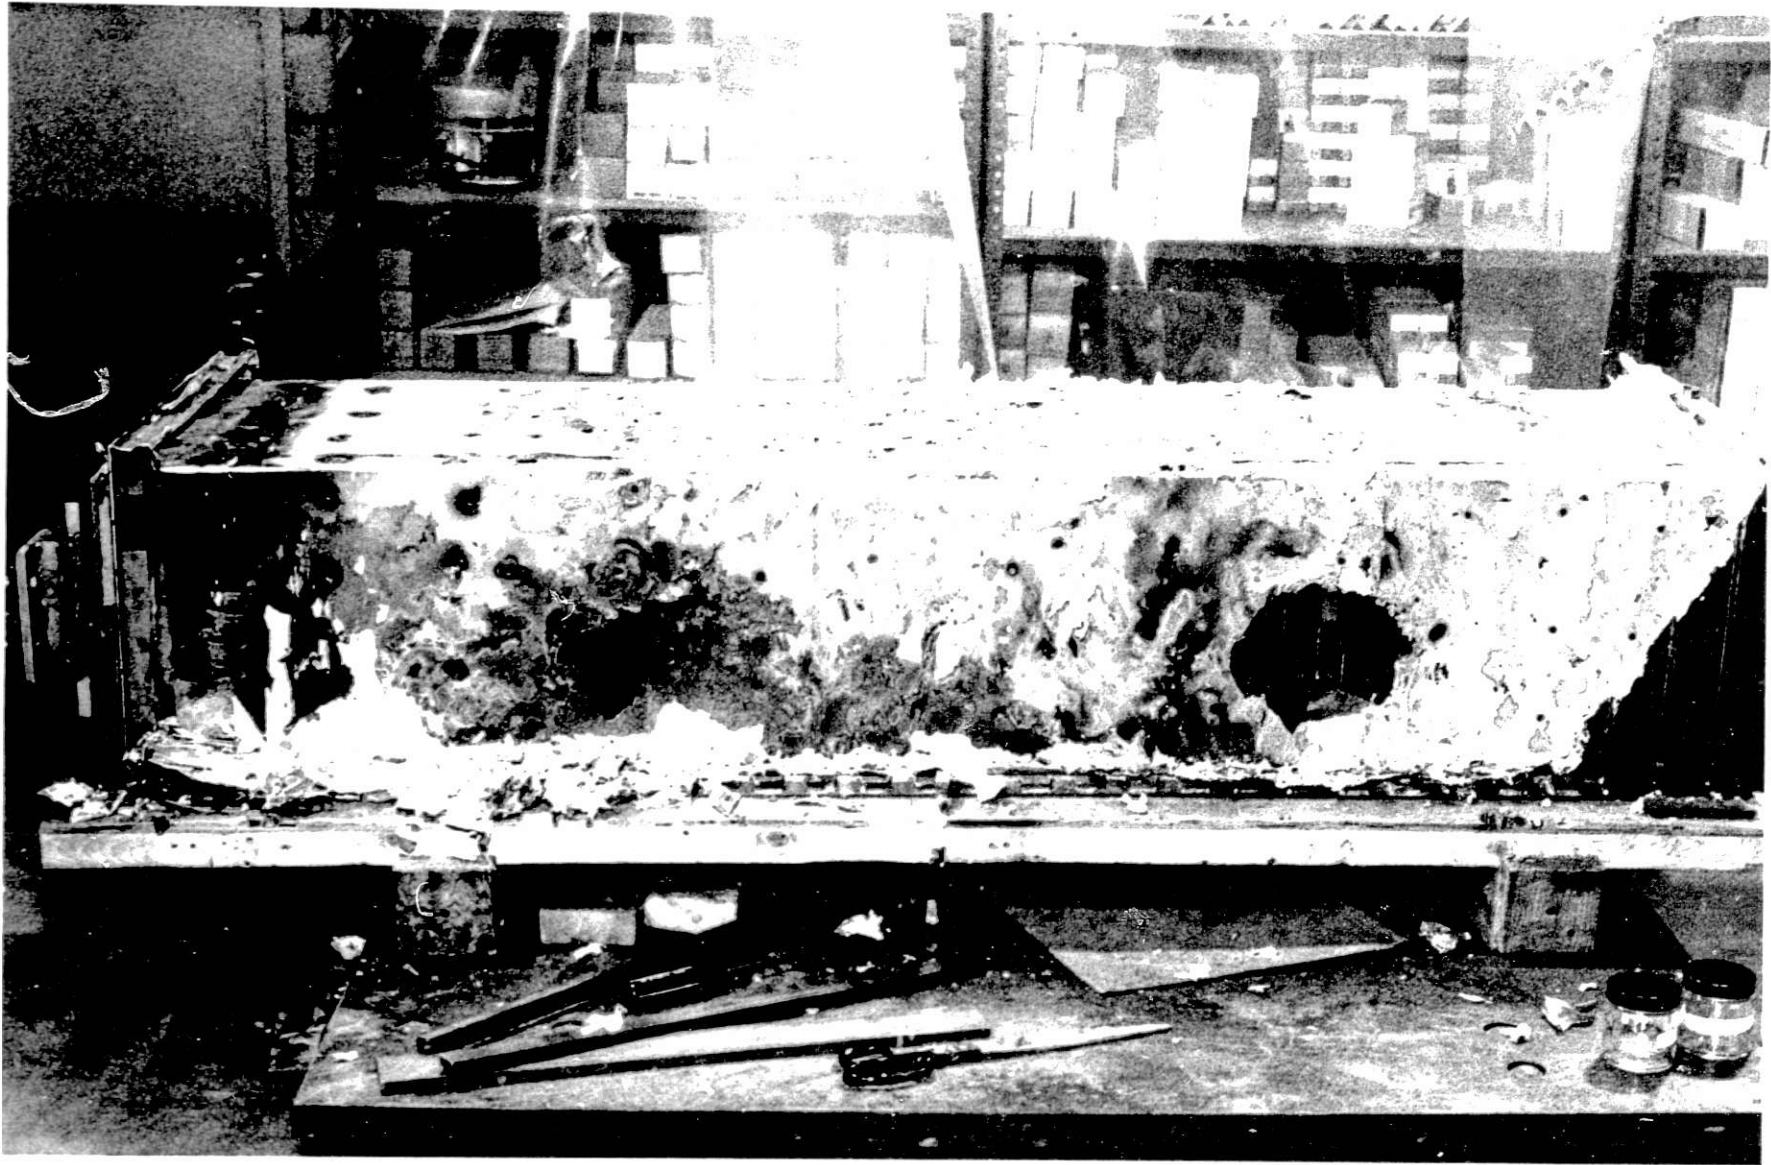
Fig. IV-2. Reaction Areas of Aluminum and Stainless Steel Foil in D-001

expose the inner stainless steel foil; local reaction areas of the stainless steel and aluminum foil are shown in Fig. IV-2. The large reaction area on the right is in the region of Cell 40. The inner corrugated case was cut off next, and finally the Inconel liner was cut off. After removal of the liner, the insulation sheet which had been placed on top of the cells was exposed; this is shown in Fig. IV-3.

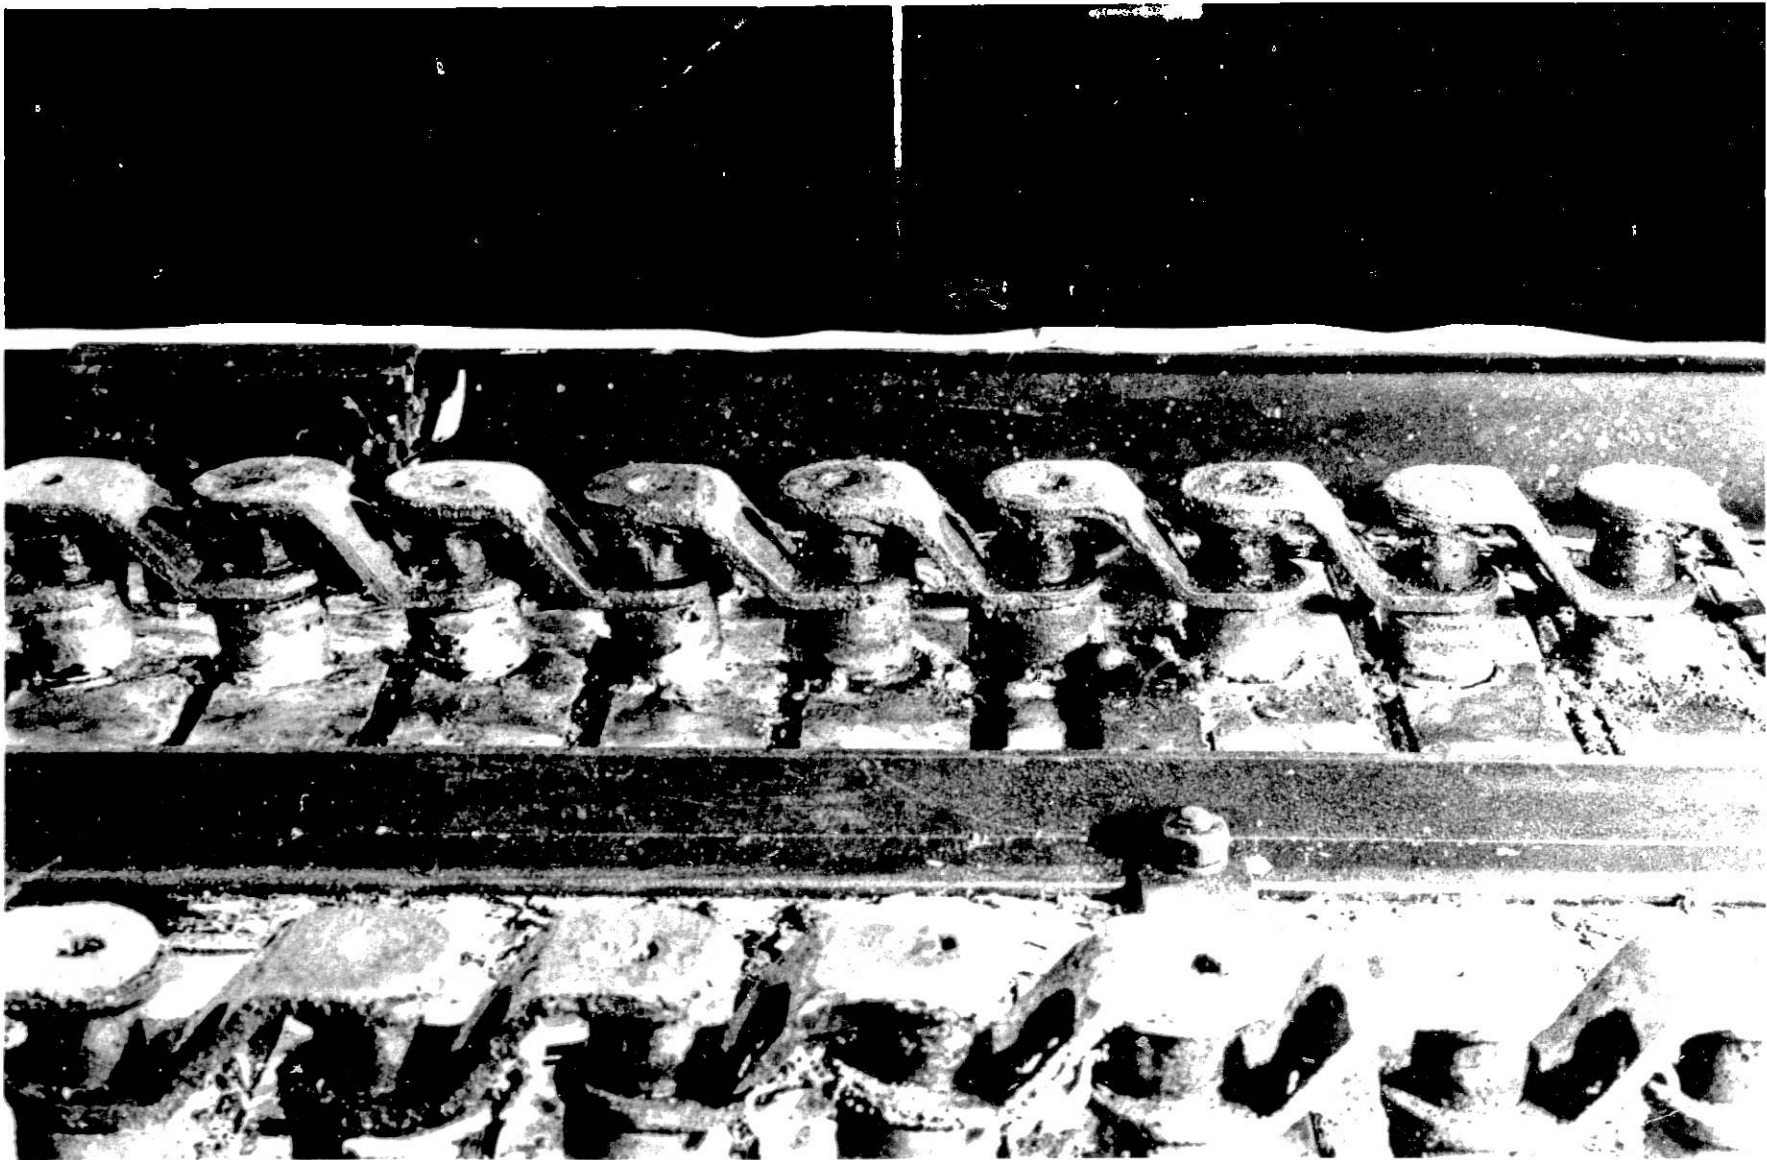
Fig. IV-6. View of Effects of Cell Movement with
Respect to Cross-over Straps

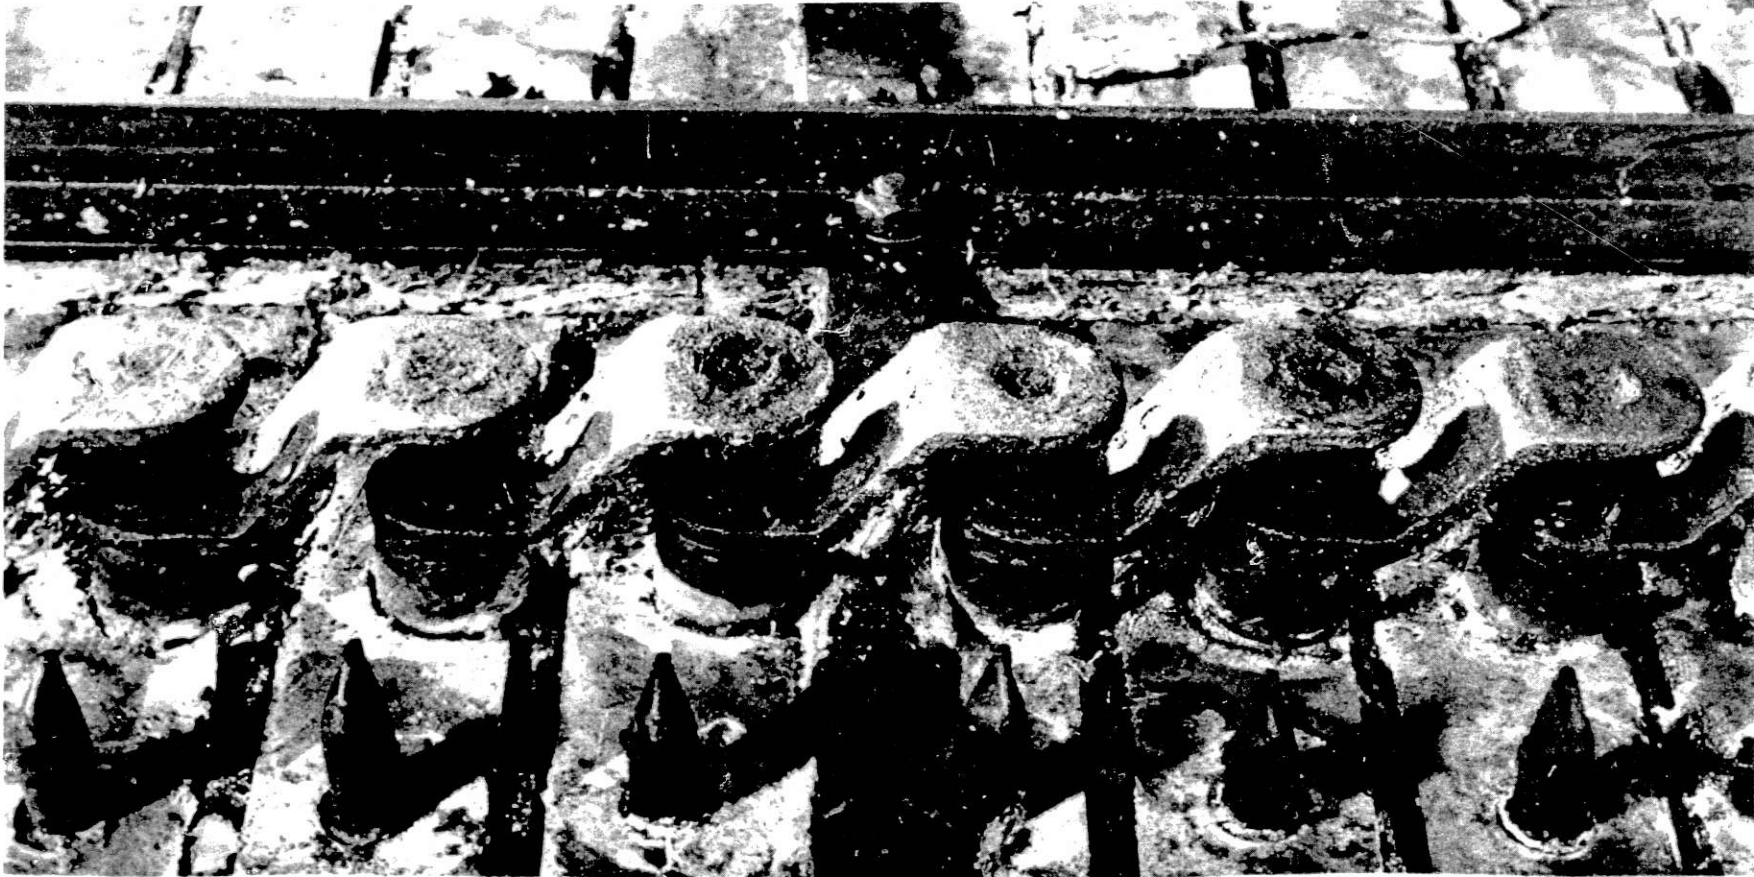
Fig. IV-8. Contact of Cross-over Straps with Fill Tube of Cell 20

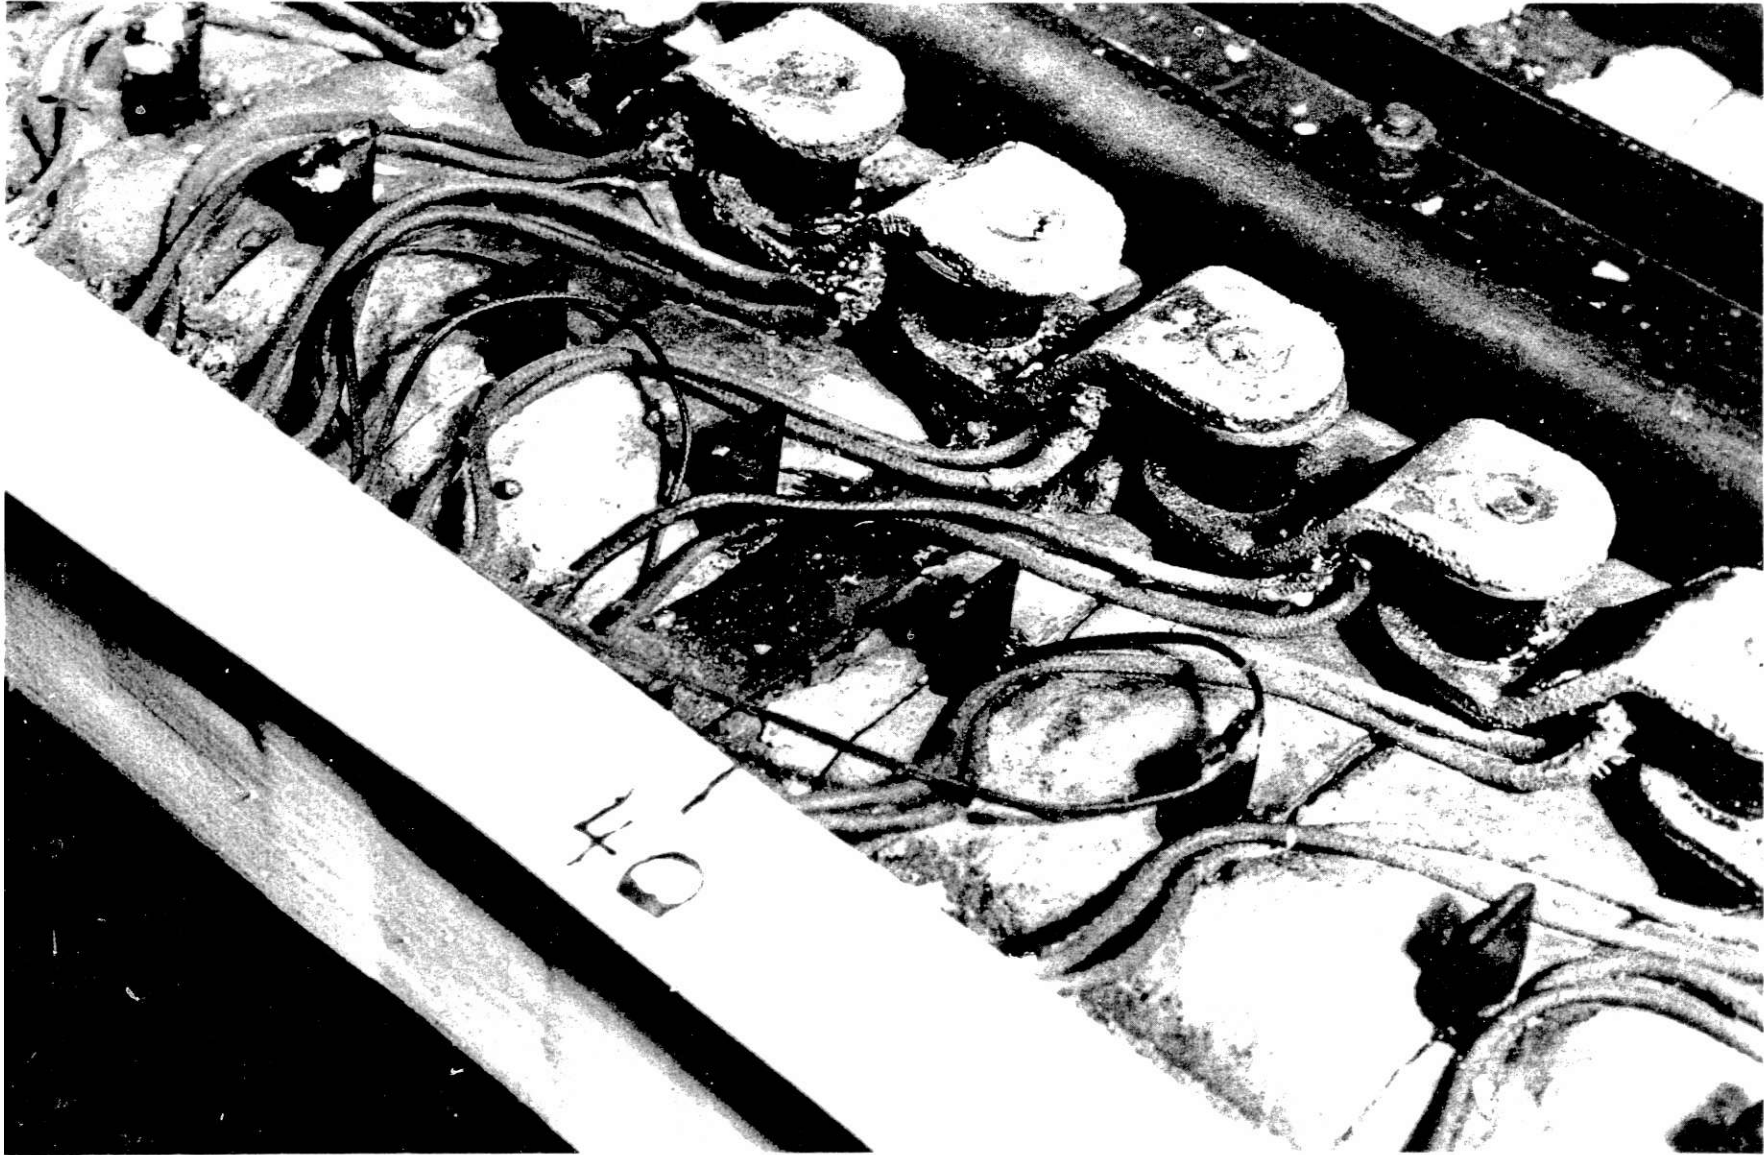
Fig. IV-10. Contact of Cross-over Strap and Feedthrough Housing of Cell 41

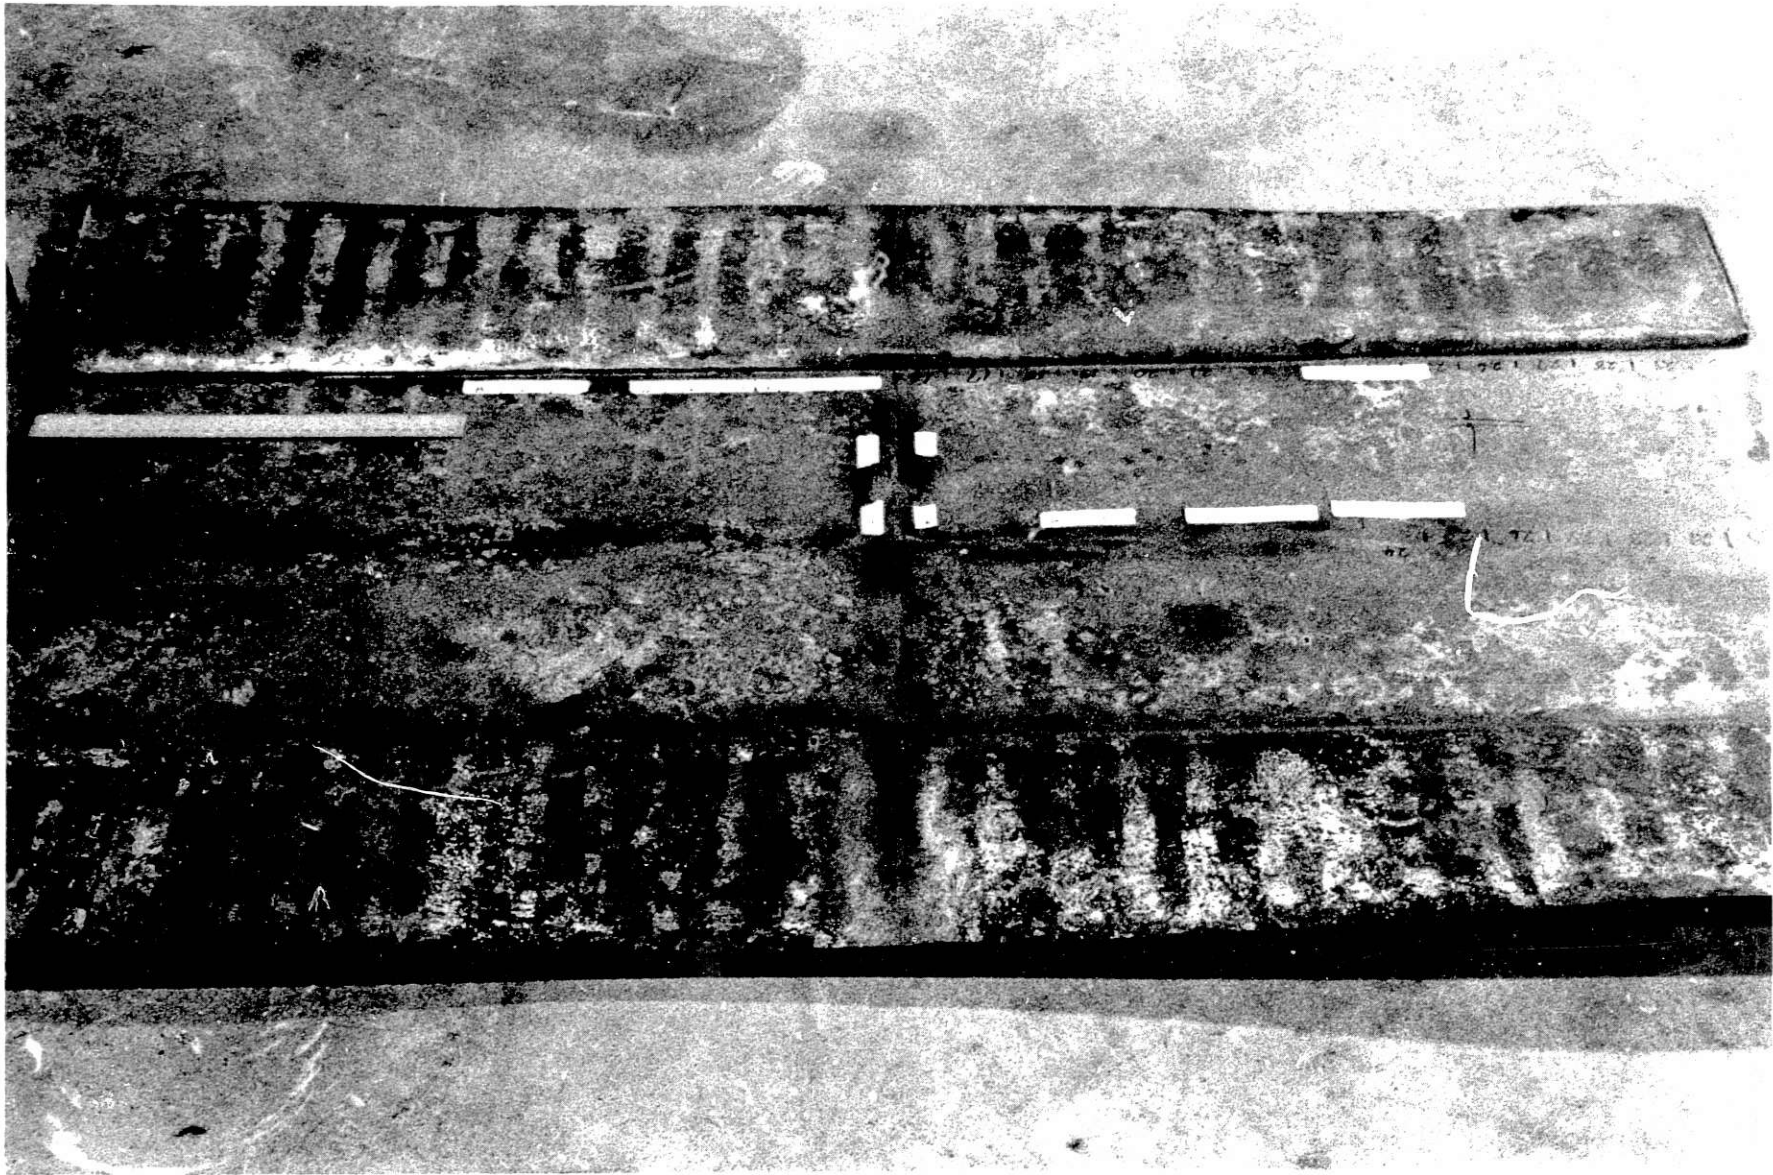
Fig. IV-11. View of Tray Bottom Showing Reaction Areas

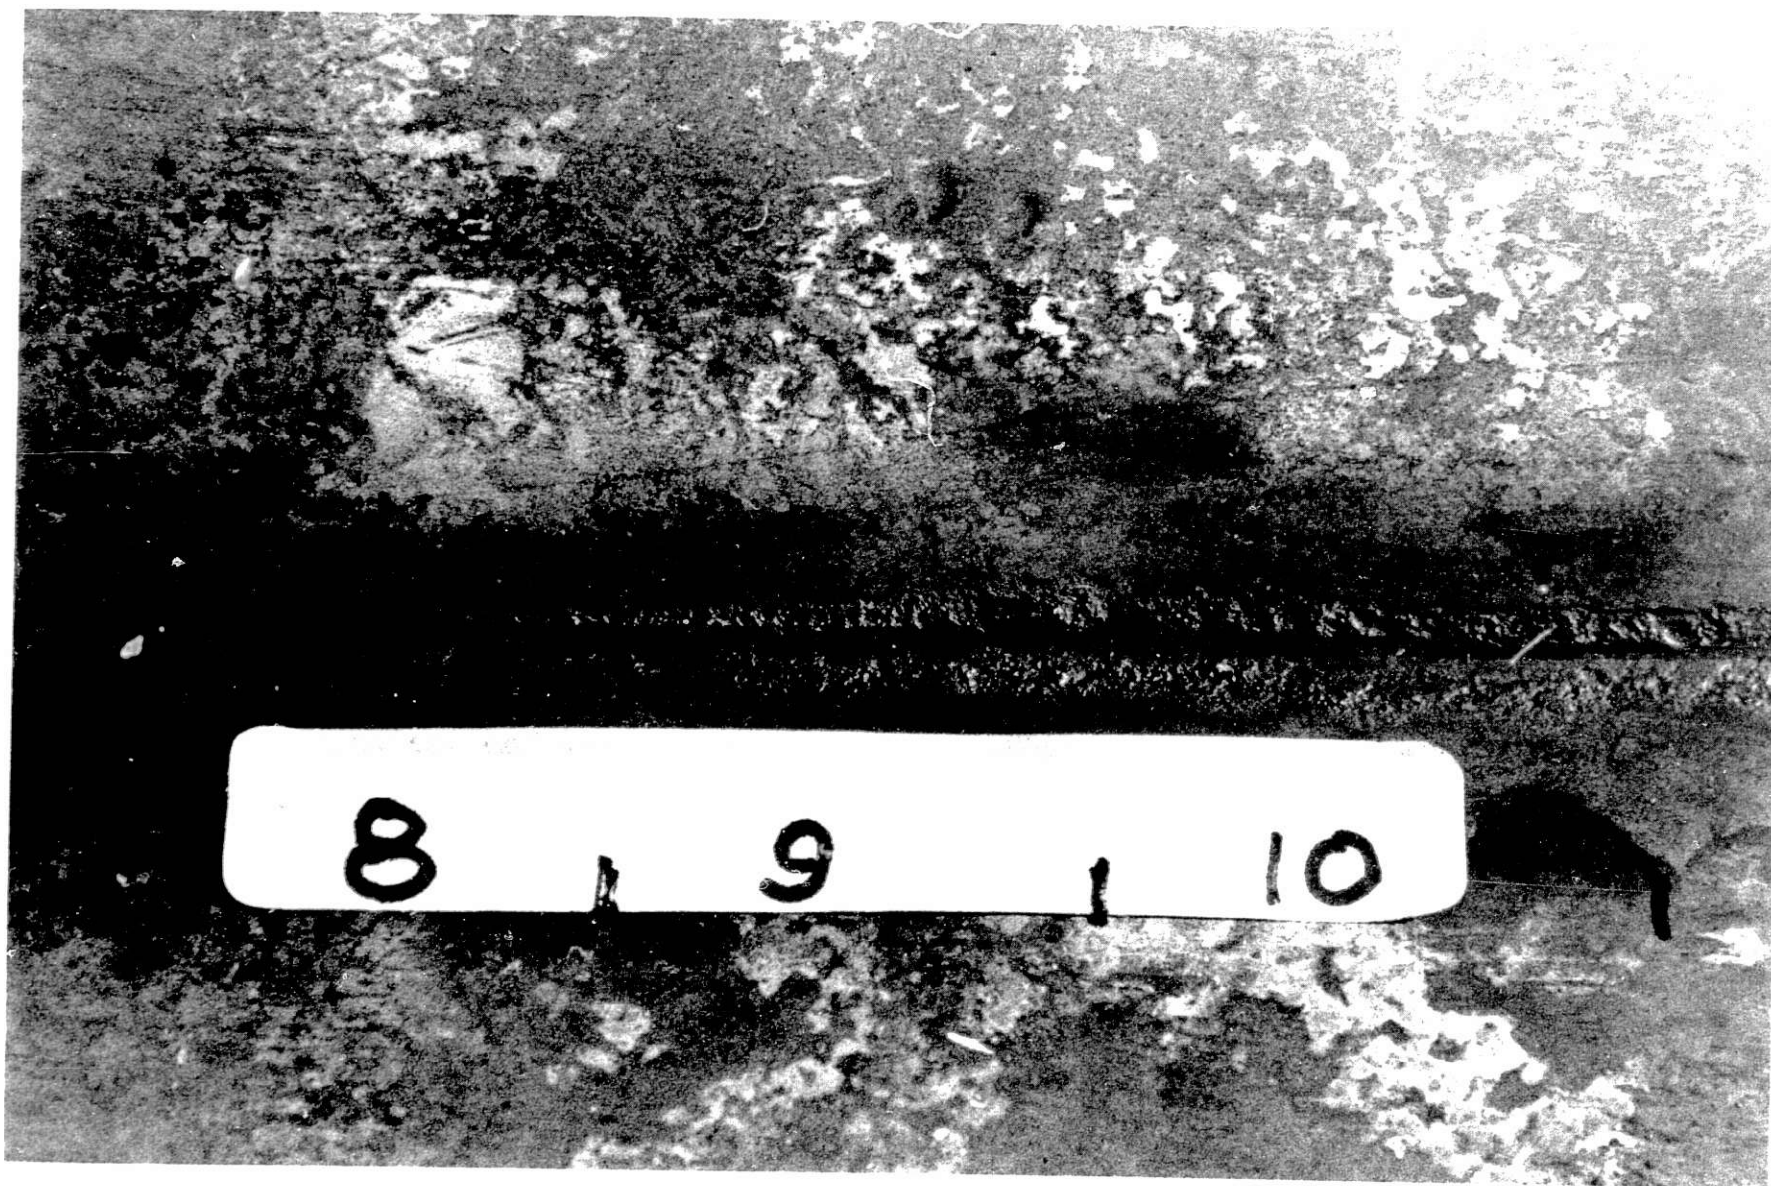
Fig. IV-12. Reaction at Edge of Tray Bottom in Regions of Cell 8 to 10

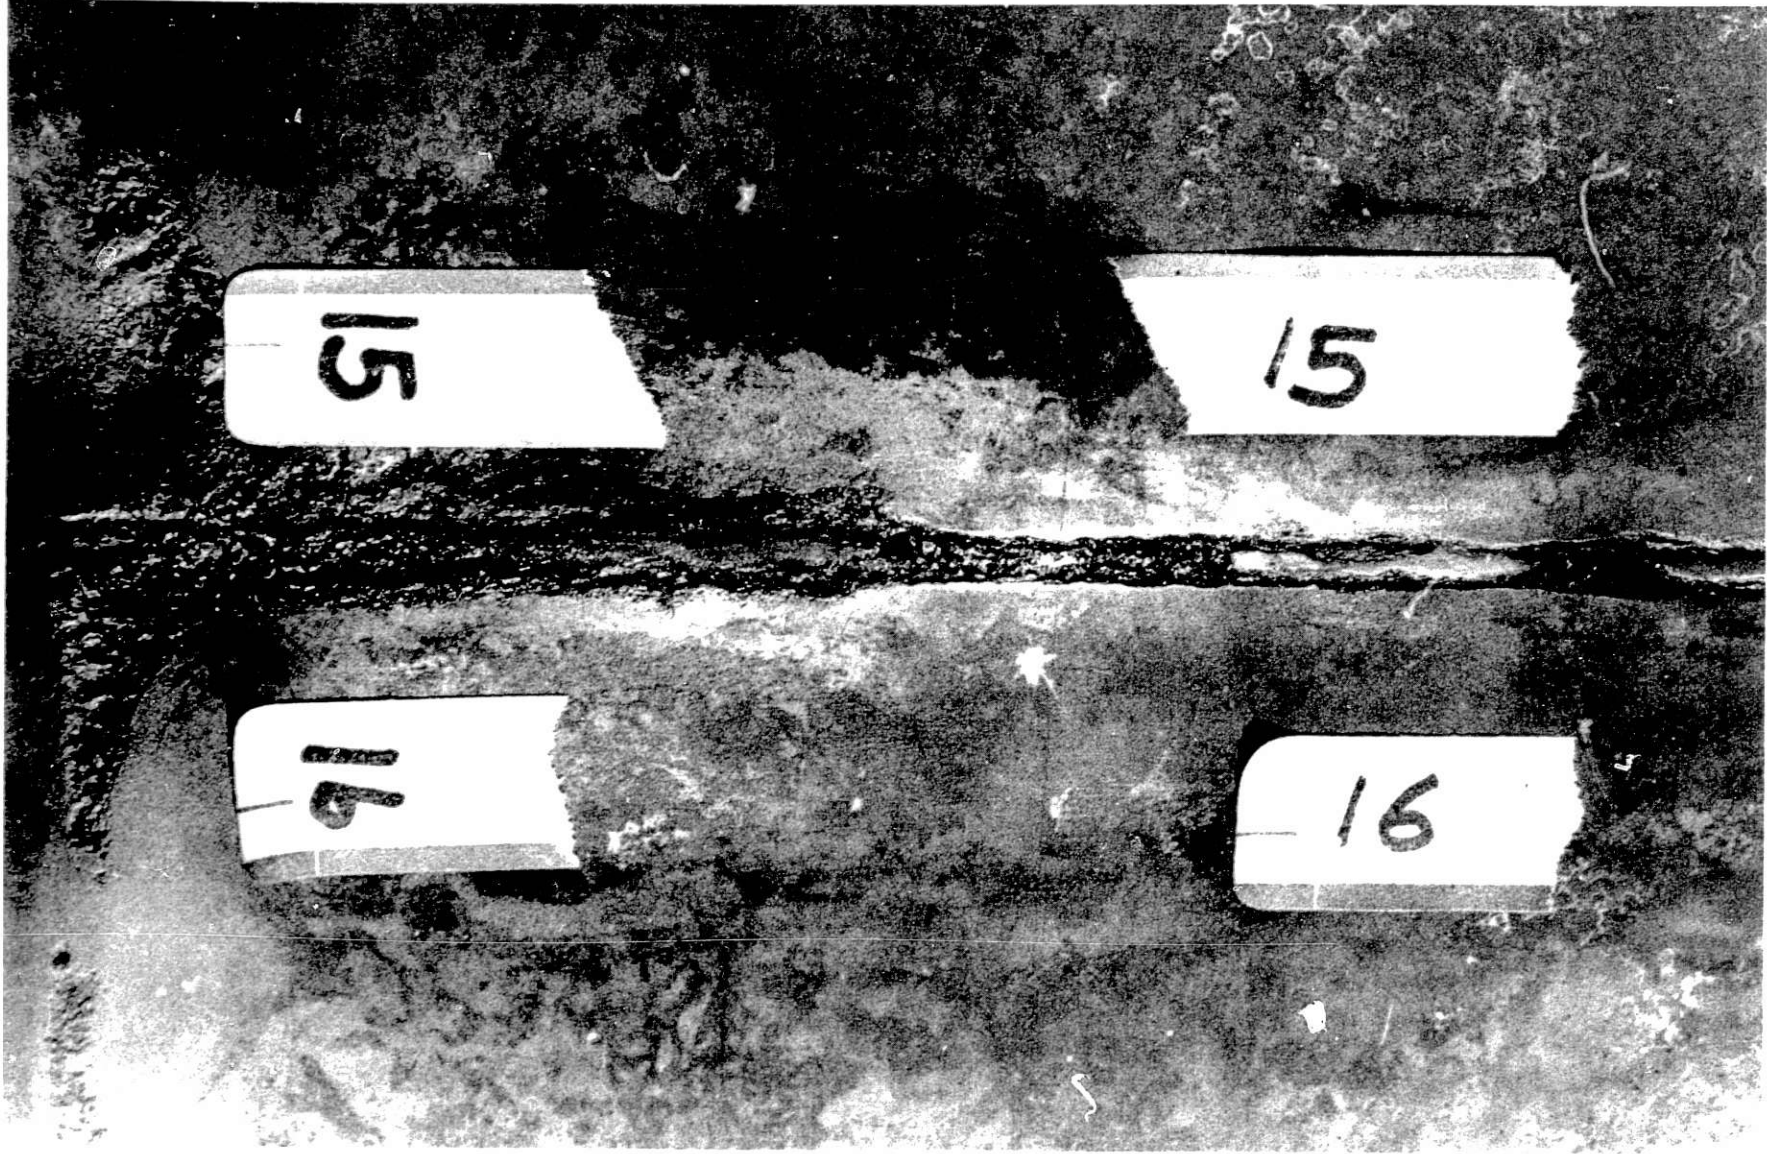
Fig. IV-13. Reaction of Tray Bottom Between Cells 15 and 16

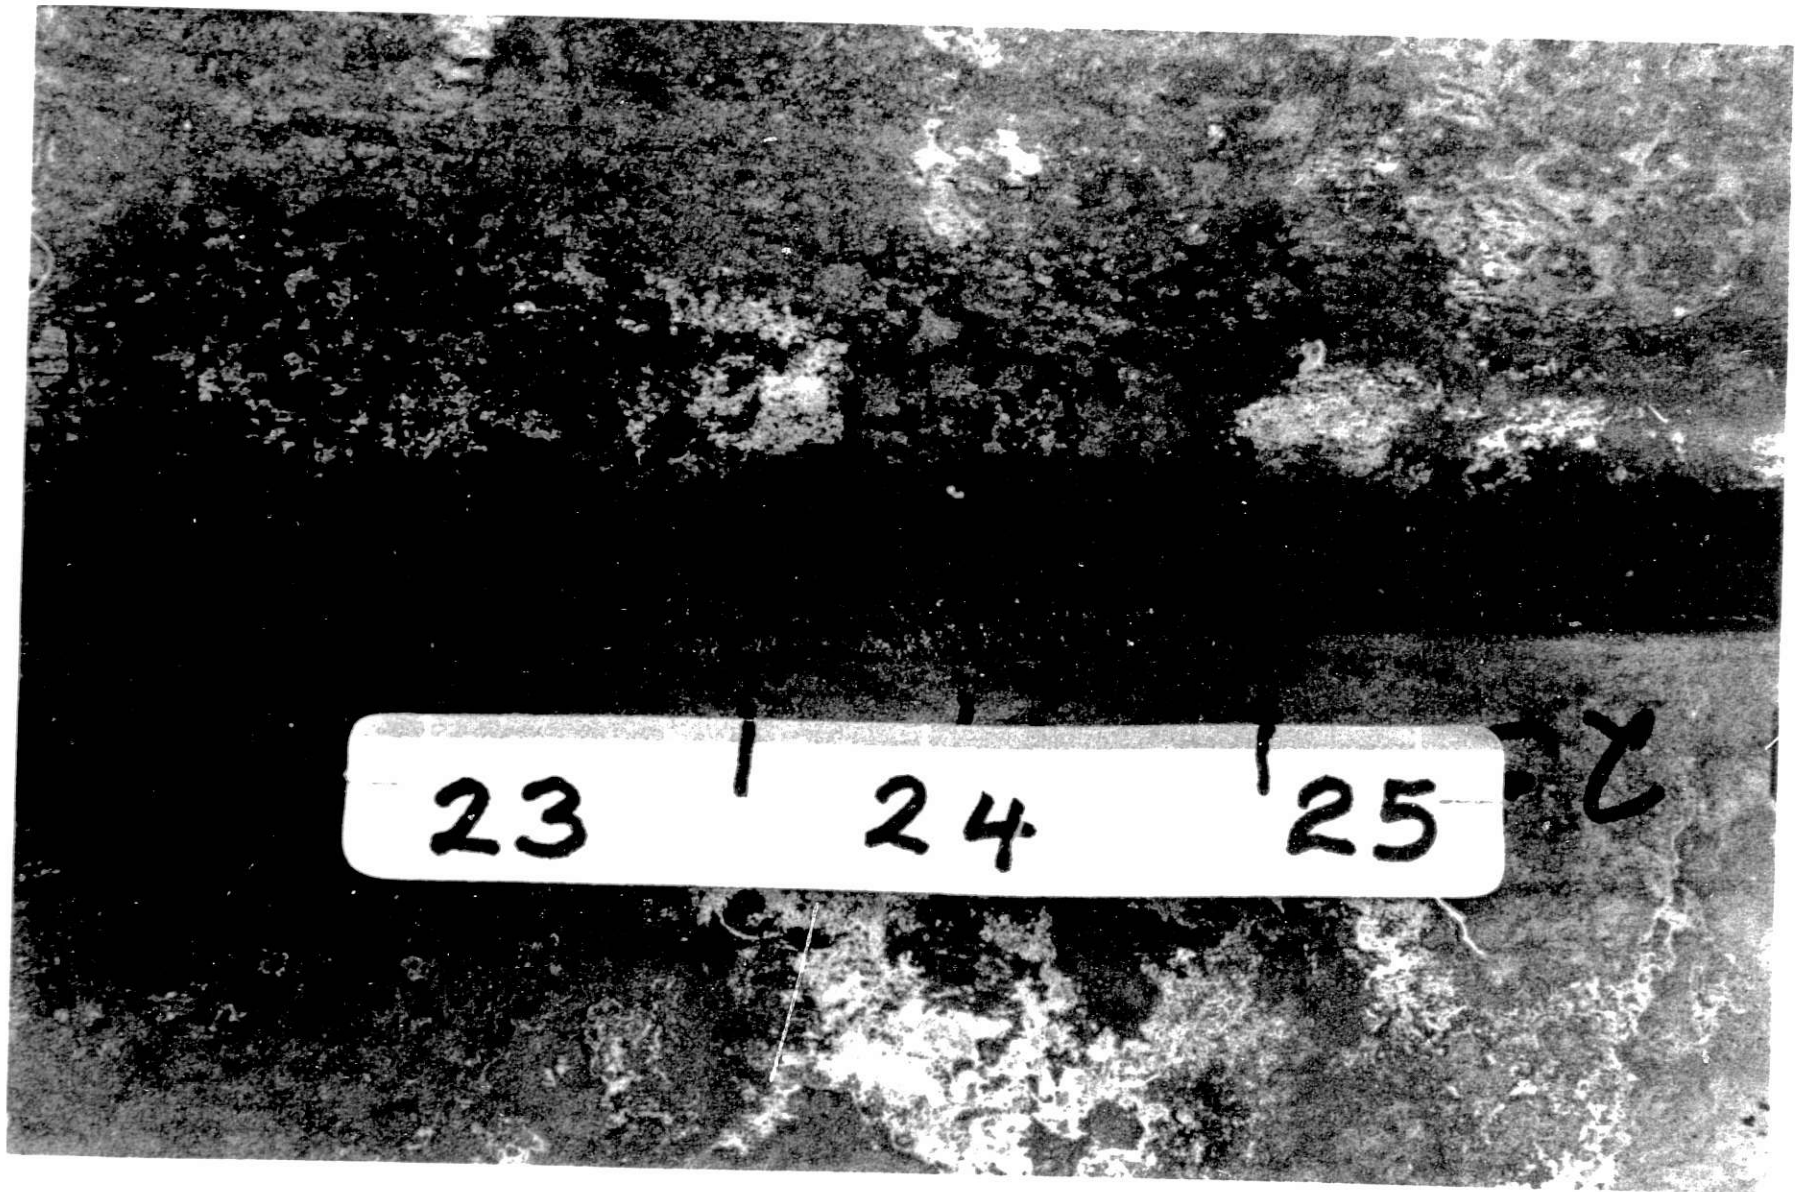
Fig. IV-14. Reaction at Edge of Cell Tray Bottom in Regions of Cells 23 to 25

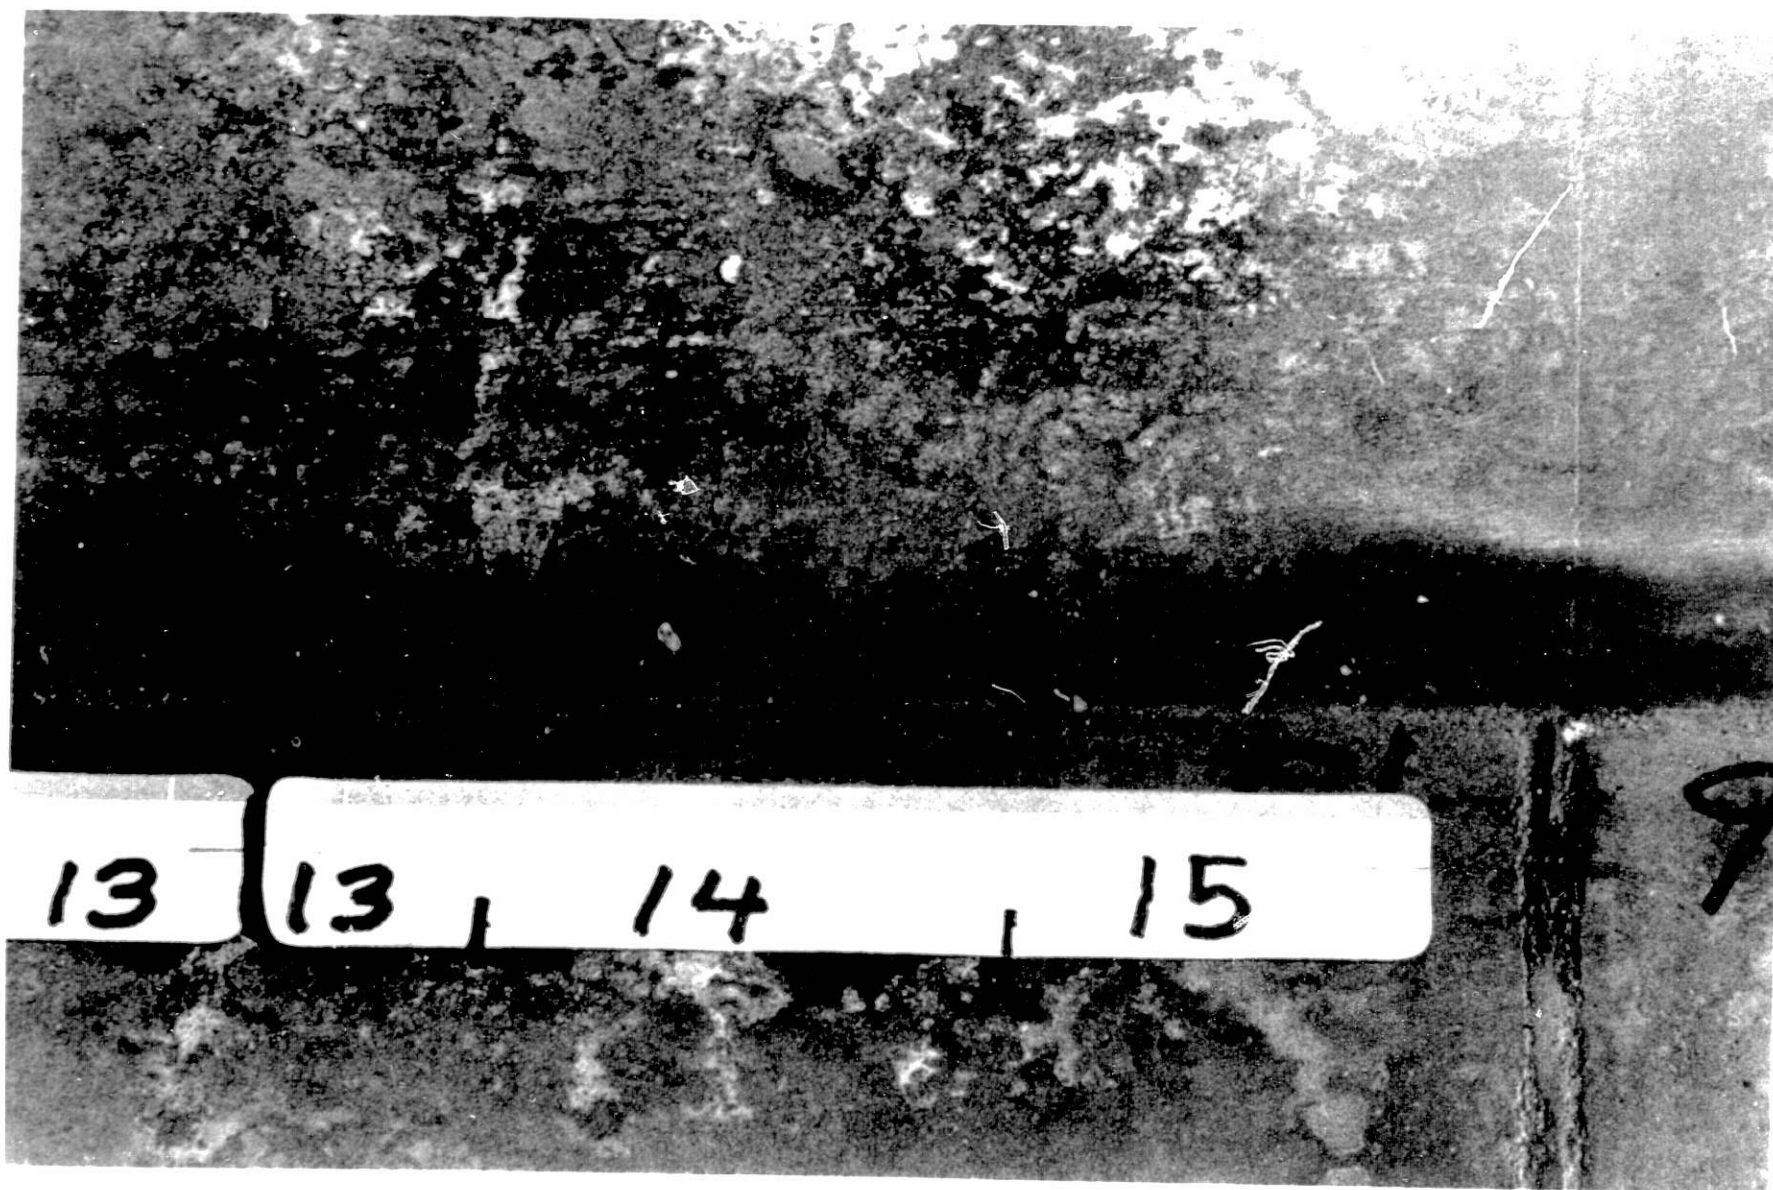
Fig. 13-16. Reaction at Edge of Tray Bottom in Region of Cells 13 to 15
