**FAILURE ANALYSIS OF MARK IA
LITHIUM/IRON SULFIDE BATTERY**

**V. M. Kolba, J. E. Battles,
J. D. Geller, and K. Gentry**

ARGONNE NATIONAL LABORATORY, ARGONNE, ILLINOIS
Prepared for the U. S. DEPARTMENT OF ENERGY
under Contract W-31-109-Eng-38

October 1980

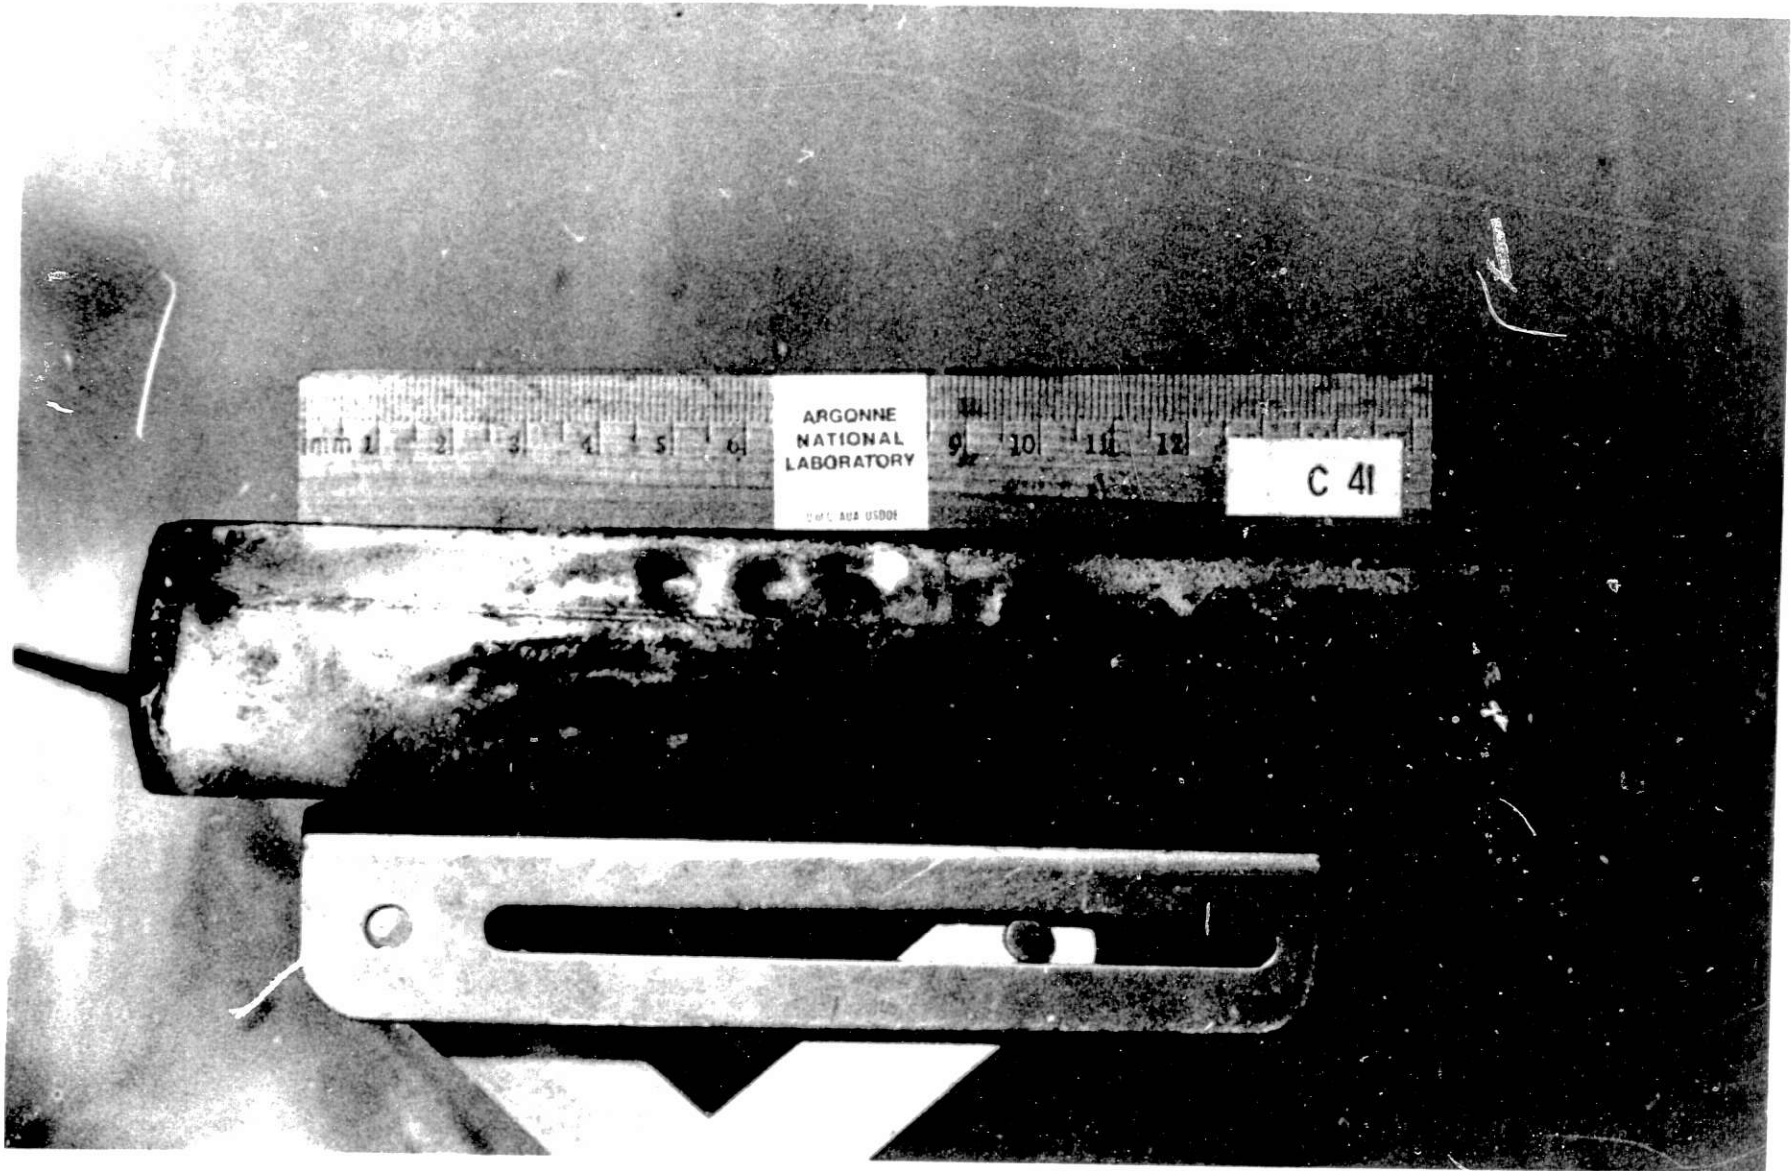
Fig. IV-19. Typical Reaction at Bottom Edge of Cell (Adjacent to Tray Center Line)

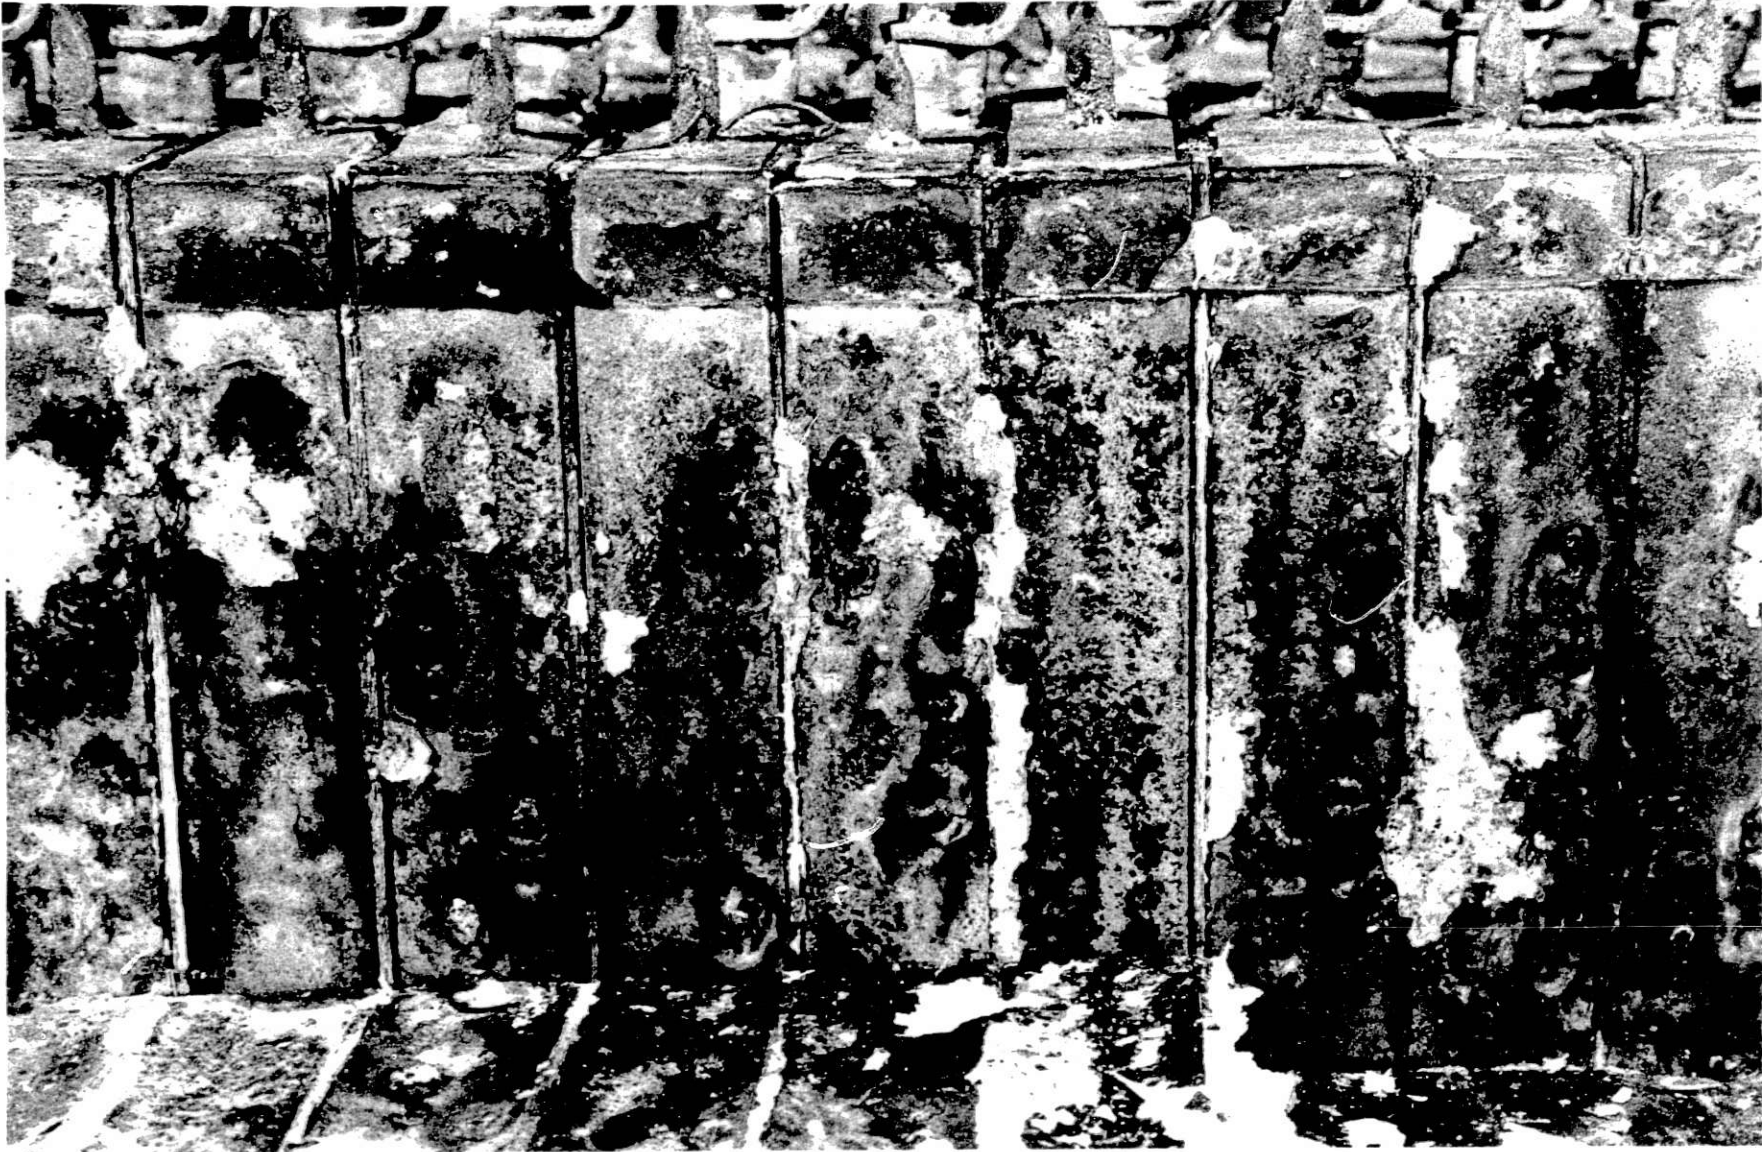
Fig. IV-25. Iron-Aluminum Reaction on Cells in Stack

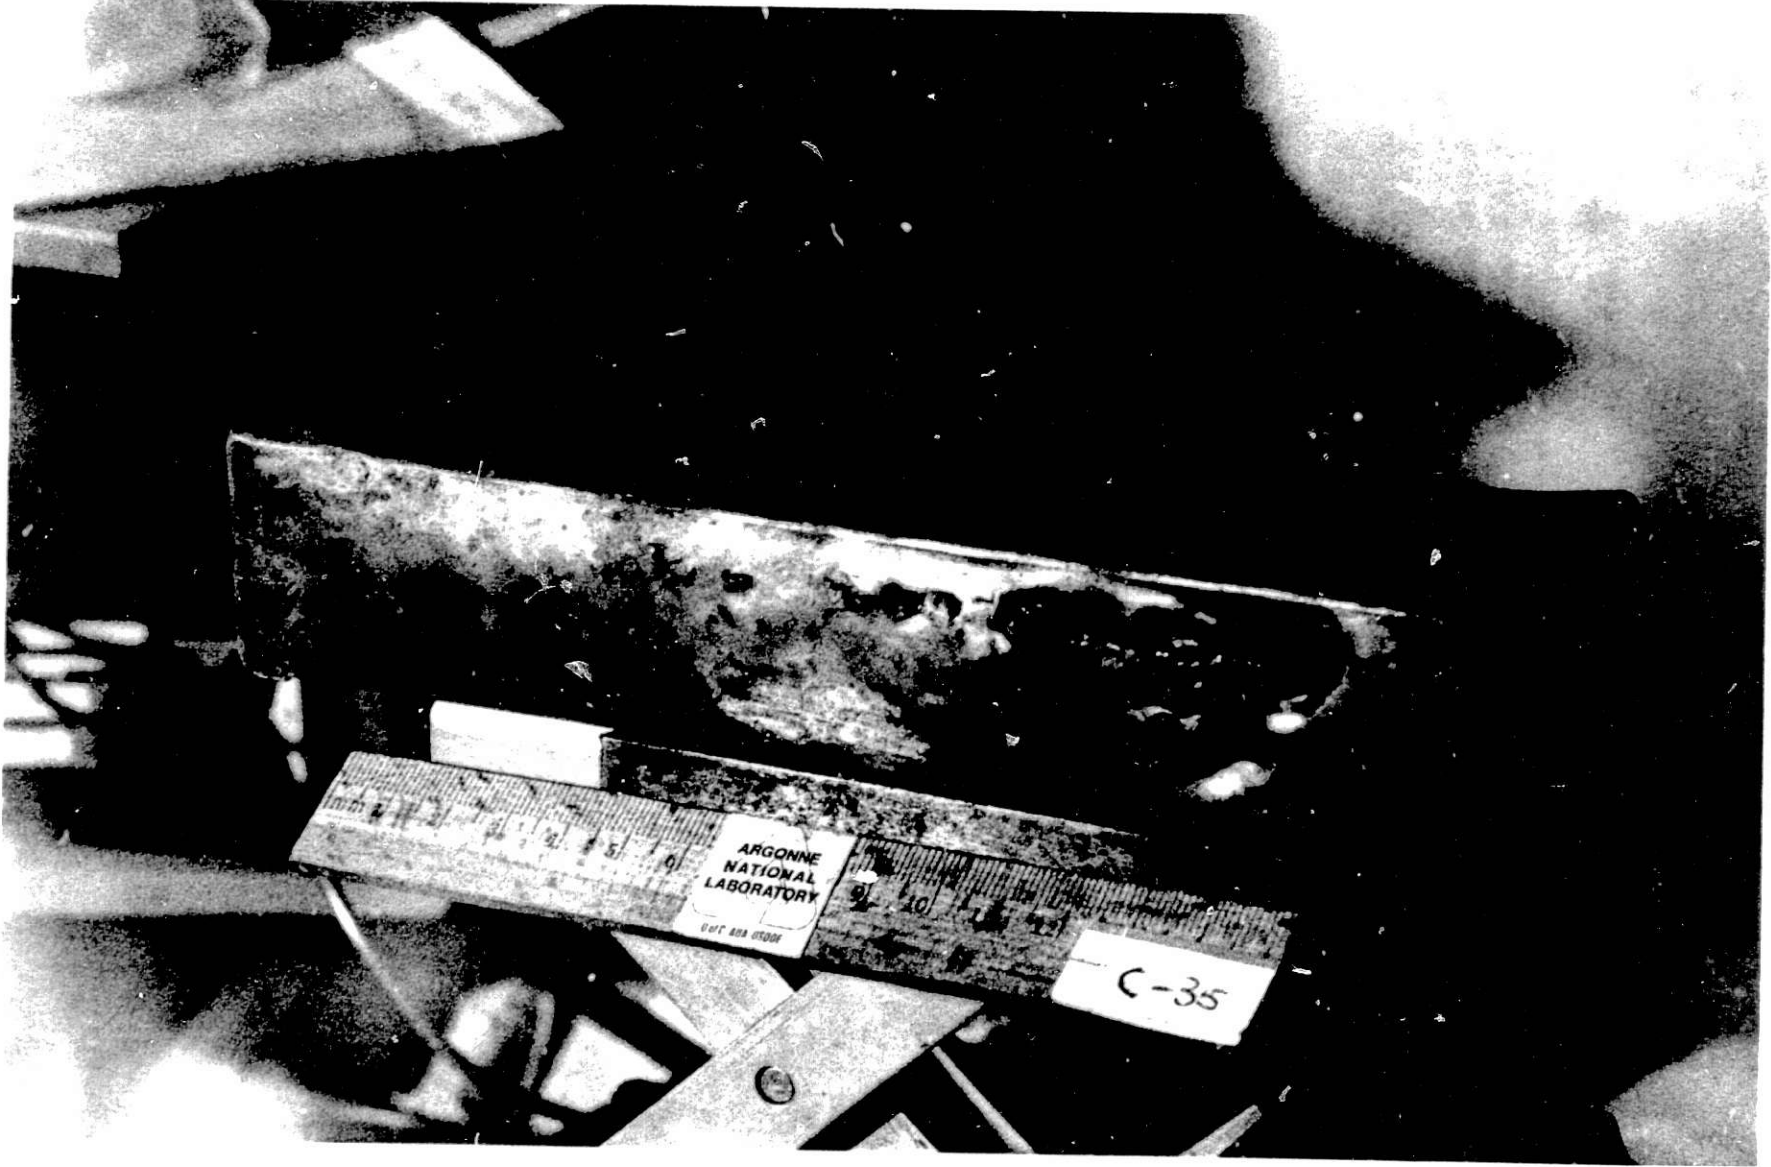
Fig. IV-26. Iron-Aluminum Reaction on Side of Cell 35

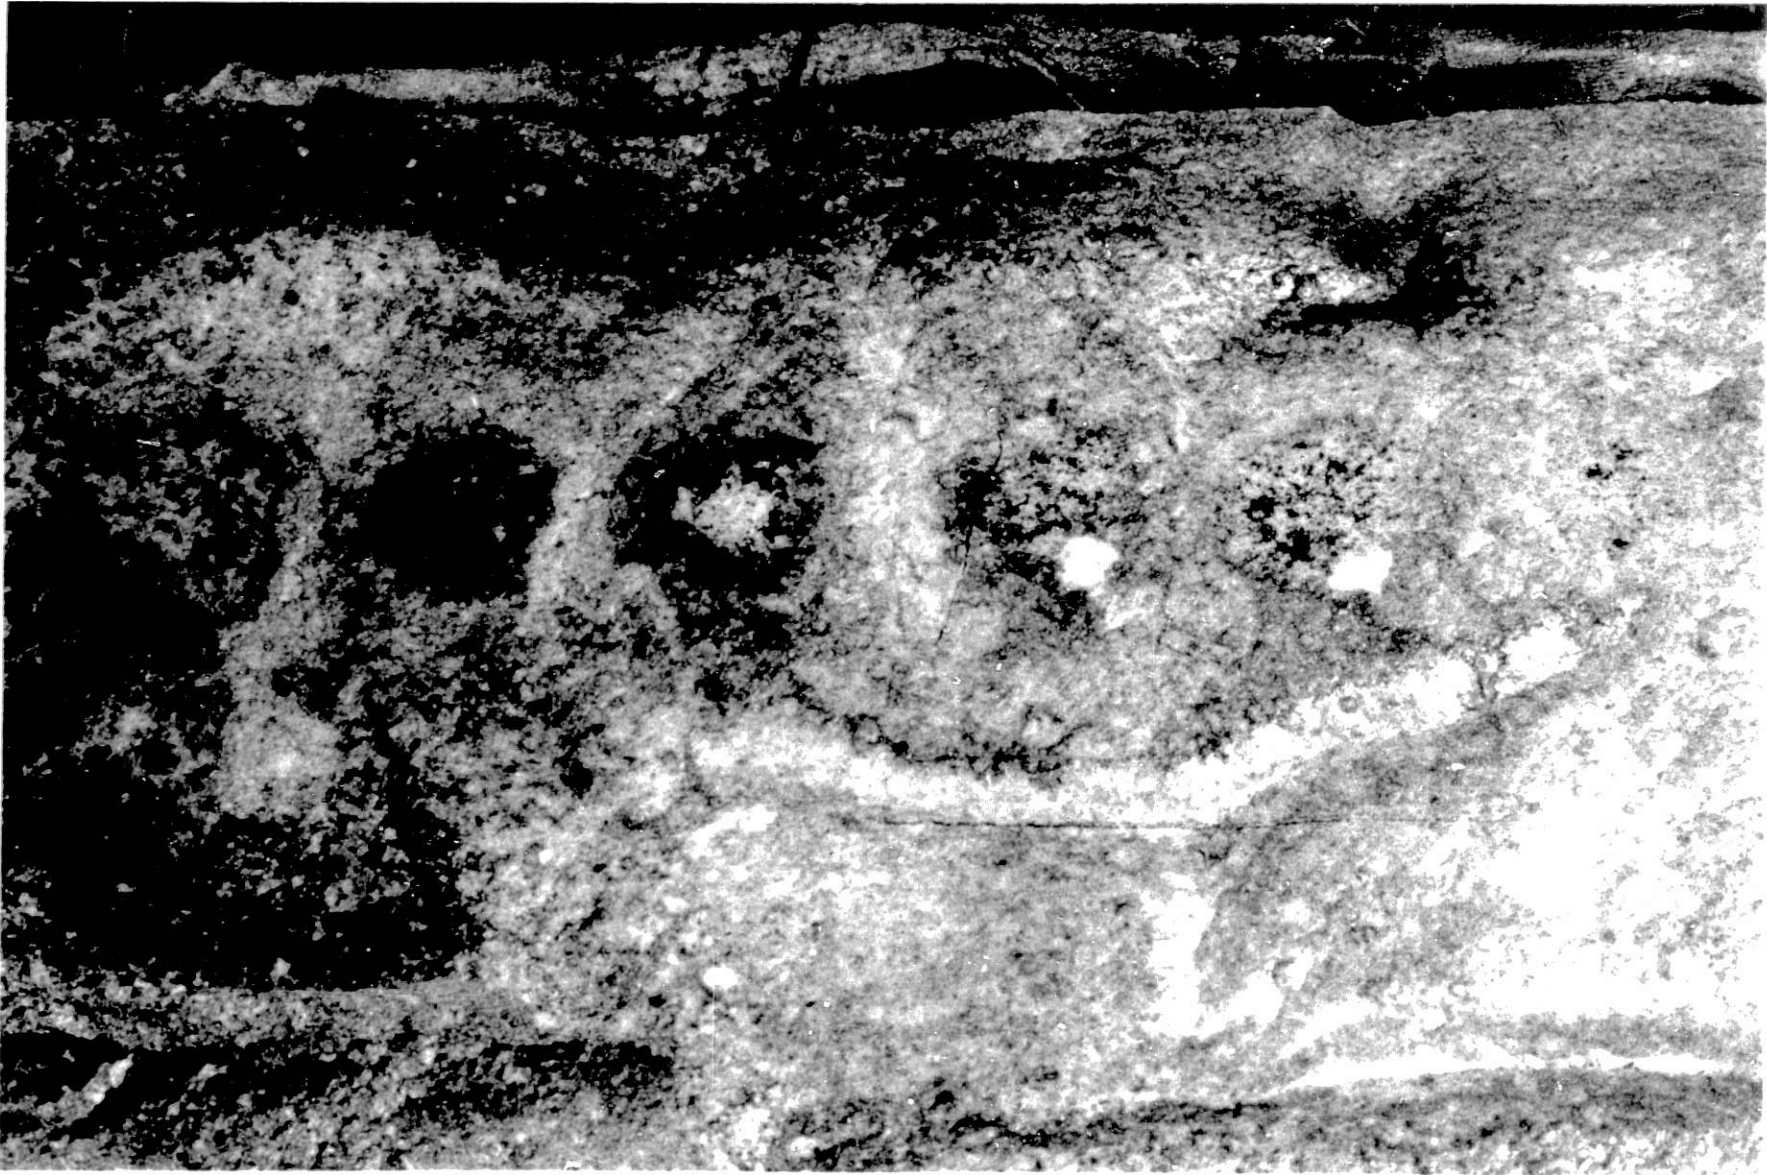
Fig. IV-28. Closeup View of Insulator Sheet Showing Crack

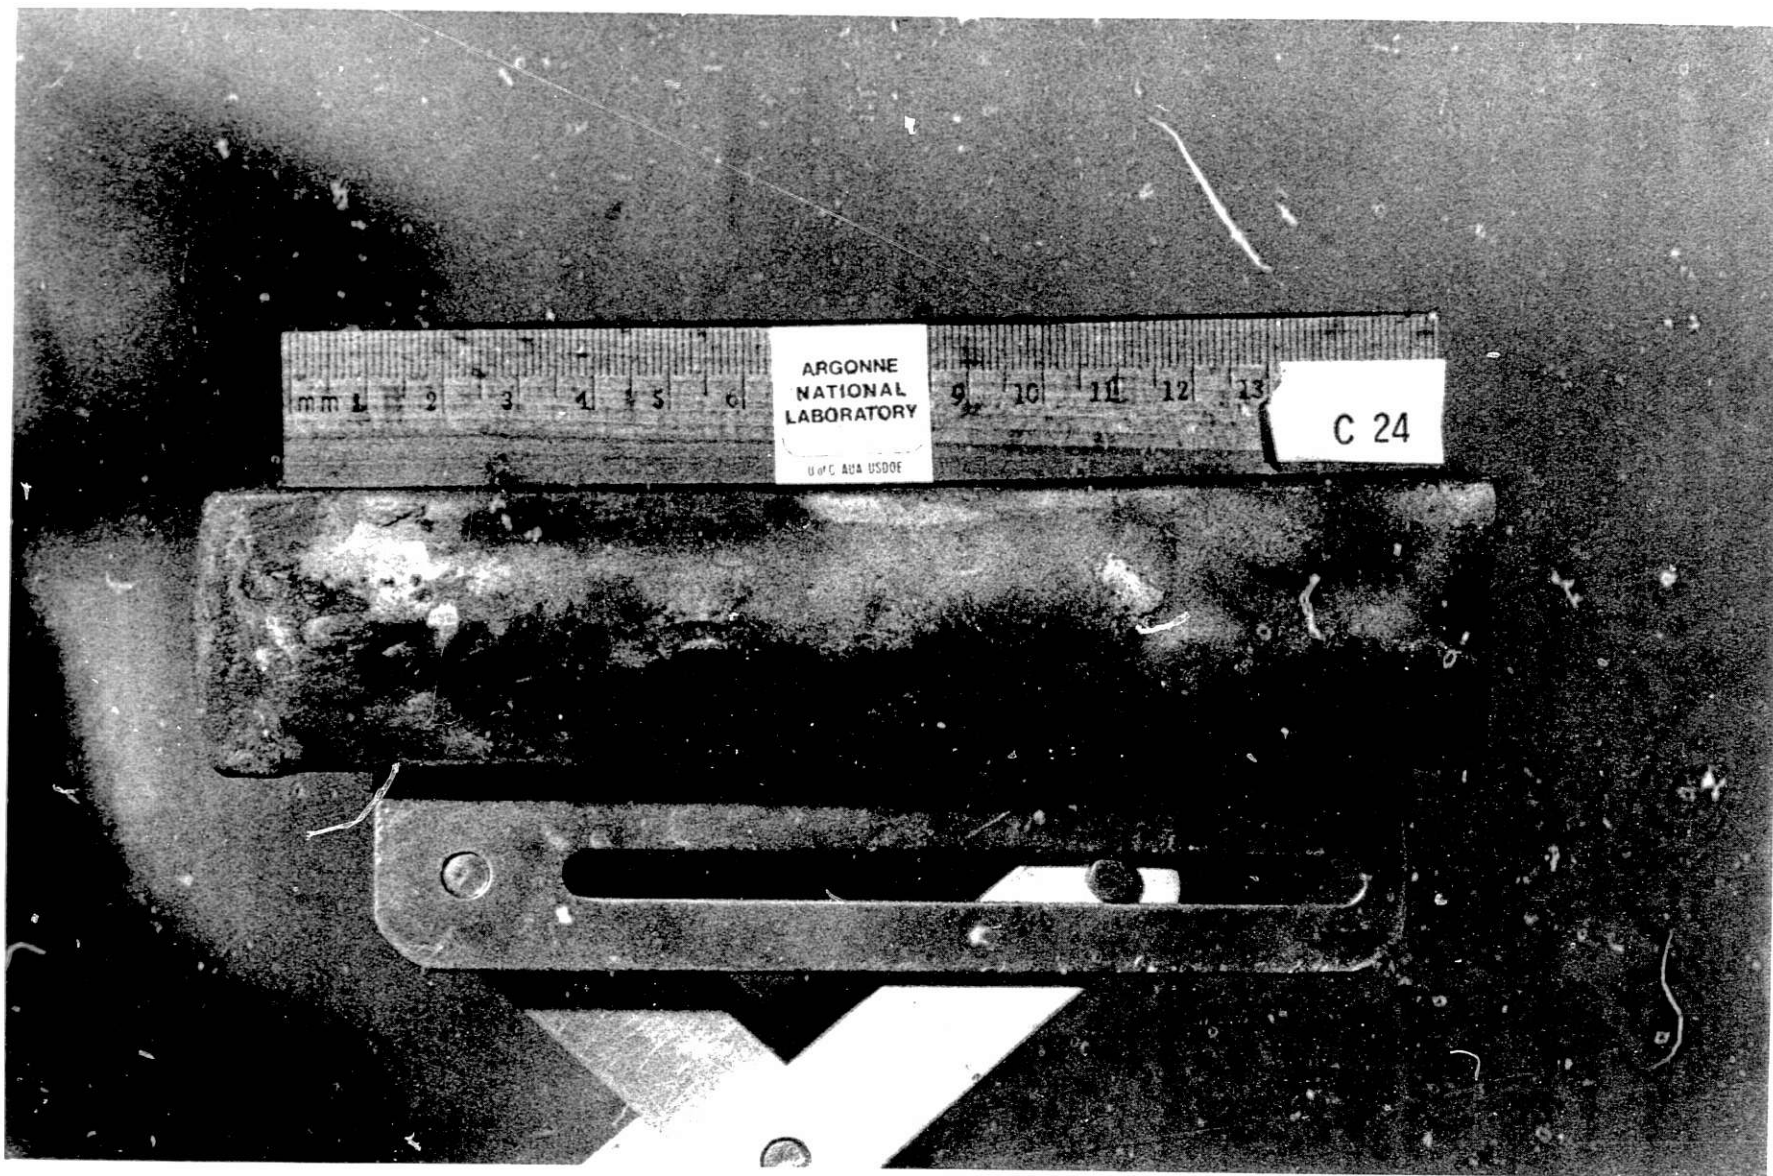
Fig. IV-32. Reaction at Lower Inside Edge of Cell 24

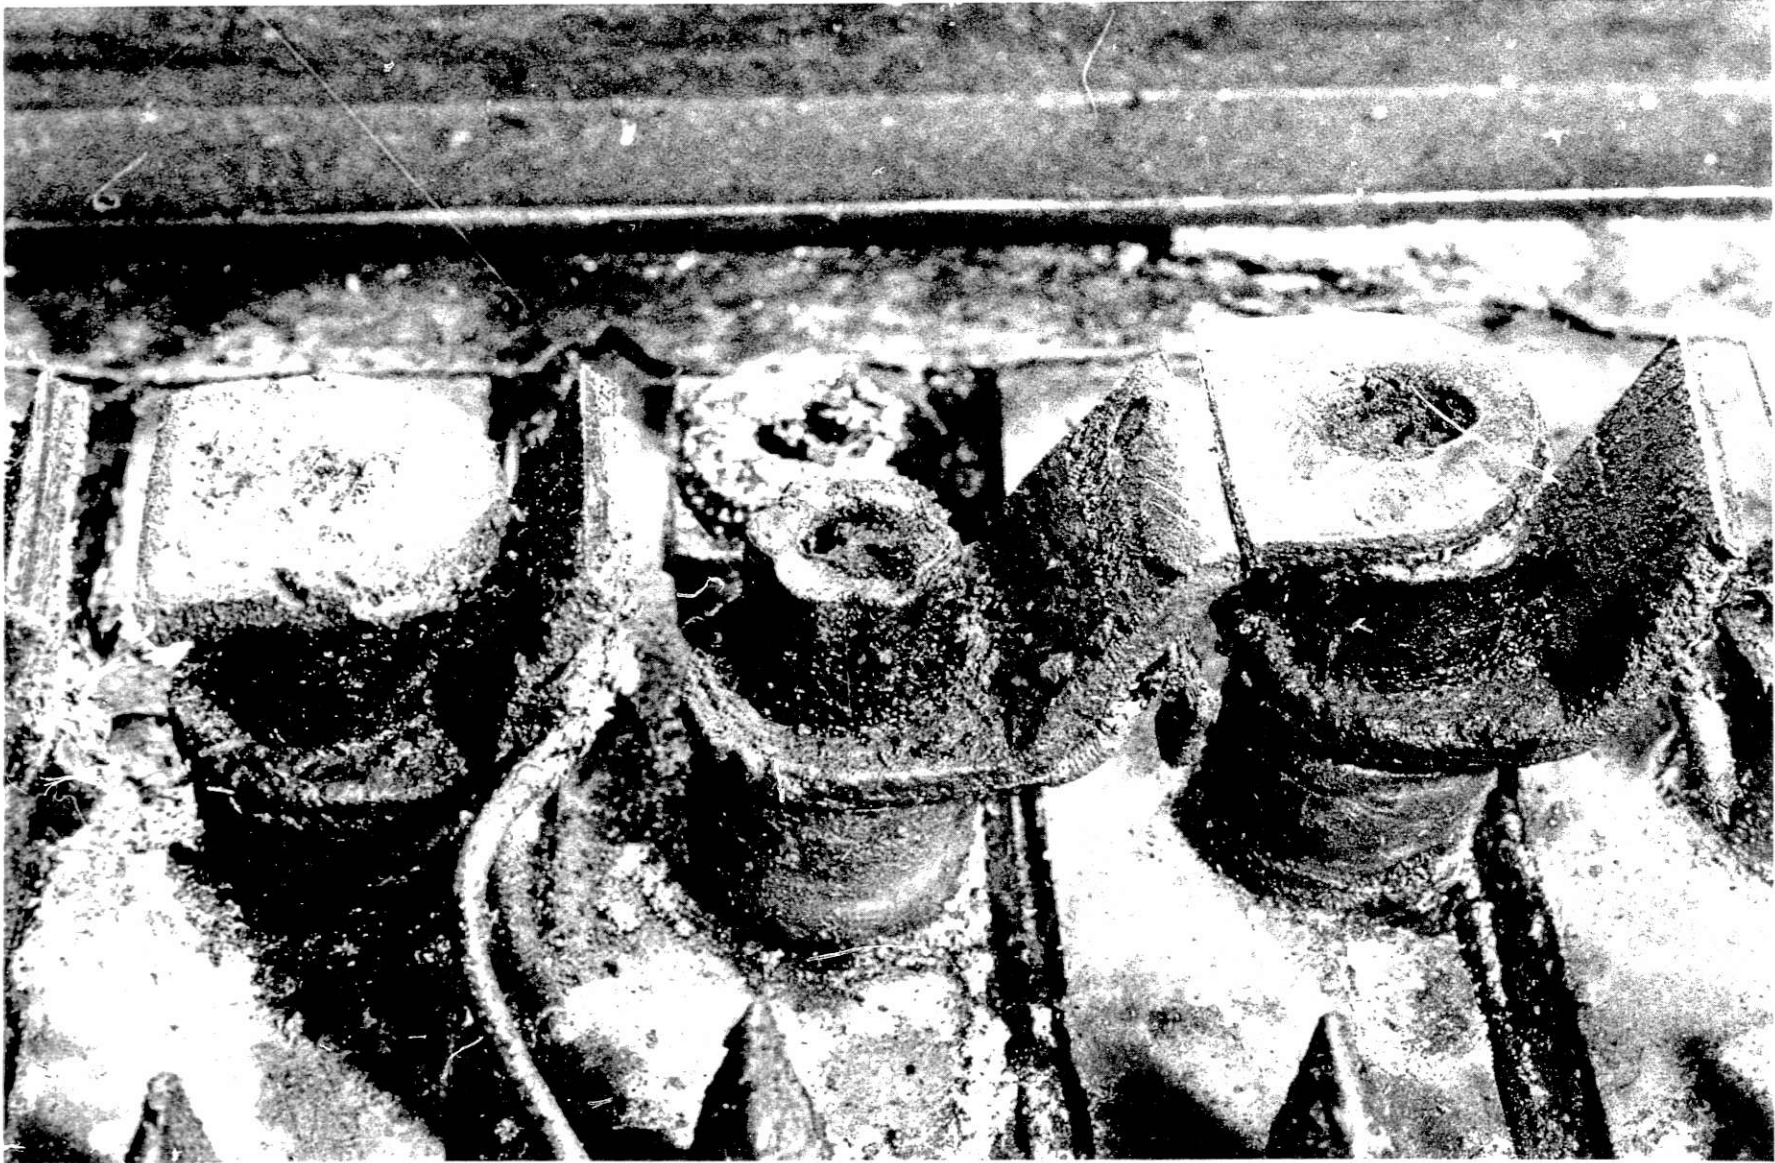
Fig. IV-33. Braze Bridge between Cells

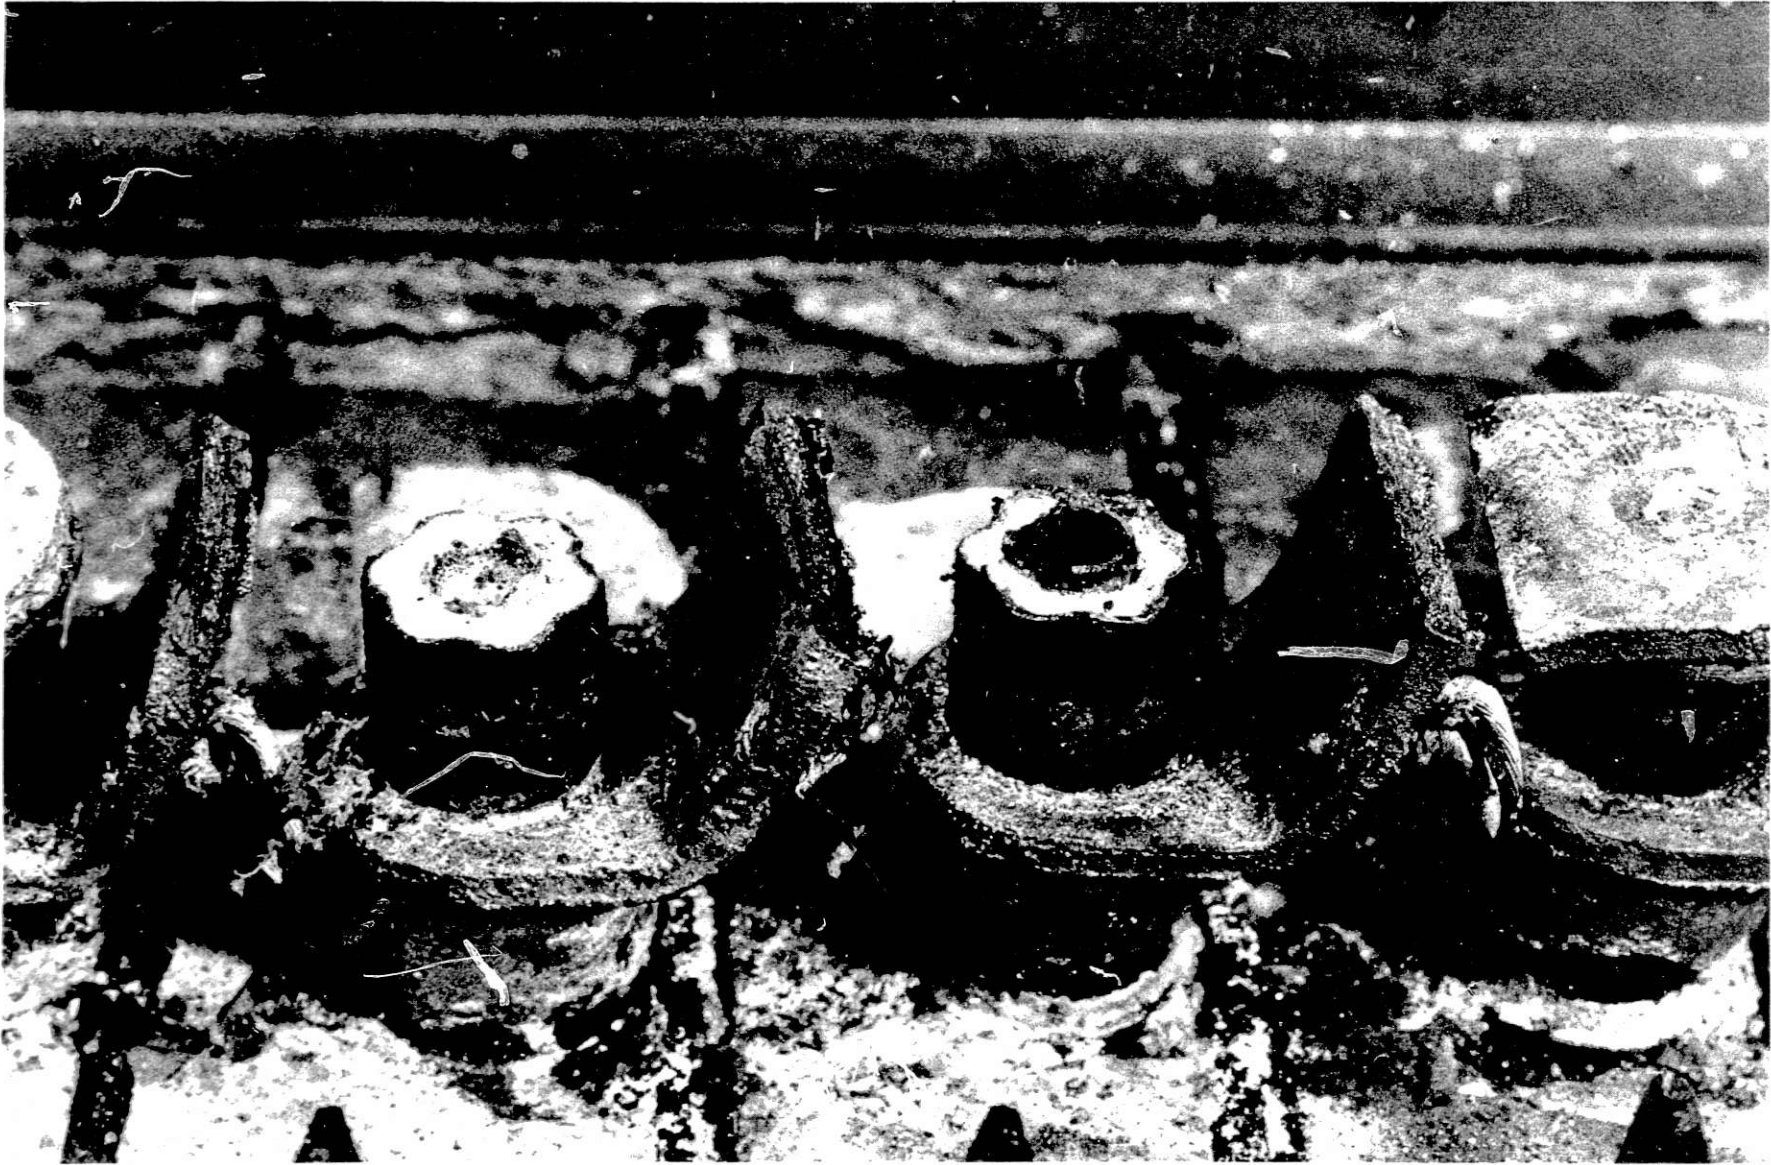
Fig. IV-34. Molten Positive Terminals and Molten Bridges across Insulation between Cells

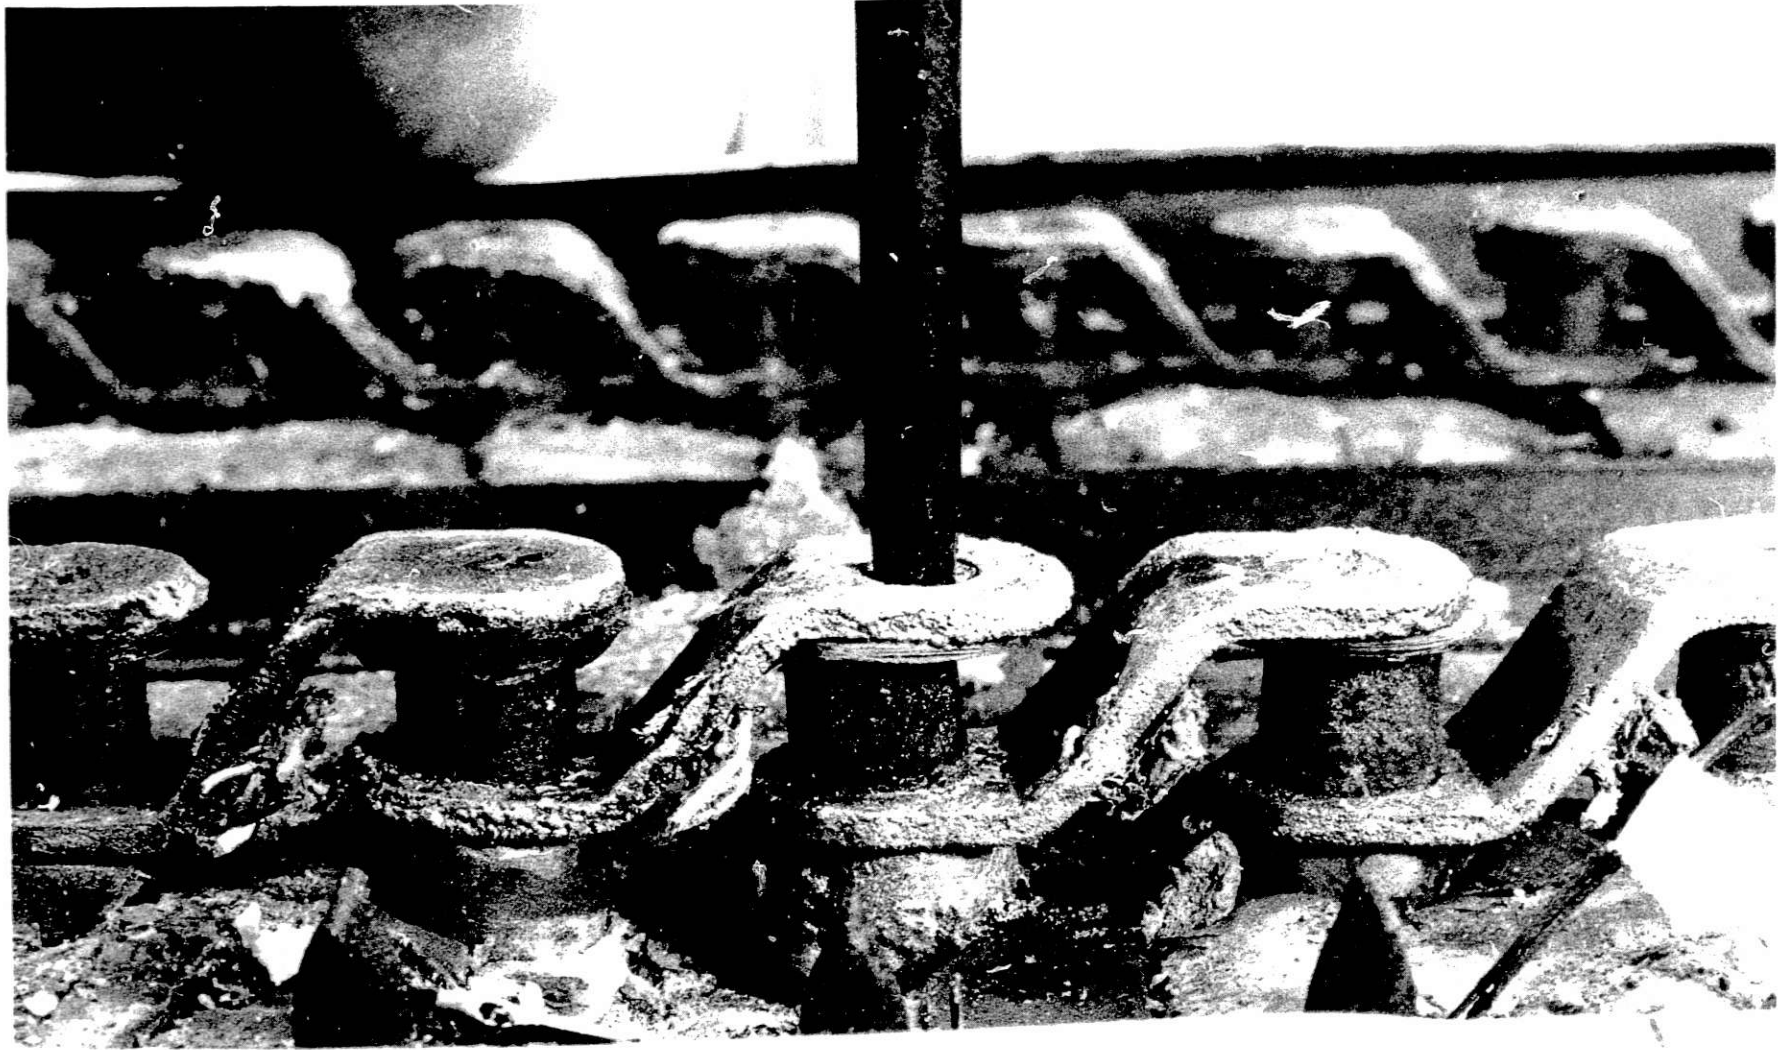
Fig. IV-35. Movement of Cell with Respect to Intercell Connector

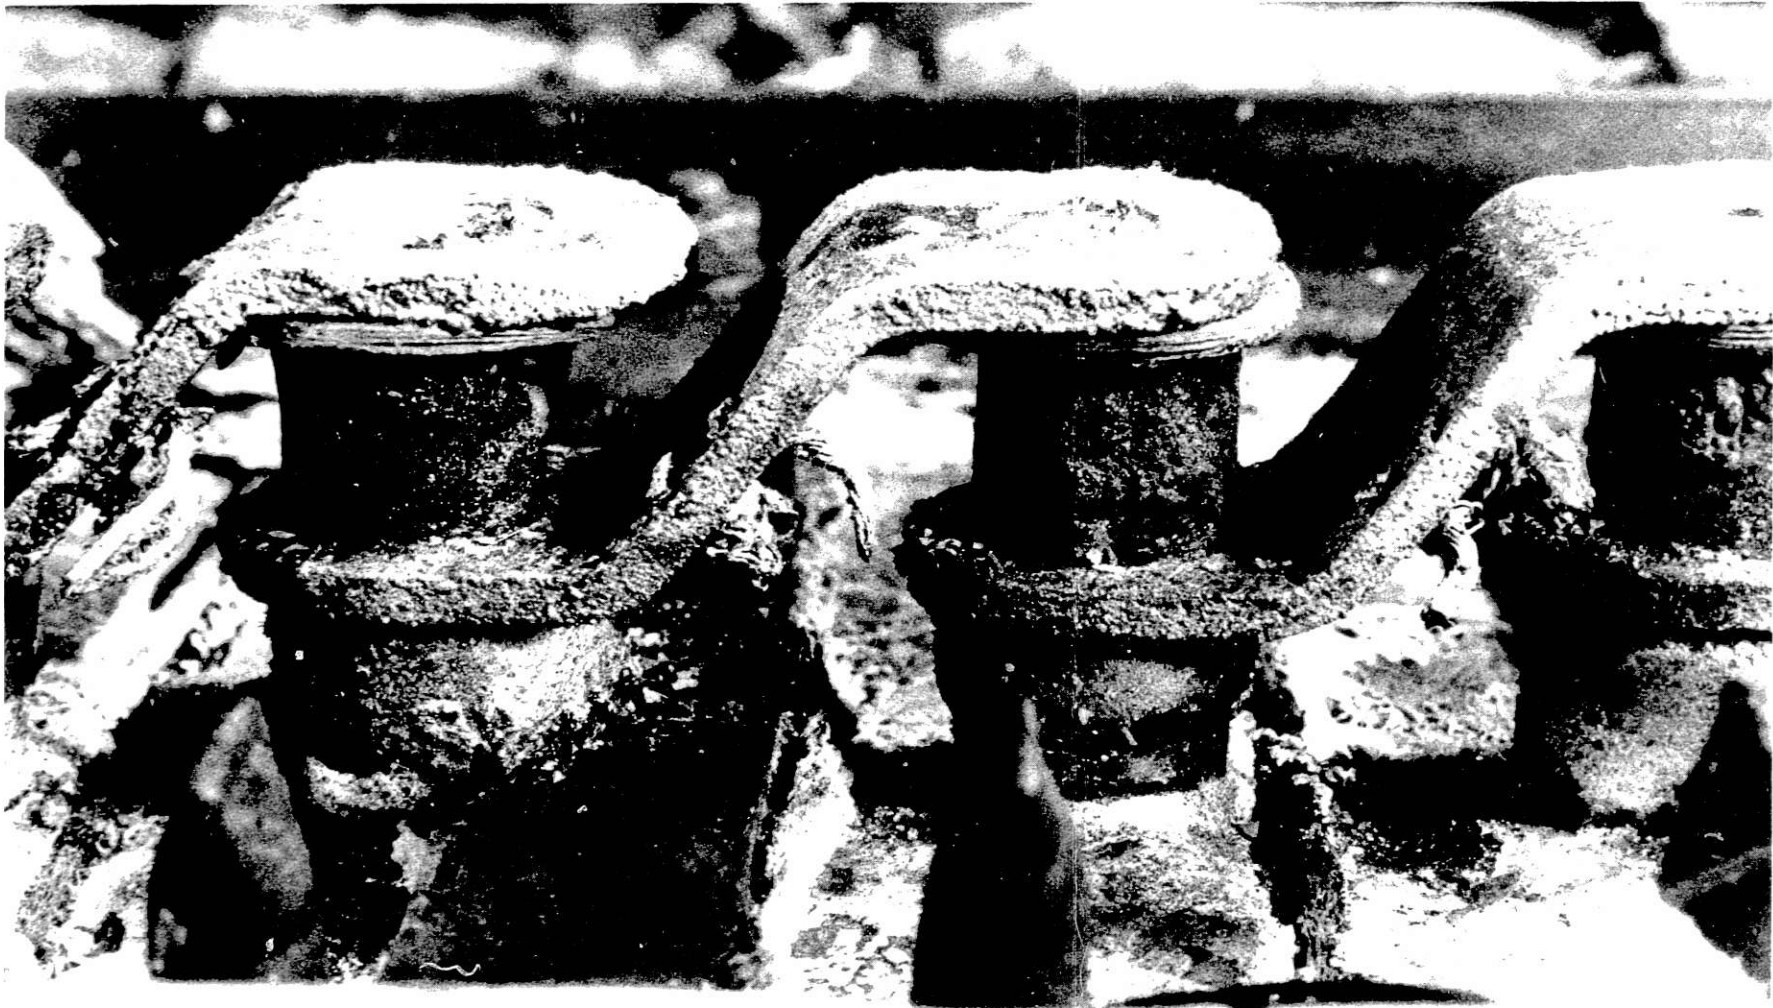
Fig. IV-36. Relative Movement between Cell and Cross-over Straps (indication of arcing at strap and alloy bridges across insulation)

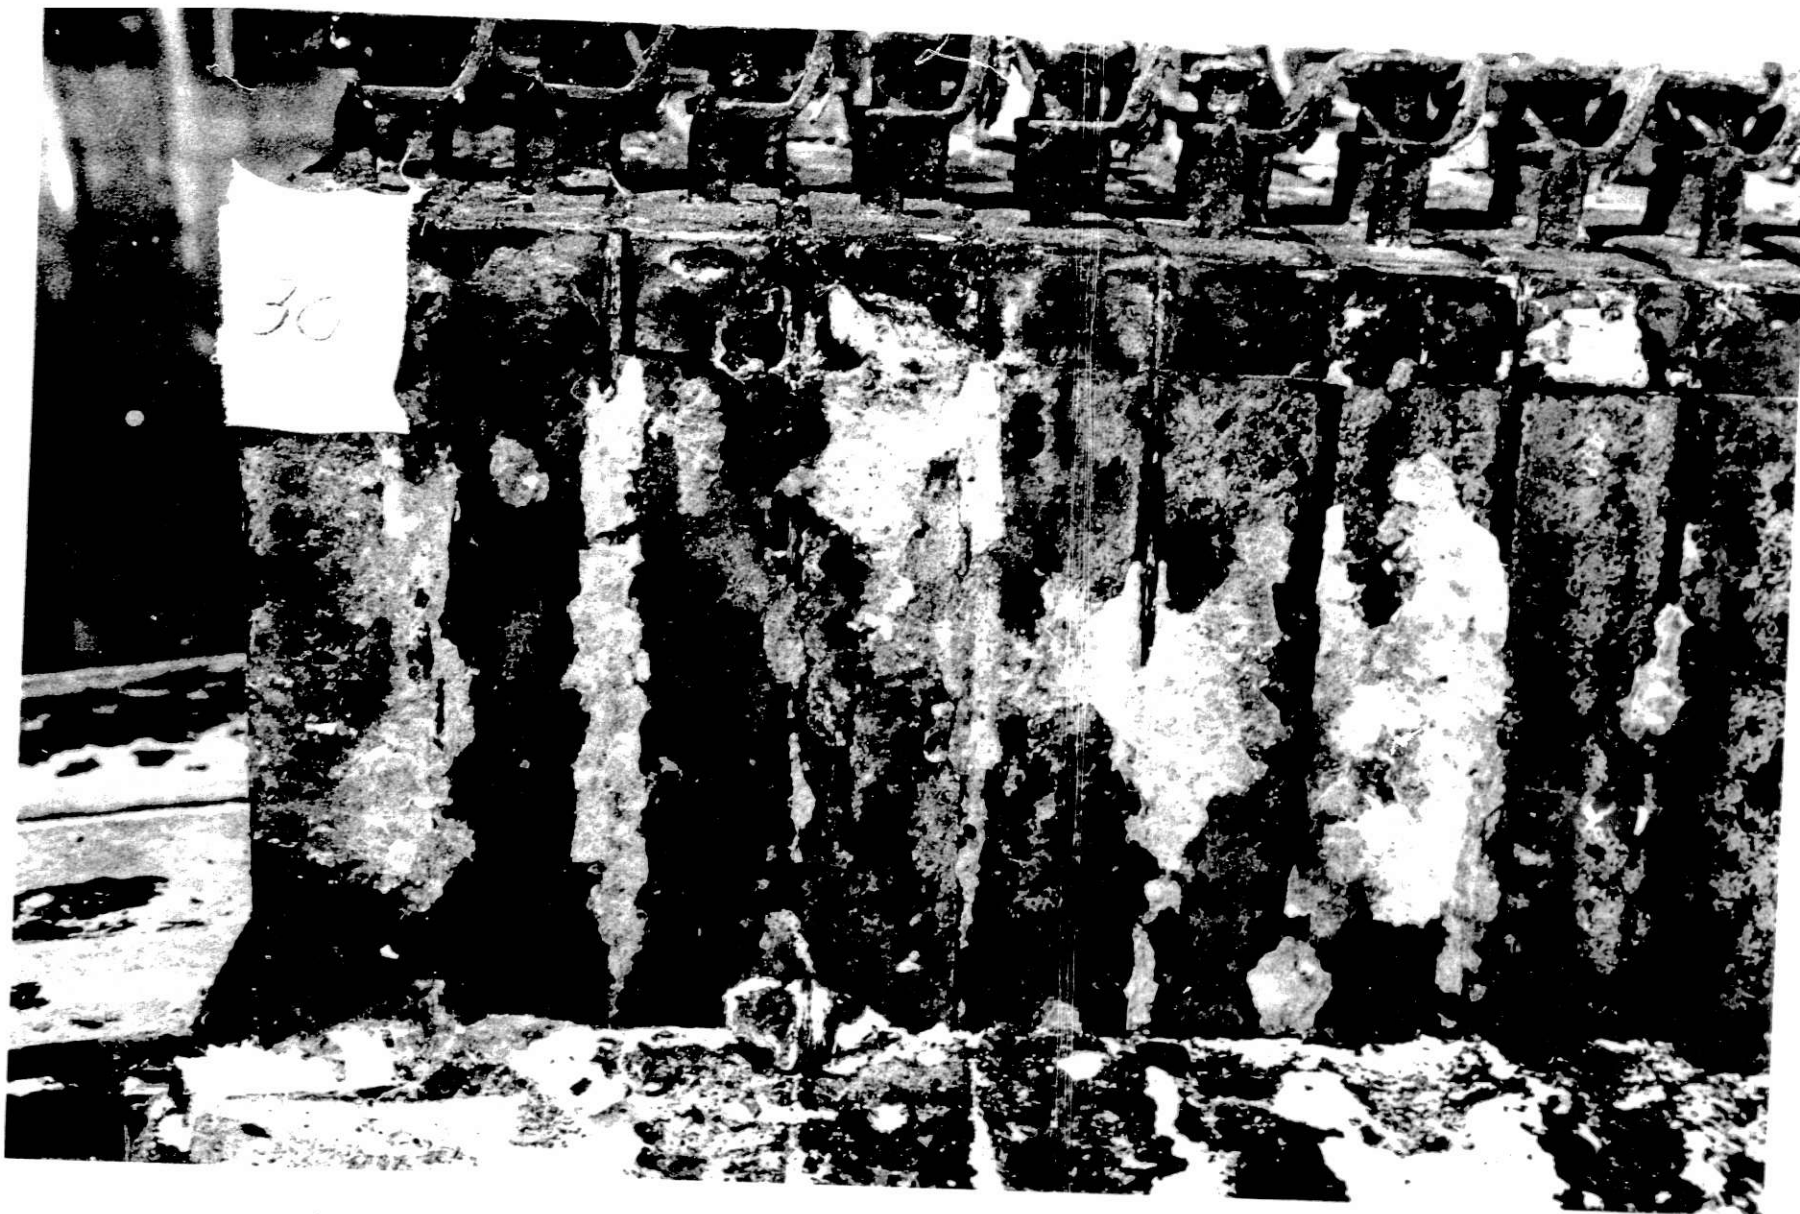
Fig. V-2. Corroded Area near Top of Cells 27/28 (Mica insulation removed. Metallic mass from corroded area is visible at the bottom of Cells 27/28. Lesser corrosion appears at the top of Cell 24.)

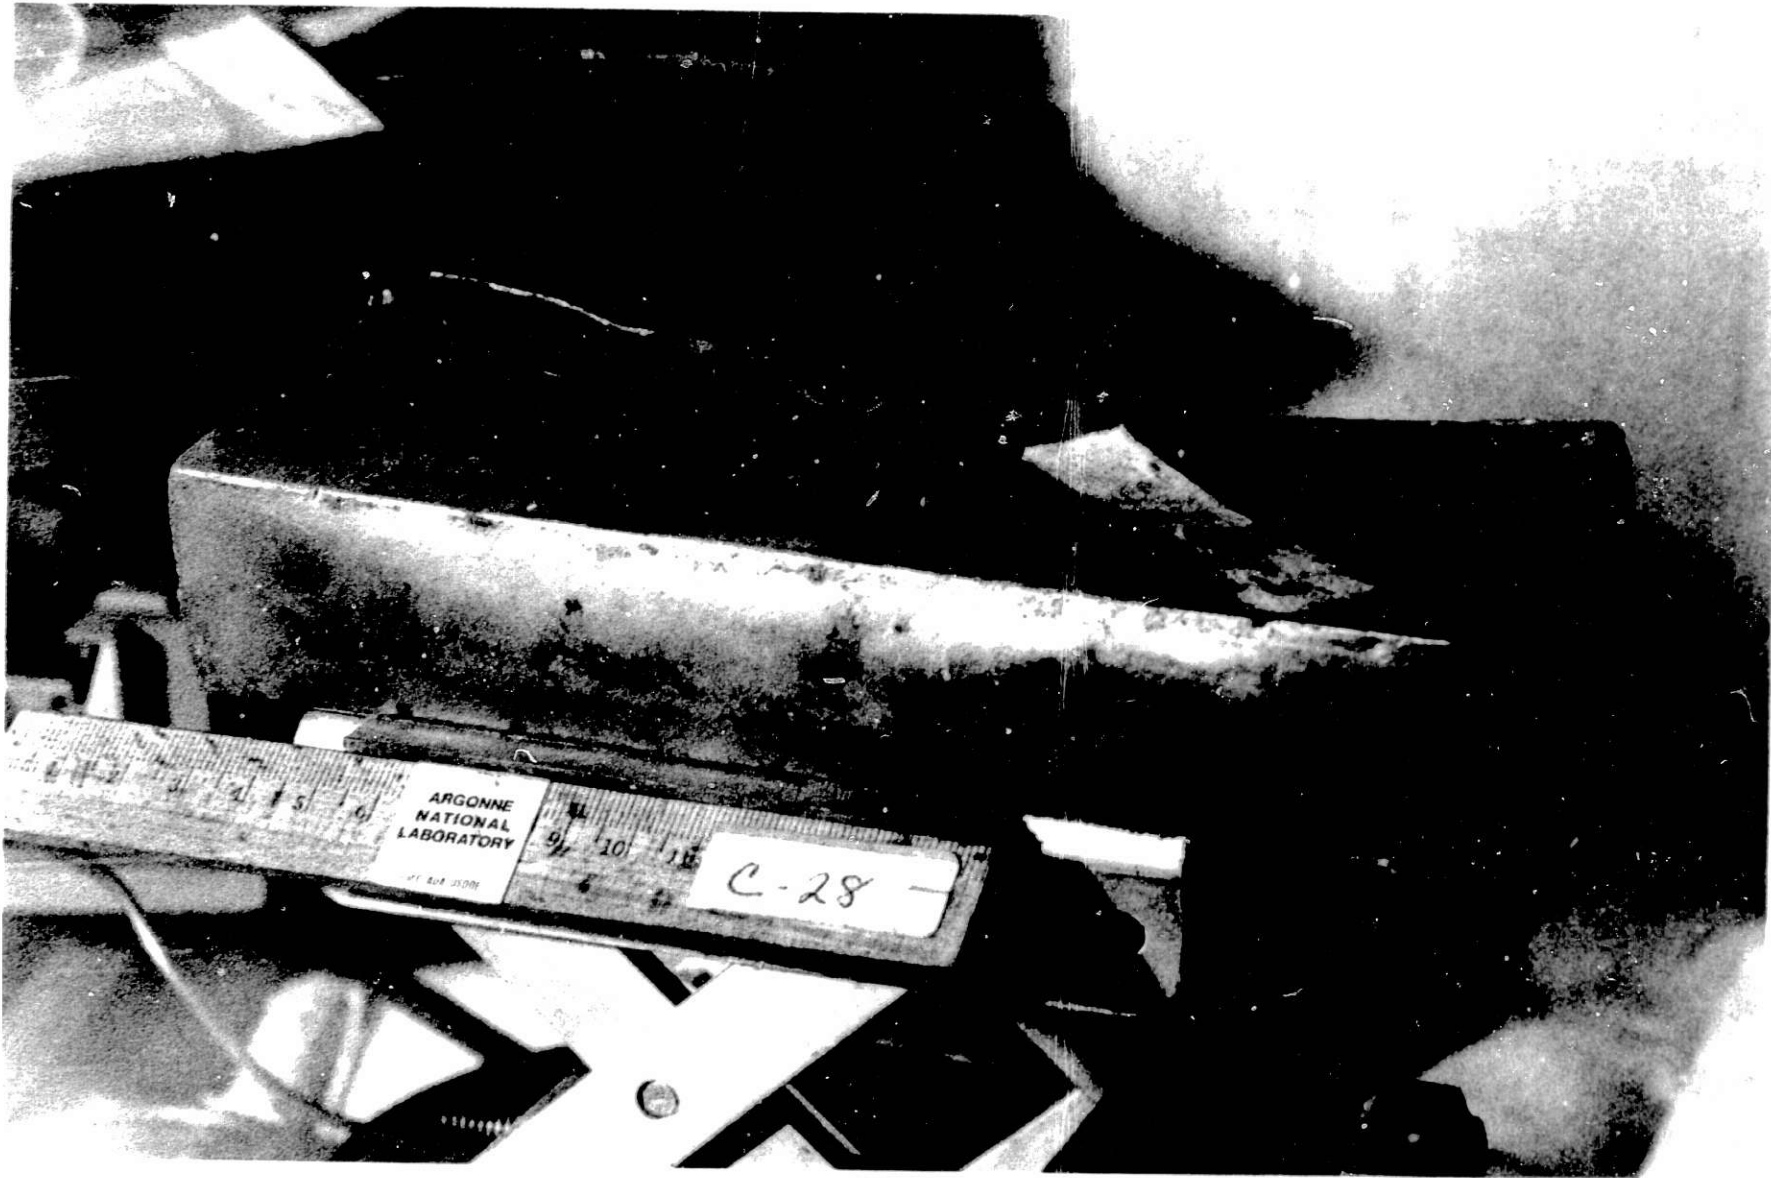
Fig. V-3. Corroded Area in Cell 28 Can
