**FAILURE ANALYSIS OF MARK IA
LITHIUM/IRON SULFIDE BATTERY**

**V. M. Kolba, J. E. Battles,
J. D. Geller, and K. Gentry**

ARGONNE NATIONAL LABORATORY, ARGONNE, ILLINOIS
Prepared for the U. S. DEPARTMENT OF ENERGY
under Contract W-31-109-Eng-38

October 1980

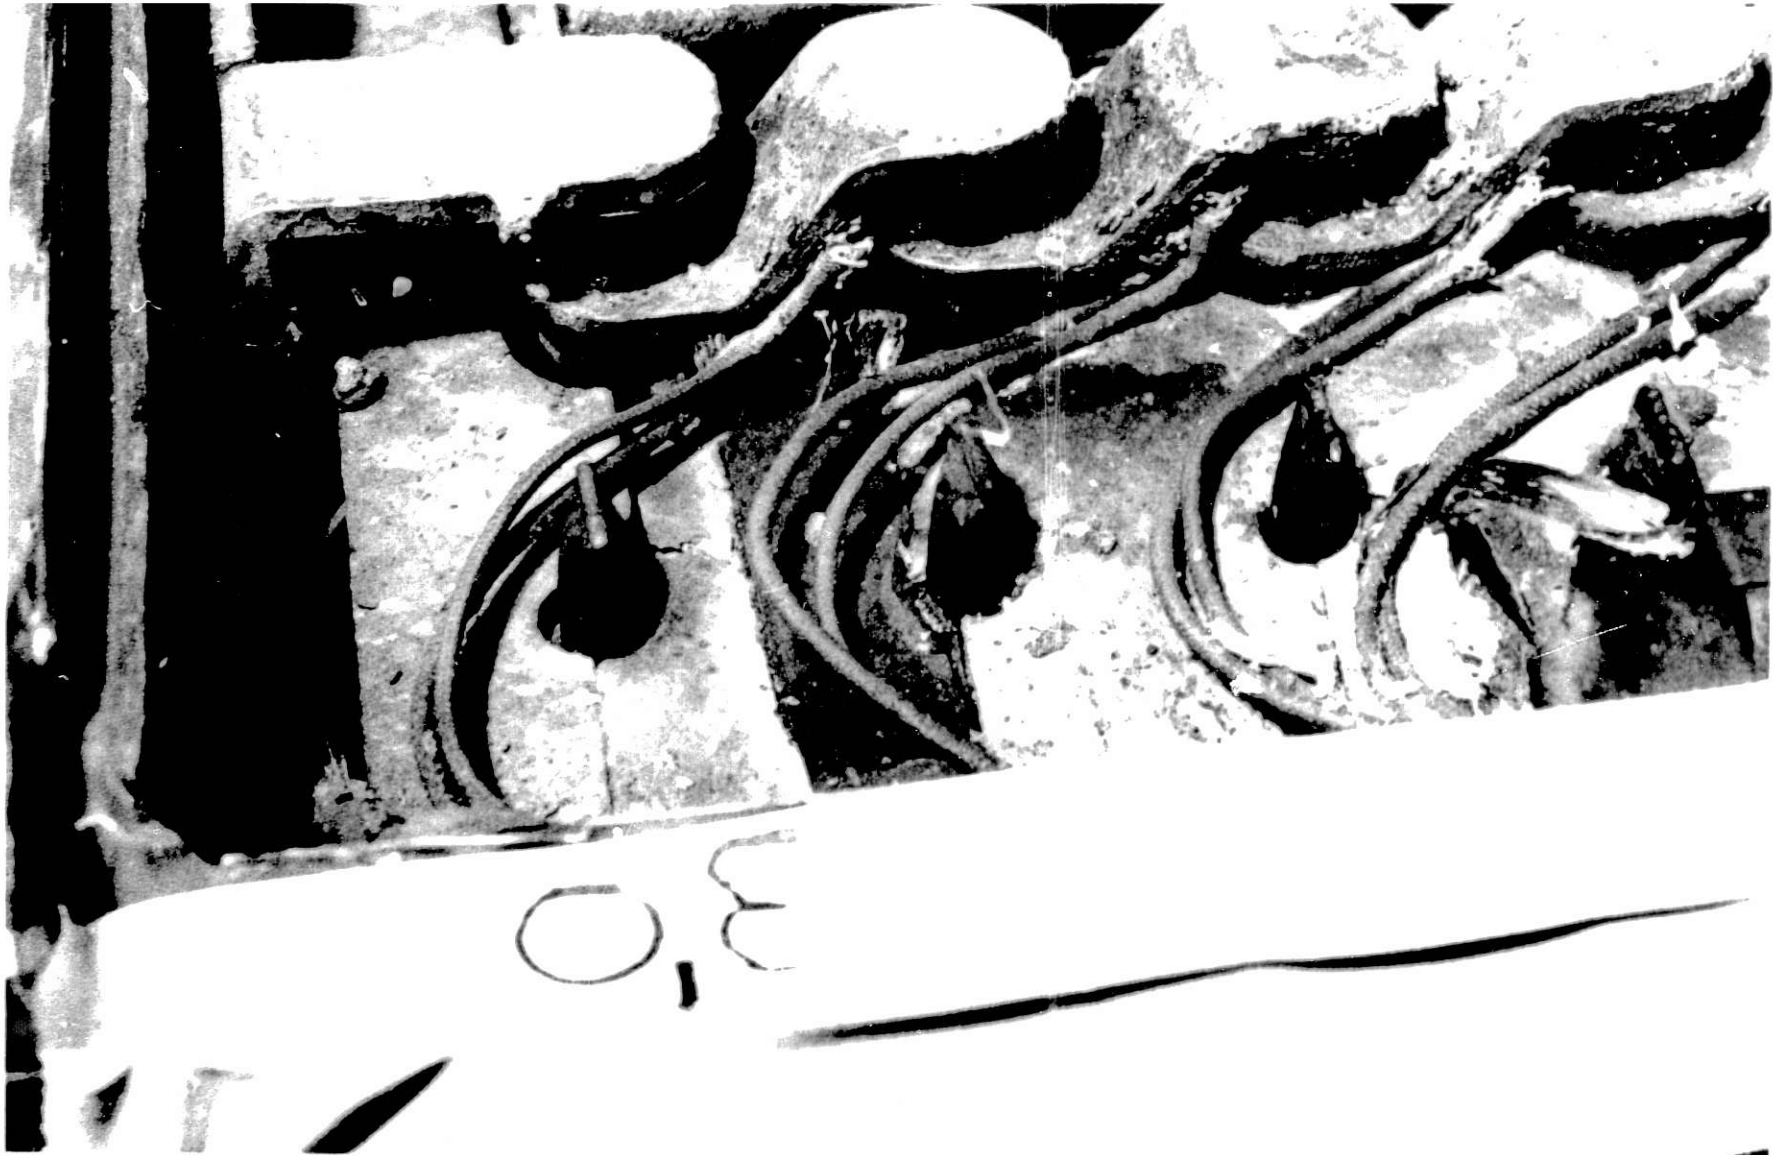
The first step in the propagation of failure was the short circuit of Cell 28 due to contact of the fill tube on Cell 29 with the cross-over strap (Fig. V-4), which was connected to the cell tray. This completed the circuit from the negative of Cell 24 through the positive of Cell 28. The initial decline in the voltage of Cell 28 occurred at 2318, two minutes after the start of voltage decline in Cells 24 through 27. The contact with the cross-over strap was attributed to thermal expansion differences in the cells and cell tray and to the expansion of Cells 24 through 27 as they discharged. This is the only case where cell expansion and contact with the cross-over strap was a primary factor in failure propagation. In all other cases, contact with the cross-over straps was merely a secondary contributor; this was verified by examining the voltage/time data for each cell relative to the cross-over strap locations.

Fig. V-4. Cross-over Strap in Region of Cell 29 Fill Tube (evidence of arcing or burnout apparent at contact point)

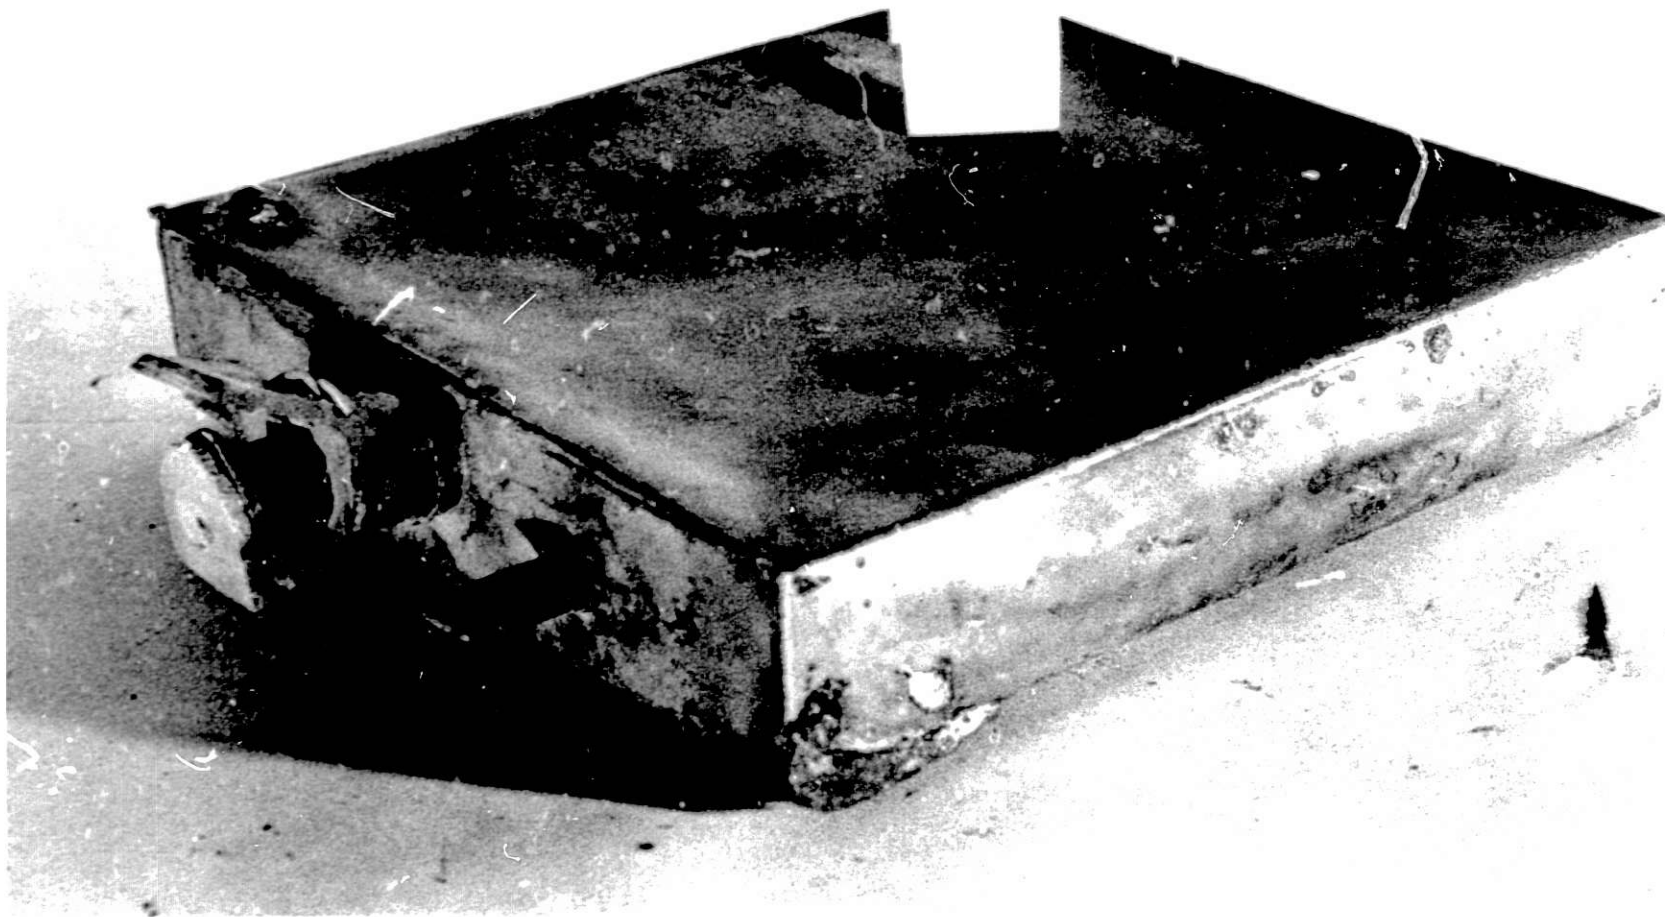
Fig. V-6. Corroded Upper Corner of Cell 32 (lower center in photograph)

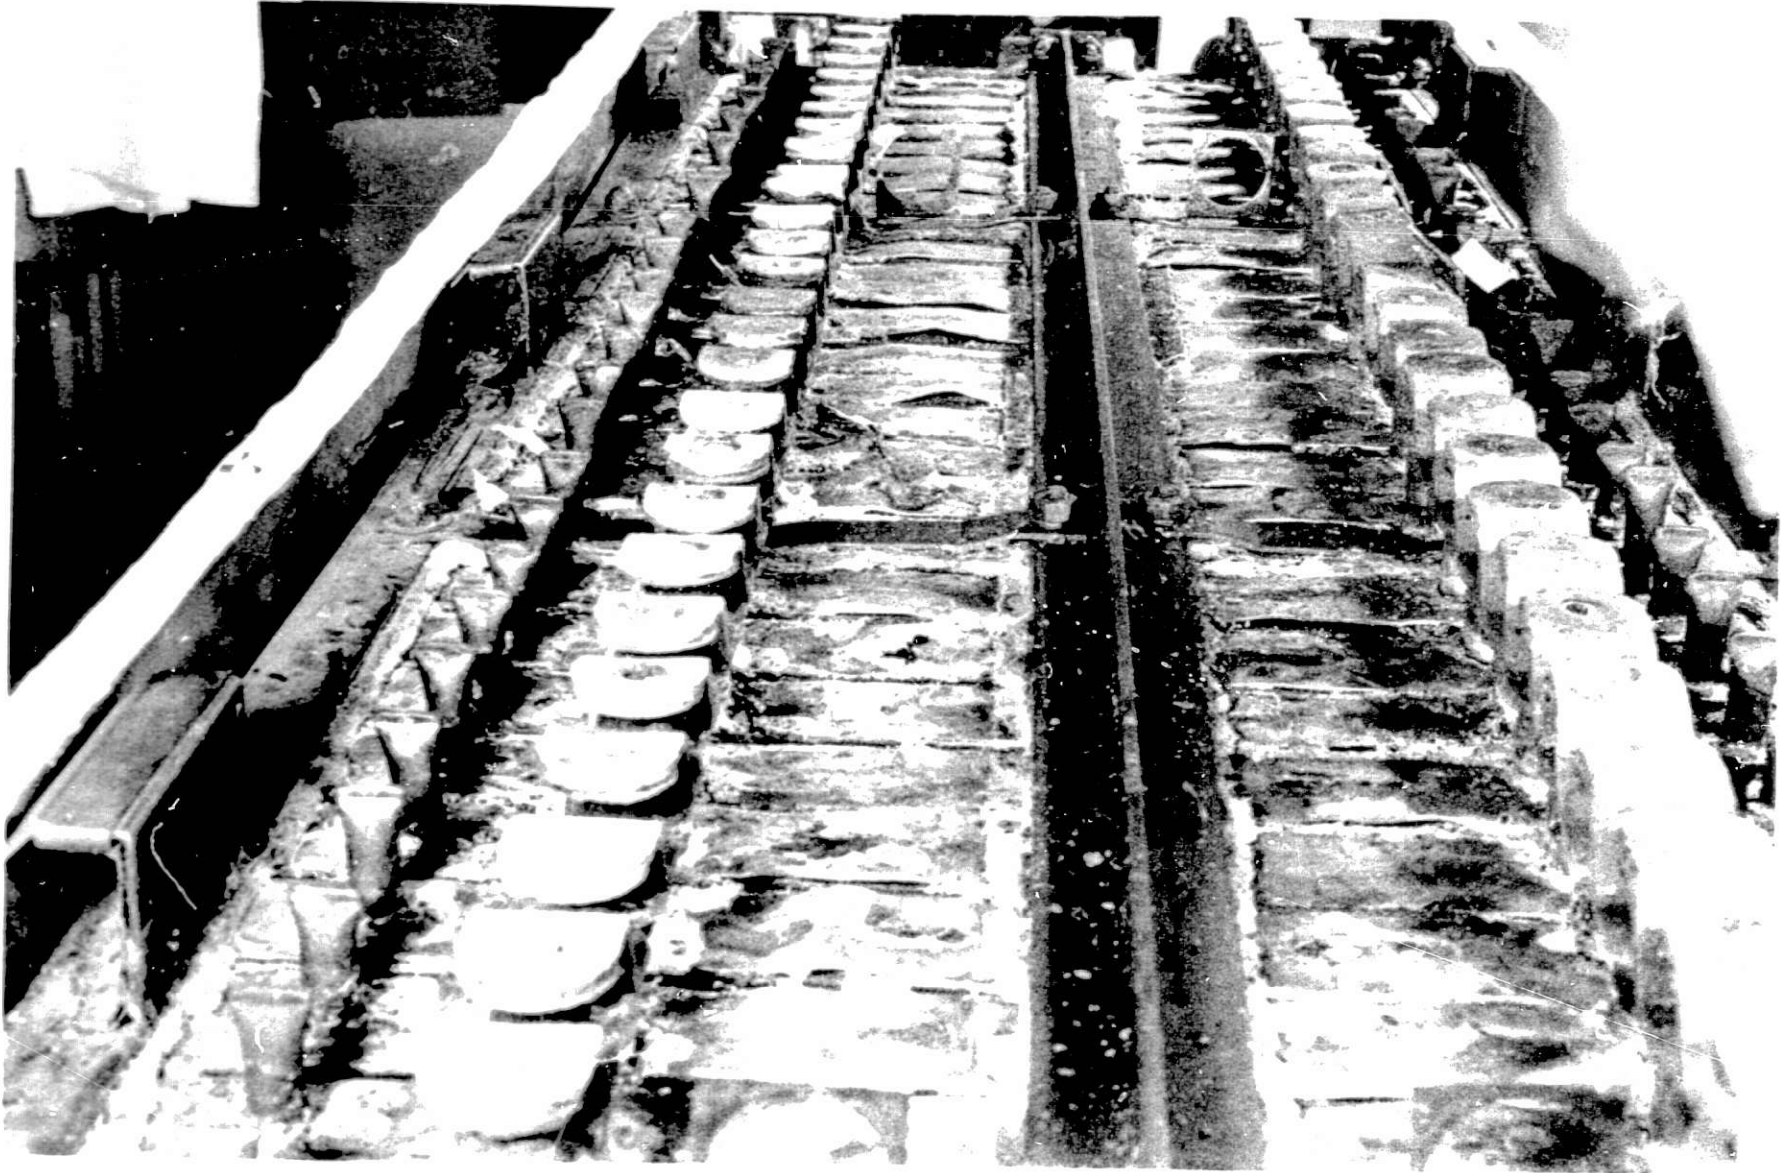
Fig. V-7. Top View of Module (The cell top insulation has been removed and evidence of electrolytic corrosion and braze melting is visible. In many areas, metallic bridges were formed between cells across the top of the mica insulation.)

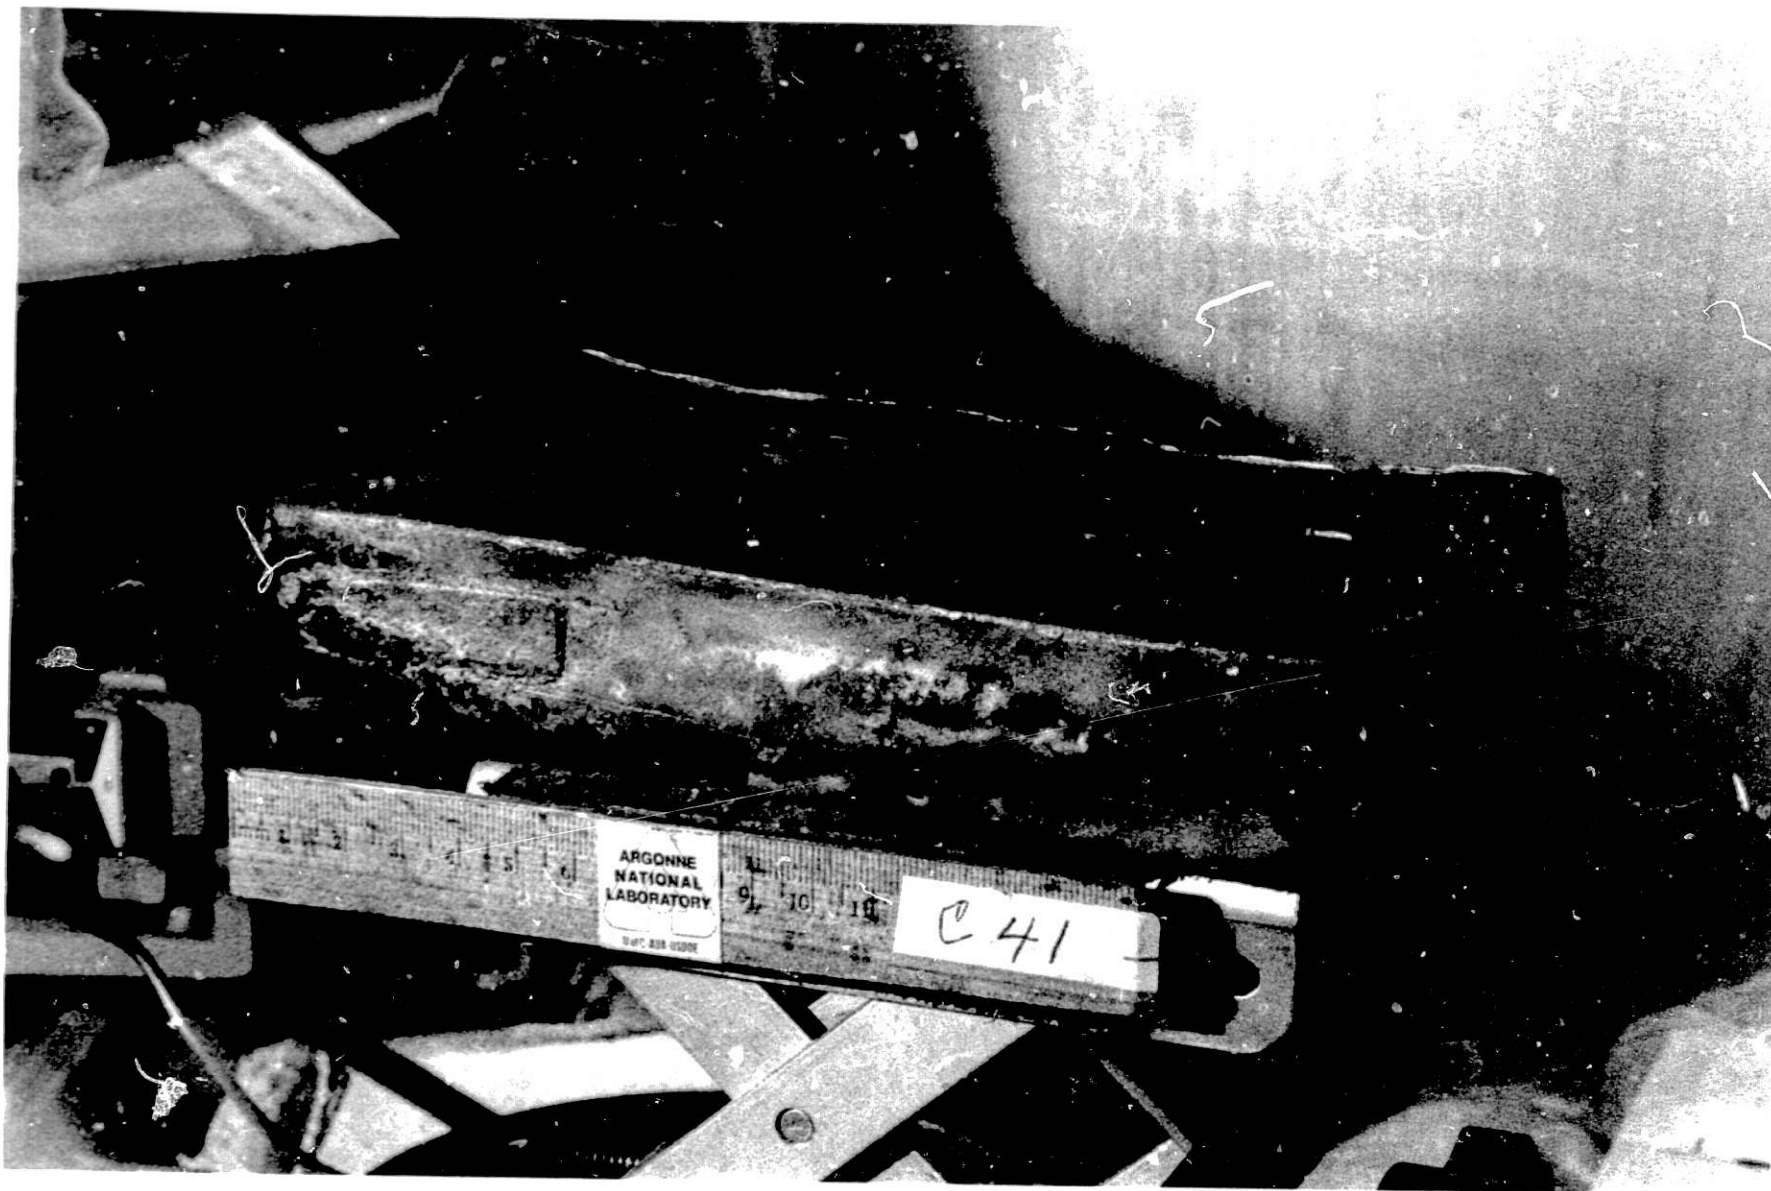
Fig. V-8. Large Hole at Lower Inside Edge of Cell 41 (Examination showed that many cells had similar holes which would allow electrolyte to flow freely from the cells.)

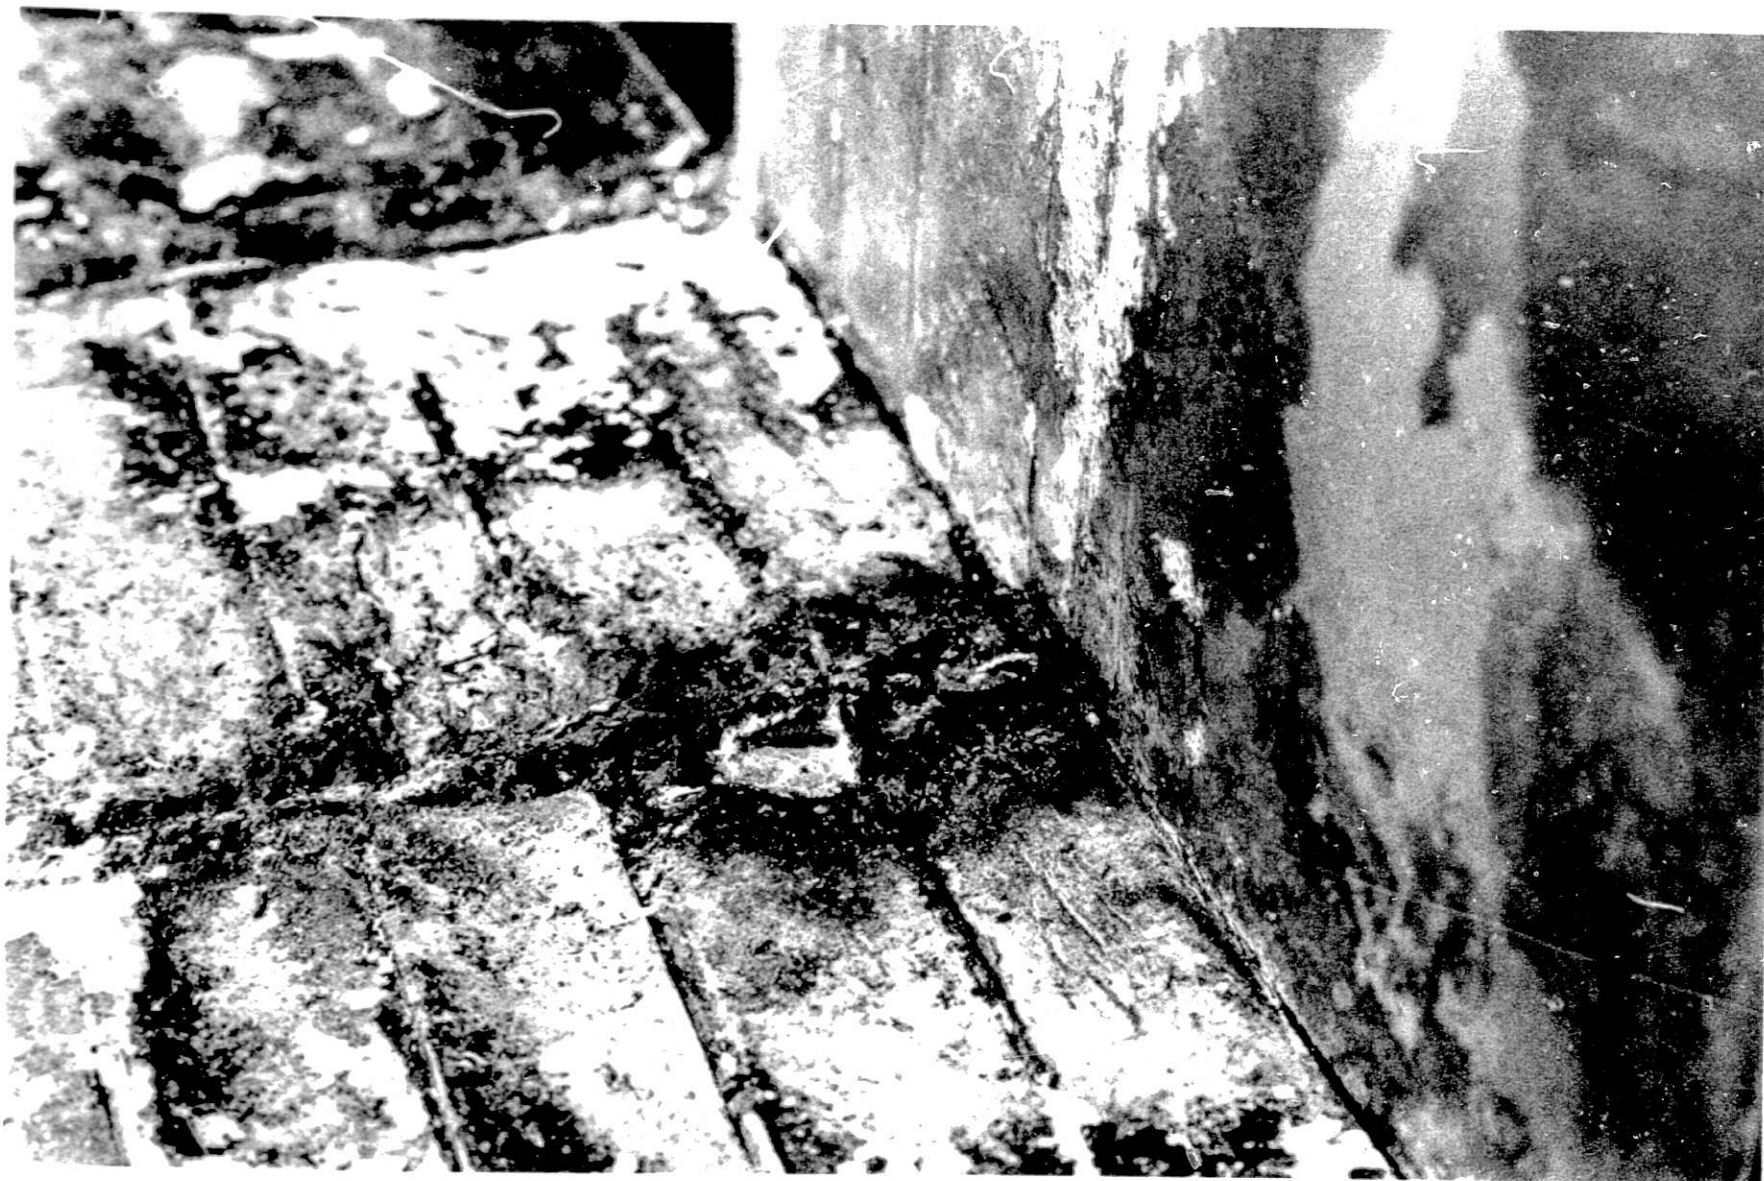
Fig. V-10. Lithium-Aluminum Alloy from Cell 2 (The Li-Al leakage occurred after the cell temperature had exceeded 600°C and after the corrosion caused by the presence of electrolyte.)

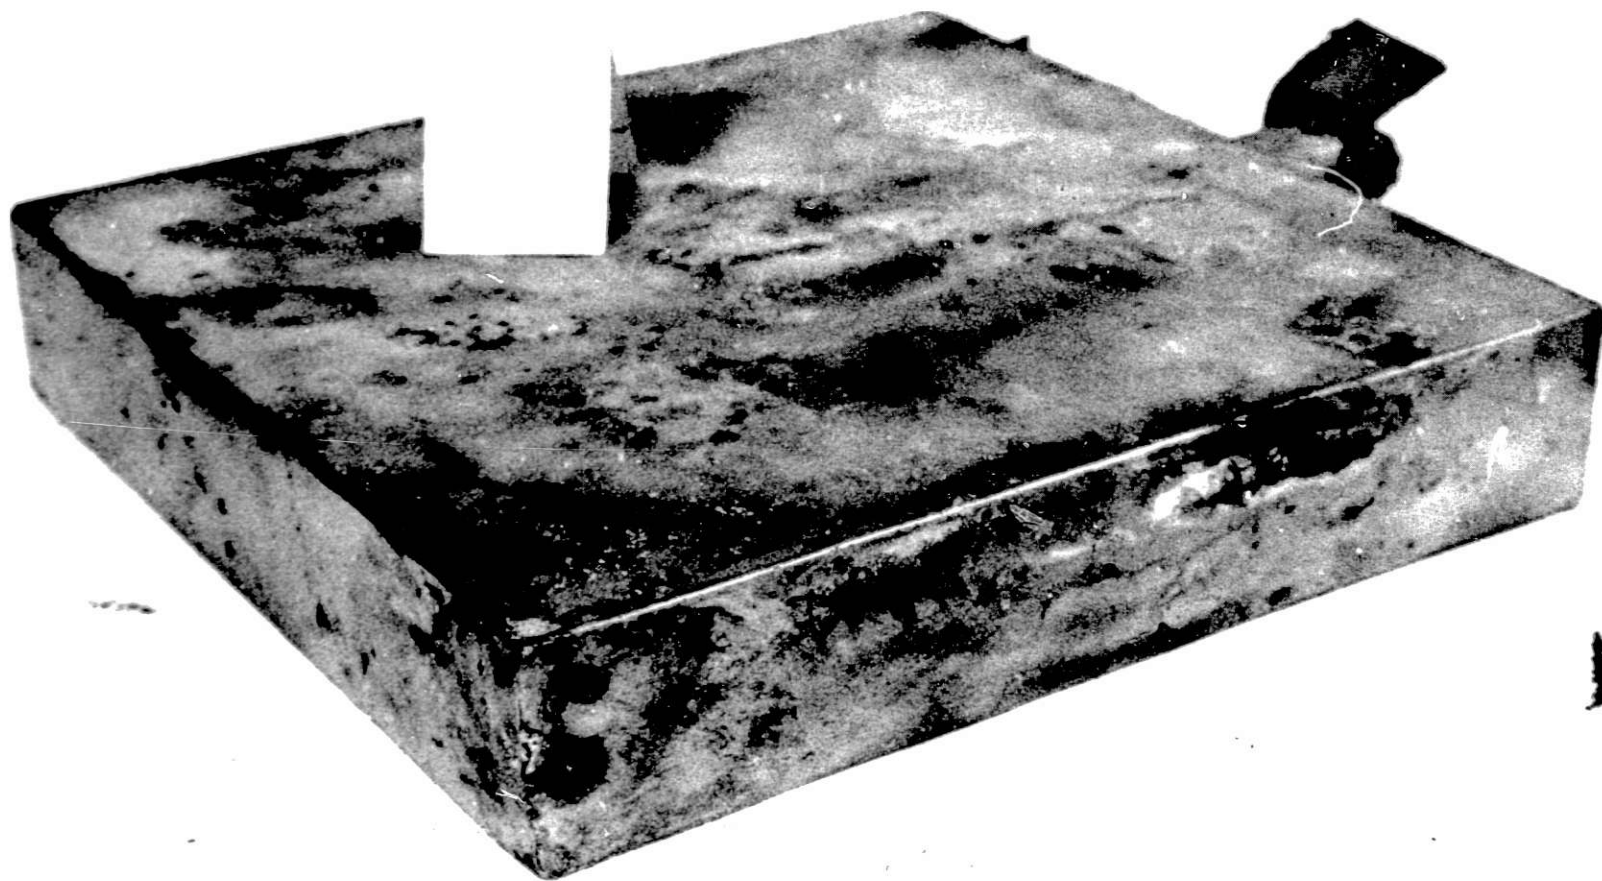
Fig. V-11. Photograph of Cell 2 (note the hole and corrosion effects at lower inside edge)
