ORNL/TM-13442

OAK RIDGE  
NATIONAL  
LABORATORY

## Composite Tube Cracking in Kraft Recovery Boilers: A State-of-the-Art Review

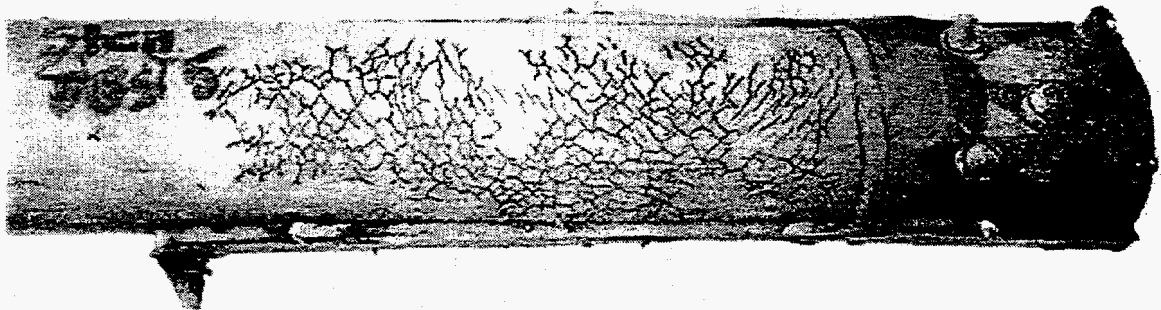
All boiler manufacturers report significant cracking of coextruded floor tubes. Cracking has also been detected in boilers with coextruded wall tubes extending for a short distance into the floor before joining carbon steel floor tubes (Fig. 6). In such boilers, cracking may occur on the portions of tubes underneath the smelt bed. Cracks have also been observed at the butt welds between the coextruded tubes and the carbon steel tubes.

**Fig. 6. Boilers with carbon steel floors and coextruded wall tubes are susceptible to cracking.** This portion of coextruded tube from a European boiler formed the lower bend of a coextruded wall tube at the point where the tube is butt-welded to a studded carbon steel floor tube.

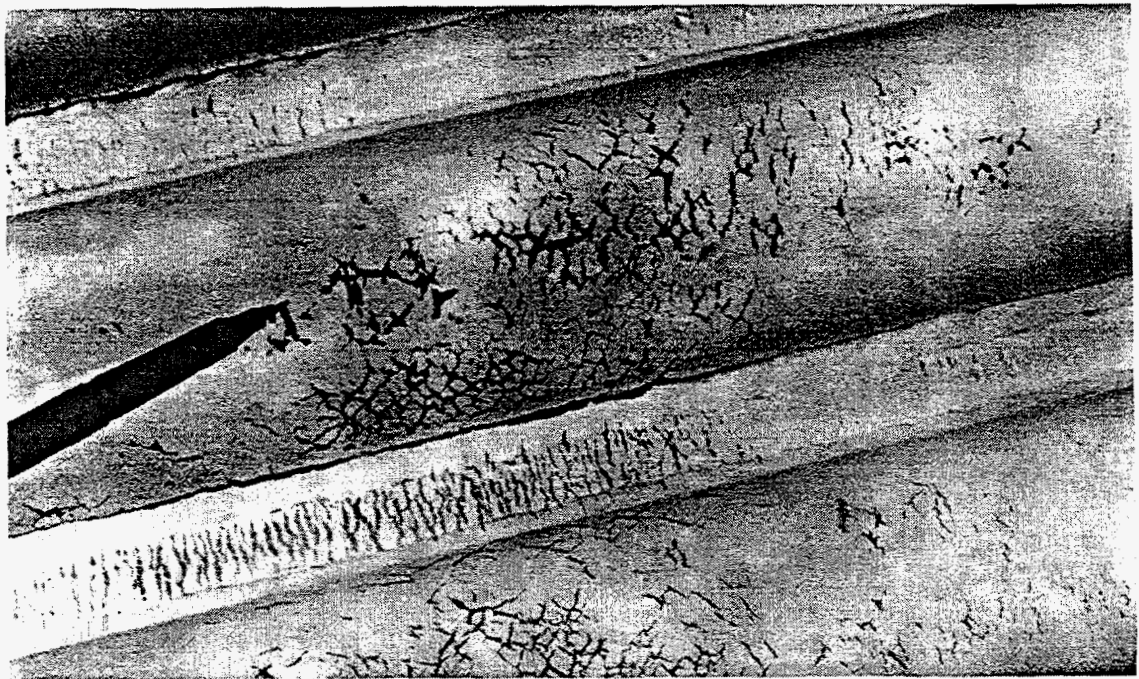
In some cases, cracking has been confined just to the membrane, but it appears more common for cracks to be present in the adjacent tube and the tube-to-membrane weld (Fig. 7). Cracking in the crowns of the tubes is also observed. In many instances, the cracking has been so severe that the outer layer of stainless steel had spalled in chunks, exposing the inner carbon steel core (Fig. 8).

**Fig. 7. Floor-tube panel from a North American boiler showing cracking in coextruded tubes.** Cracks have been highlighted by dye-penetrant inspection. Cracks can be observed on the tube crown, at the tube-membrane interface, and in the membrane.

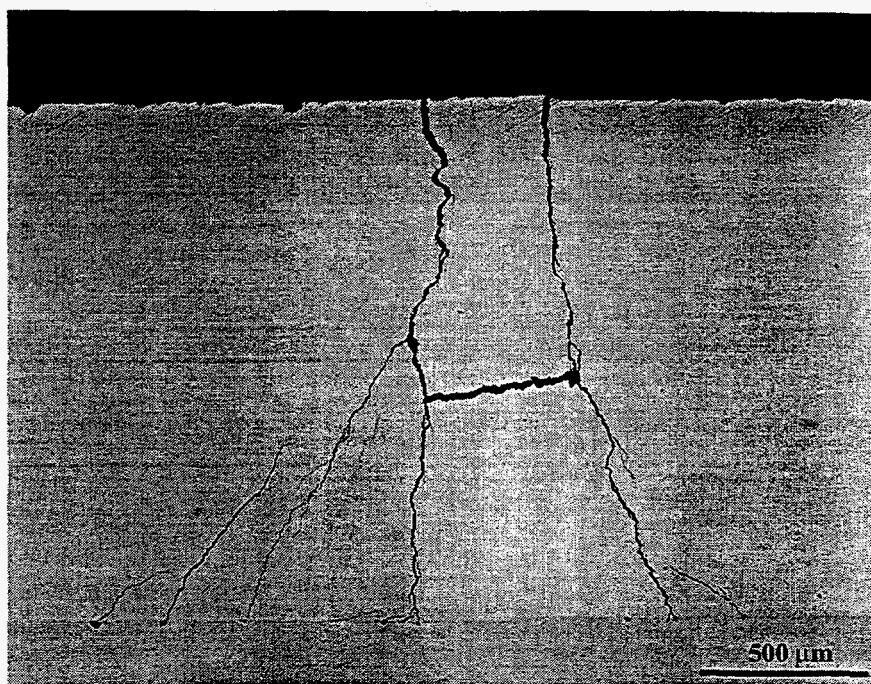
**Fig. 8. Severe cracking can lead to spalling of the outer stainless steel layer and can leave exposed carbon steel underneath.**

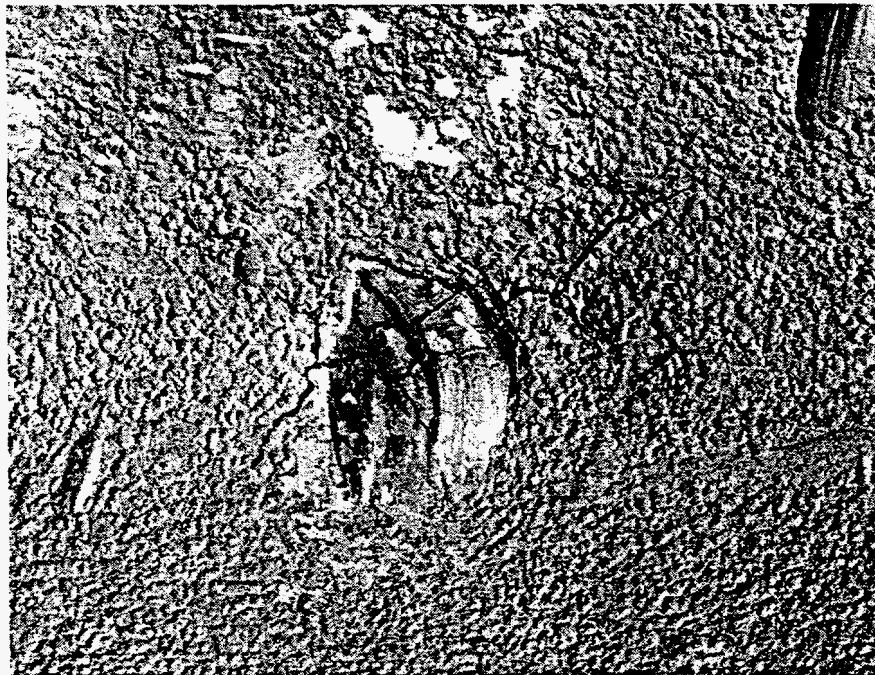
Fig. 9. "Star-burst" crack on surface of spout opening tube damaged by rodding.

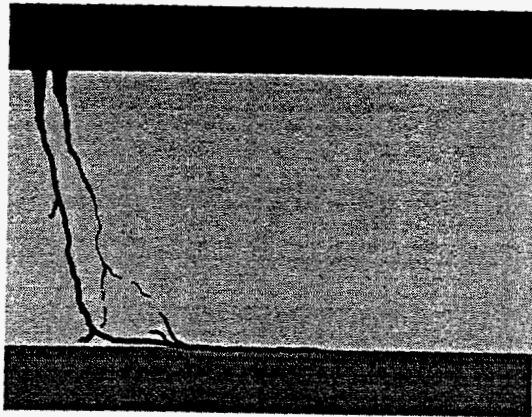
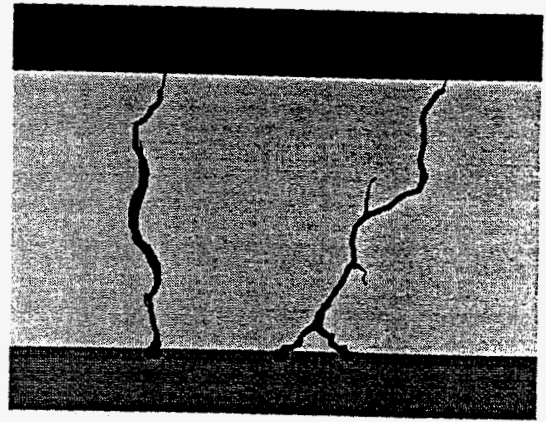
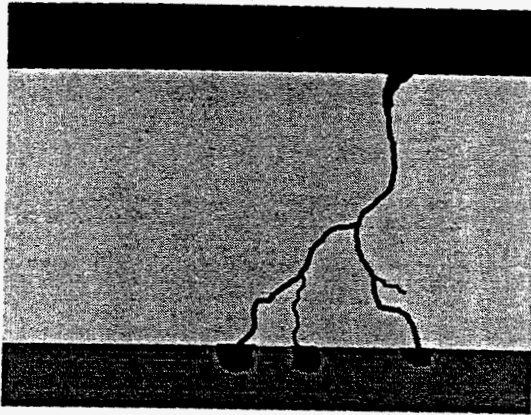
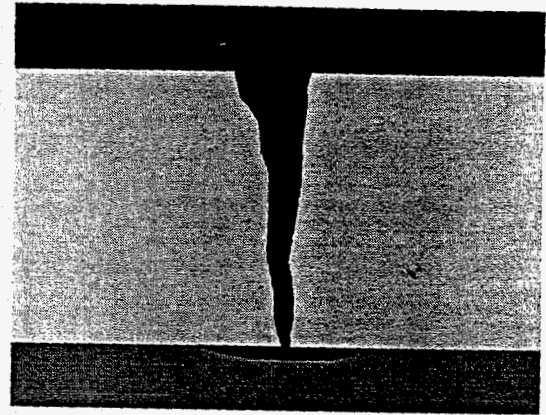
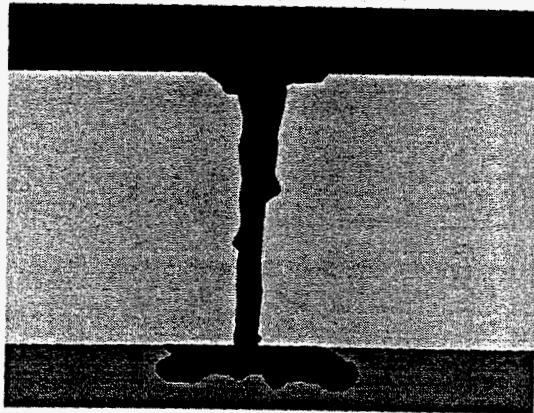
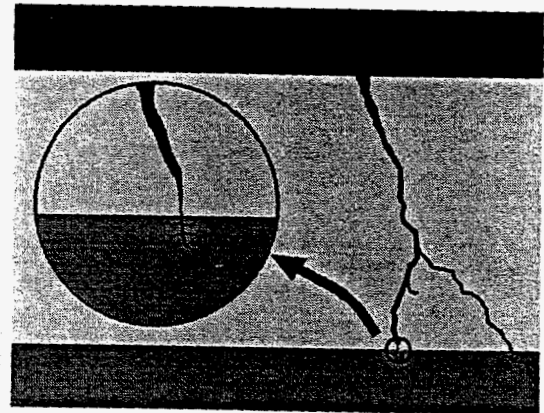
Fig. 11. (continued)

Several examples show how corrosion of the carbon steel can occur at the point where the crack meets the interface. The cracks allow access of corrosive species that attack the carbon steel at a faster rate than they attack the stainless steel. Damage may show itself as small spots of corrosion at the crack tips (Fig. 11*h*), which eventually grow into pits of considerable size (Fig. 11*i*). The region of active corrosion can spread along the interface (Fig. 11*j*), or can produce broad corrosion pits in the carbon steel (Fig. 11*k*). There are also cases in which intergranular attack of the carbon steel has been noticed in the vicinity of the crack tip (Fig. 11*l*).

The most alarming micrographs of cracks in coextruded tubes are those that show cracks that penetrate from the outer layer of stainless steel, through the interface, into the carbon steel tube. Several such cracks have been found, primarily in air ports and smelt-spout openings. In floor tubes, the information surveyed to date has revealed a few cases of crack penetration into the carbon steel. In most cases the penetration was slight, perhaps a few thousandths of an inch into the decarburized zone of the carbon steel. However, there is at least one report of a crack progressing through 50 to 60% of the carbon steel core, although without confirming metallography. More recently, a through-thickness crack initiating at the tube-membrane weld has been found.

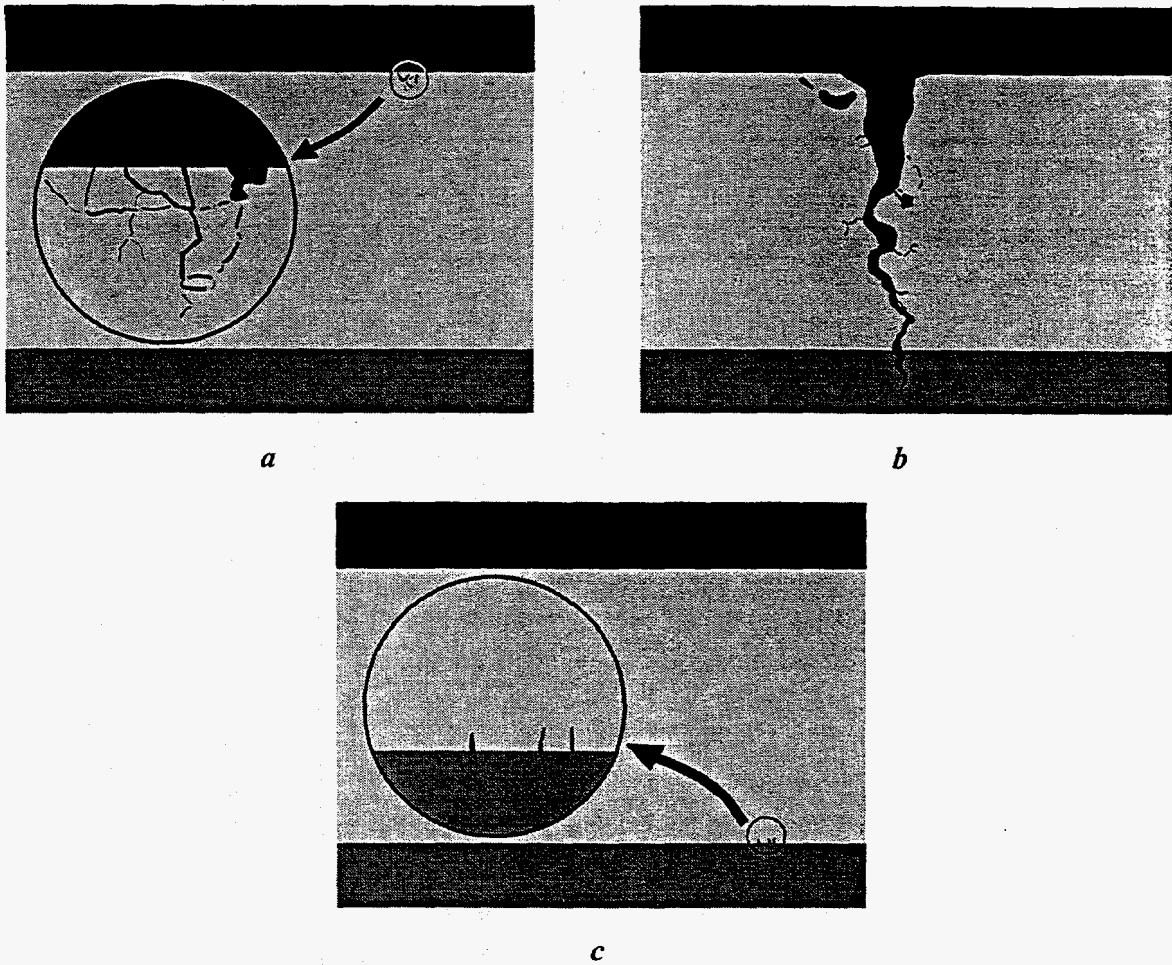
Up to this point, the cracks described in the stainless steel layer have been transgranular; however, there have been a few reports of intergranular cracking (Fig. 13*a*). These are unusual and can generally be attributed to sensitization of the stainless steel. In the early 1980s some tubes were manufactured from stainless steel with a high carbon content (i.e., AISI 304 instead of AISI 304L). These were susceptible to sensitization during heat treatment or during service if overheated. There is a recorded incident of an intergranular crack penetrating from sensitized stainless steel through the interface into the carbon steel core (Fig 13*b*). However, no further incidents of intergranular cracking have occurred in recent years.

As a final note, another type of crack morphology has been observed in coextruded tubes. It is not at all common, but a few cases were reported in the early 1980s. Subsurface cracks existed in the carburized zone of the stainless steel layer, adjacent to the interface with the carbon steel core. These were fine cracks, typically up to 0.05 mm (0.002 in.) in length, oriented perpendicular to the tube axis (Fig 13*c*). It was suggested that these cracks were the result of dense carbide precipitation and thermal fatigue. The phenomenon was described as "clad-interface cracking."

Fig. 13. Intergranular cracking and interface cracking in coextruded tubes.
