**Experimental Flight Test Vibration Measurements and
Nondestructive Inspection on a USCG HC-130H Aircraft**

David G. Moore and Craig R. Jones
FAA Airworthiness Assurance NDI Validation Center (AANC)
Sandia National Laboratories, Albuquerque, NM 87185-0615

LCDR Joseph E. Mihelic and ADC James D. Barnes
U.S. Coast Guard (USCG) Aircraft Repair and Supply Center (ARSC)
Elizabeth City, NC 27909-5001

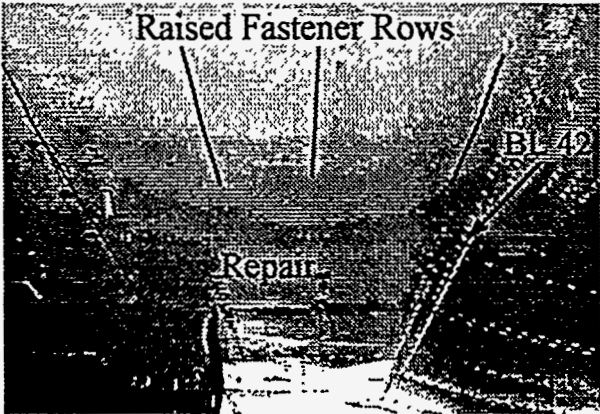
Detailed eddy current measurements were performed on the right wheel well skin structure of HC-130H (S/N 1719) at the CGAS-Clearwater, Florida by Sandia on 26-28 Aug 97 (See Figure 2). No significant problems were encountered in accomplishing these inspections. Only relatively few small cracks were found and documented during the initial inspections (See Table 1).

Figure 2: Inspection area (looking aft) of the FLIR. Repair location is where Initial damage was detected.

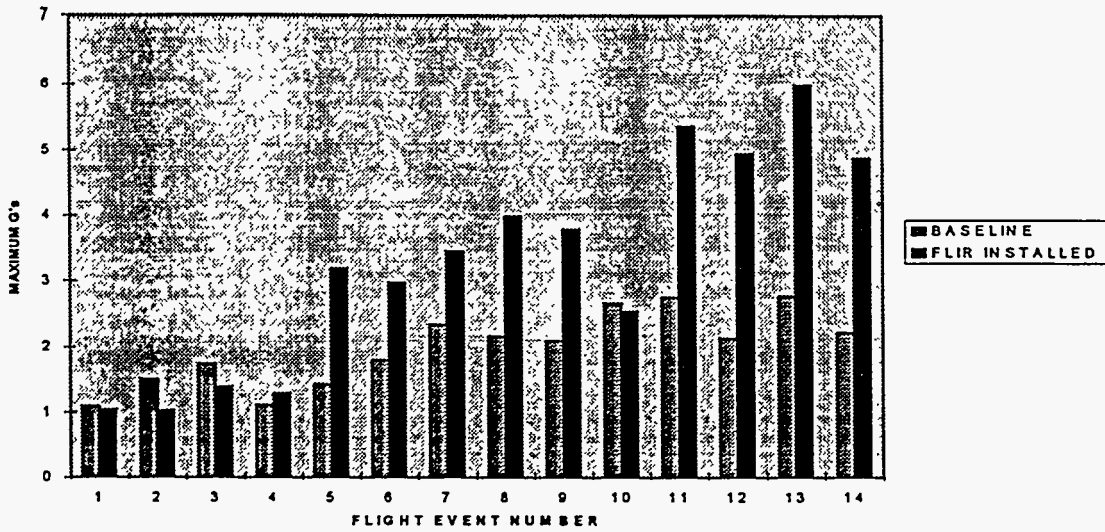
Figure 9: Accelerometer on Longeron, Before Structural Enhancement

Figures 10 and 11 (Maximum G's versus. Flight Event Number) show the loading experienced by right wheel well fairing structure throughout all phases of the test flight at one typical location. Generally, loading increased with increased airspeed and torque settings. Significant increased loading was observed with the FLIR installed. The stiffener shown here experienced an increase in loading by up to a factor of ten with the FLIR installed.

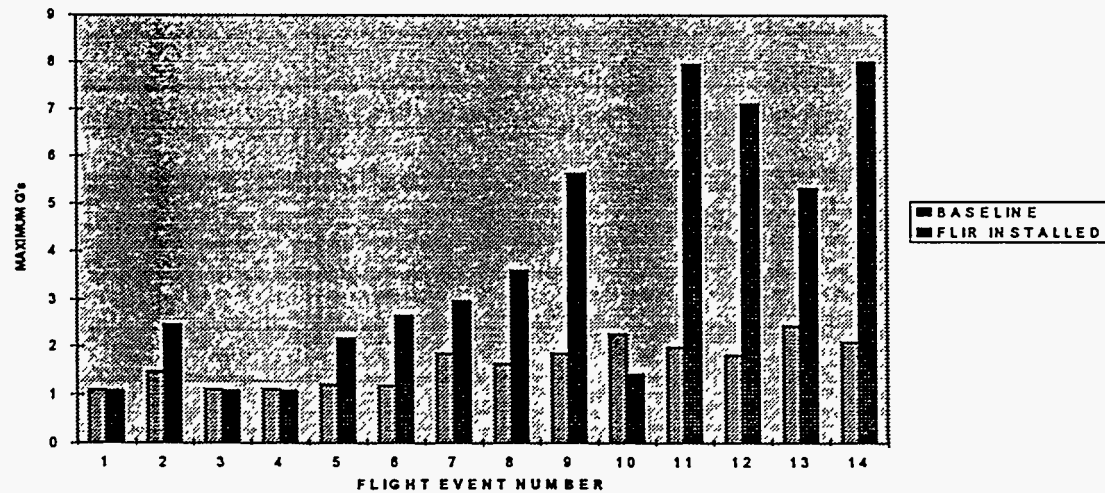
Figure 11: Accelerometer on Stiffener, After Structural Enhancement

After the structural repairs, the vibration environments encountered by the skin structure and the MLG inner door with the FLIR attached are still high in some areas. FLIR video was also available during the second flight and confirmed that there was a significant reduction in visible skin panel vibration from that observed on a previous FLIR systems testing flight in August. Comparison plots directly showed that the vibration environments with the FLIR attached were almost always higher (sometimes significantly) than those measured during the first (baseline) flight and that the structural repairs and modifications were very effective in reducing vibration environments in this part of the HC-130H structure.

The aircraft was ferried to ARSC in Elizabeth City, NC where it underwent significant structural repair and modification. This repair and modification effort included replacing the entire lower skin panel of the right main wheel well fairing with a skin of a heavier gauge, 1.60 mm (0.063"), and adding additional stiffeners and longerons to further stiffen and strengthen this region of structure. These repairs and modifications were completed on 31 Oct 97. The aircraft was then instrumented with fourteen accelerometers in this area to as closely as possible repeat the locations that were instrumented in the earlier flight tests of 27-28 Aug 97. In a few cases, the exact locations were not repeated since new structure had been added at or very near the original locations. Two test flights were conducted on 1 Nov 97 to measure vibration environments in this structure to compare with the earlier environments measured on the original structure both with and without the FLIR installed. These test flight profiles were designed to duplicate the test conditions at which data were collected during the earlier series of flight tests. The following is an overview of the vibration results obtained after the structural repair and modification. These data were compared directly with those taken during the earlier flight tests to display the effects that the heavier gauge skin and additional internal stiffening members had on reducing the vibration environments in this area of the HC-130H aircraft.
