# Nondestructive Evaluation of Ceramic Matrix Composite Combustor Components

Presented at 29<sup>th</sup> Annual Review of Progress in Quantitative Nondestructive Evaluation, Bellingham, WA, July 14-19, 2002.

J. G. Sun<sup>1</sup>, M. J. Verrilli<sup>2</sup>, R. Stephan<sup>3</sup>, T. R. Barnett<sup>4</sup> and G. Ojard<sup>5</sup>

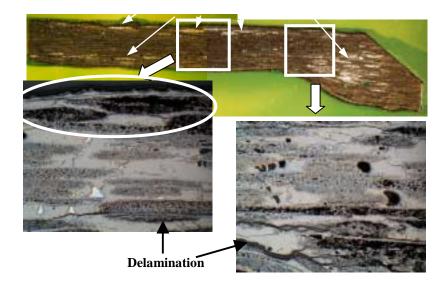
To investigate the origin of local lower diffusivity values, a LZID was sectioned and polished. Figure 4 shows the microstructure of a cross-section taken from 216-1. The line on the thermography image in Fig. 3 shows the location of the cross-section. Damaged SiC fiber tows and delaminations cracks can be seen. The diffusivity reduction shown in Fig. 3 is related to the damage (i.e., delamination) of the CMC material due to the sector testing. For a single delamination, Sun [8] showed that the diffusivity reduction could be used to determine the (air gap) thickness of the delamination.

Figure 4 – Microstructure of LZID 216-1 after 115 hours of combustion exposure. The line in Fig. 3 shows the location of this section. Arrows indicate damaged tows.

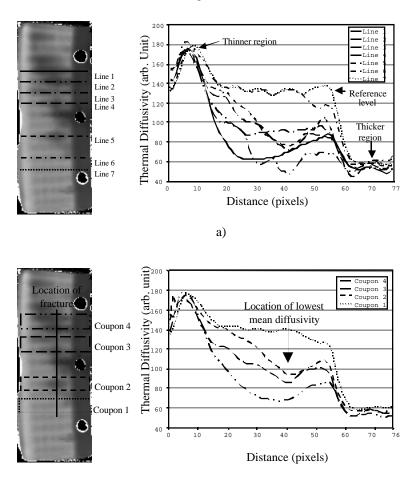
Thermal diffusivity data for another LZID with 34 % fiber volume, which was exposed in the combustion environment for 145 hours, is shown in Fig. 5. Thermal diffusivity values are plotted in Fig. 5a along 7 horizontal lines passing through several interesting regions in the thermal diffusivity image of 216-2. Although there is thickness variation near both vertical edges of the liner, the thickness is uniform in the middle section and is used in the diffusivity calculation. In this middle section, the measured diffusivity is found uniform in undamaged regions (e.g., line 7). Reduced diffusivity representing damage of varying severity is shown in other regions (lines 1-6). Figure 5b plots the width-averaged diffusivity along the length for the regions where 4 coupons were machined from the part to obtain flexure strength. It is apparent that coupons 2-4 contained large damaged areas with significant thermal diffusivity reductions and coupon 1 had only slight damage near

Figure 5 – Thermal diffusivity data for LZID 216-2 after 145 hrs of combustion exposure, a) line plots at 7 part locations, b) average values for regions of coupons machined for strength measurement.

the region of thickness transition at right. It is interesting to note that fracture occurred near the locations where lowest diffusivities were observed for coupons 2-4.

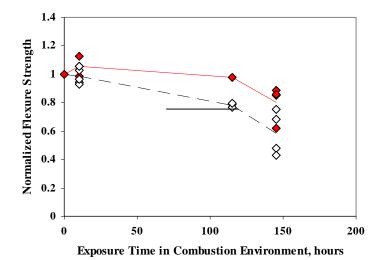
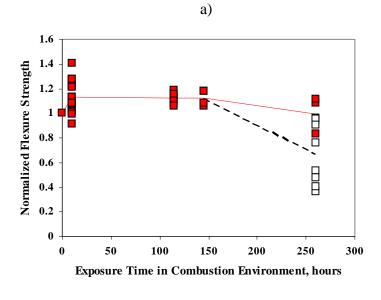
b) Figure 6 – Normalized flexure strength data obtained at 815 °C as a function of exposure time for coupons machined from LZIDs, a) data for coupons from 34 % fiber volume parts, b) data for coupons from 40 % fiber volume parts.

The normalized flexure strength versus combustion exposure time for coupons machined from all LZIDs tested in the sector rig is shown in Figure 6. The normalized flexure strength was calculated as the ratio of the strength of a coupon machined from a tested LZID to the average as-fabricated strength obtained from the LZID witness coupons for the same part. Strength decreases with increasing exposure time for the parts with 34 % fiber volume, while the strength of the 40 % fiber volume decreased after 115 hours of exposure. Also, coupons machined from component regions with thermography indications had lower strengths than coupons from regions of no NDE indications. The strength data sets for coupons with and without NDE indications follow the same trends as a function of exposure time.
