**BNL-52651
FORMAL REPORT**

**INVESTIGATION IN HARDSURFACING A
NICKEL-COPPER ALLOY
(MONEL 400)**

**Carl Czajkowski and Melissa Butters
Brookhaven National Laboratory
Upton, New York 11973-5000**

December 2001

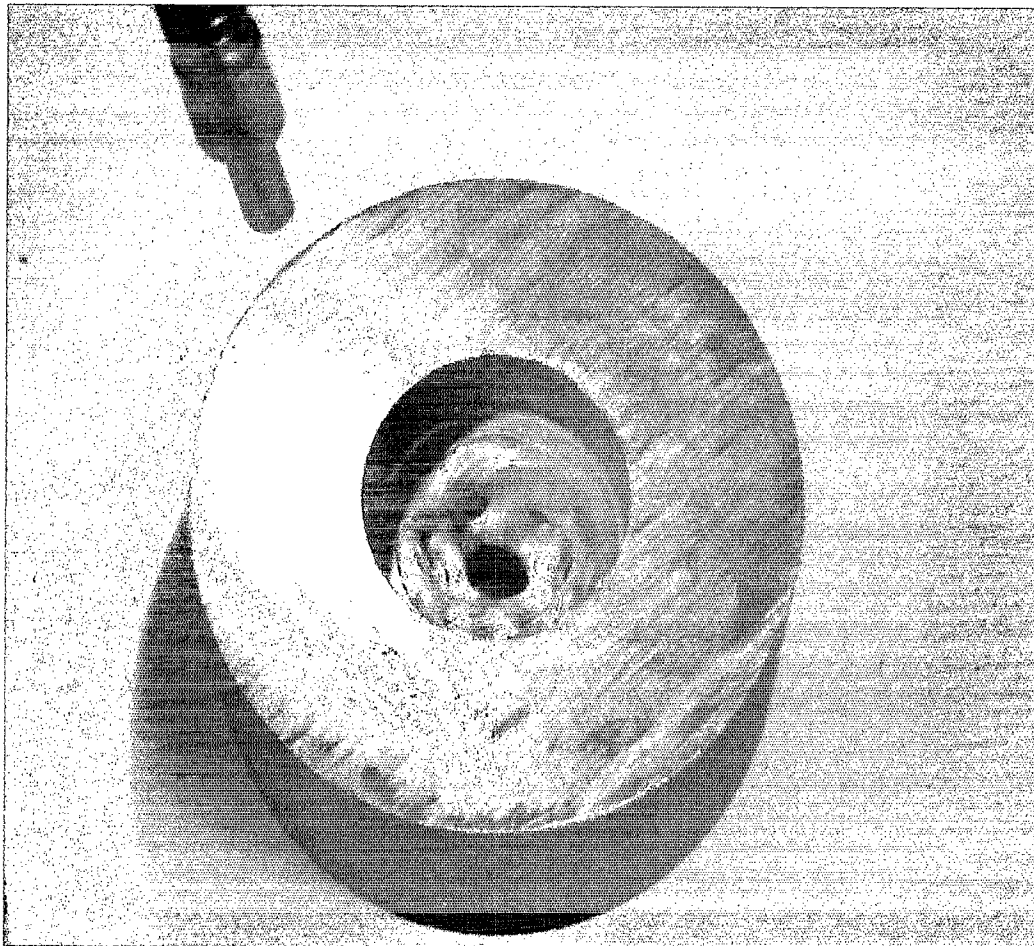
There were linear indications (cracks) evident on the valve body, both on the circumferential area (top of valve body) and below the hard surfaced weld deposit. The heat affected zone (HAZ) also contained linear discontinuities. The valve body was welded using the oxyacetylene welding process, a qualified and skilled welder, and had been given a pre-heat of between 1400-1600°F (760-871°C), which is the Target Rock qualified procedure requirement.

Discussions with the welder indicated that he had observed a reddish tint (liquid-like in appearance) cover the base metal during the application of the hard surfacing material. He was not specific on gas bubble formation during this operation, which would be indicative of gas trapped in the base metal. Target Rock personnel had indicated that this heat of material had been produced from double vacuum re-melted stock, which should have de-gassed the metal sufficiently to preclude gas entrapment. Ensuing conversations with Target Rock personnel indicated that although this part had failed during hard surfacing, the heat of material (Allvac 99-0950) had produced some acceptable parts for other component configurations. Other than this

Figure 1: Digital Photograph of the Failed Valve Bonnet, After Hard-Surfacing

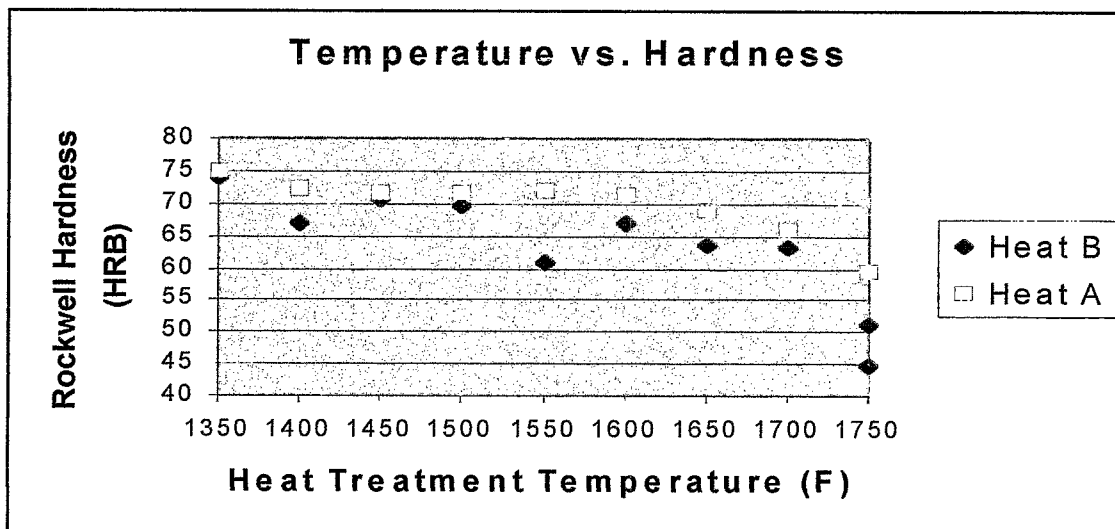
Figure 2: Relationship Between Temperature and Hardness for Heats A (Inco) and B (Allvac)

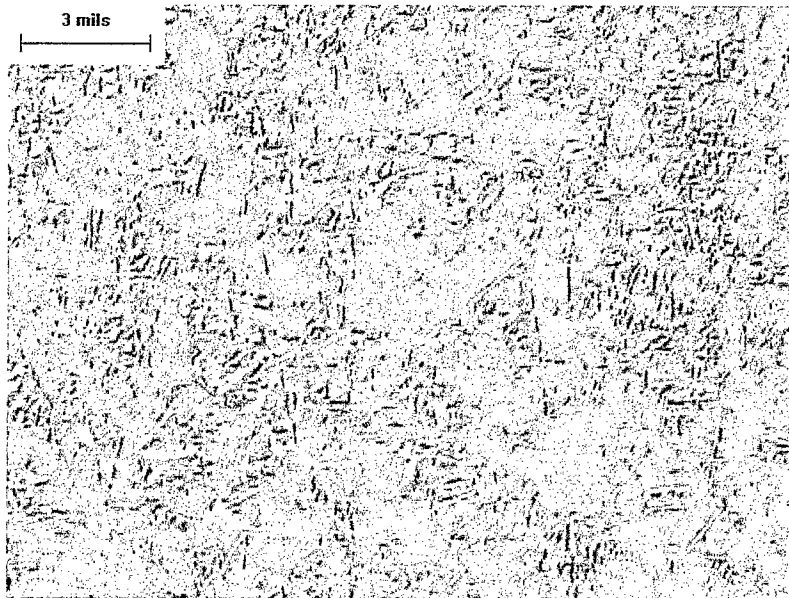
Figure 22. Optical Photomicrograph of Sample U2, “as received”, (1420 – 1430°F)

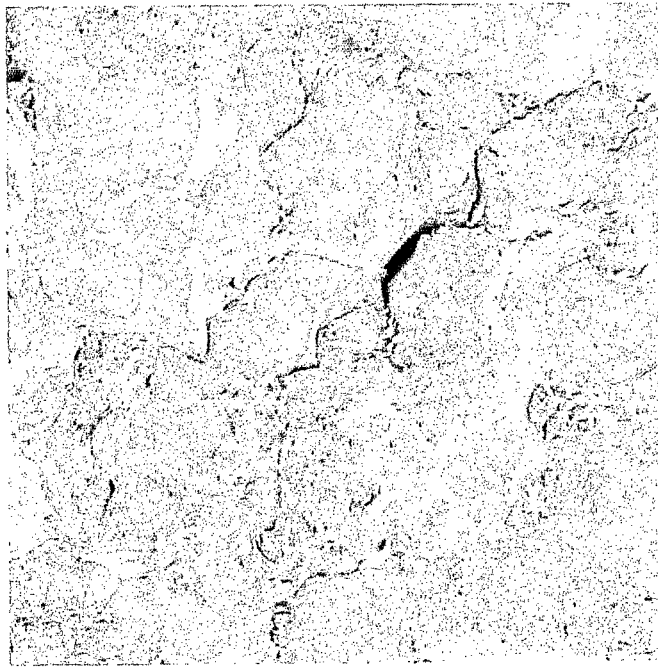
Figure 53: Intergranular Features are Very Distinct in this Fractograph of a Second Area Examined
