Final Results of Double-Shell Tank 241-AN-105 Ultrasonic Inspection

Key Words: ultrasonic, tank integrity, examination, 241-AN-105, 105-AN, inspection, wall thinning, UT testing, tank wall, UT, integrity assessment, ultrasonic inspection

FINAL RESULTS OF DOUBLE-SHELL TANK
241-AN-105
ULTRASONIC INSPECTION

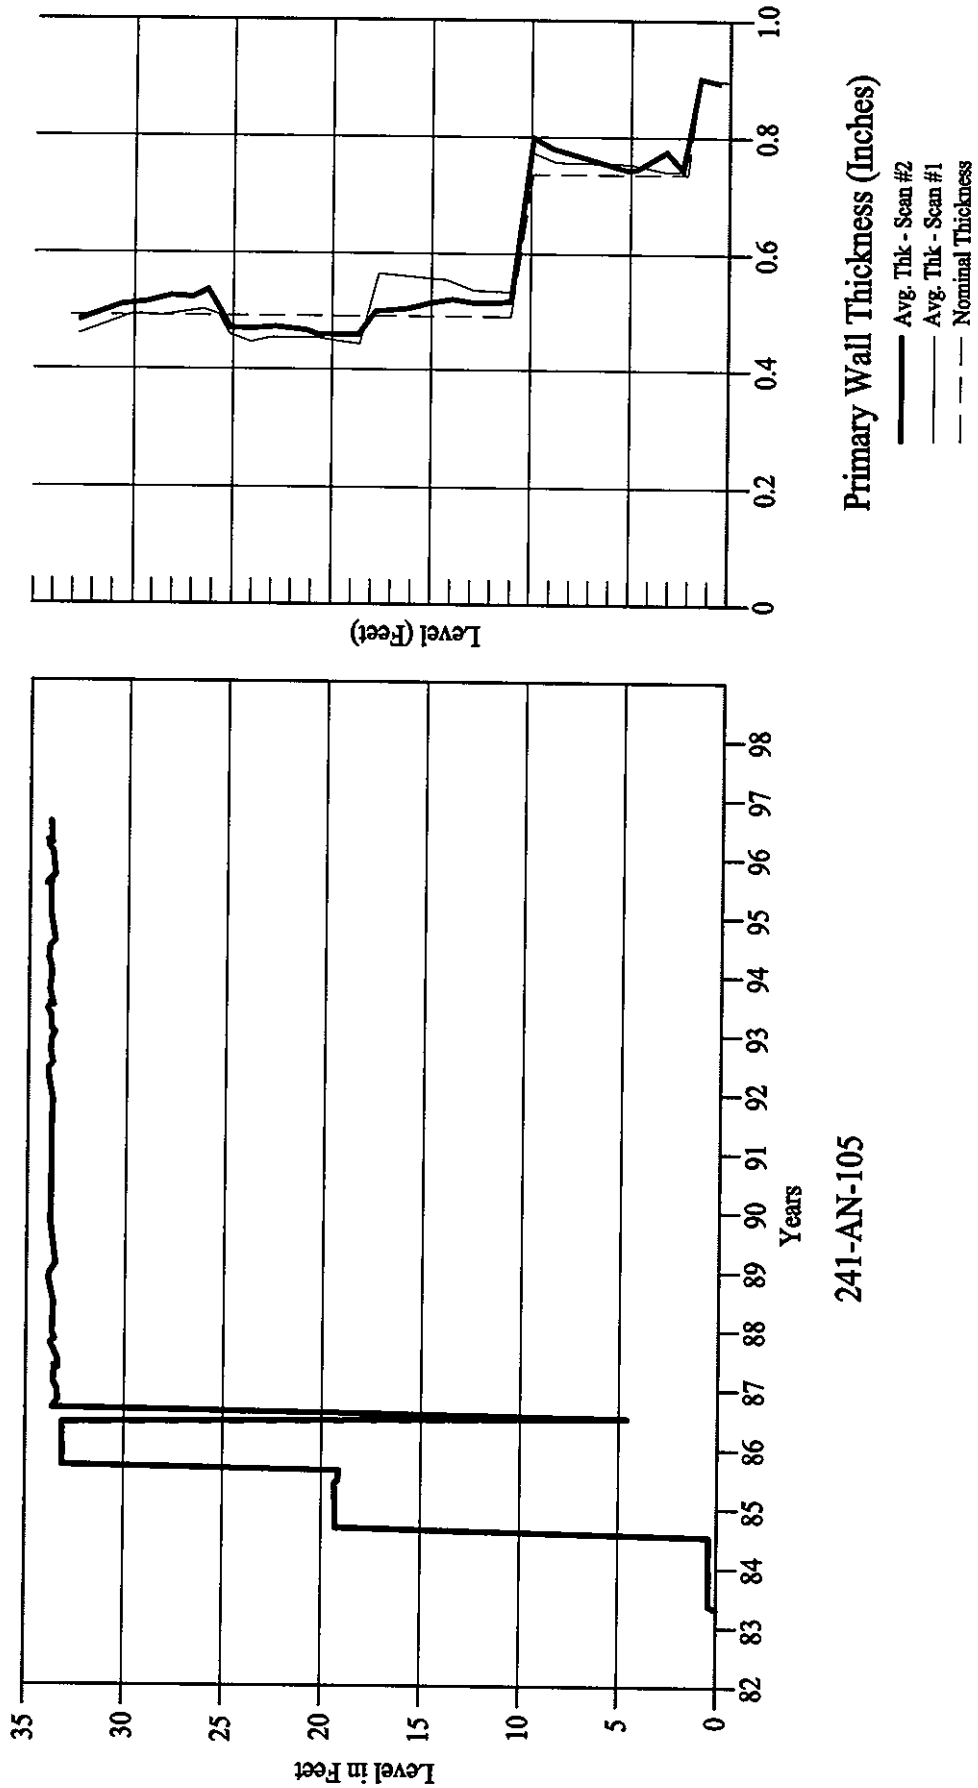
Figure 1 - Comparison of As-Measured and ASTM-Specified Plate Thickness with Waste Level, DST 241-AN-105

The results of the Tank 241-AN-105 UT examination indicated some wall thinning with no cracks detected. Attachment 1 contains the report prepared by Pacific Northwest National Laboratory (PNNL) that analyzes the data gathered from Tank 241-AN-105. Figure 1 shows the history of waste level matched with the "as-found" measurements of the primary tank wall generated from the inspection data sheets (Attachment 2). Each wall thickness measurement plotted on the figure is the average of all data collected over a 1-foot long by 15-inch wide scan area. Areas of interest are the vapor space above the waste, the liquid-vapor interface, the liquid region, the liquid-solids interface, and the solids region. The average measured wall thickness showed some indication of thinning at the lower 2 feet of plate 1 and all of plate 2.

- Some thinning is occurring in primary tank wall plates #1 and #2. The additional plate #2 scans (horizontal) pass over a vertical weld at about 15 to 16 feet from the beginning of the scan. Thinning was detected in both plates #1 and #2.
- In addition to the general thinning, localized thinning is also occurring. The thinnest area identified is 0.40 inch wall thickness.
- Scans of the heat affected zones (HAZ) in Plate #3, #4, #5, and the knuckle revealed no corrosion, pitting, or crack-like indications.
- No crack-like indications were detected in the horizontal and vertical welds.

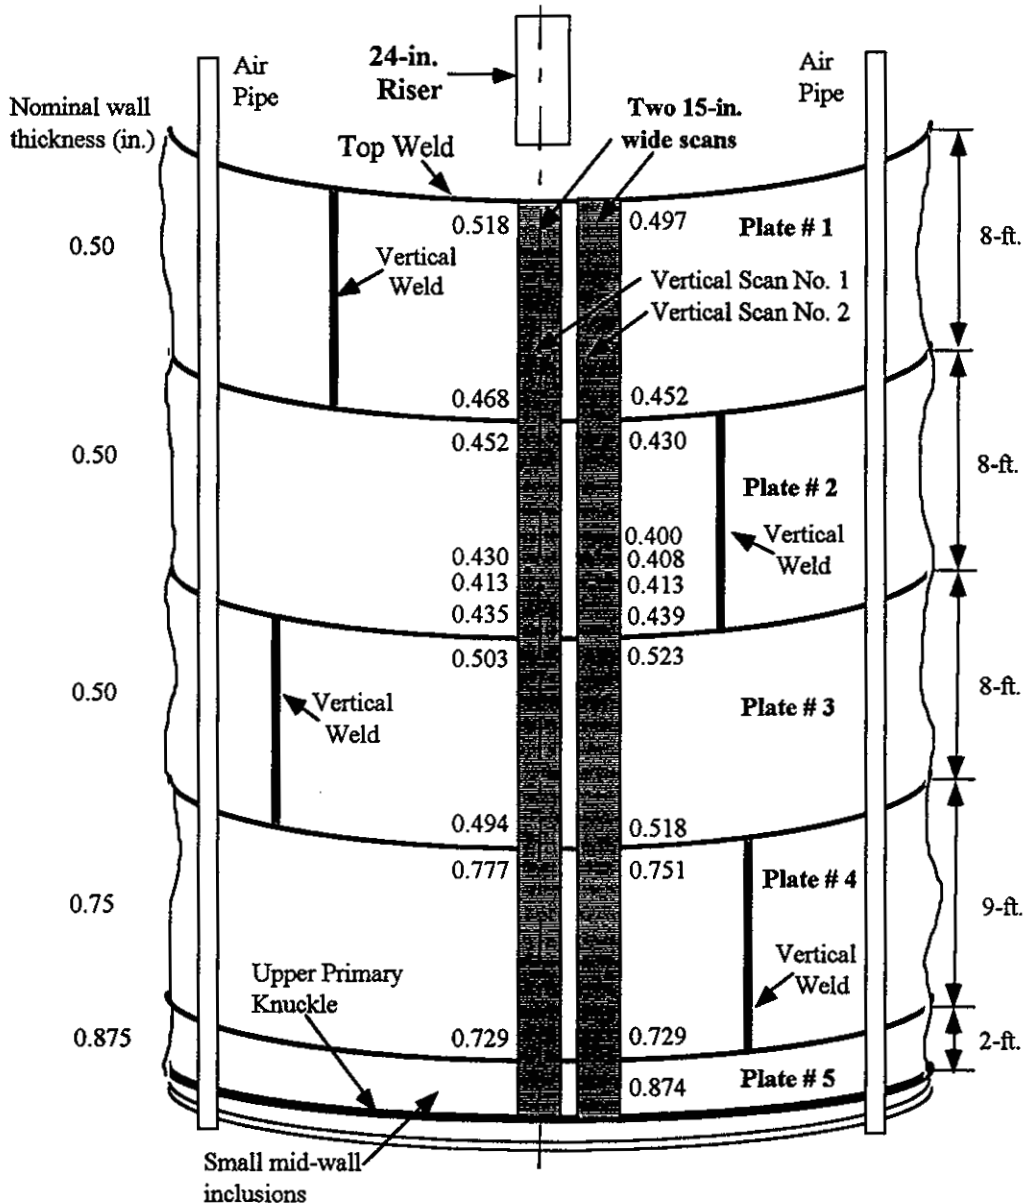
Figure S.1. Sketch of the UT Vertical Scan Paths No. 1 and No. 2 on Primary Tank 241-AN-105^(a)

- Plate #1—Scan Path No. 1—the ultrasonic data showed some general wall thinning/corrosion throughout the plate. The 1-ft section below the top weld showed the wall thickness to be 0.518 in. This thickness gradually reduced to 0.465 in. near the weld between Plates #1 and #2. Wall thickness values are shown in the Figure S.1 near the top and bottom on the plates.

- Plate #2—Scan Path No. 1—the ultrasonic data showed a wall thickness at the weld between Plates #1 and #2 to be 0.452 in. decreasing to 0.439 at the weld between Plates #2 and #3. However, there are several additional indications of wall thinning in the plate. Between 13 and 14 ft below the top weld, a small pit-like/corrosion indication was recorded at 0.430 in. Between 14 and 15 ft below the top weld a small pit-like/corrosion indication was recorded to be 0.413 in. The approximate locations of the pit-like/corrosion indications are shown as individual spots in Figure S.1.

- Plate #2—Scan Path No. 2—the data showed a wall thickness of 0.430 in. at the top and 0.439 in. at the bottom of the plate. However, between 13 and 14 ft below the top weld, a pit-like/corrosion indication was recorded at 0.400 in. Between the 14 and 15-ft level pit-like/corrosion indications of 0.408 and 0.413 in. were recorded. There also were other randomly spaced pit-like/corrosion indications throughout the lower half of this plate but none had thinner wall measurements than those identified. The approximate locations of these pit-like/corrosion indications are shown as spots in Figure S.1.

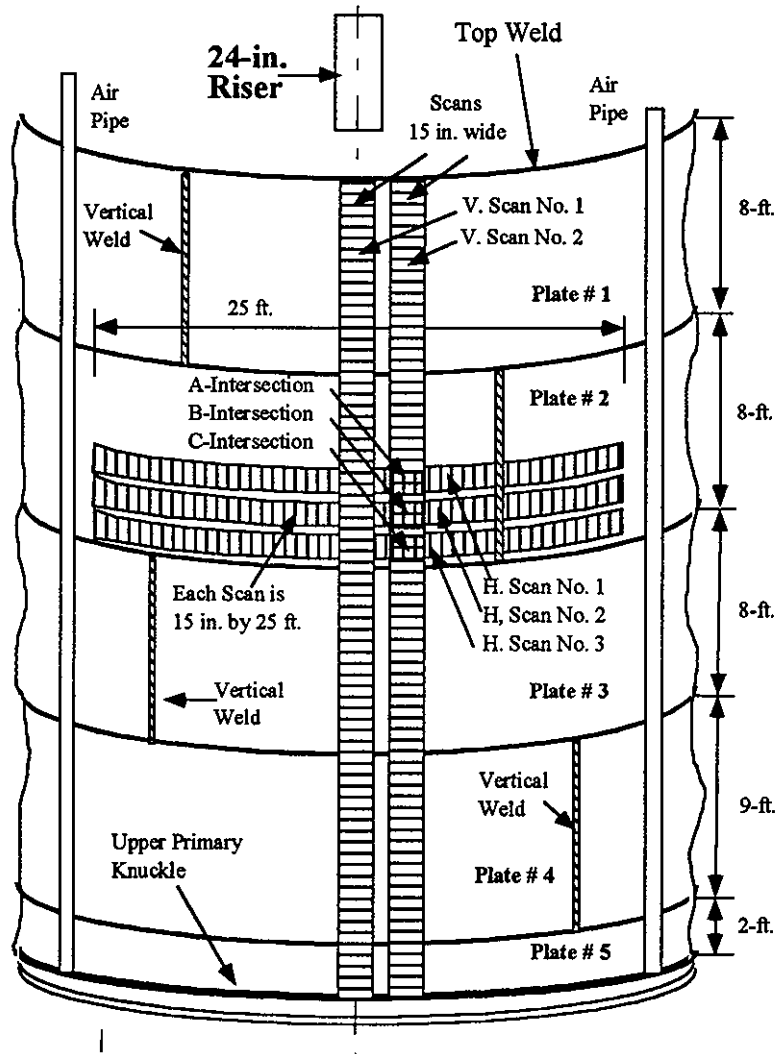
Figure 2.1. Sketch of Vertical and Horizontal Ultrasonic Scan Paths of the Wall of Plate #2 on the Primary Tank of Tank 241 AN-105

In Plate #2, the vertical scans showed areas that were thinner than 0.450 in. However, from these scans, the extent of wall thinning that might be present in the circumferential direction around the tank could not be determined. As a result, further investigations were pursued. Figure 2.1 shows two vertical and the three horizontal (circumferential direction on the tank) scan paths made to investigate the wall thickness measurements in the plate. The data acquired in the horizontal scan paths were 12-in. wide and 25-ft long. Hard copy, C-scan plots were made for each foot of the horizontal scans.

One of the regions of interest was the horizontal scan 13 to 14 ft from the top weld (6 ft below the weld between Plate #1 and #2) where the vertical scan measured a minimum wall thickness of 0.400-in. To obtain the data in the horizontal direction, the magnetic wheel crawler was maneuvered so that it was positioned at the left air pipe with the transducer assembly positioned so it could inspect the plate in the circumferential direction. Data was taken as the crawler indexed to the right air pipe shown in the sketch. The location of the air pipes with respect to the 24-in. riser was not clearly established and the physical size of the remote crawler made it difficult to locate the intersection of the vertical and horizontal scan paths. Table 3 shows the thicknesses recorded for the three 25-ft scan paths. From the data in Table 3 it appears that the thinnest areas are near the 10.5-ft and 11.5-ft distance from the air pipe. The 0.400-in. thickness measured in the vertical scan path was not detected, but several spots that were less than 0.450 in. were recorded in Scan Paths No 2 and 3.

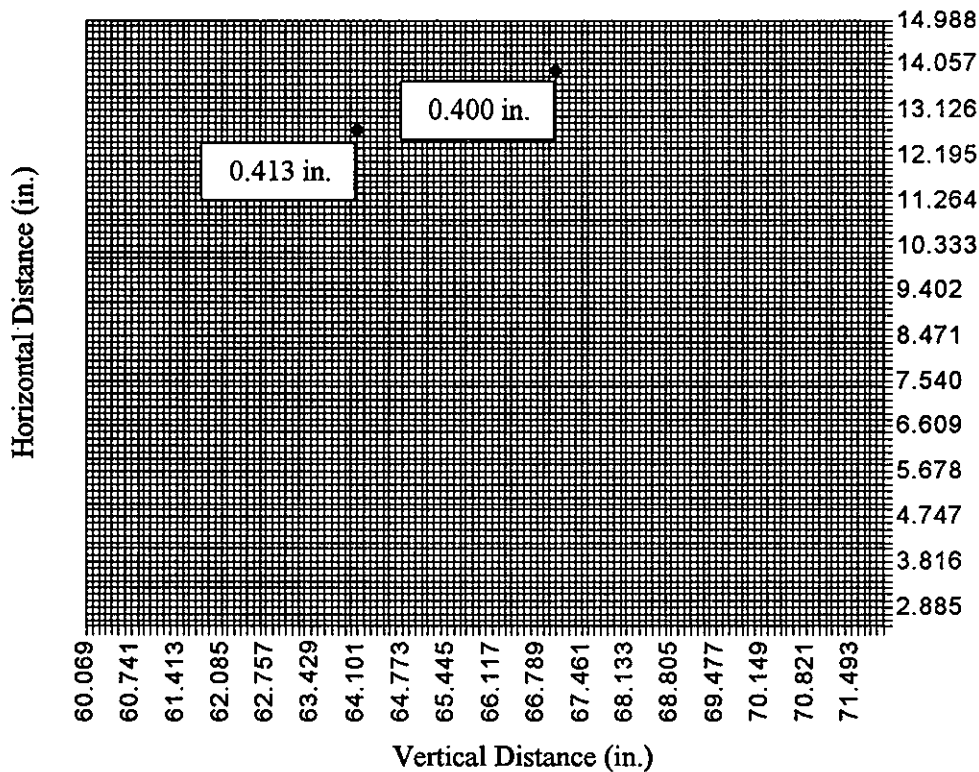
Figure 2.2. Global View of the 1-ft Area Containing two Minimum Wall Thickness Indications in the Wall of the Primary Tank (Scan Path No. 2 of Plate #2)

Figure 2.2 is a C-scan view of the 12-in. by 12-in. area containing the 0.400-in. indication.(see Table 2, Scan Path No. 2 at 13 to 14-ft level below the top weld). The information is taken from the 0-degree beam record. In the figure, the numbers on the abscissa values (60.069 in. to 71.493 in.) are incremental (or index) steps of the 1-ft vertical distance measured from the weld between Plate #1 and #2. The ordinate (2.885 to 14.988) is the traverse or circumferential distance on the tank wall (horizontal distance in graphic). The position data are obtained from the encoder on the AWS-5 mechanical crawler.

Only one minimum thickness indication (0.400 in.) was recorded in this 1-ft by 1-ft area in Table 1, but a second indication (0.413 in.) is shown in Figure 2.2. The analyst recorded only the minimum value but the C-scan plot shows that more than one pit-like indication can be present. To characterize both of the indications, orthogonal horizontal and vertical line profiles were generated from the information in the Excel spread sheet.

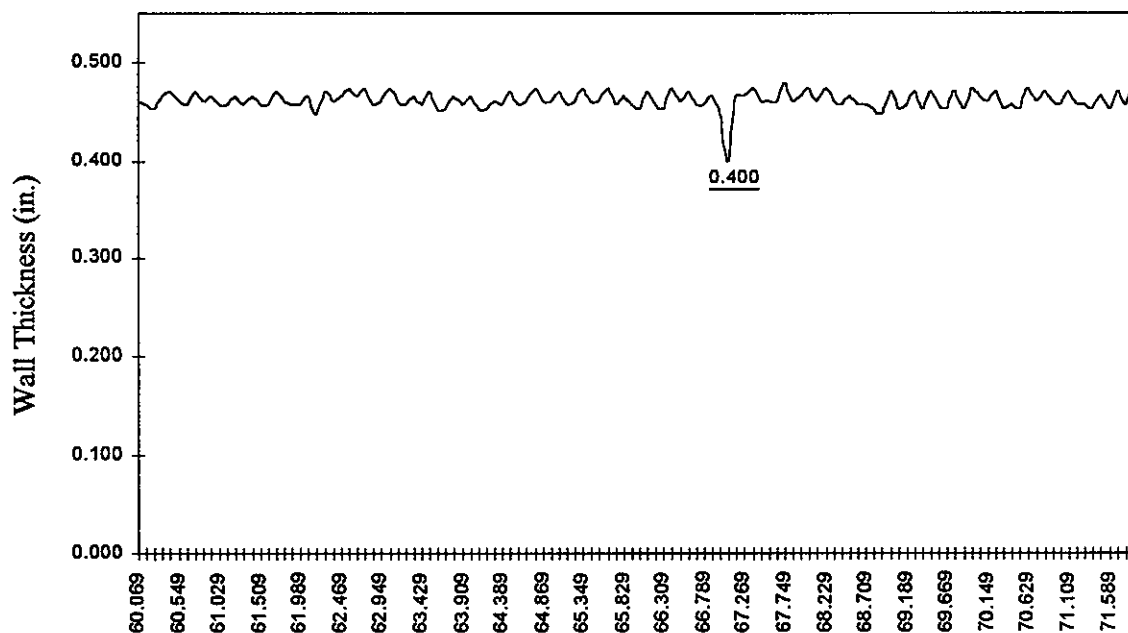
Figure 2.3. Line Profile through the Vertical Axis (index direction) of the Pit-Like/Corrosion 0.400-in. Minimum Wall Indication in Primary Tank Plate #2 of Tank 241-AN-105

Figure 2.3 shows a 1-ft-long line profile through the 0.400 indication in the vertical axis (index direction). Figure 2.4 shows a 1-ft-long line profile through the 0.400 indication in the horizontal axis (traverse direction). Because of the way the P-Scan Path ultrasonic system was programmed, the pixel sizes in the horizontal and vertical axis were different. The pixel size in the horizontal axis is 0.133 in. The pixel size in the vertical axis is 0.096 in. Table 2 shows the area of the pit-like/corrosion indication as 0.192 in. by 0.133 in.

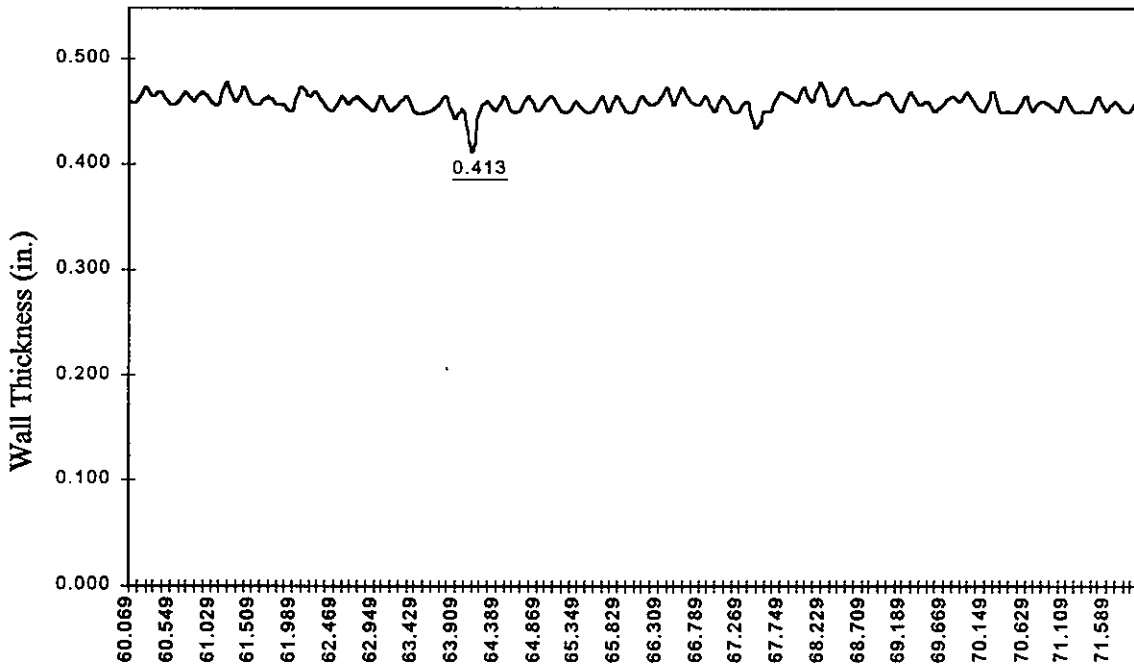
Figure 2.5. Profile through the Vertical Axis (index direction) of the Pit-Like/Corrosion 0.413-in. Minimum Wall Indication in Primary Tank Plate #2 of Tank 241-AN-105

Figures 2.5 and 2.6 are line profiles of the 0.413 pit-like/corrosion indication. The pit-like/corrosion indication in the vertical axis (index direction) is approximately 3 pixels or 0.288 in. The pit-like/corrosion indication in the horizontal axis is approximately 4 pixels or 0.532-in. The area of the pit-like indication is estimated at 0.288 in. by 0.532 in.

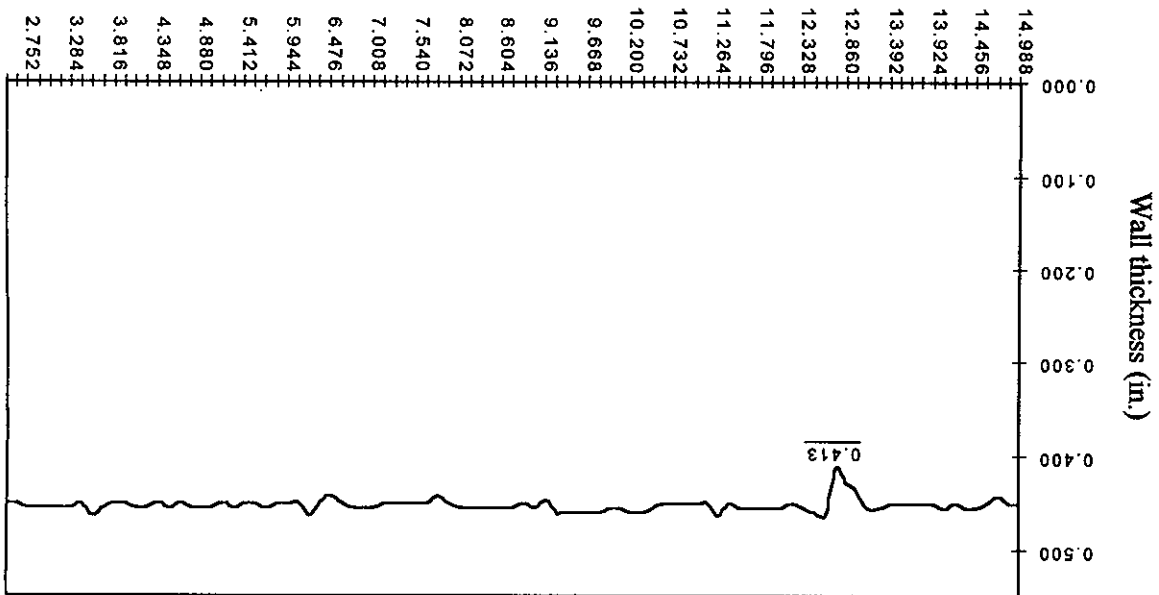
Figure 2.6. Profile through the Horizontal Axis (traverse direction) of the Pit-Like/Corrosion 0.413-in. Minimum Wall Indication in Primary Tank Plate #2 of Tank 241-AN-105

The nature of these line profiles is typical of other profiles obtained from the data in the various Excel spreadsheets. As seen in Figures 2.3 to 2.6, there appear to be modest thickness changes from pixel to pixel with an occasional deeper pit-like/corrosion indication. In analyzing the data from the Excel spreadsheet for the vertical scan paths in the 13 to 15 ft. level below the top weld, all of the pit-like/corrosion indications appear to be randomly distributed and quite small.

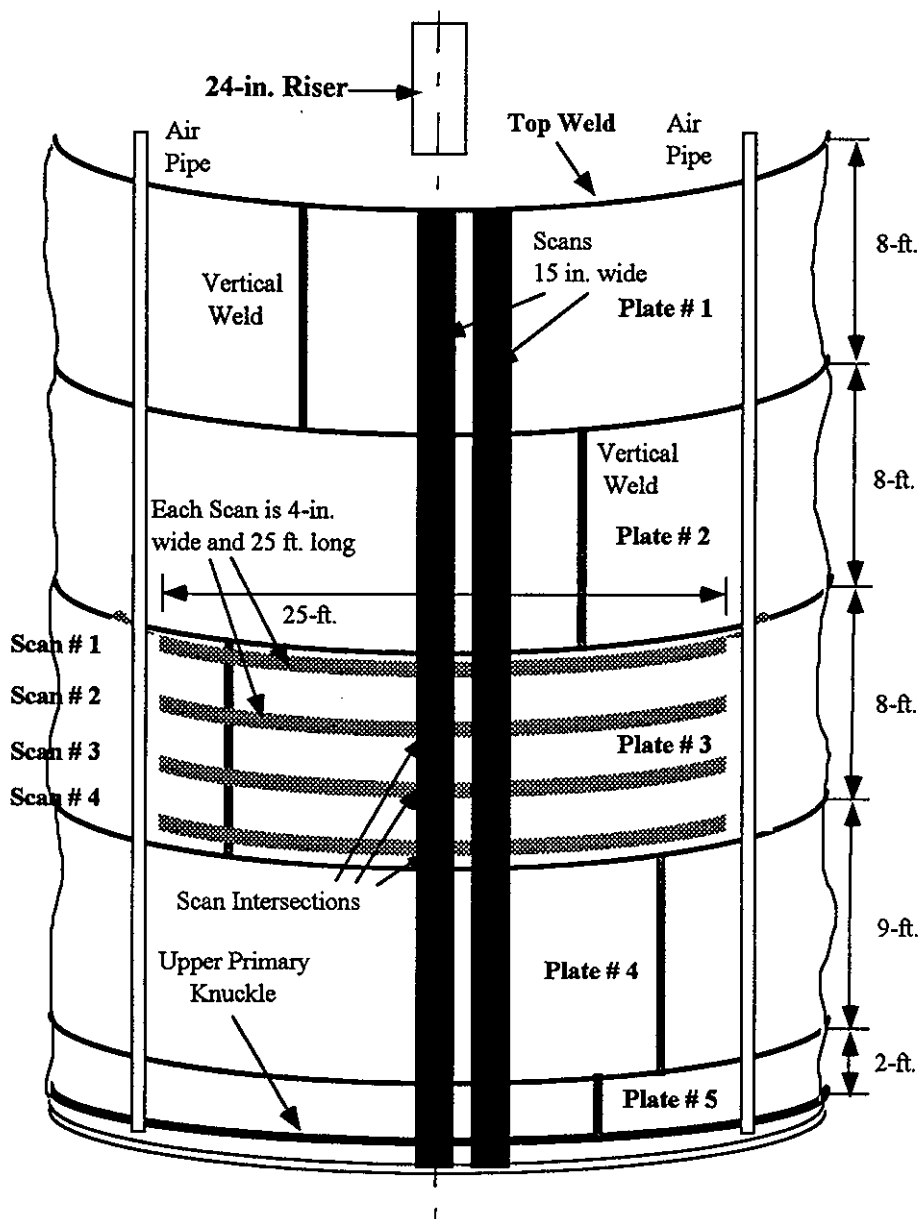
Figure 2.7. Sketch of the Vertical and Horizontal Ultrasonic Scan Path Paths on the Wall of the Primary Tank in Tank 241-AN-105

The horizontal scan #1 (see sketch on Figure 2.7) data showed a wall thickness ranging from 0.495 to 0.520 in. across the full 25-ft length of the scan path. Horizontal scan #2 showed a wall thickness ranging from 0.490 to 0.515 in. across the full length. Scan #3 showed a wall thickness ranging from 0.480 to 0.508 in., and scan #4 showed a wall thickness ranging from 0.480 to 0.528 in. across the full length of the scan.
