Stepping on Computer Floor Stringer Leads to Ankle Fracture

LL-2012-LLNL-17
LLNL-AR-XXXXXX
December 17, 2012

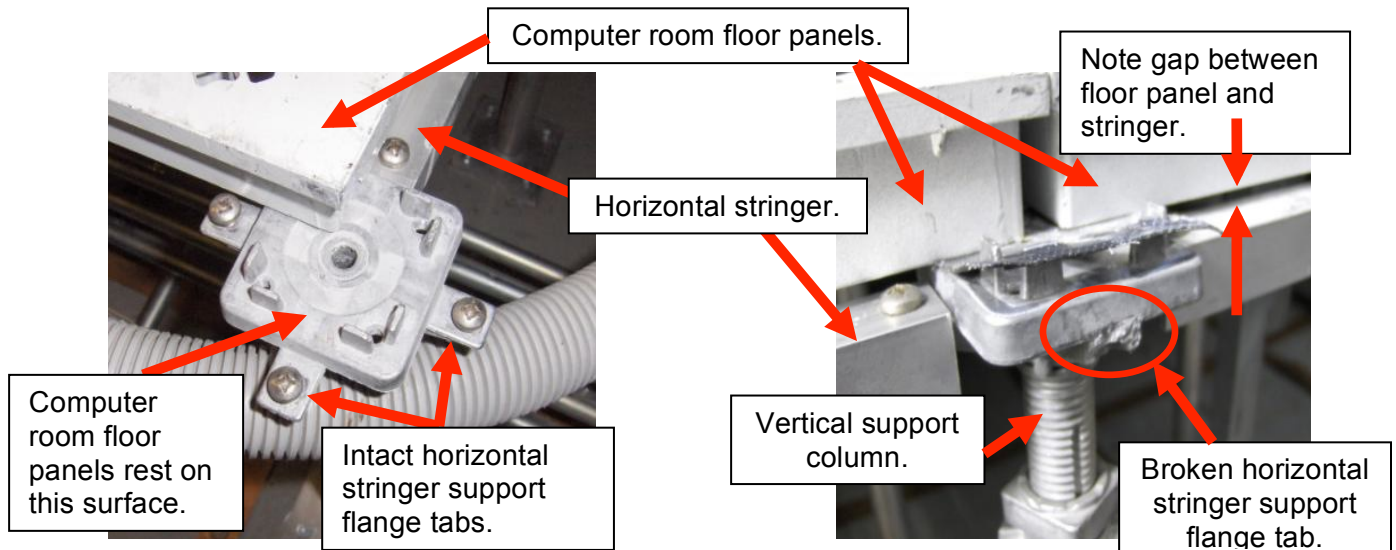
Figure 1: Overhead view of vertical support column showing intact horizontal stringer connections.

Figure 2: Side view of vertical support column showing broken horizontal stringer support flange tab.

The raised computer floor support system is composed of vertical support columns held at the base by four bolts. Horizontal aluminum stringers between the vertical support columns provide lateral stability for the columns. The stringers are bolted to the tabs of flanges at the top of each column. Stringer support flange tabs can't support the large direct loads placed upon the floor, nor are they or their connections to the columns designed to support these direct loads. The worker's weight exceeded the vertical load-bearing capacity of the stringer support flange tab, and the tab failed suddenly and catastrophically. This allowed the worker to fall approximately 30 inches.

Environmental – walking/working surfaces – The stringers and their support flange tabs are not designed to support large direct loads placed on them. The working area inside the interstitial space was congested with utilities that made it difficult to maneuver around (and under the raised computer

Lack of knowledge – The computer floor in the building was built with cast aluminum stringer supports. These stringers and the cast aluminum connection tabs on the support flanges are not designed to accept large direct loads such as an employee standing in the center of the stringer. This information was not communicated to workers at the worksite because there was no knowledge of stringer tab failures.

LLNL has many different types of raised computer floors on site. Raised computer floors may vary in their configuration and composition of materials utilized to construct them. A raised computer floor should be considered structurally intact only when it is completely installed (all components correctly installed in their proper locations) and not when floor tiles or portions of the floor are removed.

Therefore, when accessing the space beneath a computer floor, workers should not stand or step on any exposed cross members.
