Energy Retrofit Field Study and Best Practices in a Hot-Humid Climate

J. McIlvaine, K. Sutherland, and E. Martin
*Building America Partnership for Improved
Residential Construction*

March 2013

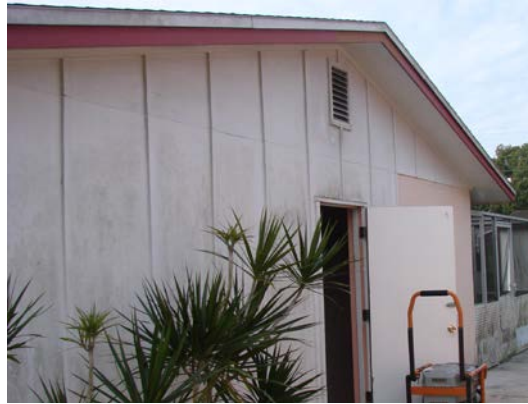
Florida does not have a snow load that requires the steeper roof pitches found in mixed and cold climates. However, homes in the dataset built in the 1980s or later had steeper roof pitches consistent with changing design preferences (Figure 11). Twenty-six (37%) homes had a shallow roof pitch of $\leq 3.5:12$ (Figure 12), 24 (34%) had a roof pitch of 4:12, and the remaining 20 homes had a mixture of steeper pitches (Figure 11).

Figure 12. Typical shallow roof pitch of Florida homes built before 1980

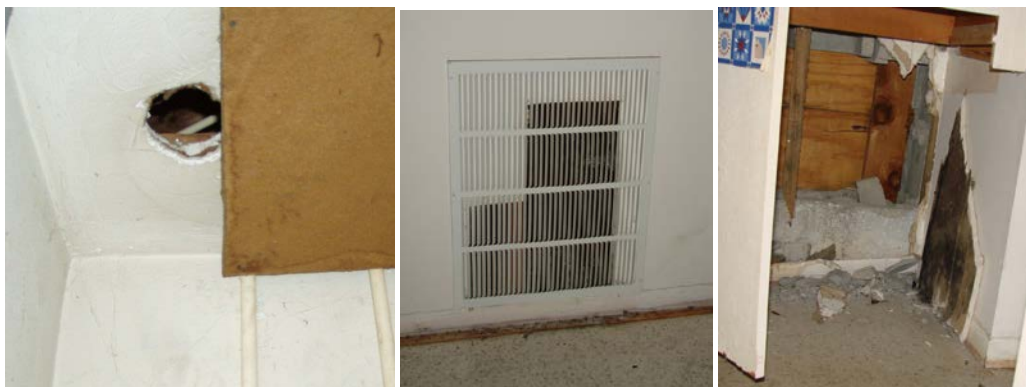
For the 59 homes, pre-retrofit ACH50 ranged from 3.6 to 41.8 with an average of 10.5. All but one home had ACH50 < 25. When test-in results were high, auditors identified airflow pathways and provided that information to the partner. In Florida’s hot-humid climate, high infiltration rates are less detrimental than they are in climates with larger temperature differentials between outside and conditioned spaces. It is less beneficial and less cost effective to expend labor on *extensive* air sealing efforts in the hot-humid climate. Air sealing efforts necessary to achieve the target ACH50 test result include sealing around drywall penetrations (for supply and return registers, dryer vents, wiring, lighting and fan fixtures, and plumbing), replacing missing plumbing access panels, correcting poor window and door closure, eliminating recessed lighting, and installing gaskets at attic access panels in the conditioned space (Figure 10 and Figure 16).

Figure 16. Pre-retrofit drywall penetrations: The ceiling fixture was removed, but penetration to the attic was unsealed (left); plumbing access in the wall covered with a return grille rather than a solid cover or patch (center); large opening beneath the bathroom vanity where block and drywall were removed as part of an incomplete renovation (right).

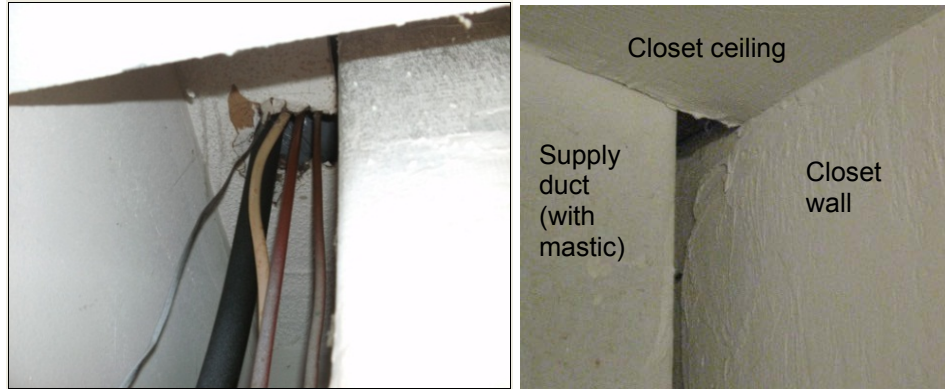
A common infiltration path that sometimes remained post-retrofit was located at the ceiling of the air handler unit (AHU) closet (Figure 17). Contractors often did not seal the gap around the supply plenum at the ceiling drywall. Access to this gap is complicated by closets that were designed for smaller AHUs.

Figure 17. Gaps or holes at ceiling of AHU closet

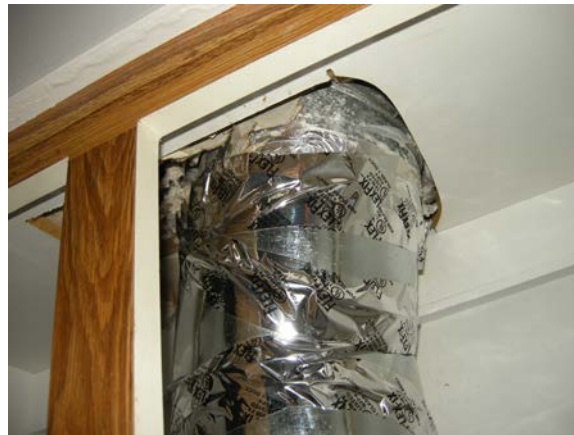
In two cases where whole-house airtightness was not improved it was virtually unchanged. In five cases, the leakage was marginally increased ($\leq 6\%$); however, in one home the leakage nearly doubled. The airflow paths included unsealed penetrations near the new bathroom vanity and the kitchen exhaust hood (Figure 18).

Figure 18. Post-retrofit: Unsealed range hood penetration through top of cabinet into the attic

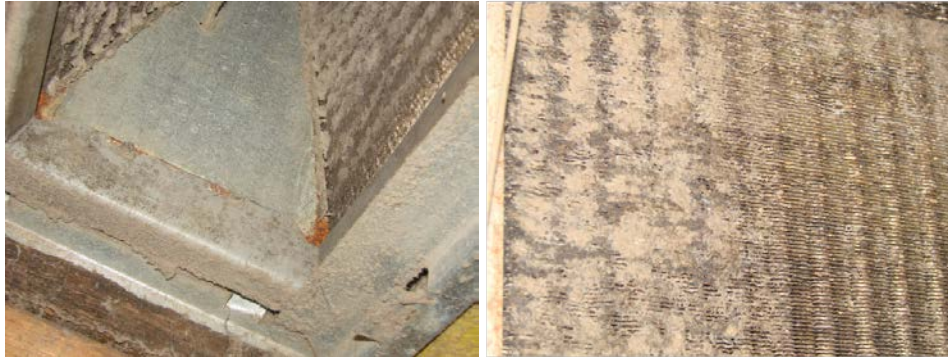
Figure 19. Looking up at pre-retrofit clogged, dirty cooling coils in the AHU (left); corroded and clogged cooling coil (right)

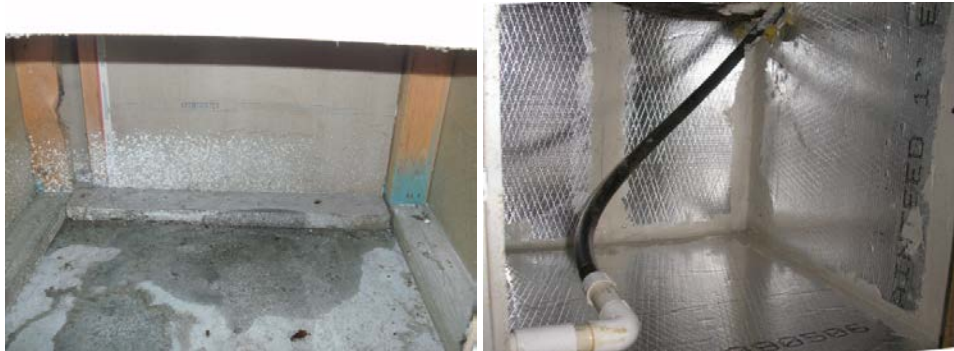
Figure 25. Return plenums were formed by either unfinished, open framing (left) or sealed duct board (right) or drywall.

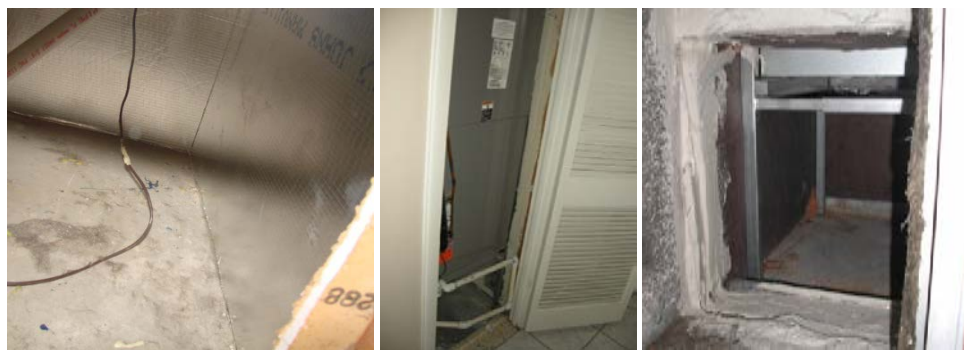
Of the 53 houses tested before and after retrofit, duct leakage was reduced in 42 (79%) and stayed the same in one (2%). In 10 homes, ducts were leakier after renovation. In three of those, new ductwork had been installed. Six had a noticeable lack of return plenum sealing (Figure 30, left). Five had no dedicated return plenum; rather, the whole AHU closet with a louvered door (Figure 30, center) or door-mounted return grille served as the return plenum surrounding an AHU mounted on a metal stand (Figure 30, right).

Figure 30. Return air plenum lined with duct board without sealant at edges and seams (left). Narrow AHU closet functioning as return with uncontrolled airflow (center). Attempt to make a sealed return plenum around a metal AHU stand (right), with noticeable unsealed gap at bottom edge of duct board.

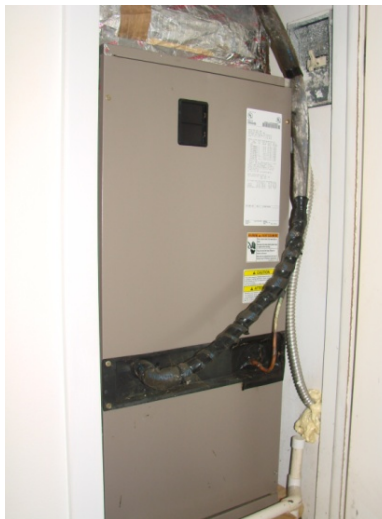
One problem encountered in many homes was that an AHU was being replaced with a larger one in a relatively small AHU closet (Figure 31). The larger AHUs are coincident with higher efficiency equipment, even within the same or smaller capacity. Contractors had a difficult time reaching the areas that needed to be sealed, including the return plenum (construction joints and connection to the AHU), the supply plenum connection to the AHU, and the gap around the supply plenum in the closet ceiling.

Figure 31. Crowded AHU closet with little room to access and seal duct connections to cabinet
