Wyandotte Neighborhood Stabilization Program: Retrofit of Two Homes

A. Lukachko, A. Grin, and D. Bergey
Building Science Corporation

April 2013

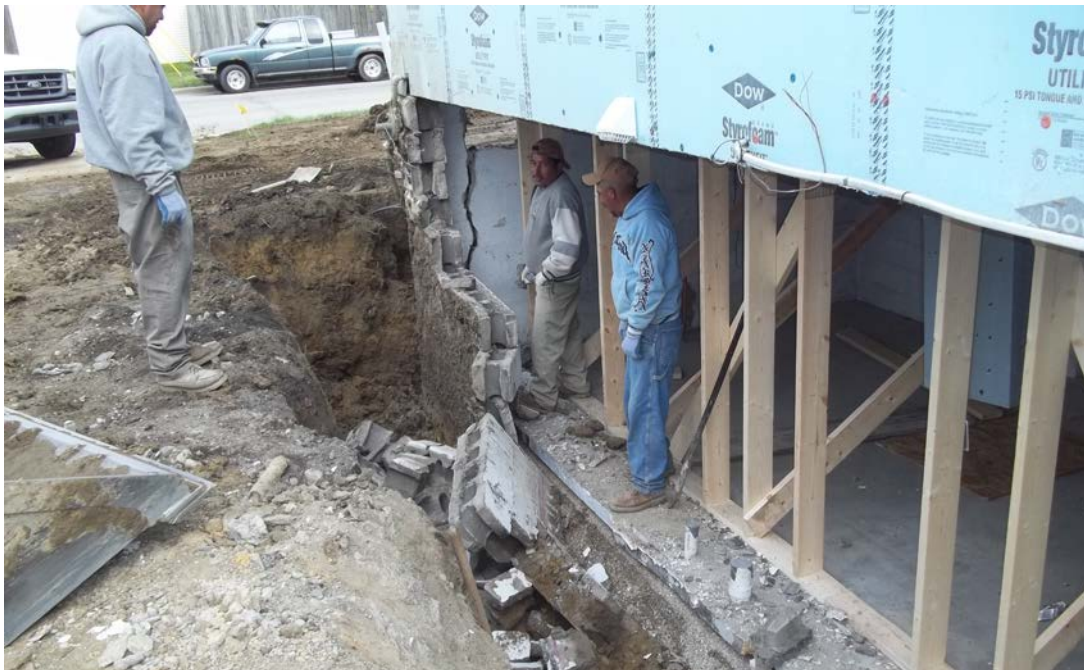
Figure 5: Repair work on Cedar 2 foundation

However, during demolition work on the house, the foundation wall suffered a partial collapse (see Figure 5 below). Construction work was delayed and a final retrofit solution for the foundation was not determined at the time of this report.

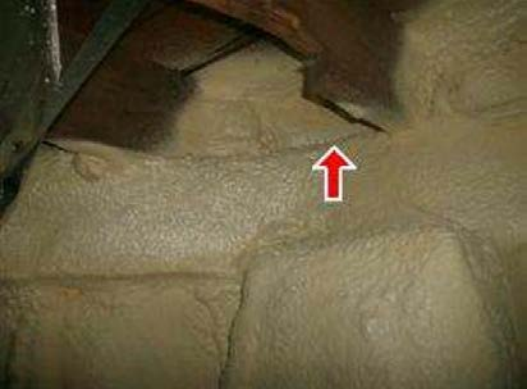
<p>(photo courtesy of Steven Christensen, WARM Training)</p>	<p>#1 – Rim joists. The primary issue with this location is that there may not be enough room for the installer to position the spray foam applicator so that insulation is sprayed on surfaces behind and around all sides of the rim joist. After the foam expands, this area may or may not be adequately air sealed.</p>

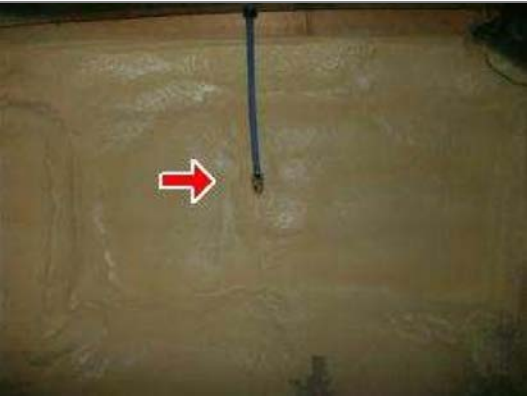
<p>(photo courtesy of Steven Christensen, WARM Training)</p>	<p>#2 – Penetrations. The photograph to the left shows a hose bib that has been installed after the foam has been cut away. This is a common problem where workers do not repair the air seal after the penetration for the SPF installation has been made.</p>

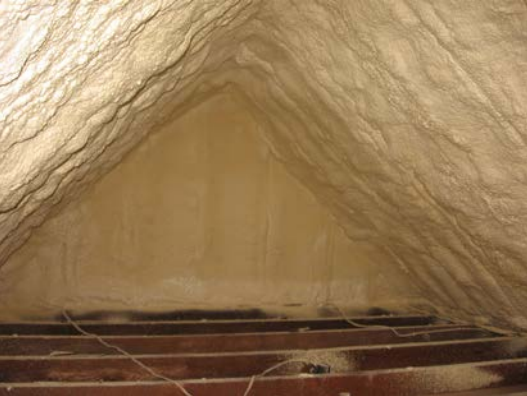
<p>#3 – Attic Rafter to Floor. Although coverage of the underside of the roof with spray foam looks to be complete, it is common for leakage paths to be missed at the intersection of the attic rafters and the attic floor.</p>

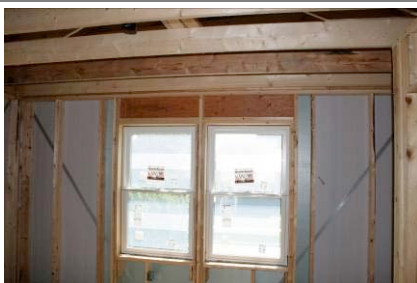
In terms of advanced framing the learning curve for this builder is evident on this home as very little was found in terms of deficiencies. The main deficiency found was the unnecessary installation of relatively heavy-duty manufactured headers above windows in non-load bearing walls. This was found on both the front and back of the house where it appears these walls are in gables and are non-load bearing. The removal of these headers has the potential to reduce construction costs. These findings were discussed with Tony Pizzo of Pizzo Construction. These findings will be discussed with Sarnacki Architects.

2011-08-22 – Unnecessary header above a window in a non-load bearing wall

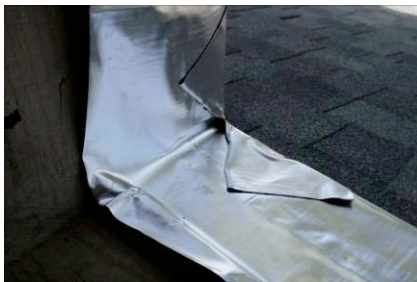
A window on the second floor had not been installed yet allowing a review of the sub-sill flashing. Care must be taken to ensure reversed flashings, gaps, or fish mouths do not occur. Shown in the photo below, a gap has been left in the corner flashing of the sub-sill flashing. This has the potential to direct water on the subsill flashing behind the insulating sheathing which is intended to be the drainage plane. This has the potential to cause moisture related damage to the structural sheathing.

2011-08-28 – Gap in corner flashing

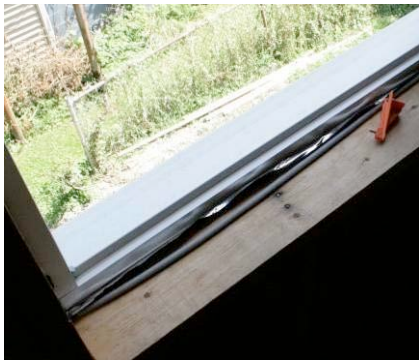
A new method of creating a back-dam on the sill was seen in this house. A back dam is used to ensure that water sitting on the sub-sill flashing cannot enter the home. In this installation a 3/8" foam backer rod was used below sub sill flashing to create this upturn. Although this has the possibility to work, it appeared that the foam backer rod did not adhere well to the flashing tape and hence did not stay in place. Alternatively a small strip of wood (or plywood) could be affixed across the full width of the rough opening and the flashing tape lapped onto the wood. This would help ensure the flashing tape has a secure, fixed substrate that has good adhesion to the tape.

2011-08-28 – Backer rod back-dam failing to adhere to the flashing tape

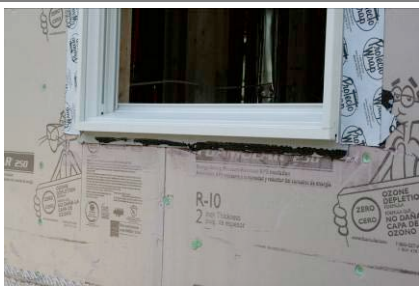
Water management details at the windows need some improvement - flashing was observed to be sealing the bottom of the window, rather than being drained. It was recommended that the flashing across the bottom of the window be slit or removed completely. BSC also recommended back dams on window openings. As recommended the flashing across the bottom of the window was removed in most areas. The east facing windows of the home on the first and second floor still require that the flashings along the bottoms of the windows be removed. There also areas within the field of the wall where the joints between the sheets of XPS must be sealed as the primary drainage plane. The windows above the front porch also require attention to repair the flashings.

Flashing at the bottom of the window removed

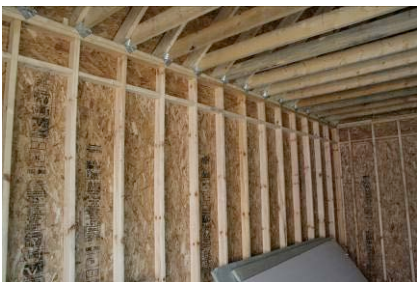
It was also noted on this house that the garage was framed as standard with 16" on centre framing. Savings could be found if the framing was reduced in the garages.

Garage framing at 16" on centre.

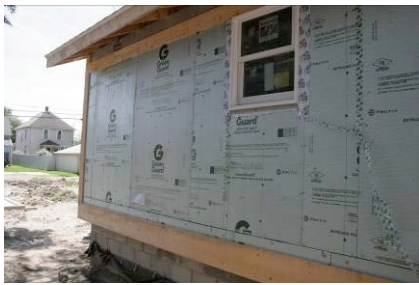
The repairs recommended in July were substantially completed where possible. During the August 22nd site visit few additional issues were found. The primary concern is the continuity of the drainage plane. The tape was no longer adhered to the insulation as a drainage plane and the step flashing over the room at the back of the house needs to be integrated to the drainage plane. Finally a small hole was found in the venting. This hole appears to have been created by another trade drilling holes to run wiring. It is important that these deficiencies be repaired.

Failing and completely missing tape

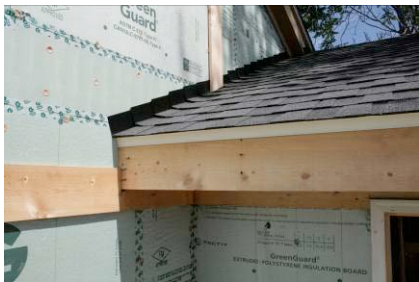
Step flashing requiring integration to the drainage plane. Details to finish this flashing with a regletted cap flashing and tape can be found at:

http://www.buildingscience.com/documents/information-sheets/common-flashing-details/files/bsc_info_303_common_flashing.pdf

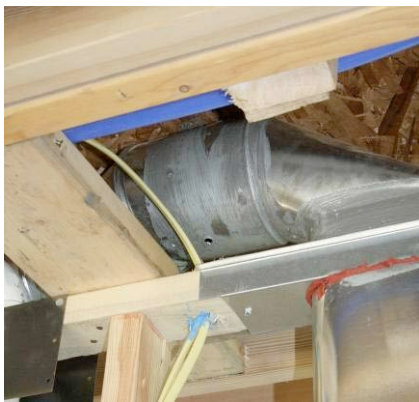
Venting hole requiring foil tape repair

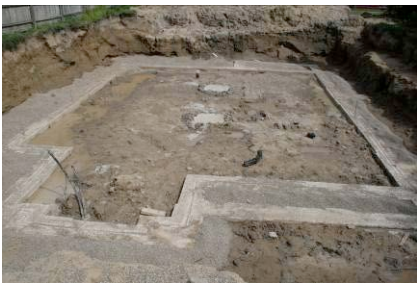
2011-08-22 – Footings complete missing capillary break

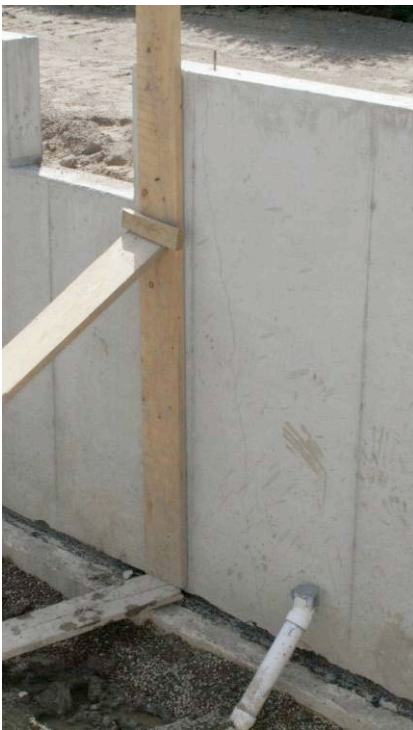
2011-08-22 – Foundation crack

During the August 22nd site visit it was found that the poured foundation was complete for this house. Exterior damp-proofing was complete but it appeared that the footing capillary break was improperly installed at the inside joint between the footing and the foundation rather than between the footing and the foundation before the foundation was poured. The crack appears to be due to the fact that the foundation was back filled before the floor of the house was installed and, as reported by Ralph Hope, before shoring was installed.

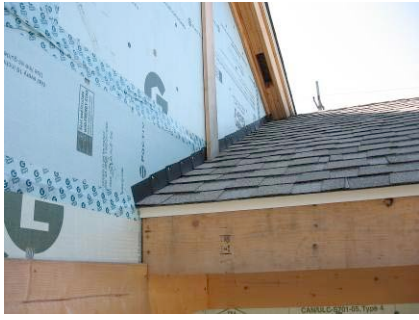
Step flashing requiring integration to the drainage plane. Details to finish this flashing with a regletted cap flashing and tape can be found at:

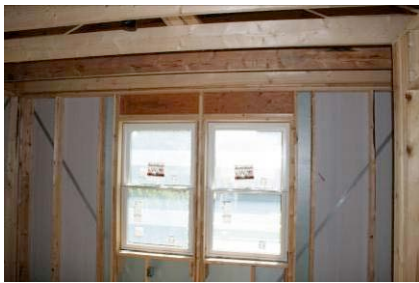
2011-08-22 – Unnecessary header above a window in a non-load bearing wall

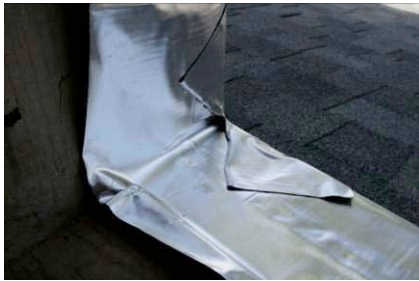
2011-08-28 – Gap in corner flashing

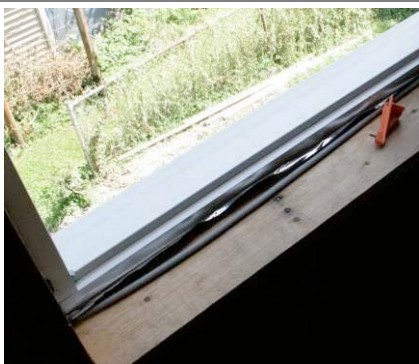
2011-08-28 – Backer rod back-dam failing to adhere to the flashing tape

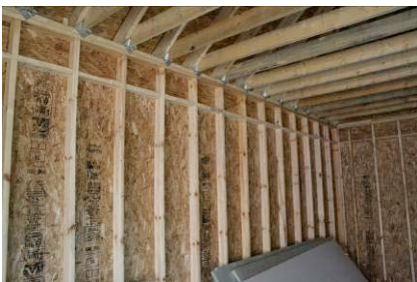
Garage framing at 16" on centre.

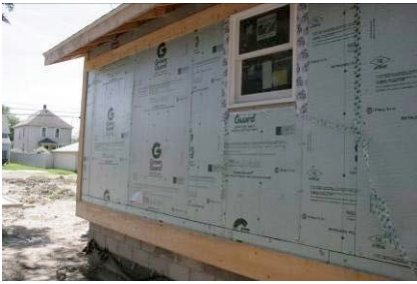
<p>Failing and completely missing tape</p>

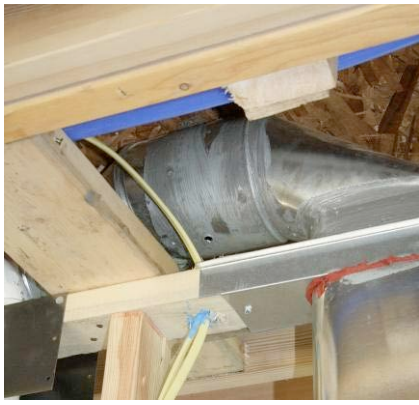
Venting hole requiring foil tape repair

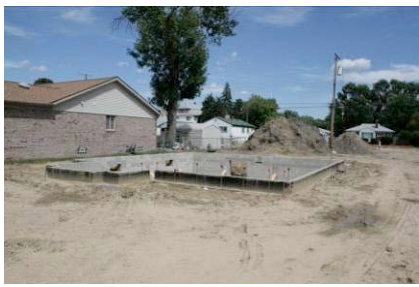
2011-08-22 – Foundation complete, capillary break not apparently present
2011-10-06 – First floor floor framing complete

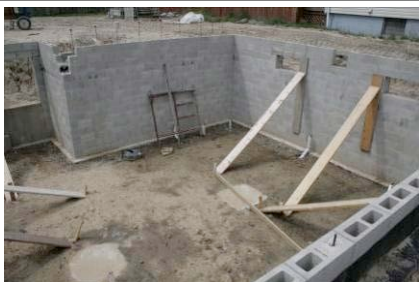
2011-08-22 – Foundation complete, missing capillary break
2011-10-06 – Foundation complete, nothing else to report

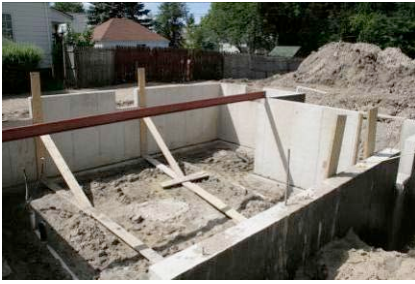
2011-08-22 – Foundation and basement floor complete. It appears that the capillary break was not properly installed between the footing and the foundation.

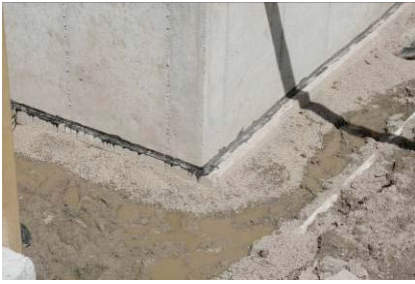
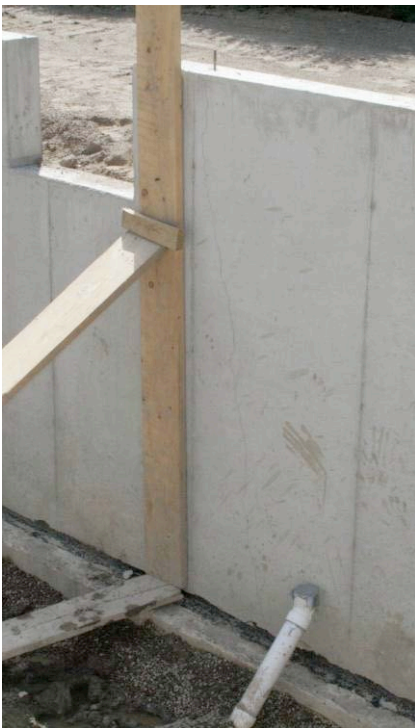
2011-08-22 – Foundation crack
