# **TMI-2 – A Case Study for PWR Instrumentation Performance During a Severe Accident**

Joy L. Rempe  
Darrell L. Knudson

March 2013

**Prepared for the  
U.S. Department of Energy  
Office of Nuclear Energy  
Under DOE Idaho Operations Office  
Contract DE-AC07-05ID14517**

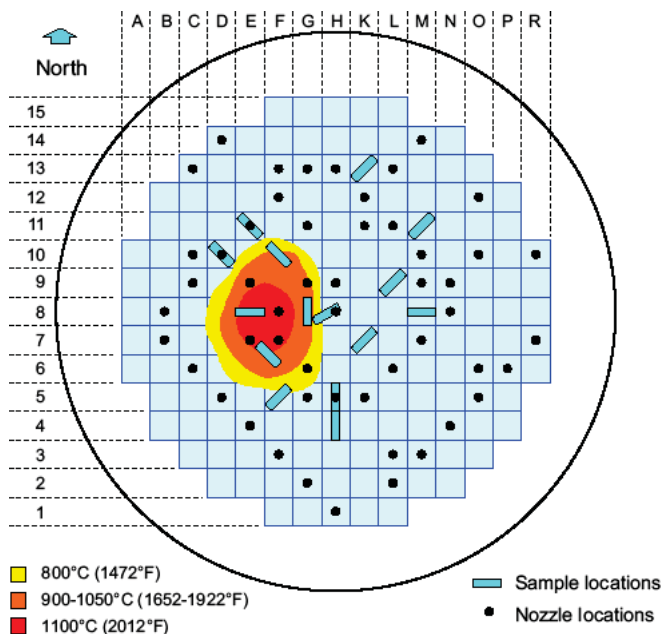
- Metallurgical examinations of the vessel lower head steel samples in conjunction with visual observations suggest that an elliptical region of the vessel, approximately 0.8 m by 1.0 m, reached peak temperatures of 1100 °C during the accident (see Figure ES-5). At locations away from the hot spot, there is no evidence to indicate that vessel steel temperatures exceeded 727 °C.

**Figure ES-5.** Location of TMI-2 lower head vessel boat samples and 'hot spot.'

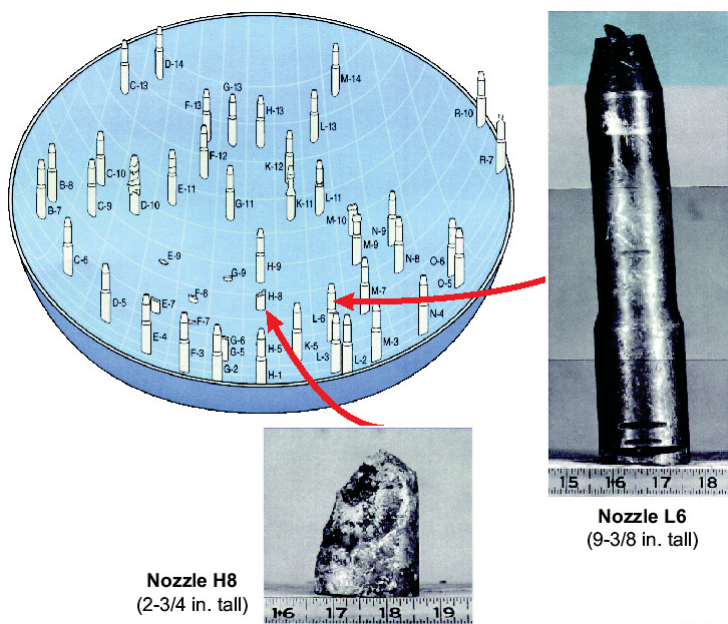
- Instrumentation nozzle damage (see Figure ES-6) was caused by molten core material relocating to the lower head. The most severe damage was observed in nozzles located within the “hot spot” region of the vessel and not related to the embedded debris height (e.g., nozzle L6 was submerged in debris, but remained undamaged).

**Figure ES-6.** End-state of nozzles on the TMI-2 vessel lower head.

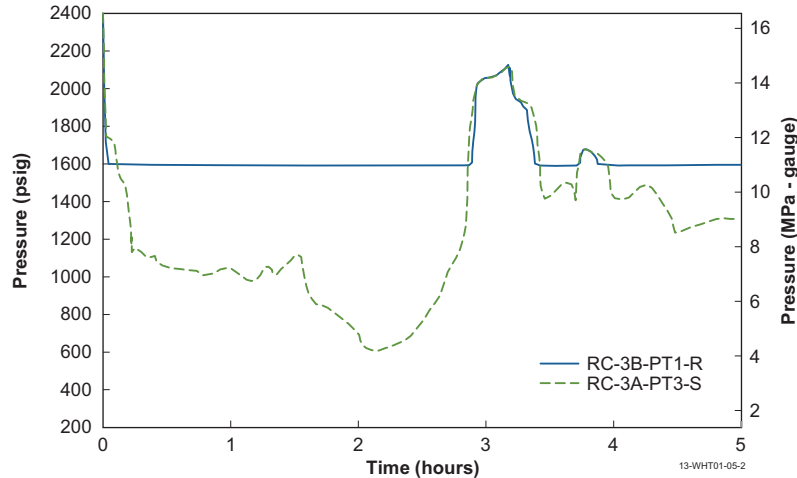
- Data unavailability was often due to computational limits, such as storage memory, inadequate paper or ink, insufficient sampling rates, and ‘preset’ limits associated with anticipated operating ranges (rather than sensor operating limits as illustrated by the pressure data shown in Figure ES-10). A wider

**Figure ES-10.** Comparison of A-loop wide range pressure recorded on the strip chart and B-loop narrow range pressure on the reactimeter (Note: narrow range pressure data limited to values above 1600 psig).

range of limits and enhanced computational capabilities, with easy-to-read graphical displays, could alleviate such issues, as occurred with TMI-2 building resistance temperature detector (RTD) temperature and steam generator reference pressure transmitter sampling.

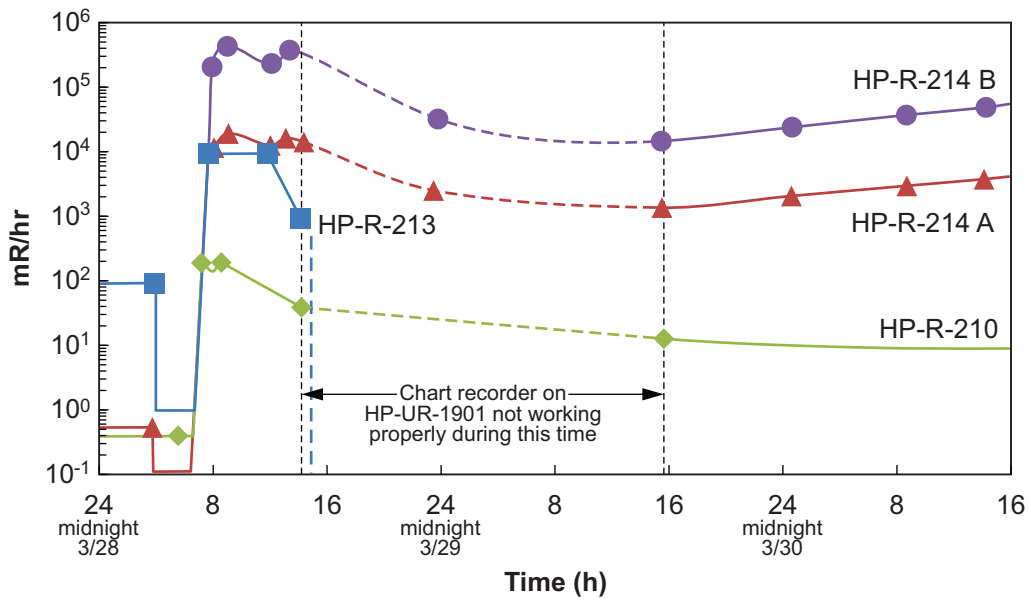
- Post-accident evaluations emphasized the need for more accurate containment radiation measurements. Identified Dome Monitor failures and data uncertainties (see Figure ES-12) led to several recommendations for design improvements, such as better seals that are periodically leak tested, the use of moisture and radiation resistant components and cabling, and relocating electronics outside the containment so that the lead shield could be removed.

**Figure ES-12.** Containment radiation monitor response (Two curves are provided for HP-R-214 to reflect upper and lower bounds associated with uncertainties in recording scale).

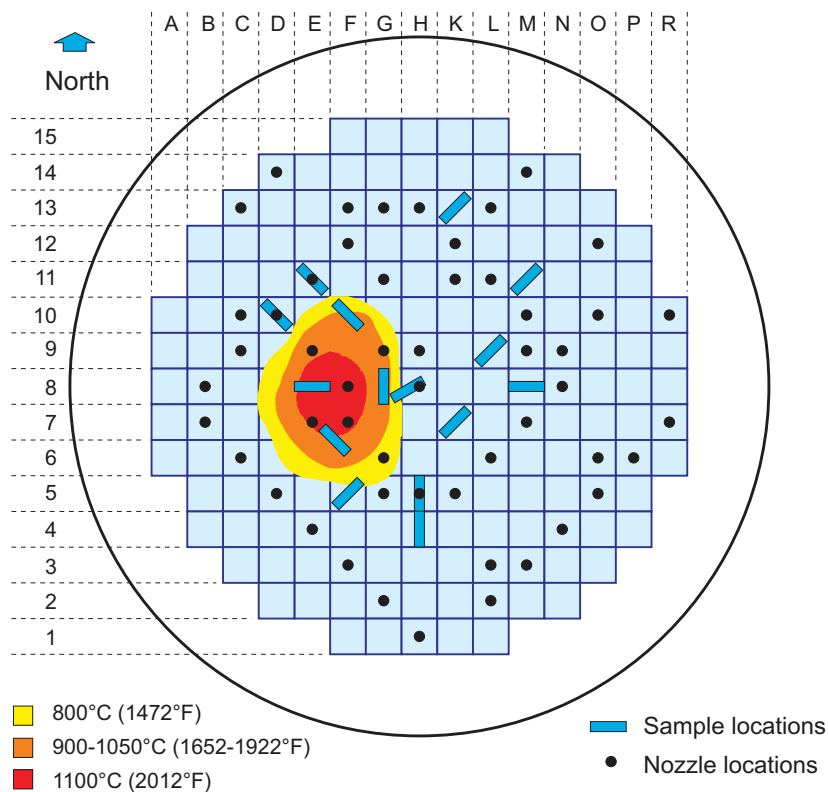
**Figure 2-5.** Location of TMI-2 vessel lower head boat samples and ‘hot spot.’<sup>6</sup>

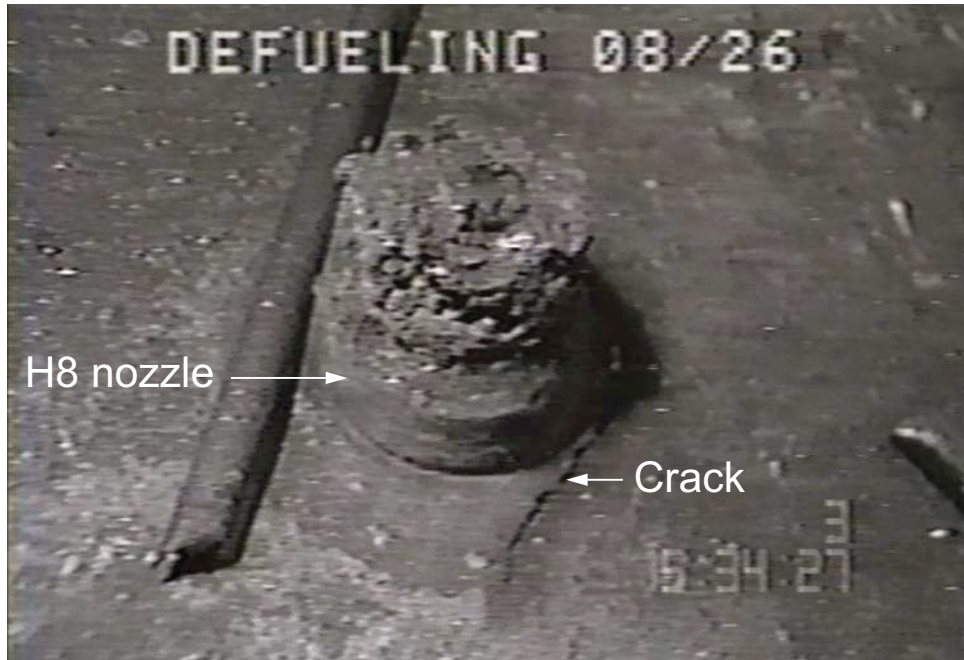
- Metallurgical examinations of cracks or 'tears' in the reactor vessel cladding (see Figure 2-6) in samples taken near the hot spot (positions E-6 and G-8) indicate that the damage extended down to, but not into, the carbon steel vessel.<sup>22</sup> Cracks were typically found near nozzles.

**Figure 2-6.** Video exams of the H8 instrumentation nozzle with crack on vessel.

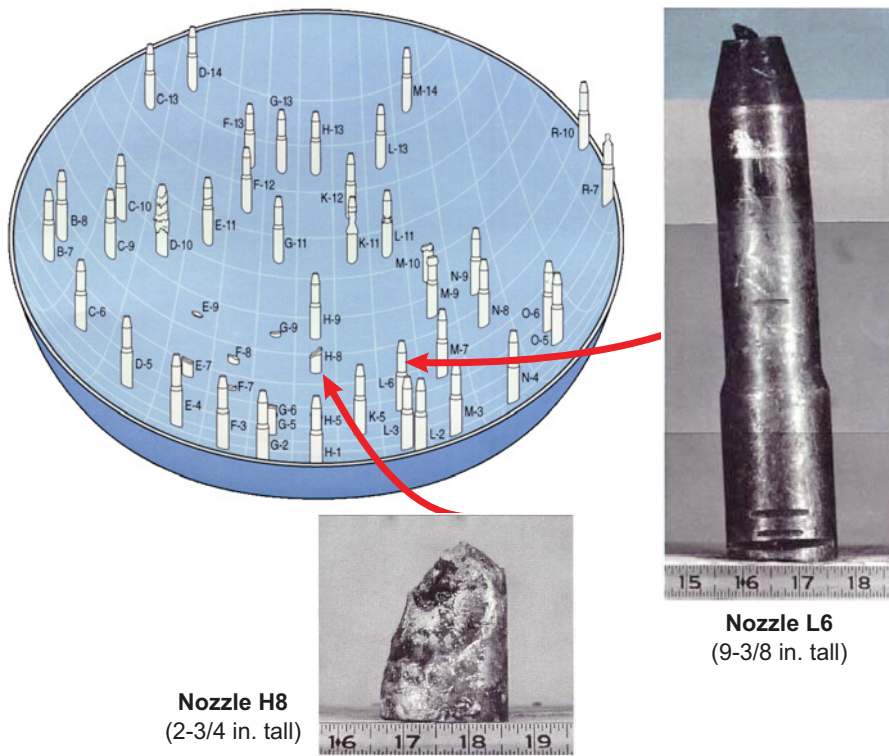
**Figure 2-7.** End-state of nozzles on the TMI-2 vessel lower head.<sup>6</sup>

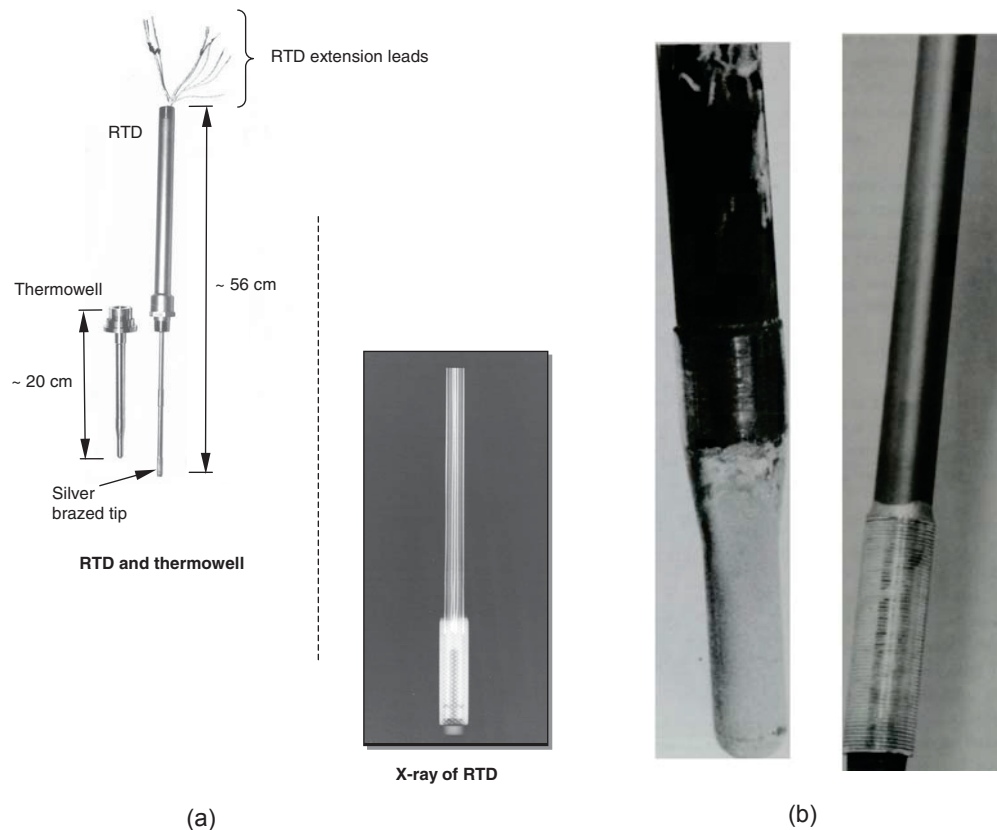
**Figure 4-2.** Rosemount Model 177HW RTD: (a) photograph and x-ray (b) thermowell and PRT from Rosemount Model 177HW PRT S/N 3670 removed from TMI-2 (the PRT appeared undamaged but radioactive deposits were found on the exterior surface of the thermowell).

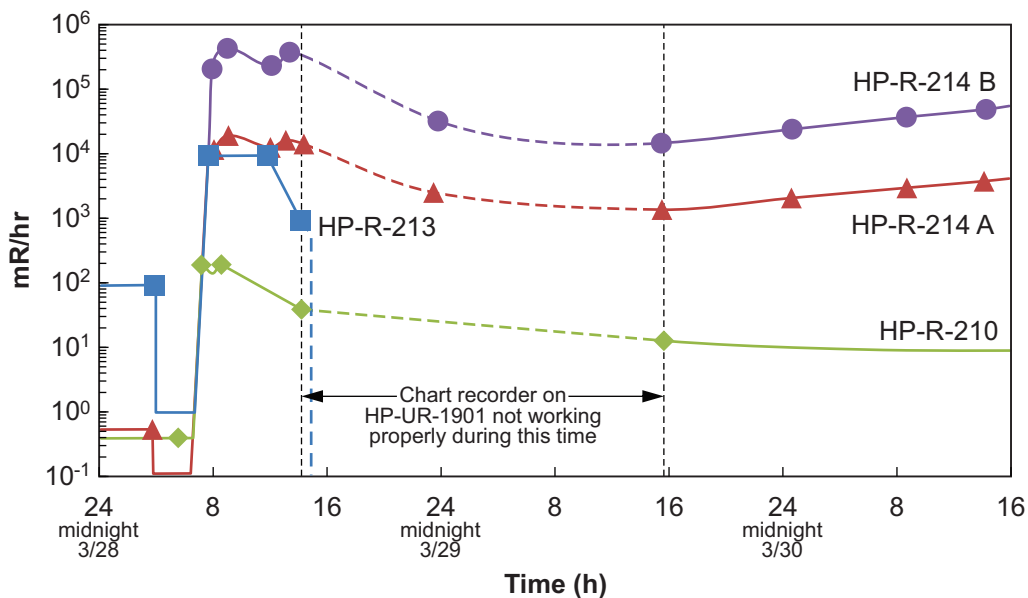
**Figure 5-6.** Containment radiation monitor response (Two curves are provided for HP-R-214 to reflect upper and lower bounds associated with uncertainties in recording scale).
