Final Report for the Erosion and Corrosion Analysis of Waste Transfer Primary Pipeline Sections from 241-SY Tank Farm

J. S. Page
R. B. Wyrwas
G. A. Cooke
Washington River Protection Solutions LLC

Date Published
September 2012

Prepared for the U.S. Department of Energy
Office of River Protection

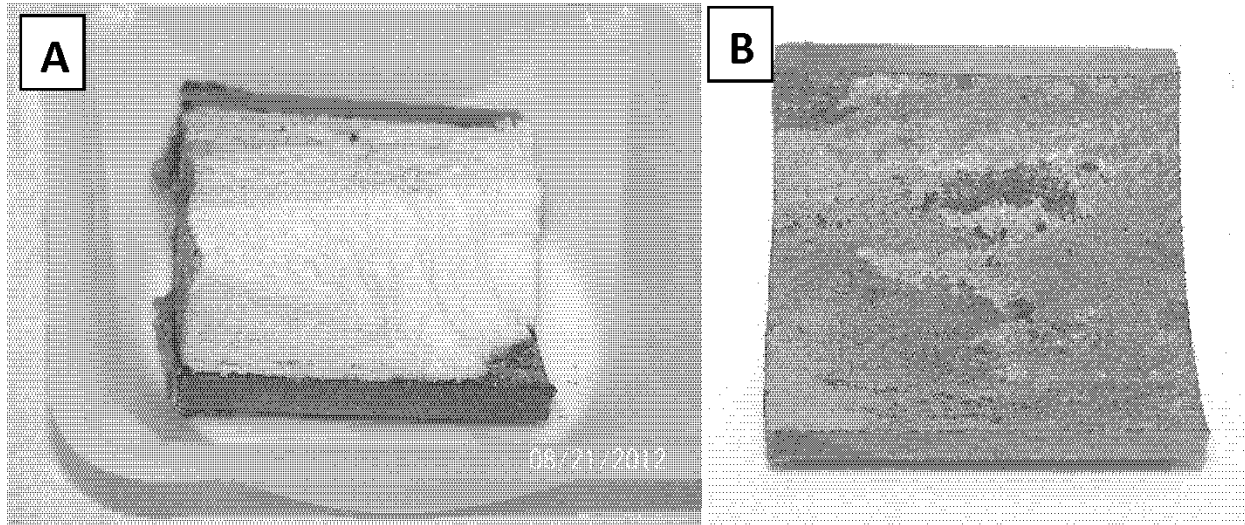
Figure 7. Photographs of the Coupon Cut from SN-285 Before and After Cleaning.

Overall, there was no obvious low spot in this pipe section. The measurements show a relatively narrow spread in thicknesses, and the variation of thickness could be from the non-flat outer surface and variation in the pipe manufacturing. Based upon these results, a 2 X 2 in. coupon was cut around the J-5 location. The thickness of the coupon was measured with a digital caliper at 210 mils. This value corresponds with the thickness measurement using the UT, and it is close to schedule 40 pipe thickness (216 mils) indicating minimal, if any, erosion or corrosion in this section.

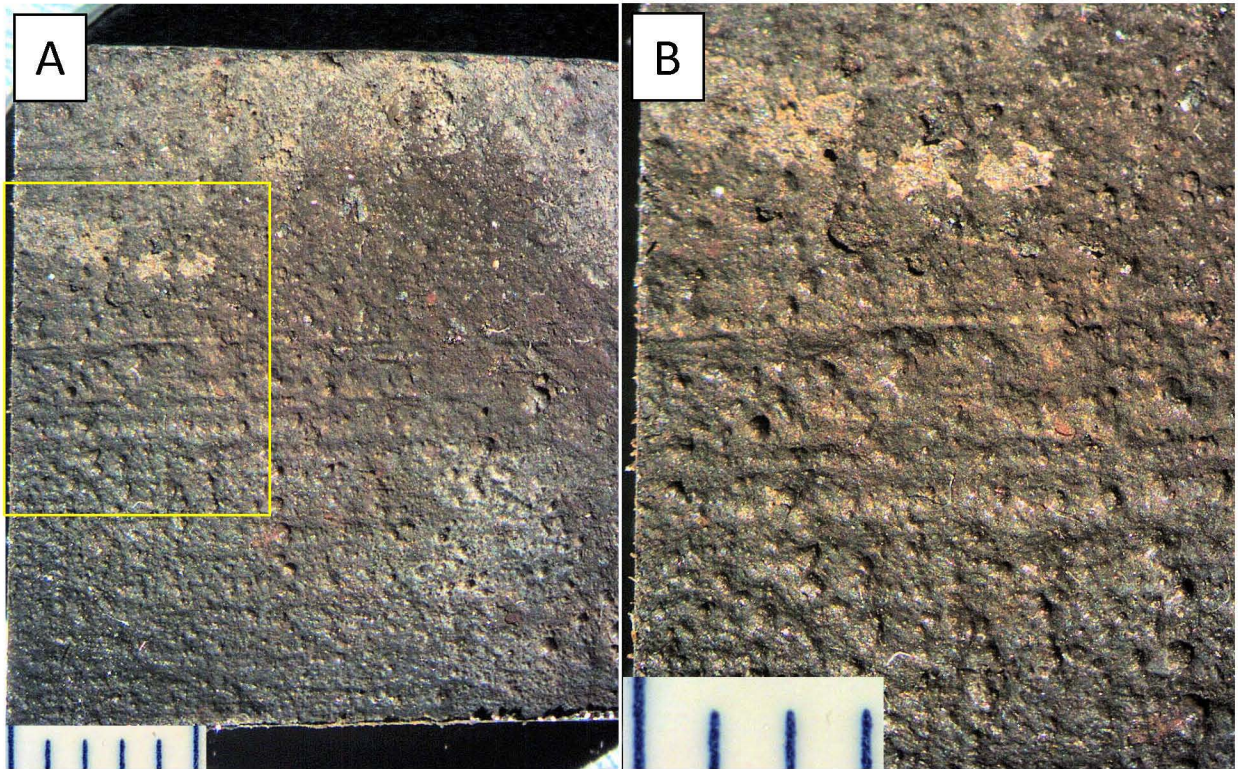
Figure 8. Microphotographs of a Subsection of the SN-285 Coupon.

A smaller piece of the pipe section was cut from the lower right hand area of the coupon in Figure 7B to fit in the SEM. Before being loaded in the SEM, photomicrographs were obtained using a Nikon² reflected light stereo microscope. Figure 8 shows the resulting photomicrographs at two different magnifications with 1 mm scale bars. The right image is a magnified area of the section in 8A indicated by the yellow box. Overall, the surface appears free of particles with raised features which could be corroded steel. In addition, the variable colors suggest patches of tank waste residue and/or iron oxide/hydroxide. Running down the axis of the pipe are also small grooves covered by the corrosion and/or tank waste indicating that the grooves were not recently made.

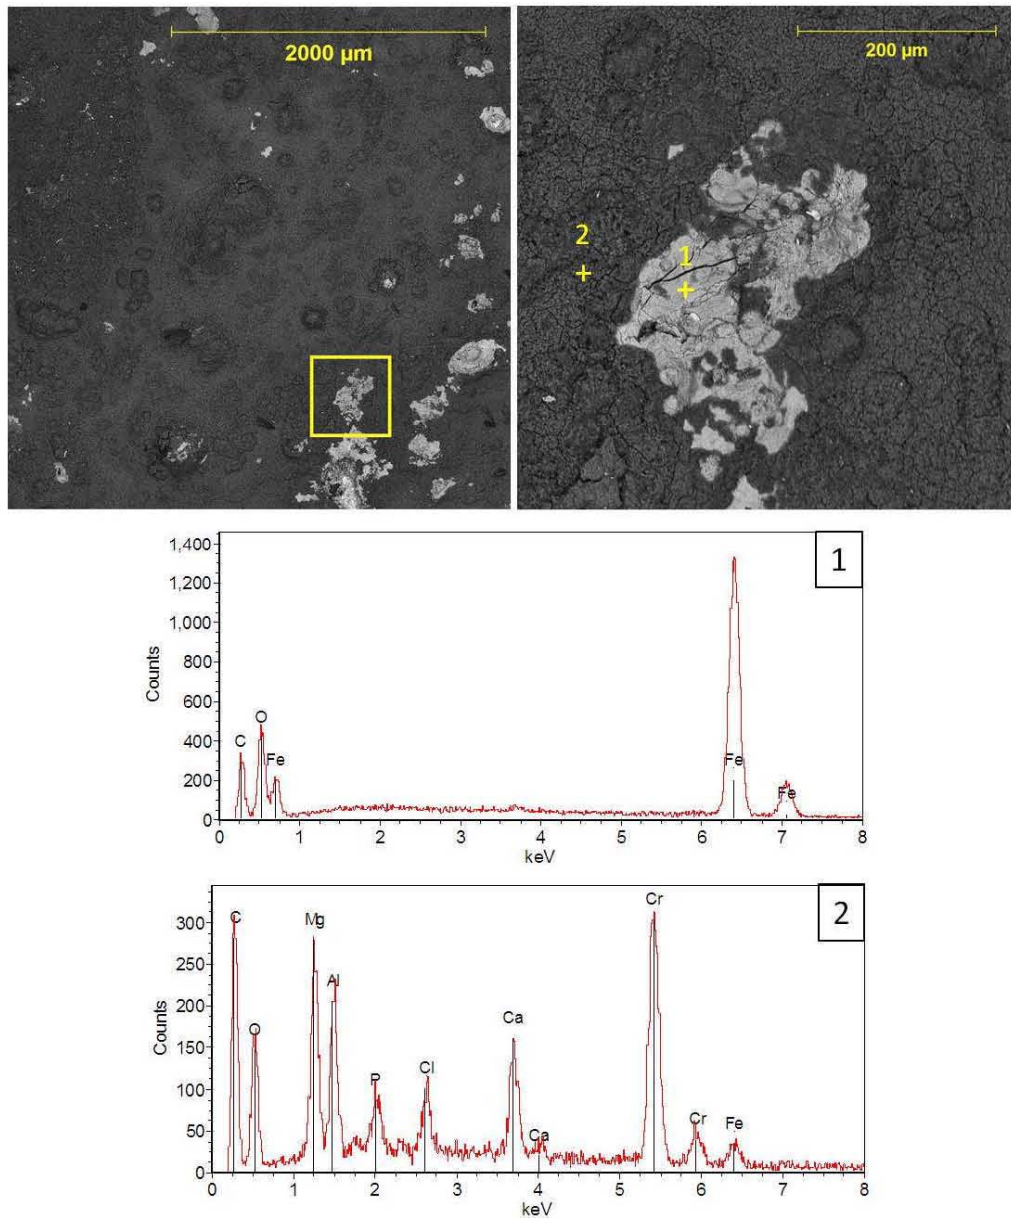
Figure 13. Scanning Electron Microscopy Image and Energy Dispersive Spectrometry Spectra of the Inner Surface of SN-285.

The pipe specimen photographed in Figure 8 was loaded into the SEM and examined. Figure 13 contains backscatter images and demonstrates that the inner surface of pipe SN-285 consists of a coating of tank waste products with islands of corrosion protruding from this layer. The probed EDS location at spot 1 shows an area of iron oxide surrounded by a residue layer rich in chromium, magnesium, aluminum, calcium, and oxygen (EDS spot 2).

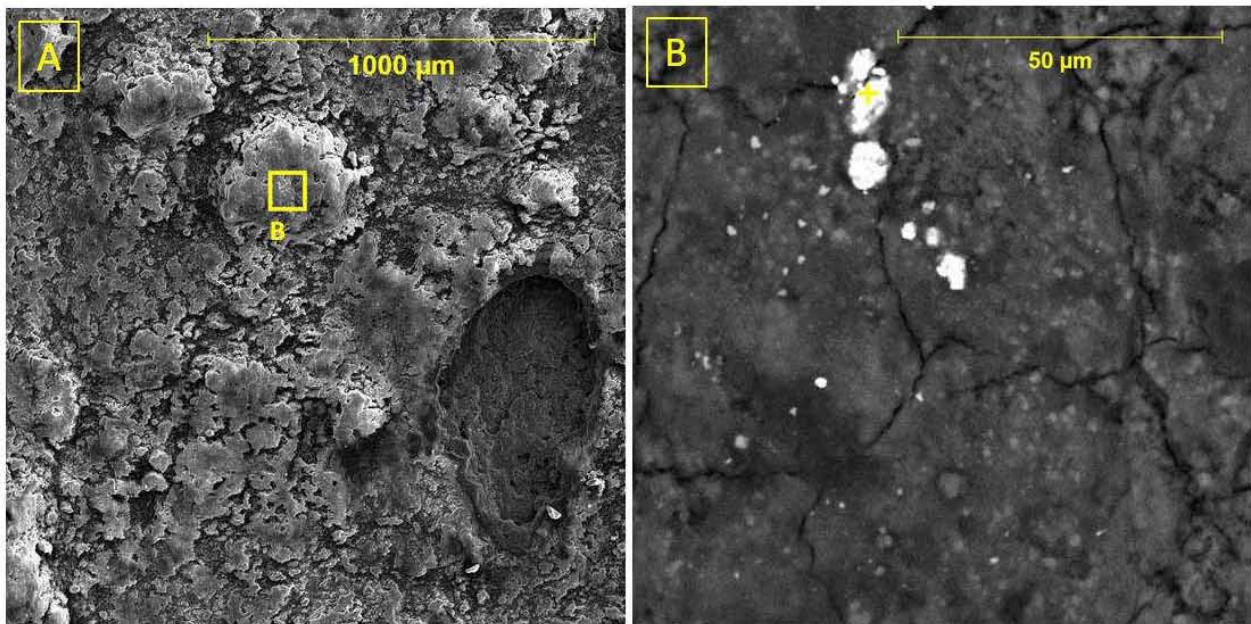
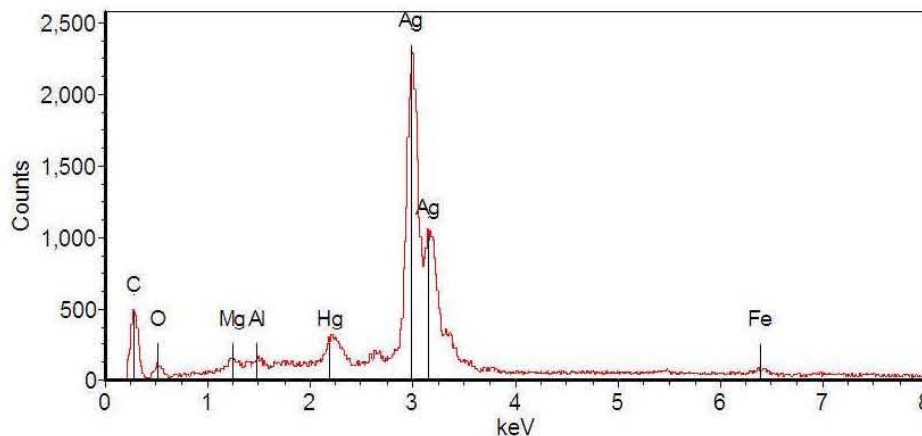
Figure 14. Secondary Electron Imaging and Backscatter Electron Imaging of the Inner Surface of SN-285 Pipe Section.

Another location on the inner pipe surface was imaged in SEI mode. The secondary electron detector provides good contrast of surface features and depth compared to BEI mode, which uses a backscatter electron detector that gives a flatter picture but contrasts atomic number (element mass). An SEI image in Figure 14A shows the mottled surface of the tank waste residue layer. In the lower right part of the image, a crater feature of pipe corrosion is present. Throughout the surface, small (< 10 μm) particles of silver were also detected. Some of these particles can be seen in Figure 14B (magnified image of the area in the yellow box in 14A) which was acquired in BEI mode making the silver contrast well with the surrounding residue layer. These silver deposits might be a result of a reduction process created by the cathode protection of the pipeline, RPP-25299, *Volume 4: IQRPE DST System Integrity Assessment – Cathodic Protection for DST Transfer Lines*.

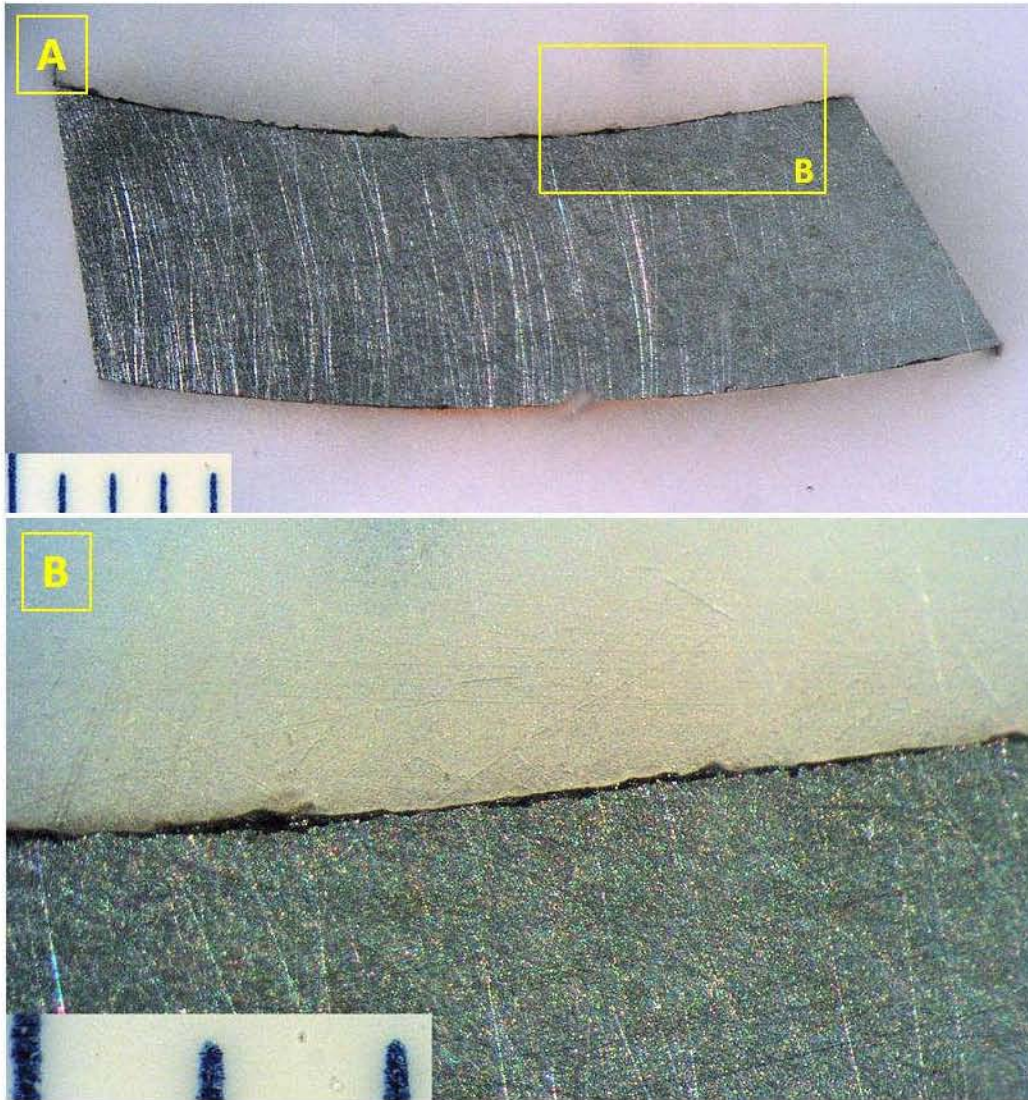
Figure 15. Microphotographs of Cross-Sectioned Specimen from SN-285.

In order to obtain information on the tank waste residue layer thickness, corrosion layer thickness, and size of corrosion pitting, a piece of the SN-285 coupon was embedded in epoxy and cross-sectioned. The cross-sectioned specimen was then polished down to a 600-grit surface. Figure 15 shows photomicrographs of the cross-section with 15B as a magnified view of the area inside the yellow box in 15A. The top of the cross-section in the photos is the inner surface of the pipe. The scale bars are in 1 mm increments. It is possible to see a thin, variable thickness, dark-colored layer on the surface and the presence of small pits. Both of these features are better seen when viewed using the SEM.

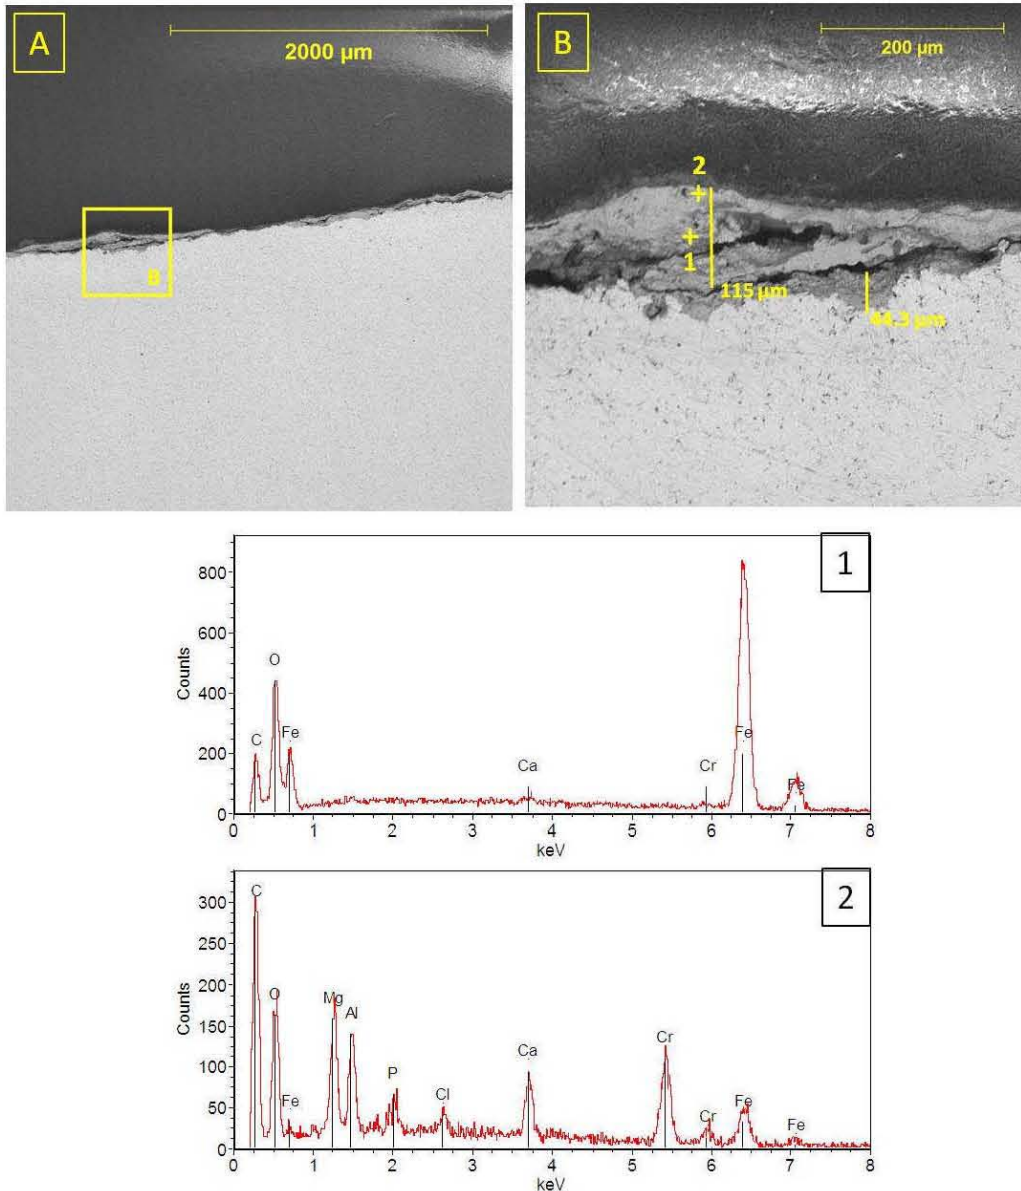
Figure 16. Scanning Electron Microscopy Image and Energy Dispersive Spectrometry Spectra of the Cross-Sectioned Specimen of SN-285.

Figure 16A shows the same location as in Fig. 15B but imaged with the SEM in BEI mode. The metal appears as the brightest area while the epoxy shows up as the dark area. The intensity of the corrosion layer is between these two levels. Figure 16B is a magnified image of the area marked in 16A, and it displays measurements of both the corrosion layer and a pit in the surface. The two EDS spectra indicate that the corrosion layer has the tank waste residue layer on top.

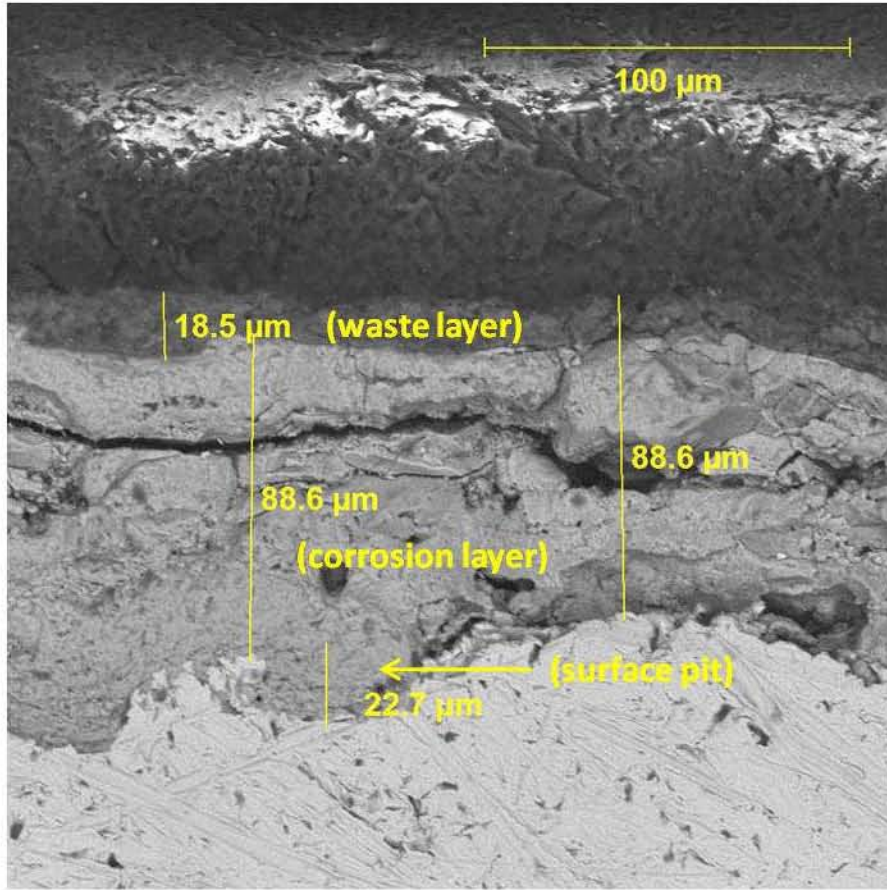
Figure 17. Scanning Electron Microscopy Image of the Different Layers on the Cross-Section of SN-285.

Individual thicknesses of the tank waste and corrosion layer were better defined in another location on the cross-section. Figure 17 shows that the corrosion layer was about 5-times thicker than the residue layer in this area. A depression, or pit, is also present below the corrosion layer with a depth of ~ 23 μm (1 mil).

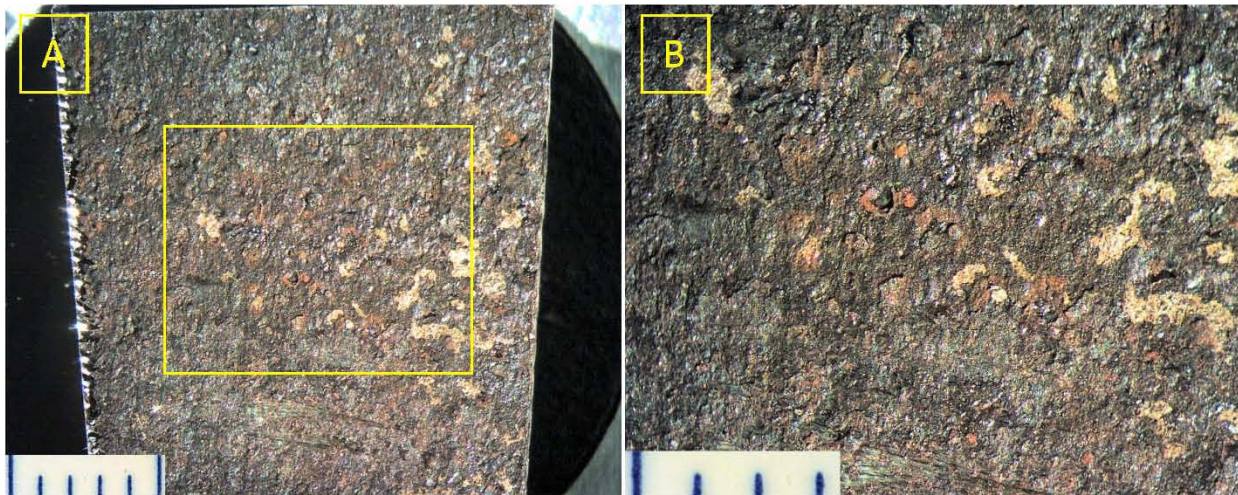
Figure 19. Photomicrographs of a Subsection of the SN-286 Coupon.

A smaller piece was cut from the upper right hand part of the coupon in Figure 18B to better fit in the SEM. Before being loaded in the SEM, photomicrographs were obtained using a Nikon[®] reflected light stereo microscope. Figure 19 shows the resulting photomicrographs at two different magnifications with 1 mm scale bars. The right image is a magnified area of the section in 19A indicated by the yellow box. Overall, the surface appears rough with a layer (or layers) of corrosion and tank waste residue.

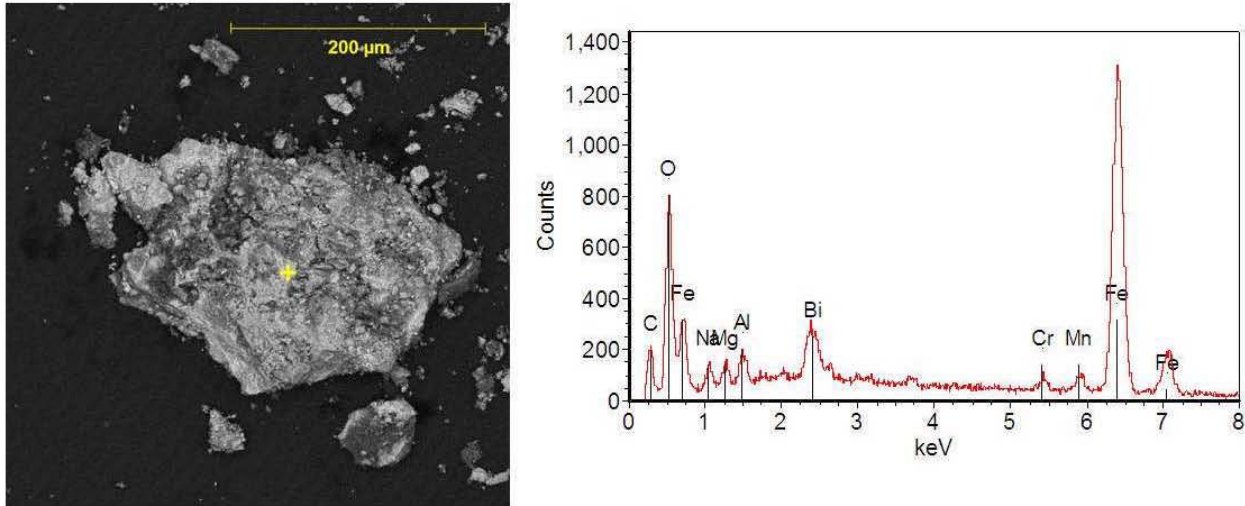
Figure 21. Scanning Electron Microscopy Image and Energy Dispersive Spectrometry Spectrum of a Corrosion Particle Scraped from the Inner Surface of SN-286.

Figure 21 shows a larger particle identified by EDS as iron oxide with some tank waste residue on the surface.

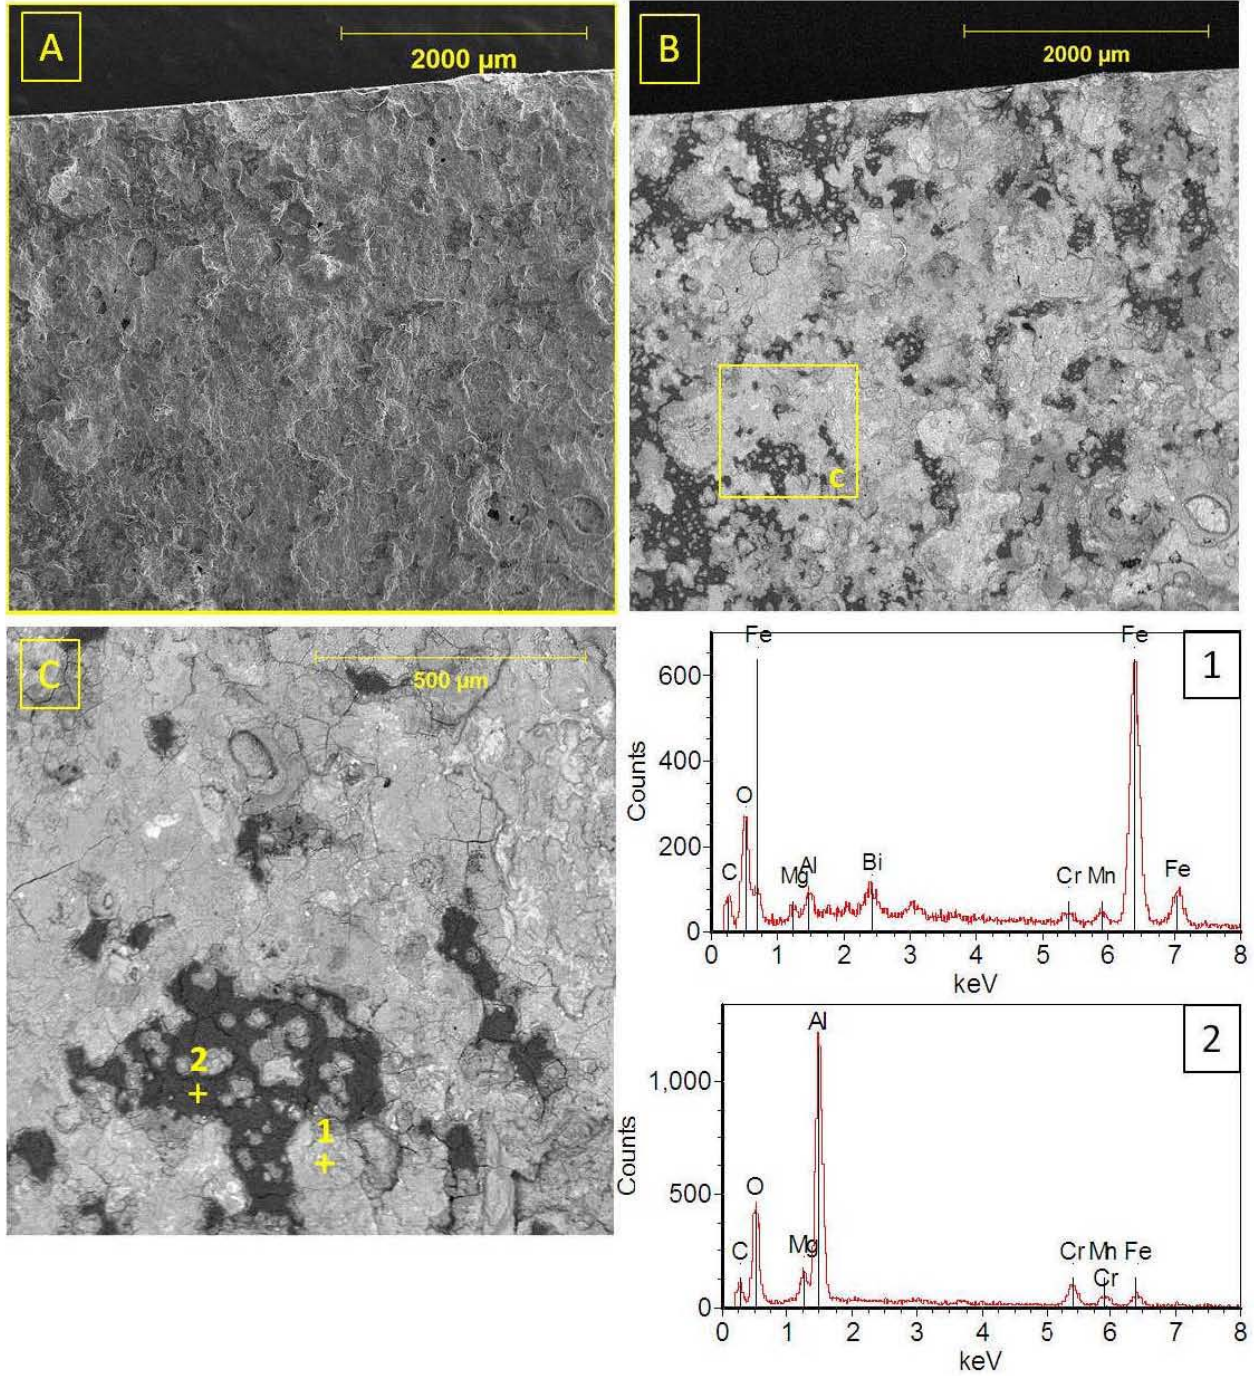
Figure 24. Scanning Electron Microscopy Image and Energy Dispersive Spectrometry Spectrum of the Inner Wall of Pipe Section SN-286.

The pipe specimen photographed in Figure 19 was loaded into the SEM and examined. The SEI in Figure 24A shows the roughness of the surface, and the BEI in Fig. 24B shows that most of the area is covered by the brighter, iron oxide/hydroxide (corrosion) layer with smaller, darker areas of tank waste residue. The magnified area in Figure 24C details better the pockets of tank waste residue on top of the continuous corrosion. The probed EDS spot 1, marked with a yellow cross, detected corrosion with small amounts of tank waste elements, and the EDS spot 2 indicated aluminum oxide, possibly gibbsite, was the tank waste phase on top of the corrosion.

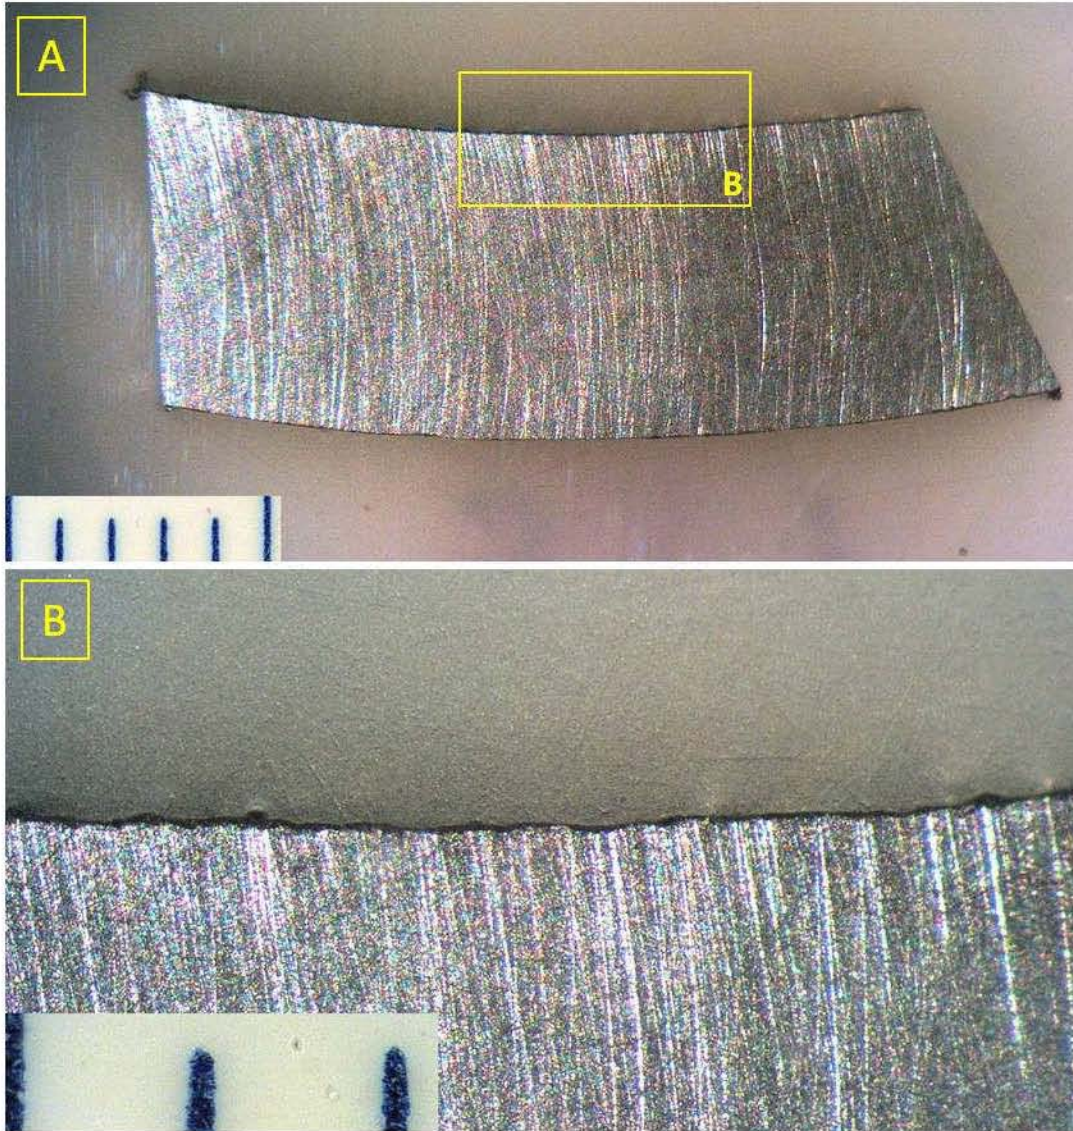
Figure 26. Photomicrographs of Cross-Sectioned Specimen from SN-286.

In order to obtain information on the tank waste residue layer thickness, corrosion layer thickness, and size of corrosion pitting, a section of the SN-286 coupon was embedded in epoxy and cross-sectioned. The cross-sectioned specimen was then polished down to a 600-grit surface. Figure 26 shows photomicrographs of the cross-section; Figure 26B is a magnified view

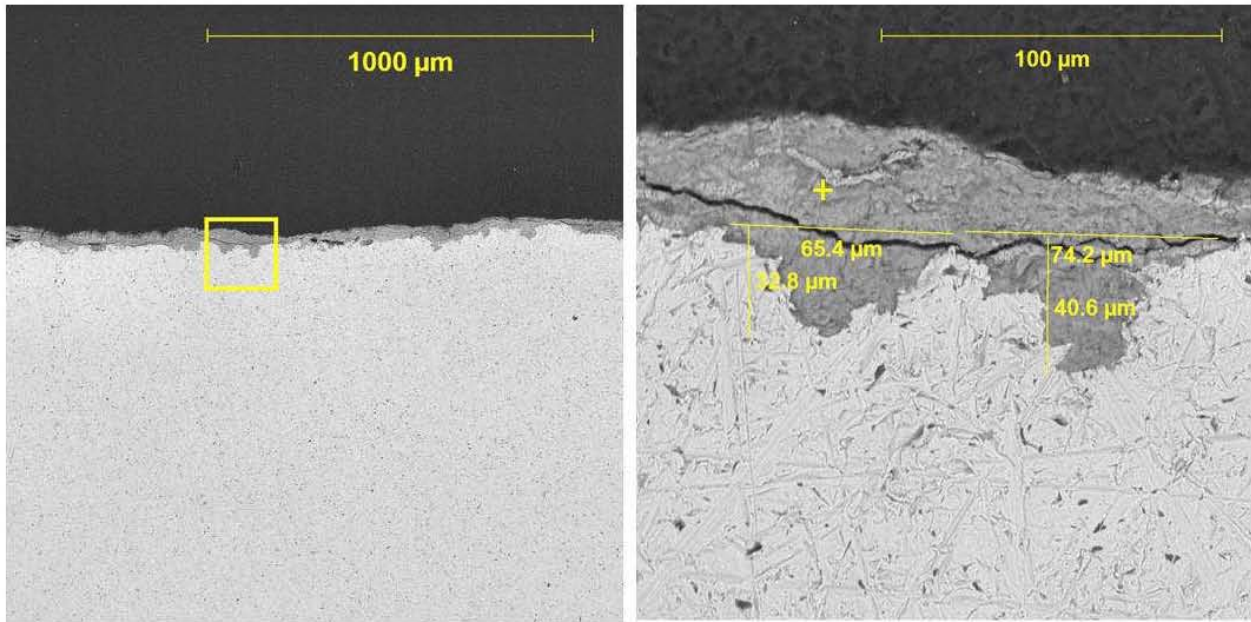
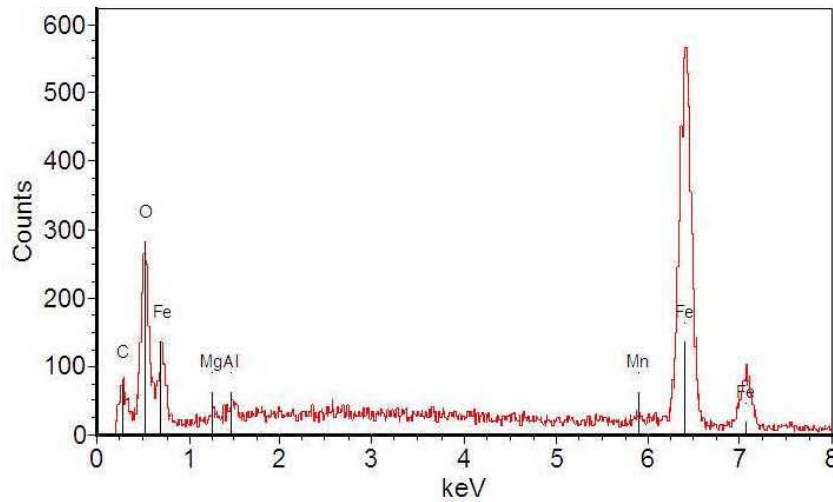
Figure 27. Scanning Electron Microscopy Image and Energy Dispersive Spectrometry Spectra of the Cross-Sectioned Specimen of SN-286.

Small pits do show up using the increased magnification of the SEM. Figure 27 shows an area on the cross-sectioned coupon at two different magnifications (the right image is a magnified view of the area in the yellow box of the left image). In general, the pits were measured at less than 50 μm (2 mils) in depth. The EDS spectrum indicates that the dark layer on the surface of the pipe is corrosion with trace elements of tank waste origin.

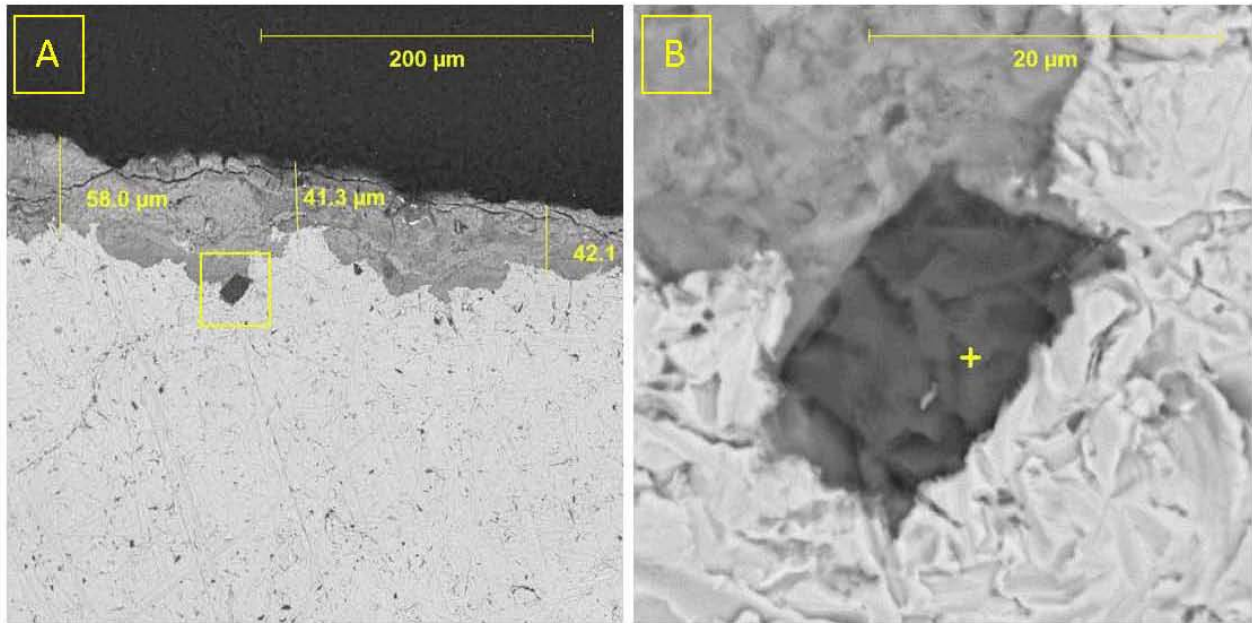
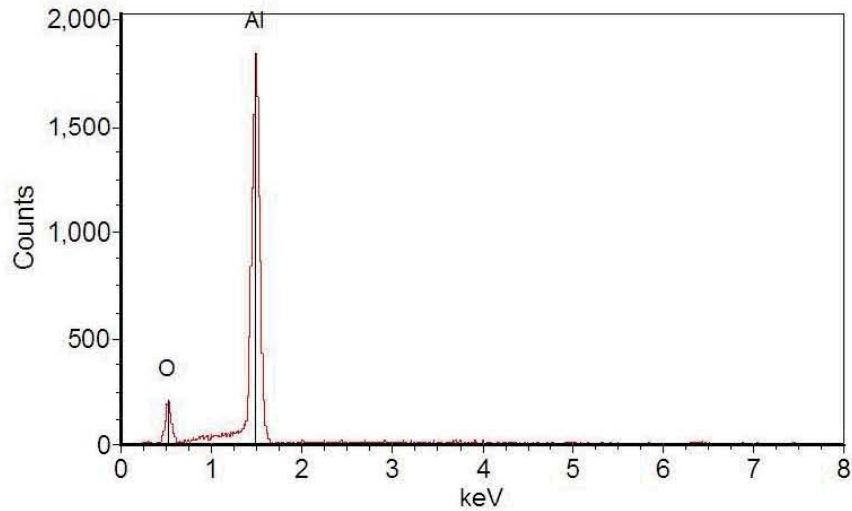
Figure 28. Scanning Electron Microscopy Image and Energy Dispersive Spectrometry Spectrum of the Corrosion Layer on SN-286 Inner Pipe.

The continuous corrosion layer on the inner surface of the SN-286 pipe section ranged between 40 (1.5 mils) to 60 μm (2.5 mils) in thickness, Figure 28A. Throughout this layer, individual particles of aluminum oxide tank waste (possible gibbsite) were observed as shown in Figure 28B. All the aluminum oxide particles detected in this cross-section were below the corrosion layer and adjacent to the metal surface.

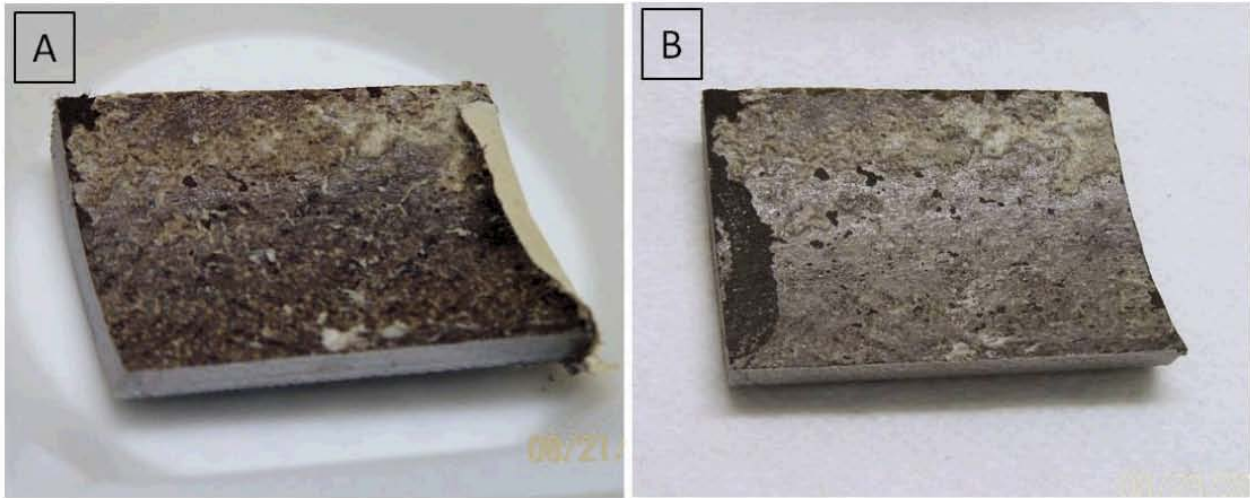
Figure 29. Photographs of the SN-278 Coupon Before and After Cleaning.

Similar to the previous two pipe sections, there were no obvious thin spots in this pipe section. Based upon the UT results, a 2 X 2 in. coupon was cut around the I-2 location on the pipe. The thickness of the coupon was measured with a digital caliper at 227 mils. This corresponds with the thickness measurement using the UT, and it is close to schedule 40 pipe thickness (216 mils) indicating minimal, if any, corrosion or erosion in this section.

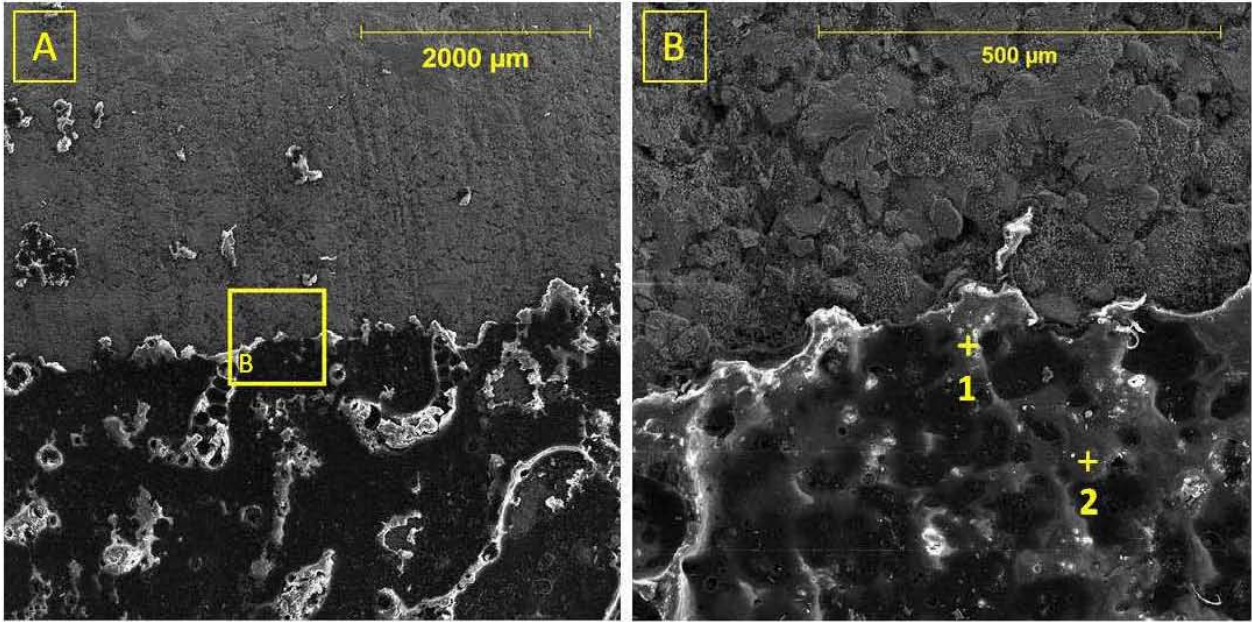
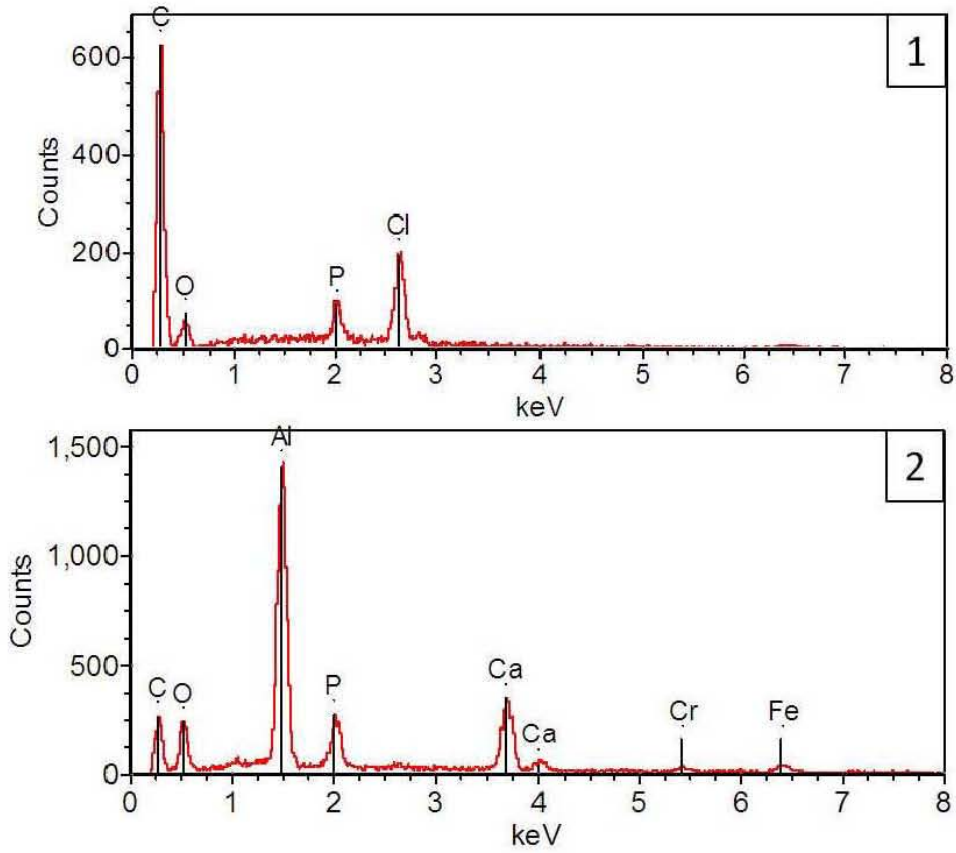
Figure 34. Scanning Electron Microscopy Image and Energy Dispersive Spectrometry Spectra of the Inner Wall of Pipe Section SN-278.

The primary pipe specimen photographed in Figure 30 was loaded into the SEM and examined. Figure 34 shows the resulting images of a location which borders an area which was scraped. The thin layer, detached in places, is evident in the lower parts of the images. The bare metal surface in the upper part of the images shows grooves which ran the length of the pipe. The image in Figure 34B is a magnified area of the yellow box in Figure 34A in which the grains of the metal can be seen as rounded nodules in the upper part of the figure. It appears that the corrosion in this area occurred at grain boundaries.

Unlike the 3150 stainless steel pipe described in 7S110-GAC-05-035, all three of these pipe sections show evidence for corrosion. Where the layer of tank waste is found, the corrosion layer is between the tank waste and the remaining metal of the pipe. This under-deposit corrosion is patchy, and appears to be most apparent in SN-278 and least apparent in SN-286. In SN-278, pits up to 200 μm (8 mils) deep and the thickness of the corrosion layer several hundreds of microns thick were observed. In the other two pipe sections, the thickness of corrosion and the depth of pits rarely exceeded 100 μm (4 mils) in the cross sections. This corrosion appears to progress by attacking metallic grain boundaries (Figure 34b).

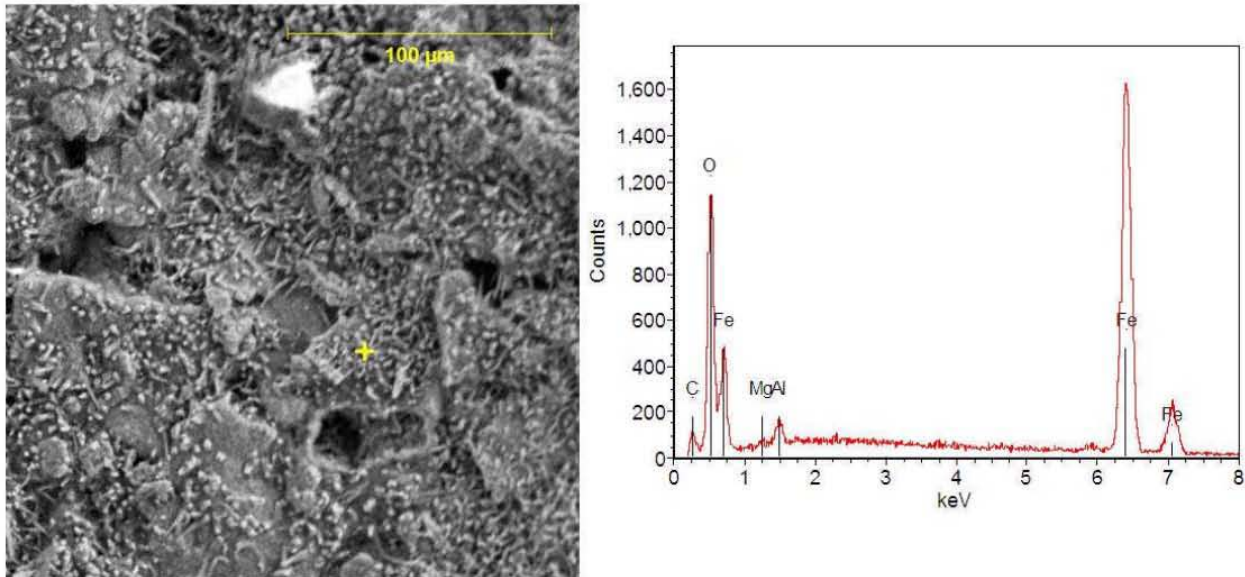
Figure 35. Scanning Electron Microscopy Image and Energy Dispersive Spectrometry Spectrum of Corrosion on the Exposed Grains of the Metal.

Looking at the bare pipe surface at a higher magnification reveals the presence of two morphologies in the corrosion phase: granular and acicular, Figure 35, on top of the exposed grains of the metal.

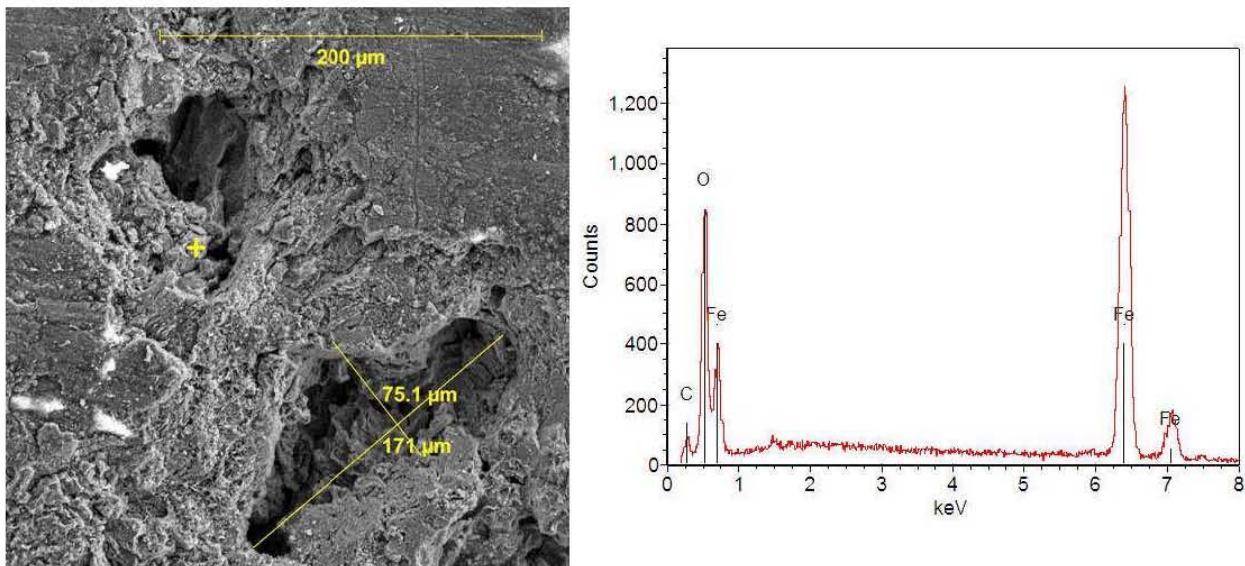
Figure 36. Scanning Electron Microscopy Image and Energy Dispersive Spectrometry Spectrum of Pitting on the Inner Surface of the Pipe.

Pits were also observed on the exposed pipe surface. Figure 36 shows two of the pits with one measuring 171 X 75 μm (7 X 3 mils).

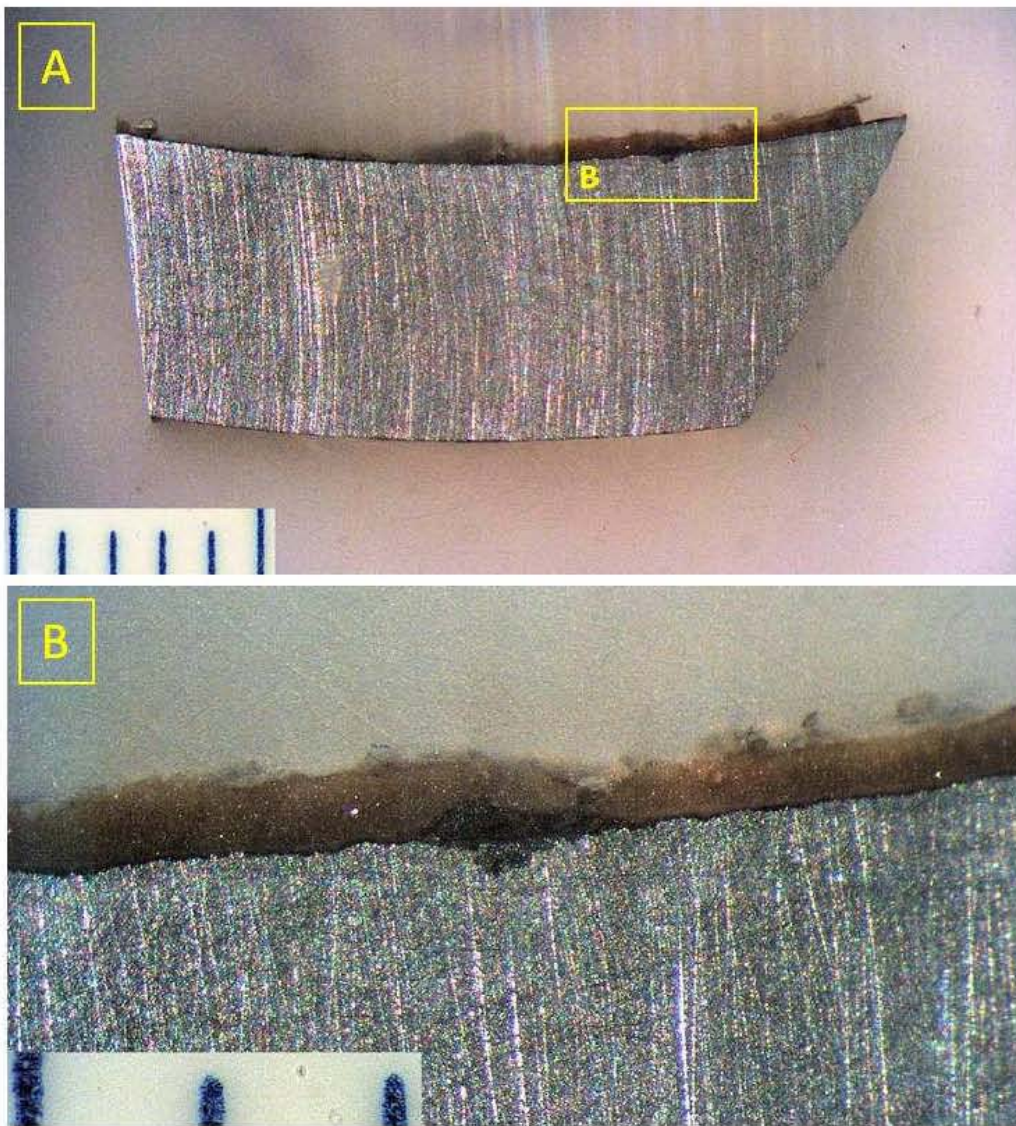
Figure 37. Photomicrographs of Cross-Sectioned Specimen from SN-278.

In order to obtain information on the flaky residue layer thickness, corrosion layer thickness, and the depth of corrosion pitting, a section of the SN-278 coupon was embedded in epoxy and cross-sectioned. The cross-sectioned specimen was then polished down to a 600-grit surface. Figure 37 shows photomicrographs of the cross-section with Figure 37B as a magnified view of the area inside the yellow box in Figure 37A. The scale bars are in 1 mm increments. There were some noticeable pits even at this magnification, and the inner pipe surface appeared irregular with a thin, dark film on the entire surface covered in some areas by a thicker dark-brown layer.
