Final Report for the Erosion and Corrosion Analysis of Waste Transfer Primary Pipeline Sections from 241-SY Tank Farm

J. S. Page
R. B. Wyrwas
G. A. Cooke
Washington River Protection Solutions LLC

Date Published
September 2012

Prepared for the U.S. Department of Energy
Office of River Protection

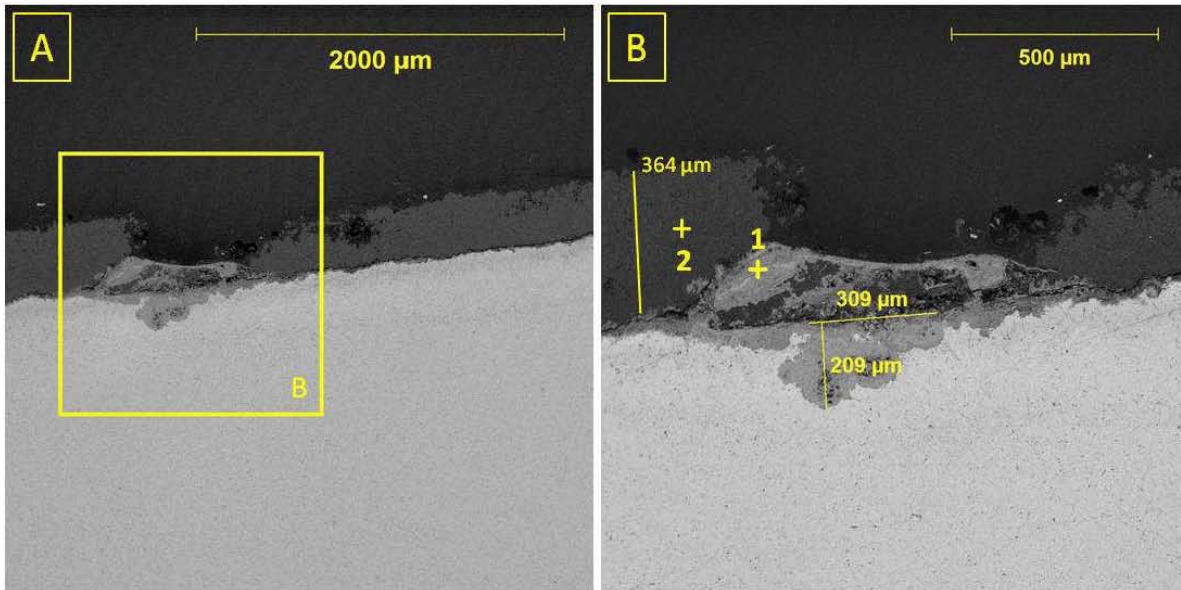
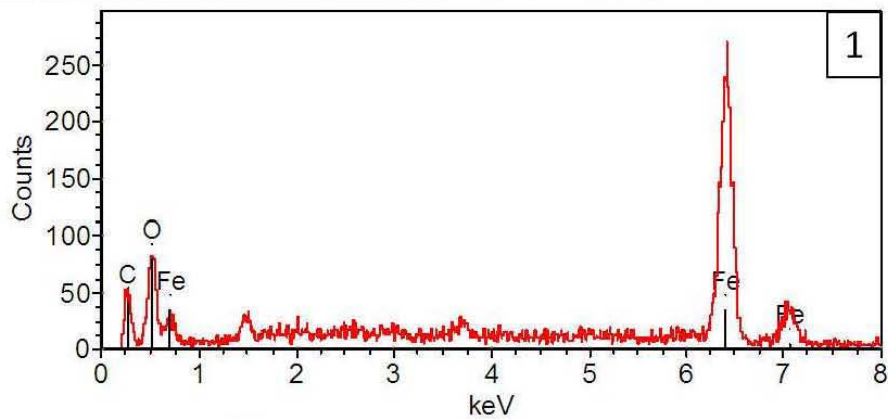
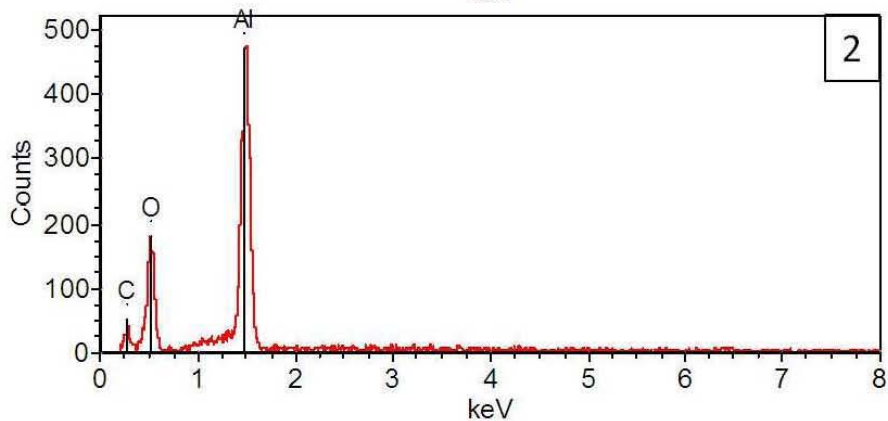
Figure 38. Scanning Electron Microscopy Image and Energy Dispersive Spectrometry Spectra of the Cross-Sectioned Specimen of SN-278.

The pit in the center of the photo in Figure 37B is shown as SEM images at different magnifications in Figure 38. Here, the pit, measuring 209 μm (8 mils) deep, has corrosion in and

directly above the pit. On both sides of the corrosion, a relatively thick layer, $\sim 350 \mu\text{m}$ (14 mils), of aluminum oxide, possibly gibbsite, is present.
