Hanford Single-Shell Tank Leak Causes and Locations - 241-A Farm

Washington River Protection Solutions

Abstract: This document identifies 241-A Tank Farm (A Farm) leak causes and locations for the 100 series leaking tanks (241-A-104 and 241-A-105) identified in RPP-ENV-37956, Hanford A and AX Farm Leak Assessment Report. This document satisfies the A Farm portion of the target (T04) in the Hanford Federal Facility Agreement and Consent Order milestone M-045-91F.

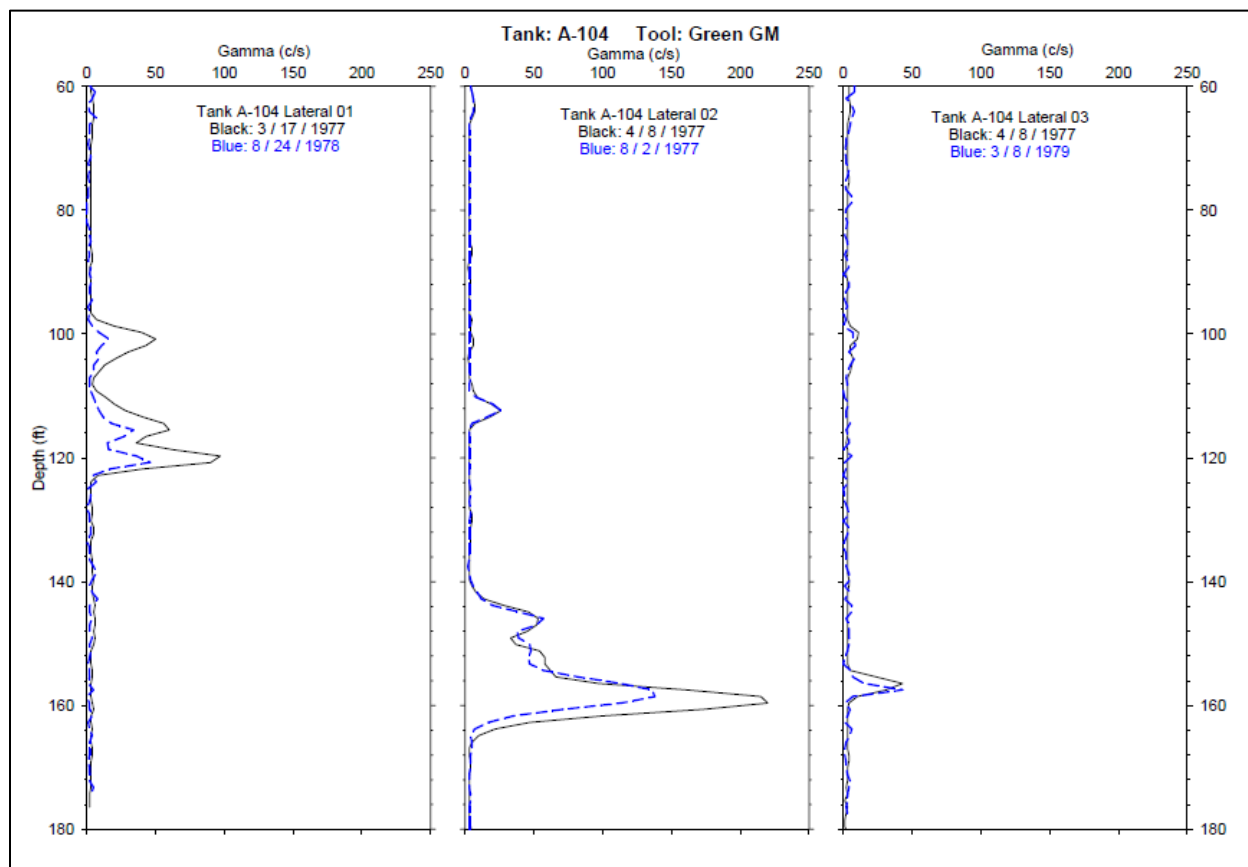
**Figure 4-9. Tank A-104 Historical Lateral Surveys (counts per second)
(RPP-RPT-27605, Rev. 0)**

The historical gross gamma profiles shown in Figure 4-9 for laterals 14-04-01, 14-04-02, and 14-04-03 (RPP-35484, *Field Investigation Report for Waste Management Areas C and A-AX*, page 3-91) indicate that the contaminant or contaminants emitting this radiation were relatively short-lived (e.g., ruthenium-106, cerium-144). The April 2005 gamma surveys (see Figure 4-10 and Figure 4-11) under tank A-104 did not identify any gamma activity above background levels (RPP-RPT-27605). Lateral 14-04-03 was not surveyed during this time.

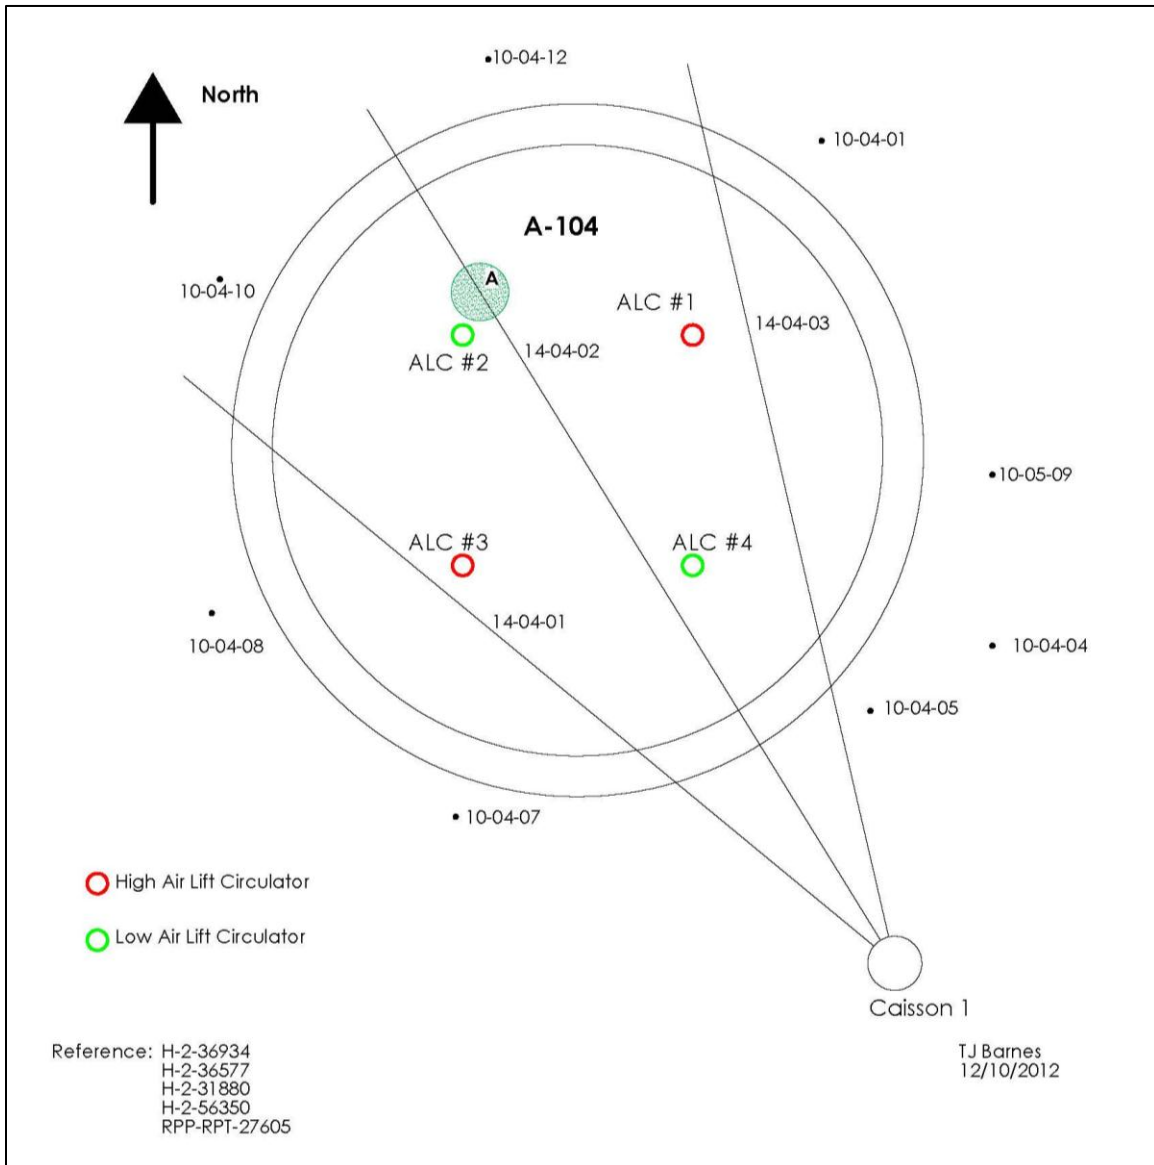
Figure 4-20. Tank A-104 Possible Leak Location (March 1975)
 Tank inner ring is steel liner; outer ring is outer edge of tank footing

Tank A-104 was first suspected of leaking in March 1975 due to radioactivity being detected in lateral 14-04-02 in the northern portion of the tank.

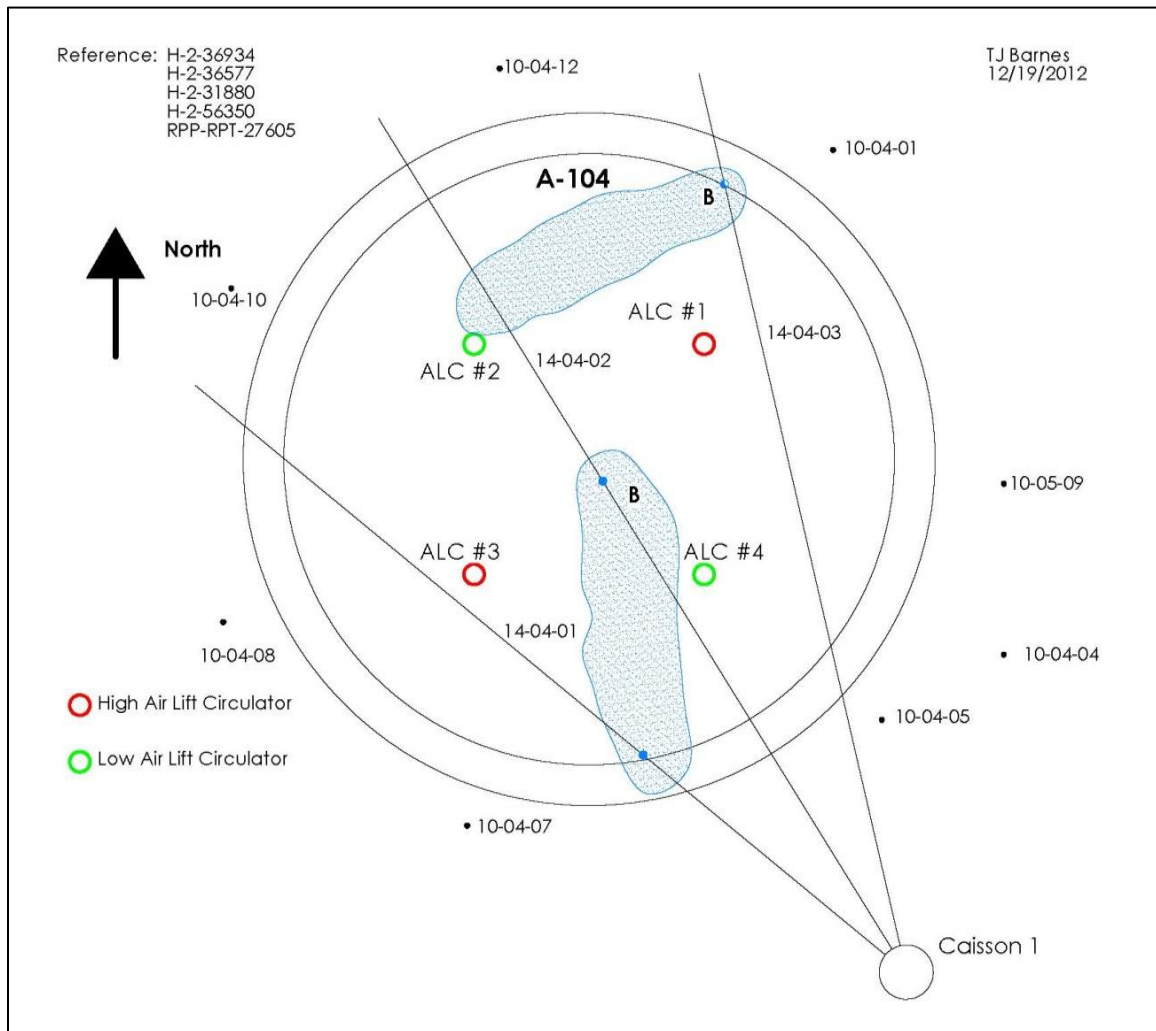
Figure 4-21. Tank A-104 Leak Indication (April 1975)
 Tank inner ring is steel liner; outer ring is outer edge of tank footing

Tank A-104 was first suspected of leaking in March 1975 due to radioactivity being detected in lateral 14-04-02 in the northern portion of the tank.

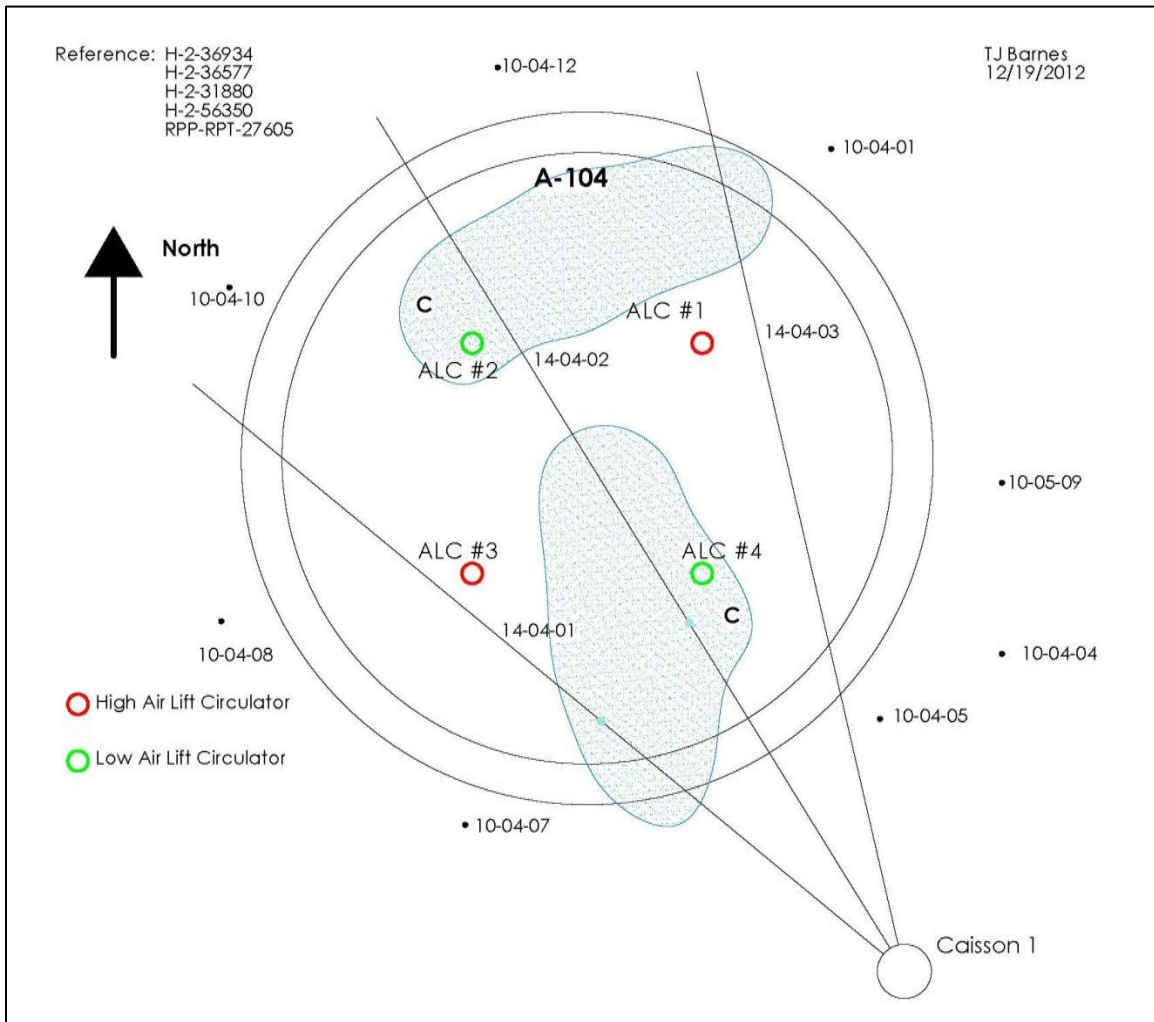
Figure 4-22. Tank A-104 Leak Indicators (May 1975)
 Tank inner ring is steel liner; outer ring is outer edge of tank footing

Tank A-104 was first suspected of leaking in March 1975 due to radioactivity being detected in lateral 14-04-02 in the northern portion of the tank.

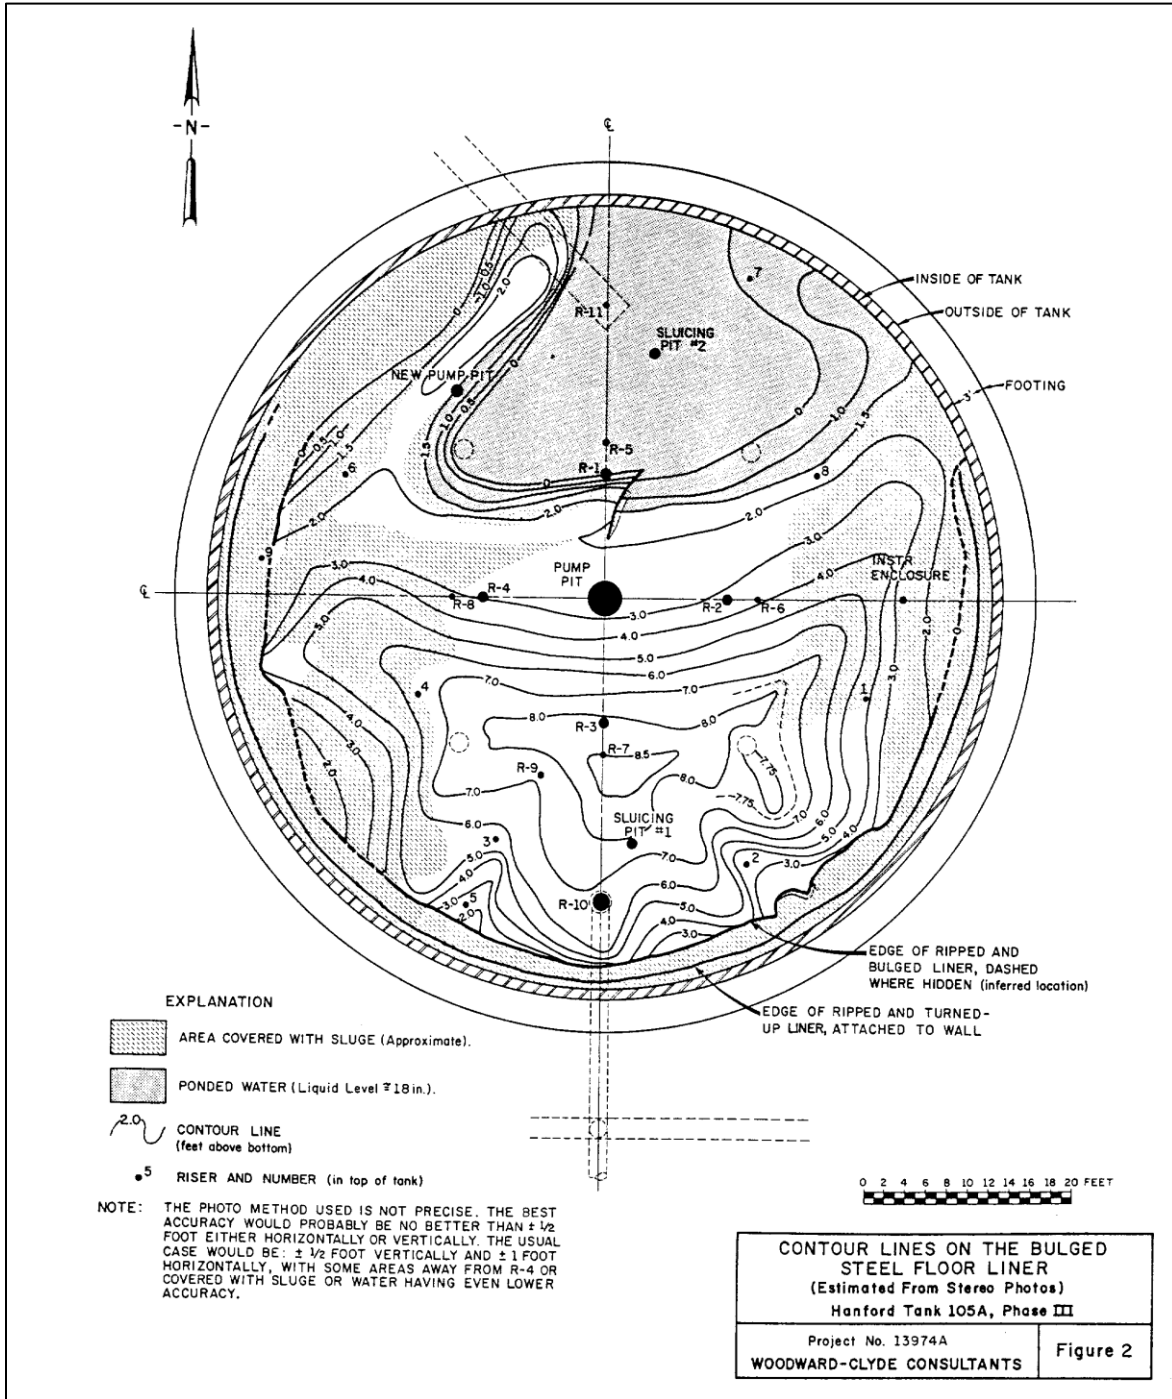
**Figure 5-5. Tank A-105 Contour Lines on the Bulged Steel Floor Liner
March 24, 1978 (TRAC-0022)**

Tank A-105 may have experienced a bulge in 1963 before the 1965 steam eruption. A bulge of the tank bottom liner may have set up conditions that resulted in the 1965 steam eruption (see tank A-105 section).

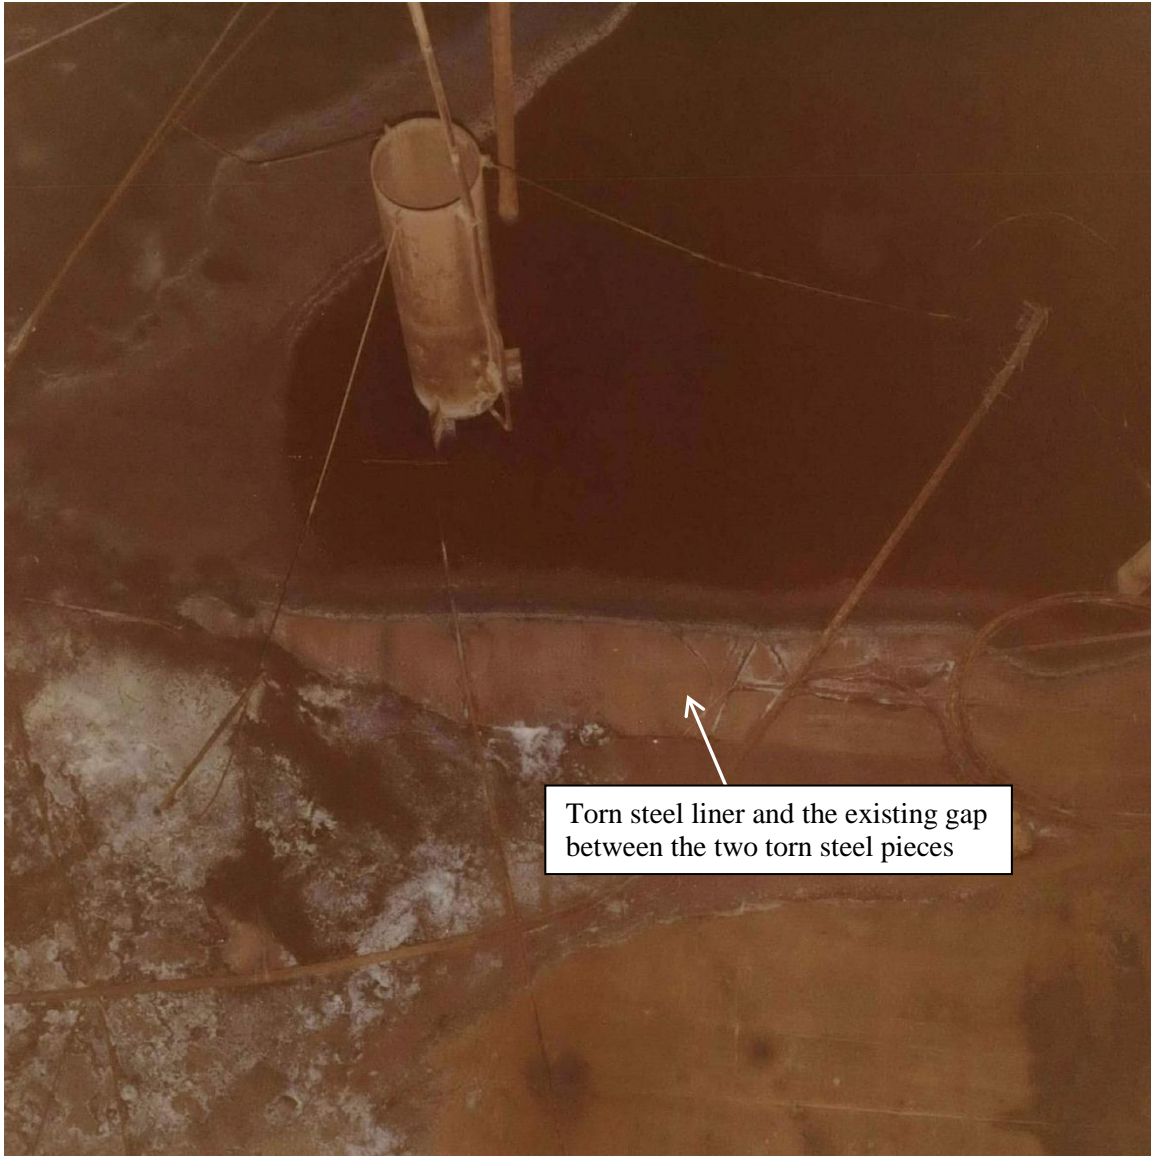
**Figure 5-7. Tank A-105 ALC #2 Photograph 769357-19CN
October 7, 1976**

Tilted
ALC

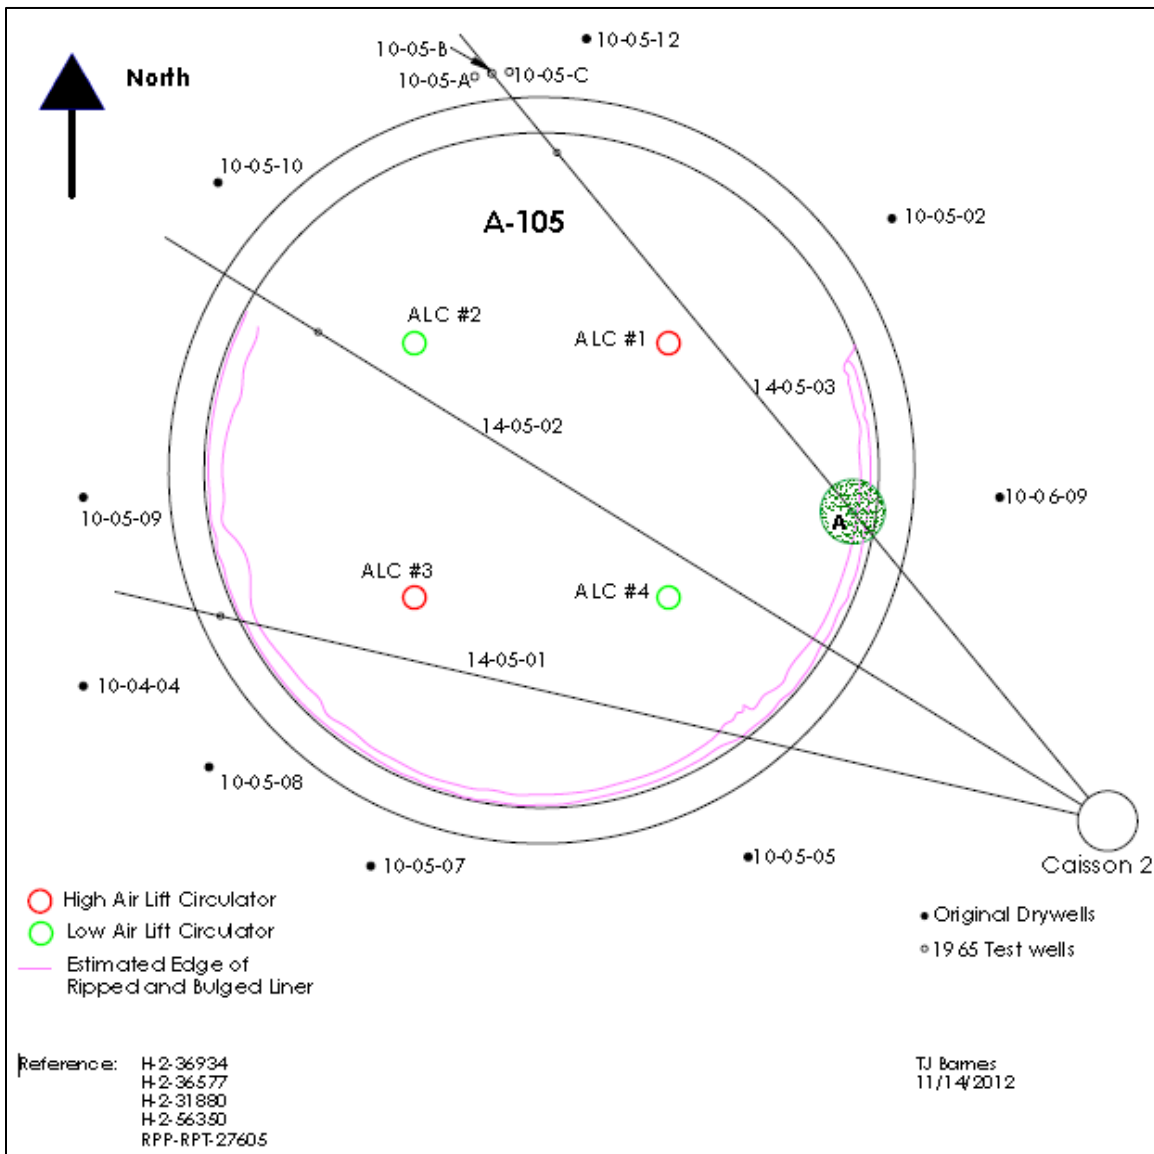
Figure 5-23. Tank A-105 Possible Leak Location (November 1963)
 Tank inner ring is steel liner; outer ring is outer edge of tank footing

Tank A-105 was first suspected of leaking in November 1963 due to radioactivity being detected in lateral 14-05-03 near the southeast portion of the tank.

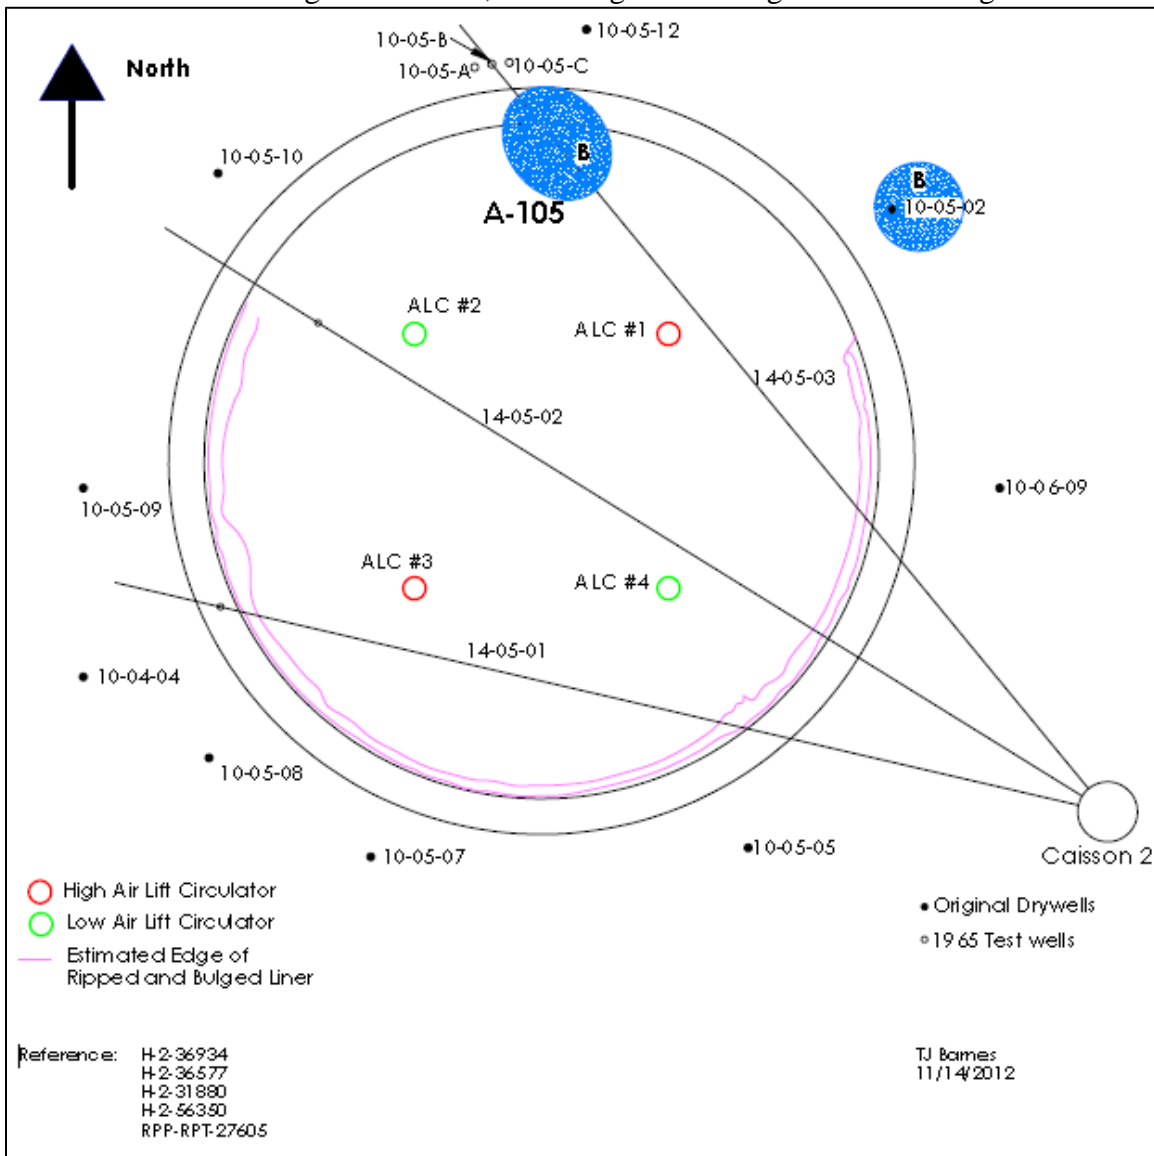
Figure 5-24. Tank A-105 Leak Indication (1965)
 Tank inner ring is steel liner; outer ring is outer edge of tank footing

Tank A-105 was first suspected of leaking in November 1963 due to radioactivity being detected in lateral 14-05-03 near the southeast portion of the tank.

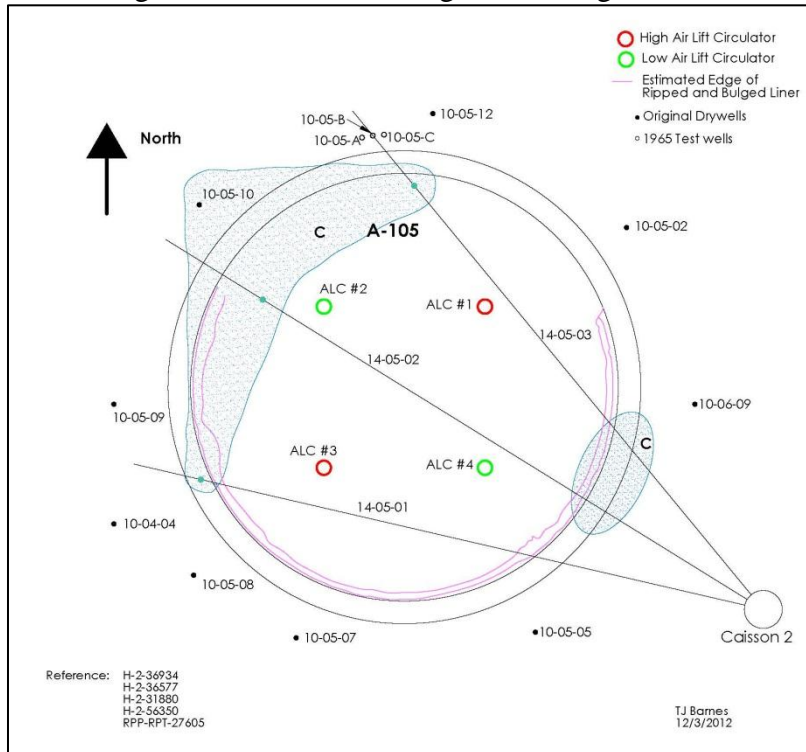
Figure 5-25. Tank A-105 Leak Indicators (1968-1970)
 Tank inner ring is steel liner; outer ring is outer edge of tank footing

Tank A-105 was first suspected of leaking in November 1963 due to radioactivity being detected in lateral 14-05-03 near the southeast portion of the tank.
