Hanford Single-Shell Tank Leak Causes and Locations - 241-C Farm

C.L. Girardot, D.G. Harlow

Washington River Protection Solutions

Key Words: leak location, leak cause, tank, integrity assessment, C Farm, C-101, C-105, leak assessment

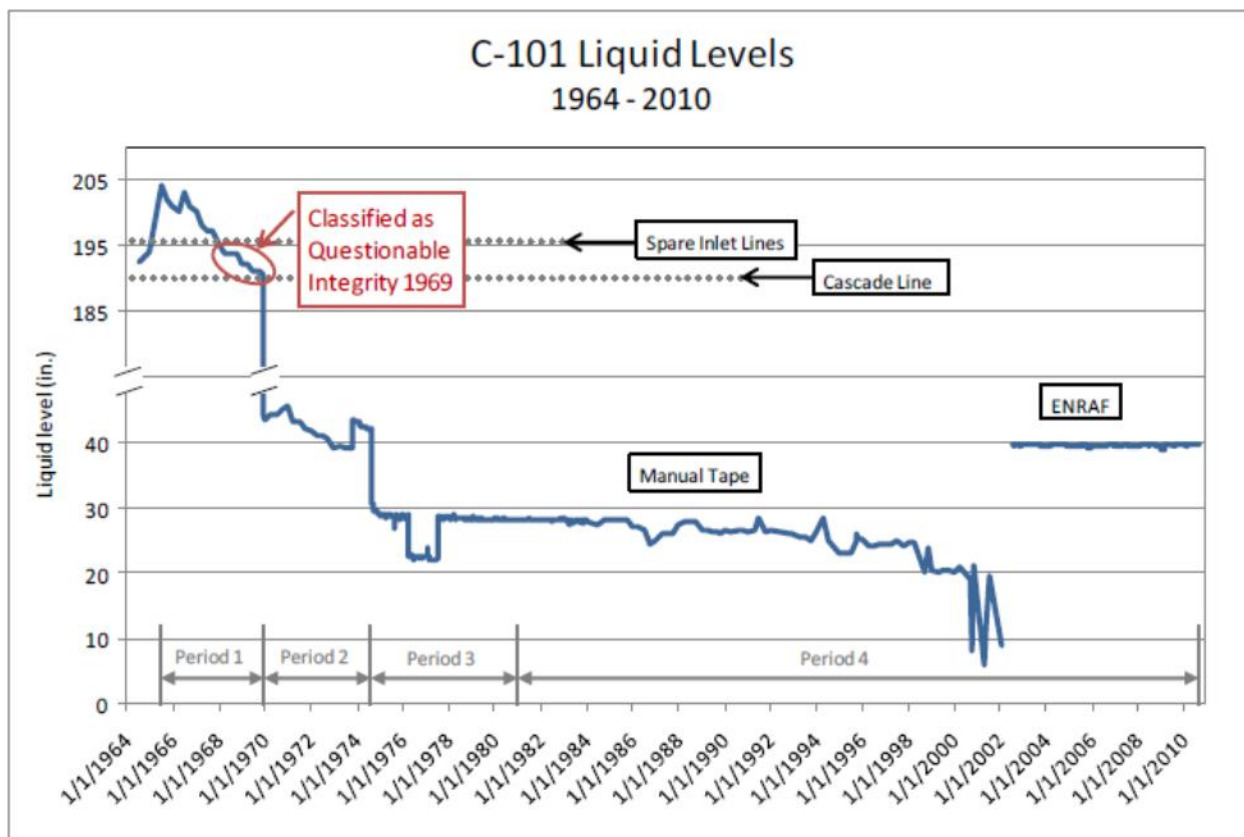
Figure 4-5. Tank C-101 Liquid Level 1964 – 2010

The detailed liquid level analysis indicated the possibility that the inlet line and cascade line packing could have leaked. The cascade line which had a partial plugging problem earlier could have been seeping to tank C-102 which was obscured by multiple transfers into and out of tank C-102. In addition, the liquid level could have been decreasing with vapor that was not condensed in the atmospheric condenser or that could have leaked past the condenser gasket. Also, there is a possibility of a tank leak. It was noted the liquid level rate was decreasing as it approached the cascade line when the tank was pumped and little evidence exists for a liquid level decrease after pumping.

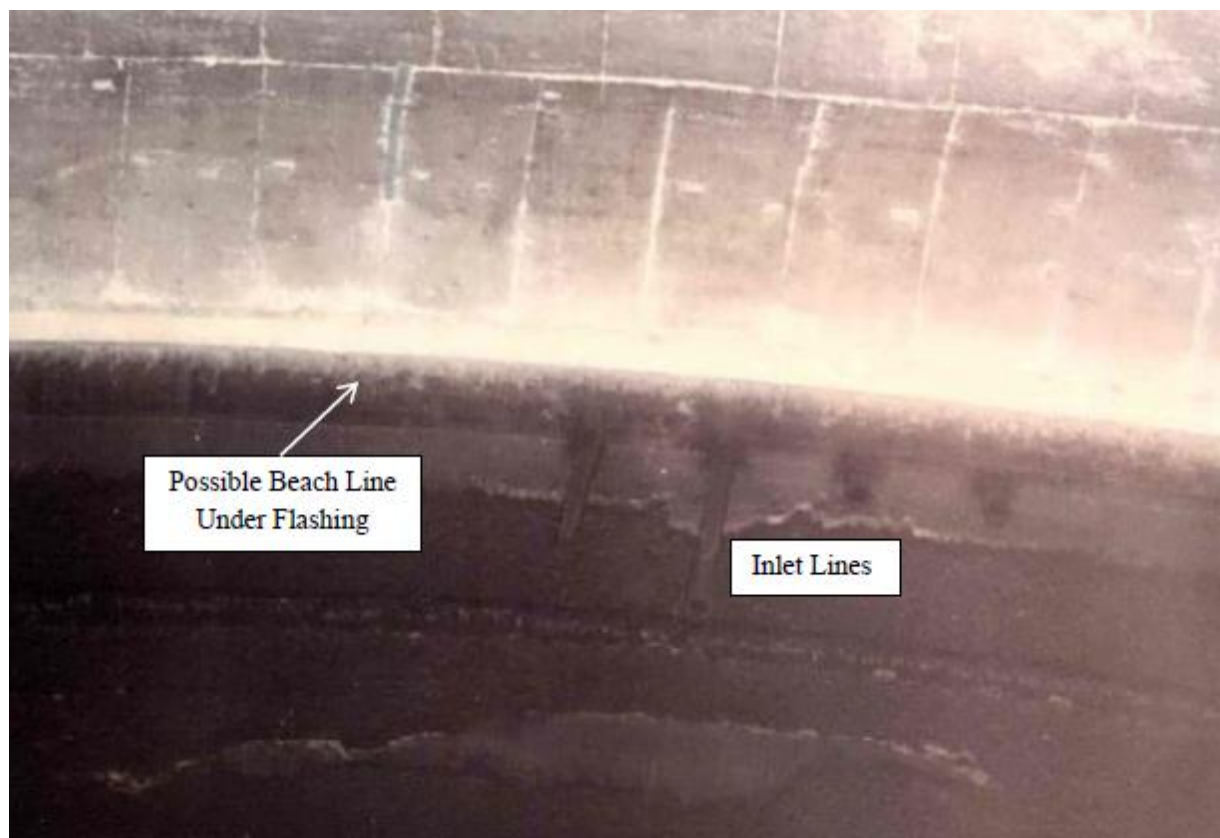
Figure 4-7. Tank C-101 Photograph February 13, 1970 (700695-4 CN)

A photograph of the inlet lines (two active and two spares) also show a beach line which appears to be above the inlet lines (see Figure 4-7). The tank C-101 photographs do not show any evidence pointing to a tank leak.

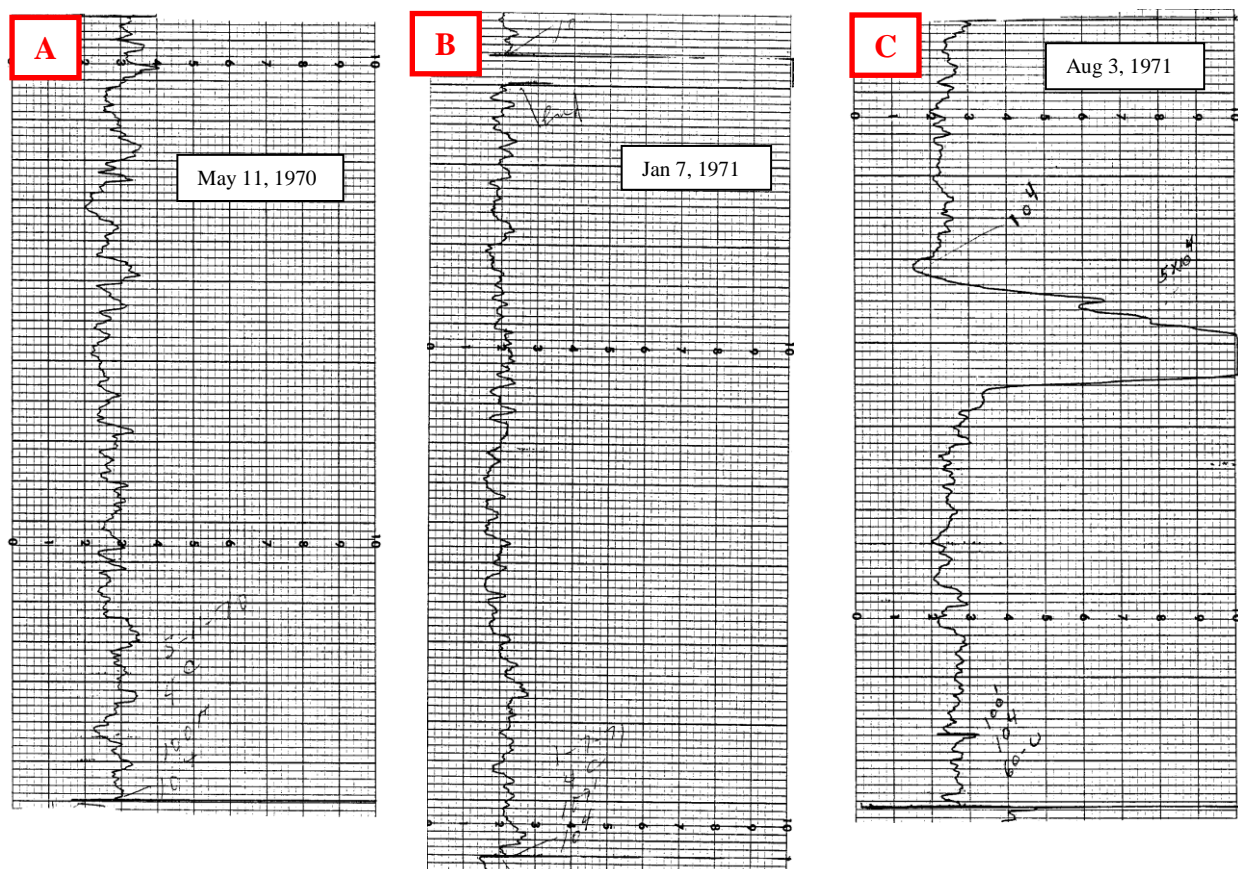
Figure 4-8. Drywell 30-01-01 Historical Gross Gamma Logging

In September 1997, Cs-137 and Co-60 were the only man-made radionuclides detected in this drywell (GJ-HAN-85). From the ground surface to 13-ft BGS, Cs-137 was detected continuously and almost continuously from 20.5 to 32-ft and from 97.5 to 98-ft BGS. The maximum Cs-137 concentration was approximately 2 pCi/g at 29.5-ft BGS. From 37 to 41-ft BGS, Co-60 was detected almost continuously with a maximum concentration of 0.16 pCi/g at 38 and 38.5-ft BGS. Document GJ-HAN-85 reports, “The Cs-137 from the ground surface to about 13 ft may be the result of a surface spill”...and, “The Cs-137 contamination from 20.5 to 32 ft may be from a pipeline leak.”

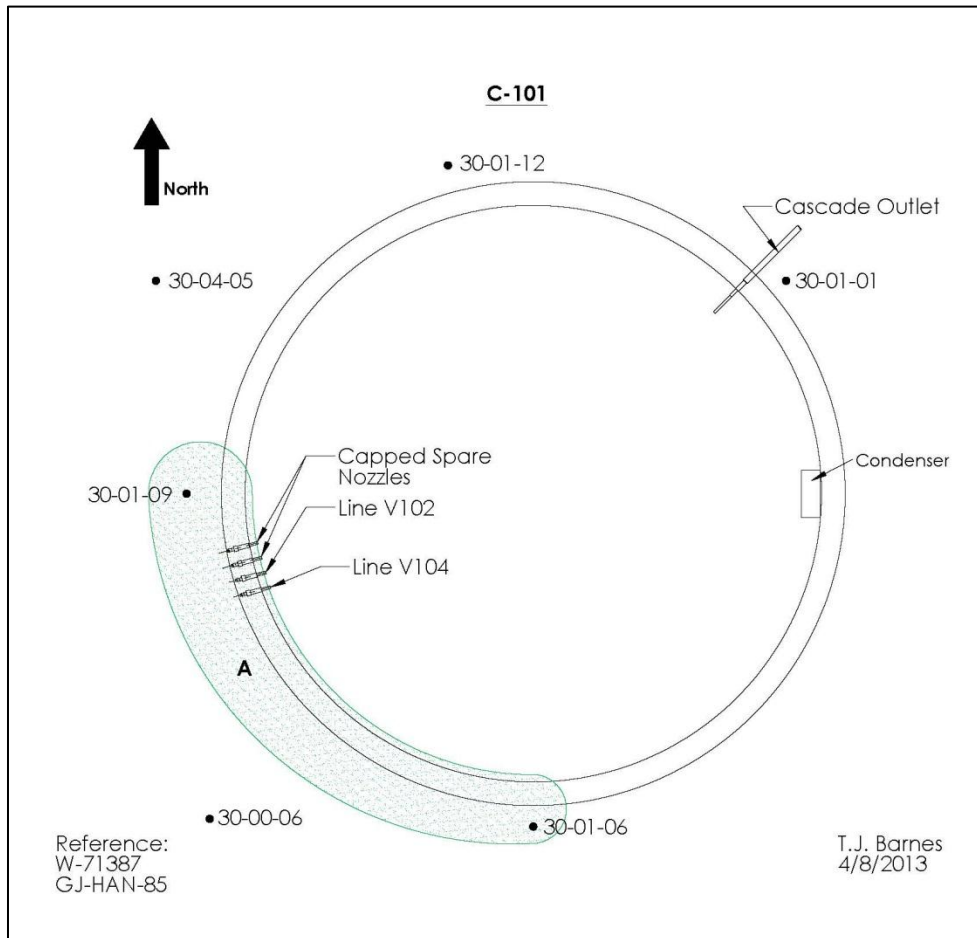
Figure 4-18. Tank C-101 Possible Leak Location (April 1970)
Tank inner ring is steel liner; outer ring is outer edge of tank footing

If there was a leak from tank C-101, it could have occurred as early as June 1965 based on liquid level decreases

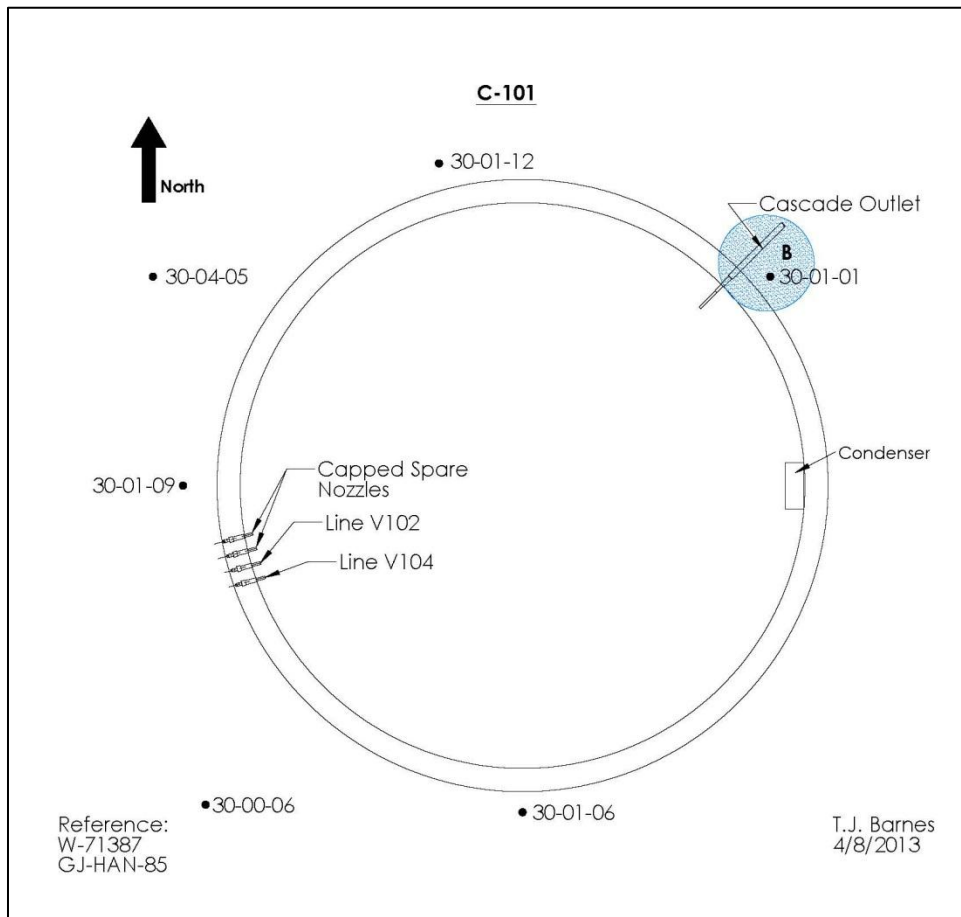
Figure 4-19. Tank C-101 Possible Leak Location (August 1971)
 Tank inner ring is steel liner; outer ring is outer edge of tank footing

If there was a leak from tank C-101, it could have occurred as early as June 1965 based on liquid level decreases

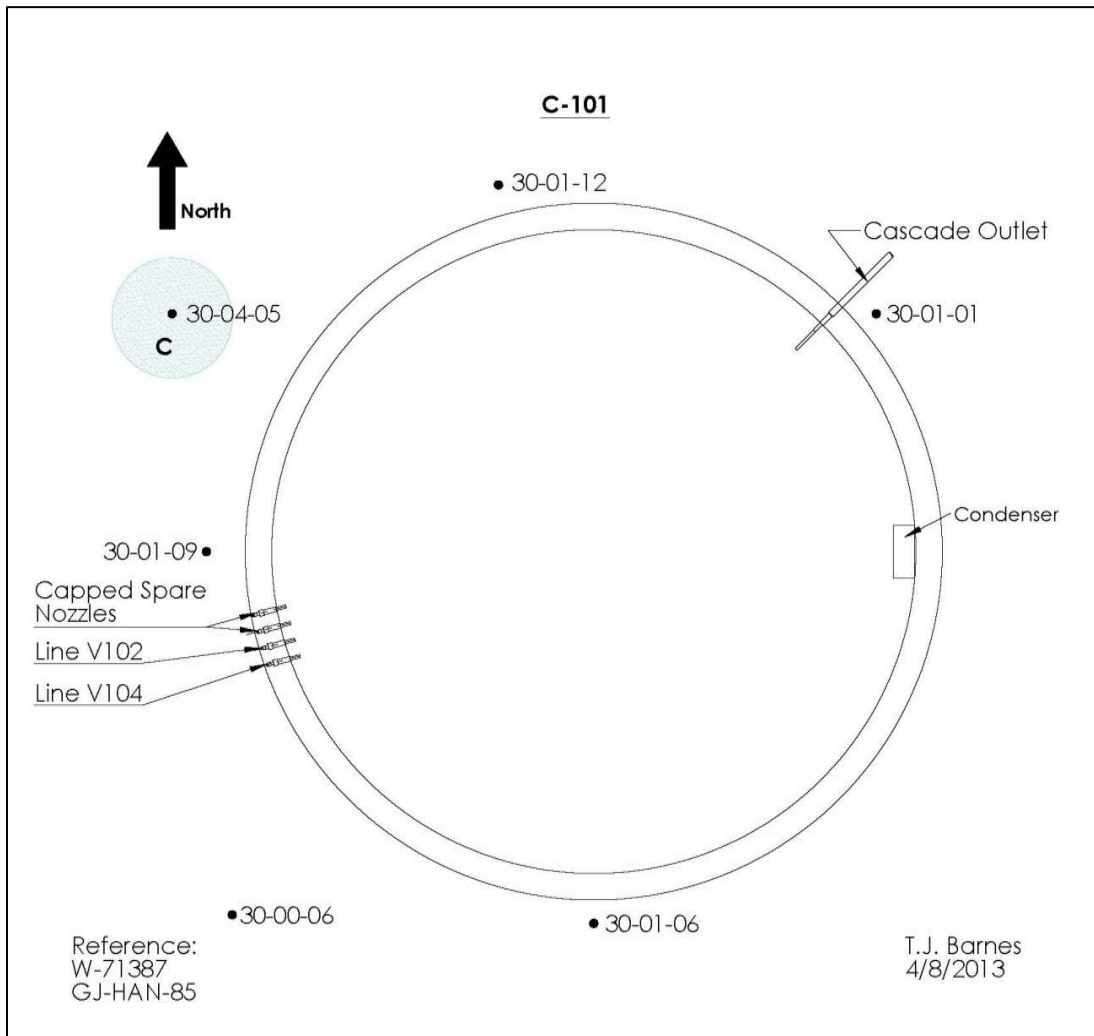
Figure 4-20. Tank C-101 Possible Leak Location (September 1974)
 Tank inner ring is steel liner; outer ring is outer edge of tank footing

If there was a leak from tank C-101, it could have occurred as early as June 1965 based on liquid level decreases

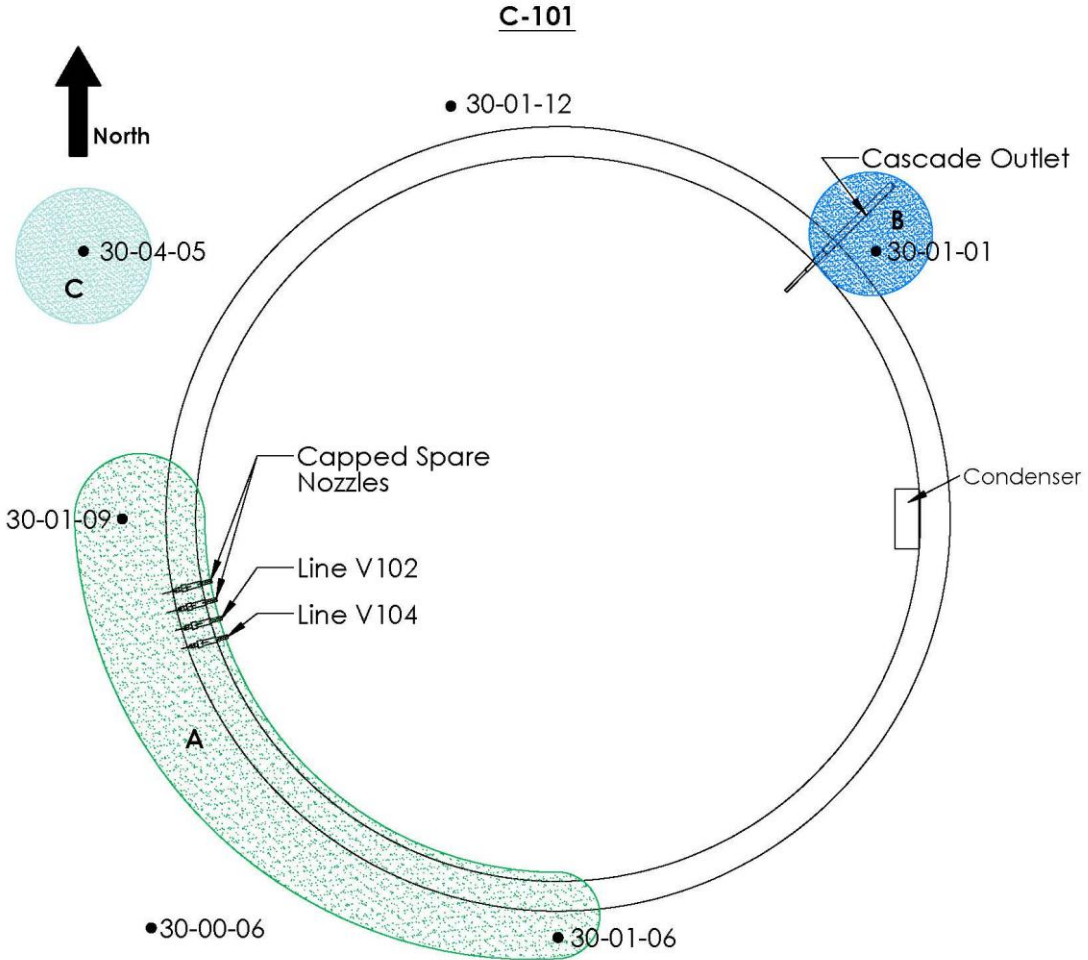
Figure 4-21. Tank C-101 Possible Radial Leak Locations
 Tank inner ring is steel liner, outer ring is outer edge of tank footing

A	B	C
Apr-70	Aug-71	Sep-74
<p>If there was a leak from tank C-101, it could have occurred as early as June 1965 based on liquid level decreases. The liquid level was above the spare inlet lines as well as the cascade outlet line when the liquid level initially started to drop. Some of the liquid level decrease may be the result of a tank leak and/or other sources. In April 1970, drywells 30-01-09 (23 to 36-ft BGS) and 30-01-06 (~35-ft BGS) reported radioactivity. Drywell 30-01-09 is located near the spare inlet lines and the spare inlet lines are located at ~22-ft BGS. The source of radioactivity likely started near drywell 30-01-09 with migration to drywell 30-01-06.</p>	<p>A new peak was reported in drywell 30-01-01 at ~33-ft BGS. This appears to be a separate site unrelated to the radioactivity detected in the southwestern portion of tank C-101. It is likely the radioactivity detected in drywell 30-01-01 is due to a leak from the packing of the cascade outlet line which is located at ~22-ft BGS. However, a tank C-101 sidewall leak cannot be ruled out.</p>	<p>Drywell 30-04-05 reported a peak at ~13-ft BGS shortly after being drilled. It is likely radioactivity detected in this drywell is due to migration from a surface spill with the remote possibility of a pipeline leak. This appears to be separate and unrelated to the earlier April 1970 site due differences in the BGS depth. The source of the radioactivity in drywell 30-04-05 does not appear to be tank C-101</p>

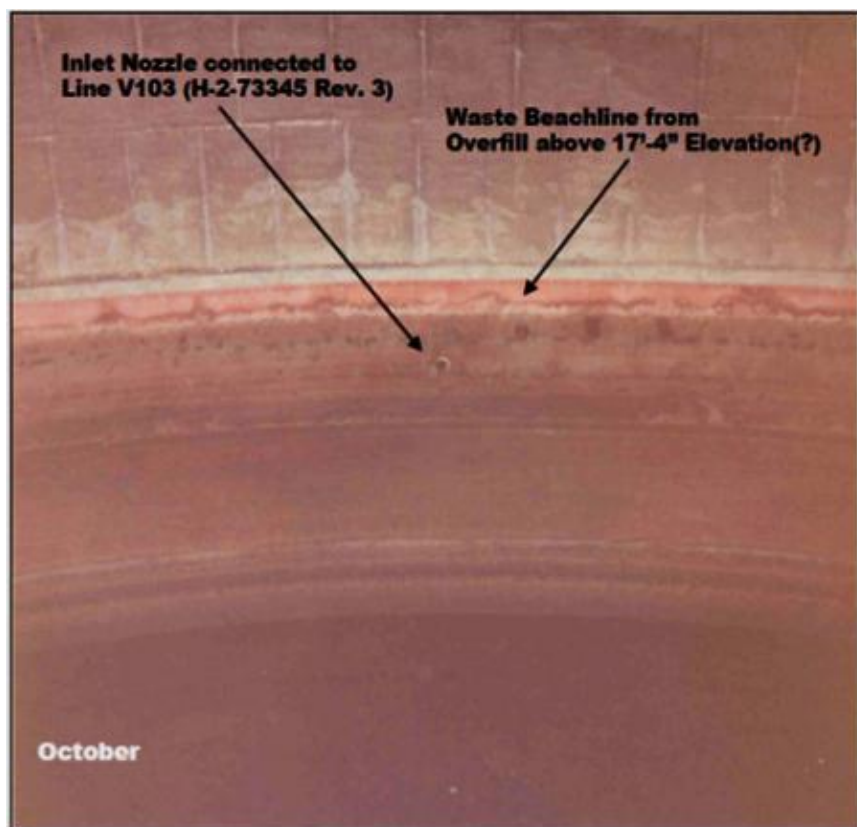
Figure 5-5. Tank C-105 Inlet Nozzle Line V103 and Beachline

October 11, 1974 Waste Level = 78.8" (Negative 746325-29CN)

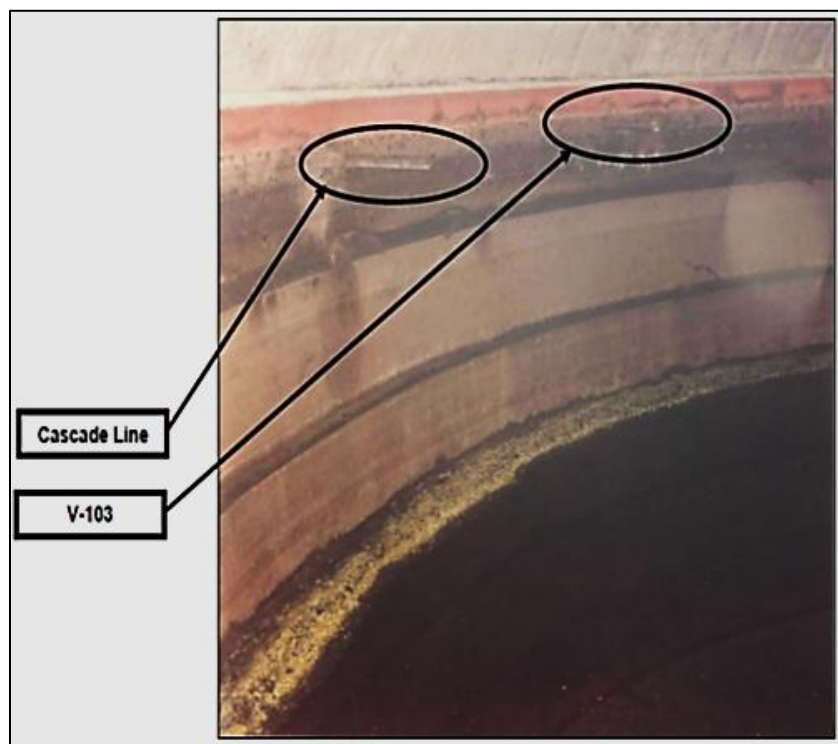
Figure 5-6. Tank C-105 Cascade line and V103 Inlet Line

March 28, 1985 Waste Level = 55 inches (Negative 8502079-6CN)
