241-AZ Farm Annulus Extent of Condition Baseline Inspection

Washington River Protection Solutions

Abstract: This report provides the results of the comprehensive annulus visual inspection for tanks 241-AZ-101 and 241-AZ-102 performed in fiscal year 2013. The inspection established a baseline covering about 95 percent of the annulus floor for comparison with future inspections. Any changes in the condition are also included in this document.

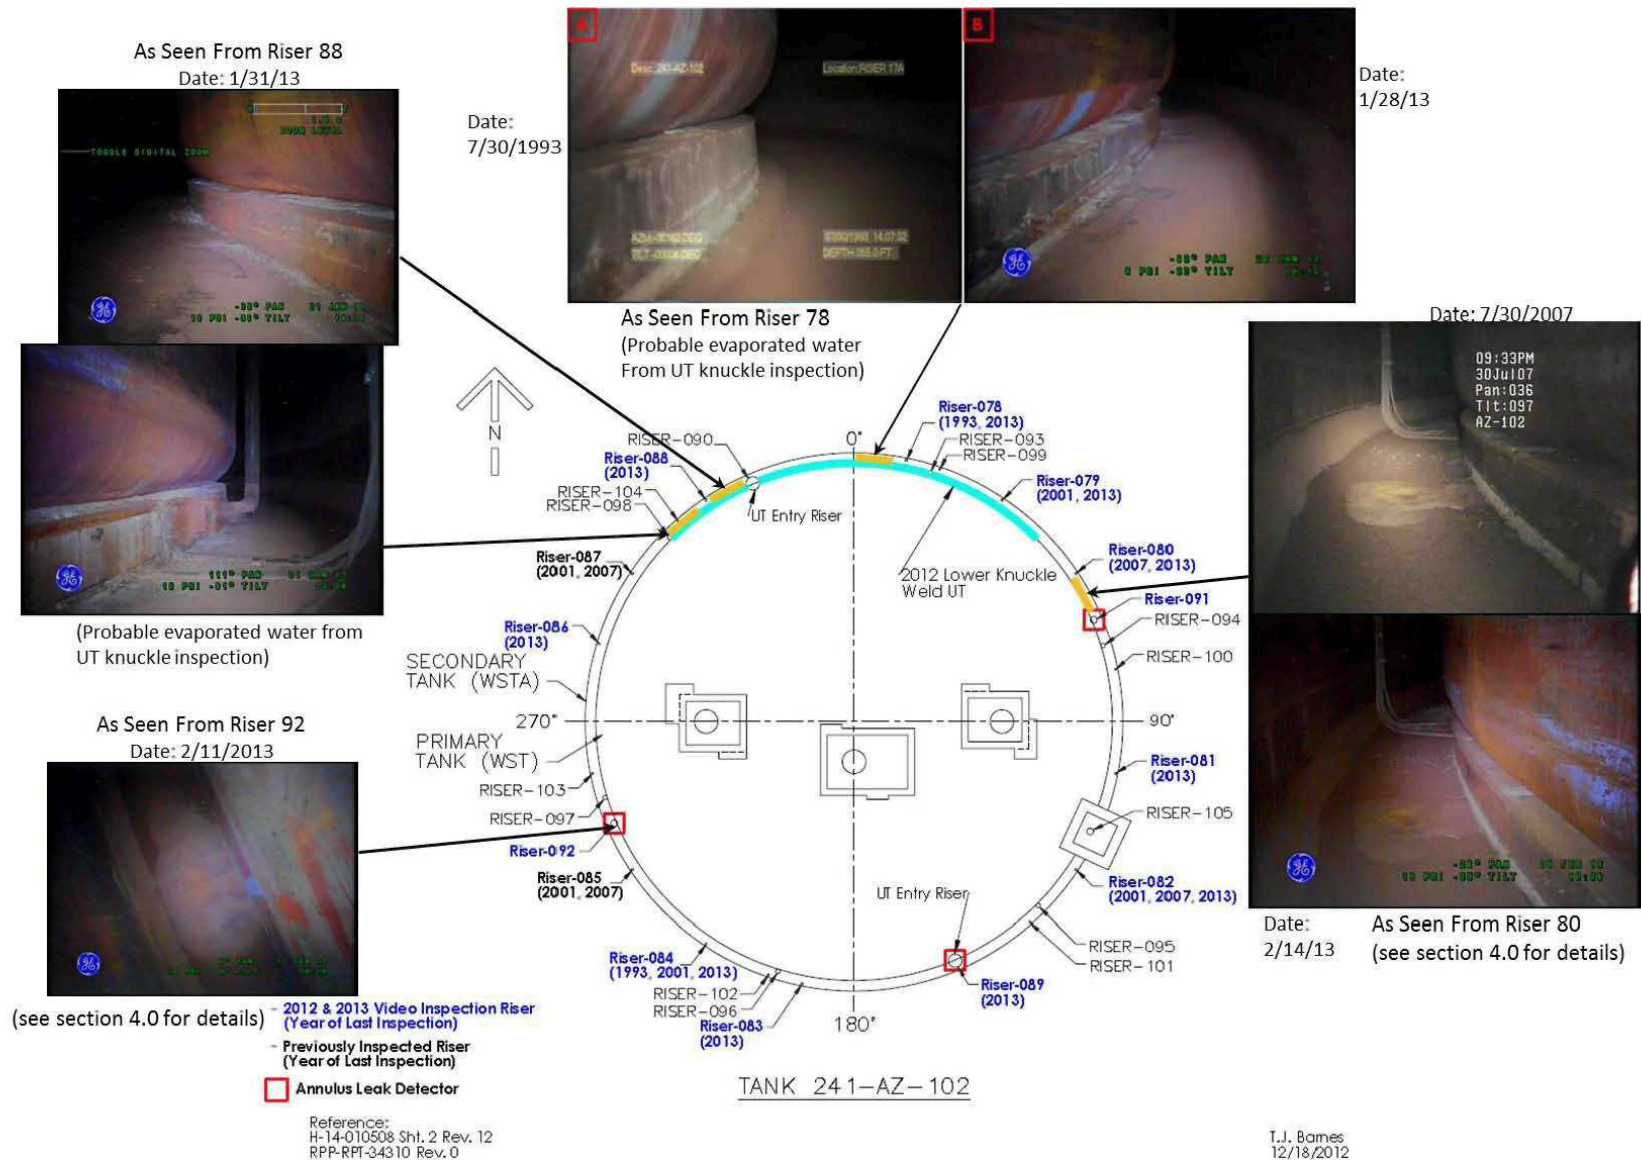
Annulus inspections identified small amounts of change on the annulus floor of tanks AZ-101 and AZ-102 (see Figure ES-3 and Figure ES-4, respectively) as compared to areas previously inspected. These changes are likely attributed to evaporated couplant water from UT examinations that occurred in nearby risers after the previous visual inspection. Additional stains were also identified on the annulus floor of tanks AZ-101 and AZ-102, however, these stains can be correlated back to existing equipment locations (e.g., annulus pump pit, riser penetrations, ENRAFs, etc.). Despite the changes identified in the current inspection, there was no evidence indicative of active water intrusion or a primary tank leak for tanks AZ-101 and AZ-102.

Figure ES-4. Tank AZ-102 Baseline Inspection Results Showing Additional Material on the Annulus Floor Attributed to Ultrasonic Inspections and ENRAF Installation

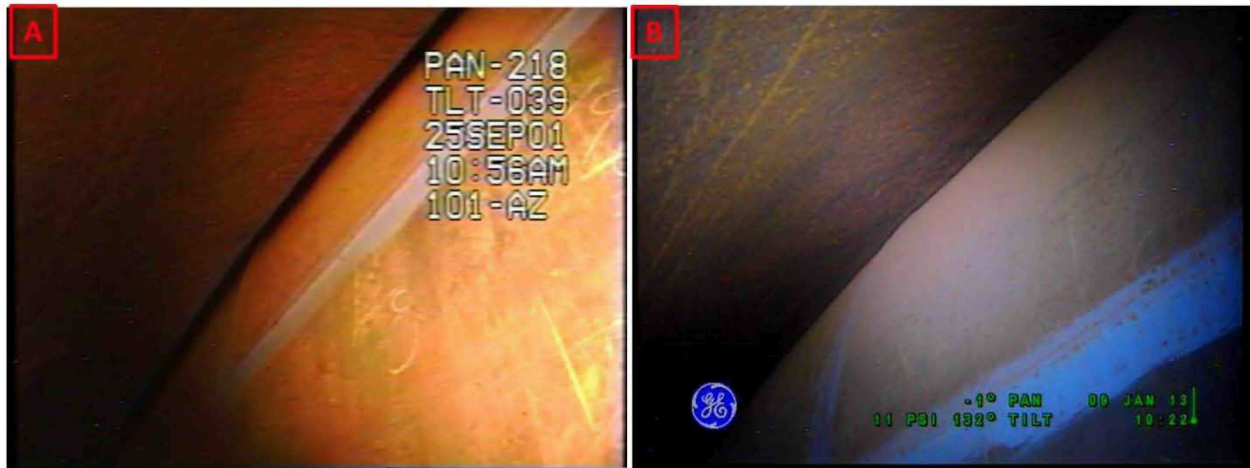
The tank dome and upper haunch area were not visible during the 1993 inspection. Figure 2-1 and Figure 2-2 show comparisons of the upper haunch area between inspections performed in 2001 and 2013. Since the camera was lower in the 2001 inspection, it is difficult to make any comparisons with the 2013 inspection of the top knuckle area. However, there appears to be no significant changes in the condition of this area from 2001 to 2013. No areas of interest were identified in the top knuckle region during the 2013 inspection.

Figure 2-1. Riser 78 Upper Haunch Comparisons Between Inspections on September 25, 2001 (A) and January 9, 2013 (B) Looking Towards Riser 93

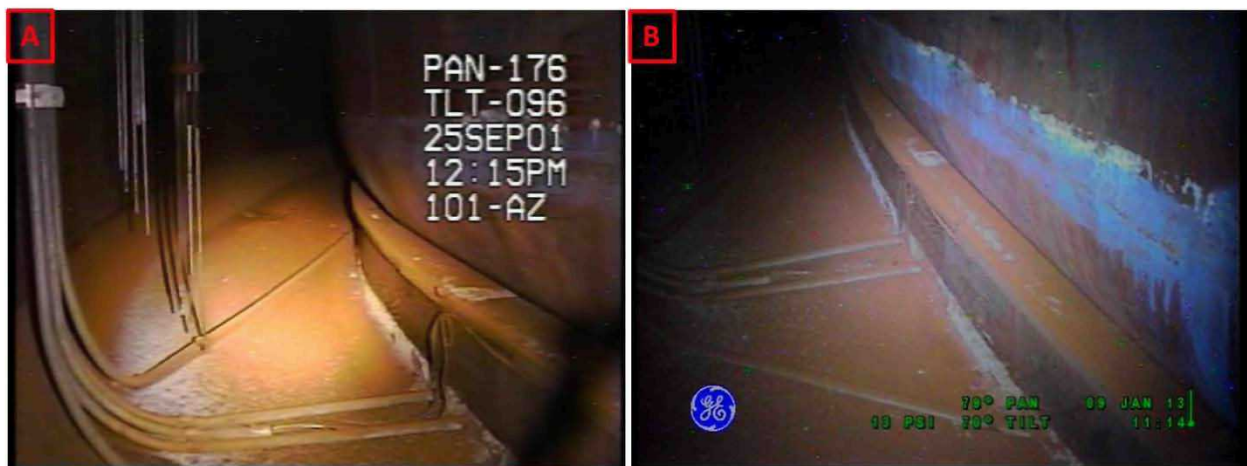
Figure 2-3 and Figure 2-4 show comparisons of the lower knuckle and annulus floor between inspections performed in 2001 and 2013. There appears to be no significant change in the condition of this area between 1993 and 2013. A beachline can also be seen along the annulus floor in Figure 2-3 and Figure 2-4 which is likely the result of evaporated couplant water used during UT examinations. Figure 2-5 shows the general condition of the refractory slots in 2013 and no anomalies were noted. No anomalies were identified on the lower knuckle of the primary tank, insulating refractory, refractory slots, stiffener ring, or annulus floor during the 2013 inspection.

Figure 2-3. Riser 78 Lower Knuckle and Annulus Floor Comparisons Between Inspections on September 25, 2001 (A) and January 9, 2013 (B) Looking Towards Riser 93

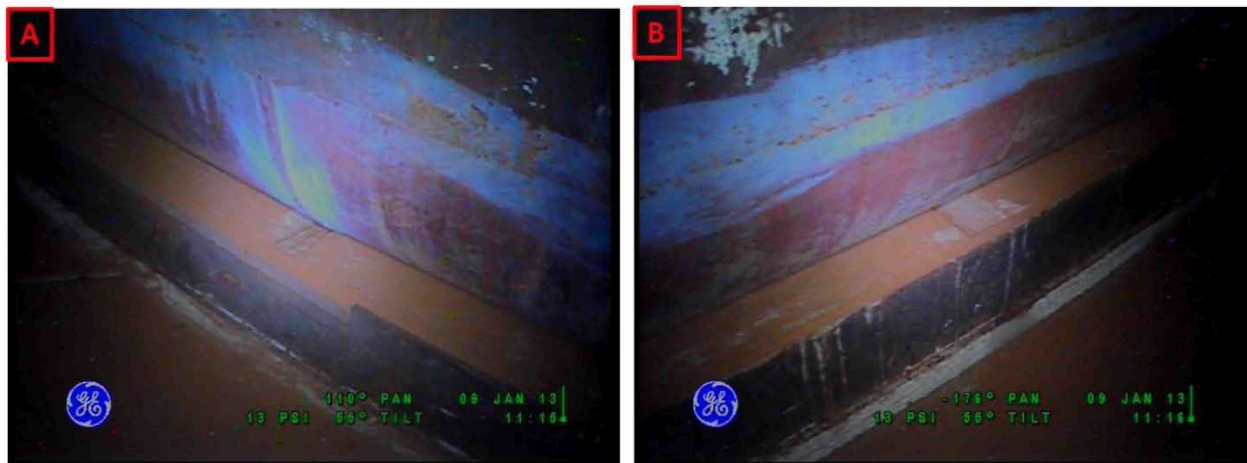
Figure 2-5. Riser 78 General Condition of the Refractory Slots on January 9, 2013

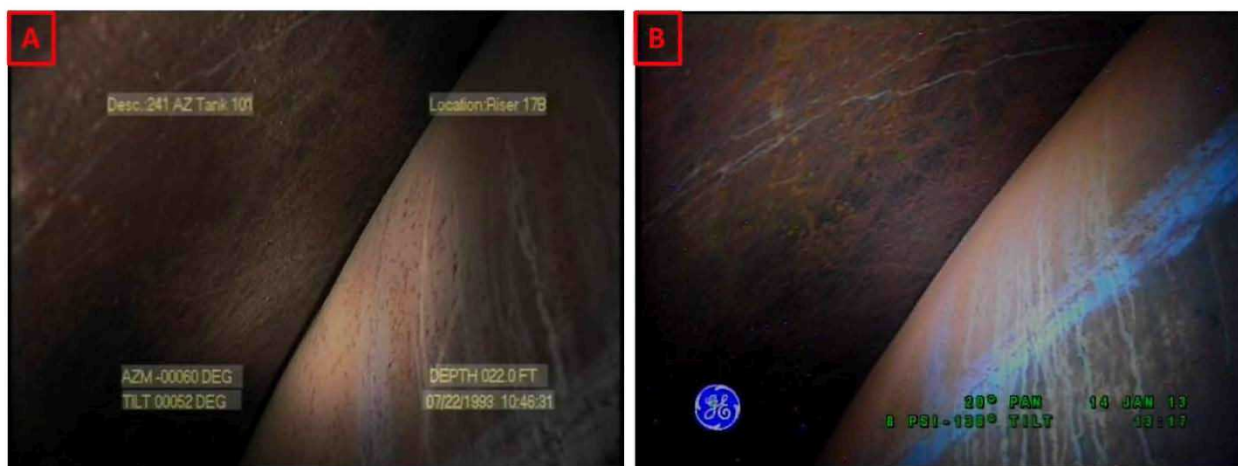
Figure 2-6 and Figure 2-7 show comparisons of the upper haunch area between inspections performed in 2001 and 2013. In both of these figures, white streaks can be seen on the primary tank. These white streaks, which are commonly seen among the DSTs, are referred to as laitance flow attributed to the pouring of the concrete dome during construction. There were no significant changes in the condition of this area from 2001 to 2013. No areas of interest were identified in the top knuckle region during the 2013 inspection.

Figure 2-6. Riser 79 Upper Haunch Comparisons Between Inspections on July 22, 1993 (A) and January 14, 2013 (B) Looking Towards Riser 80

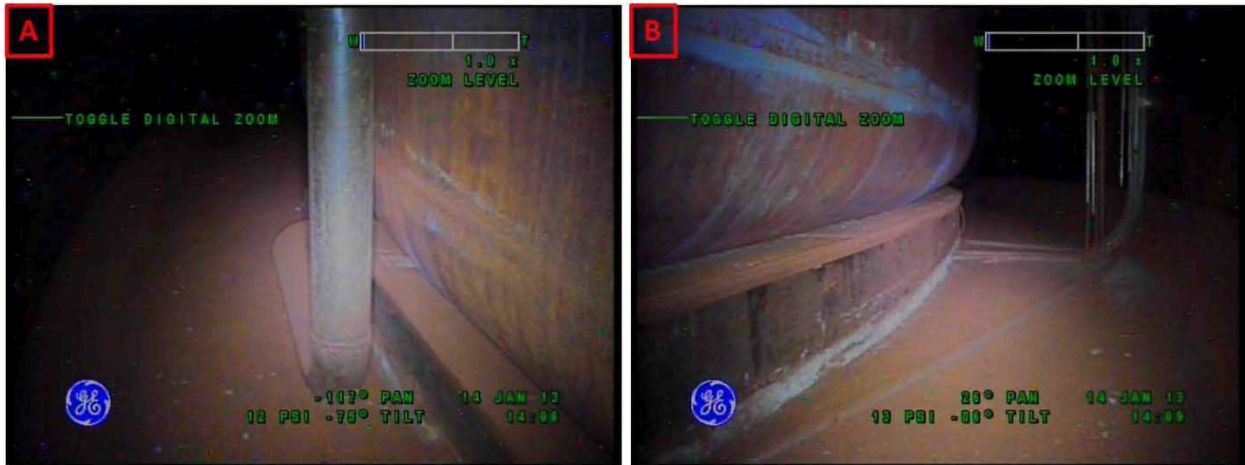
The lower knuckle and annulus floor were not visible during the 1993 inspection. Figure 2-8 shows the general condition of the lower knuckle and annulus floor in 2013. A beachline can be seen along the annulus floor in Figure 2-8 which is likely the result of evaporated couplant water used during UT examinations. Figure 2-9 shows the general condition of the refractory slots in 2013 and no anomalies were noted. No anomalies were identified on the lower knuckle of the primary tank, insulating refractory, refractory slots, stiffener ring, or annulus floor during the 2013 inspection.

Figure 2-8. Riser 79 Lower Knuckle and Annulus Floor Condition on January 14, 2013 Looking Towards Riser 80 (A) and Looking Towards Riser 99 (B)

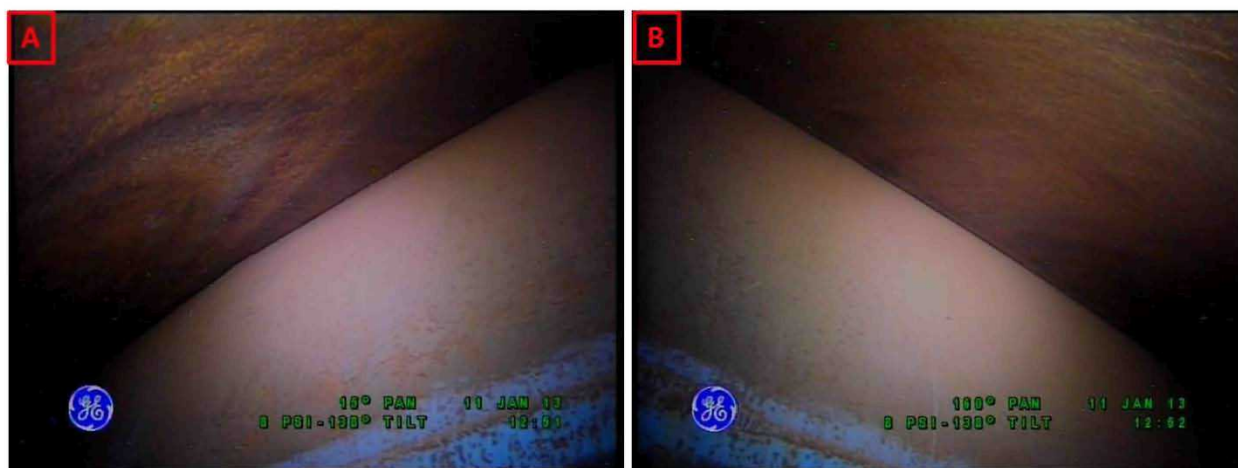
Figure 2-10 shows the general condition of the top knuckle area in January 2013. No areas of interest were identified in the top knuckle region during the 2013 inspection.

Figure 2-10. Riser 81 Upper Haunch Condition on January 11, 2013 Looking Towards Riser 105 (A) and Looking Towards Riser 100 (B)

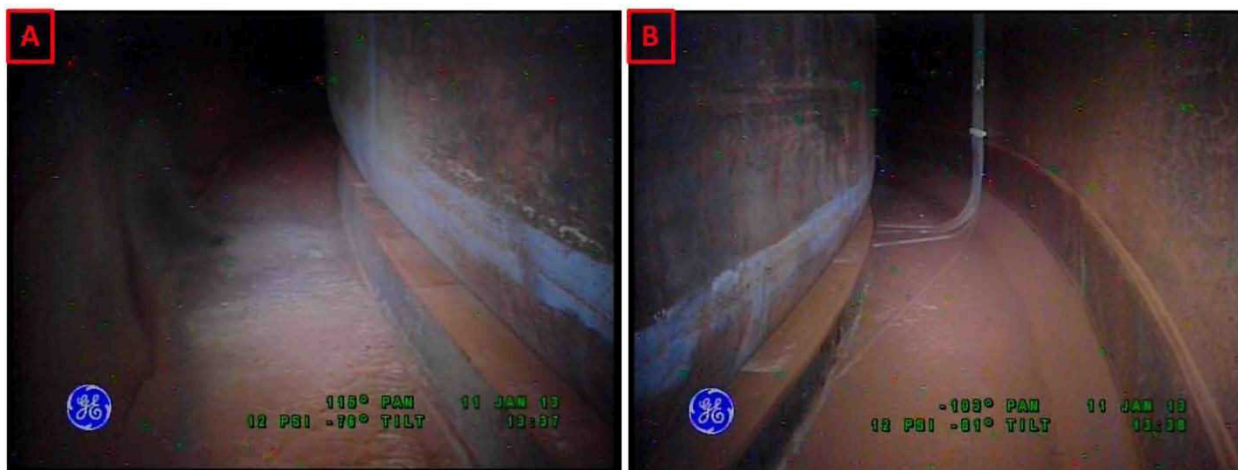
Figure 2-11 shows the general condition of the lower knuckle and annulus floor in January 2013. A beachline can also be seen along the annulus floor in Figure 2-11 which is likely the result of evaporated couplant water used during UT examinations. In Figure 2-11A, there appears to be signs of previous intrusion coming from Riser 105, the annulus pump pit. There is currently no pump installed in the AZ-101 annulus pump pit. The debris seen in Figure 2-11A is most likely remnants of past dirt and moisture which migrated into the pit and eventually into the annulus space. Figure 2-12 shows the general condition of the refractory slots in 2013 and no anomalies were noted. No anomalies were identified on the lower knuckle of the primary tank, insulating refractory, refractory slots, stiffener ring, or annulus floor during the 2013 inspection.

Figure 2-11. Riser 81 Lower Knuckle and Annulus Floor Condition on January 11, 2013 Looking Towards Riser 105 (A) and Looking Towards Riser 100 (B)

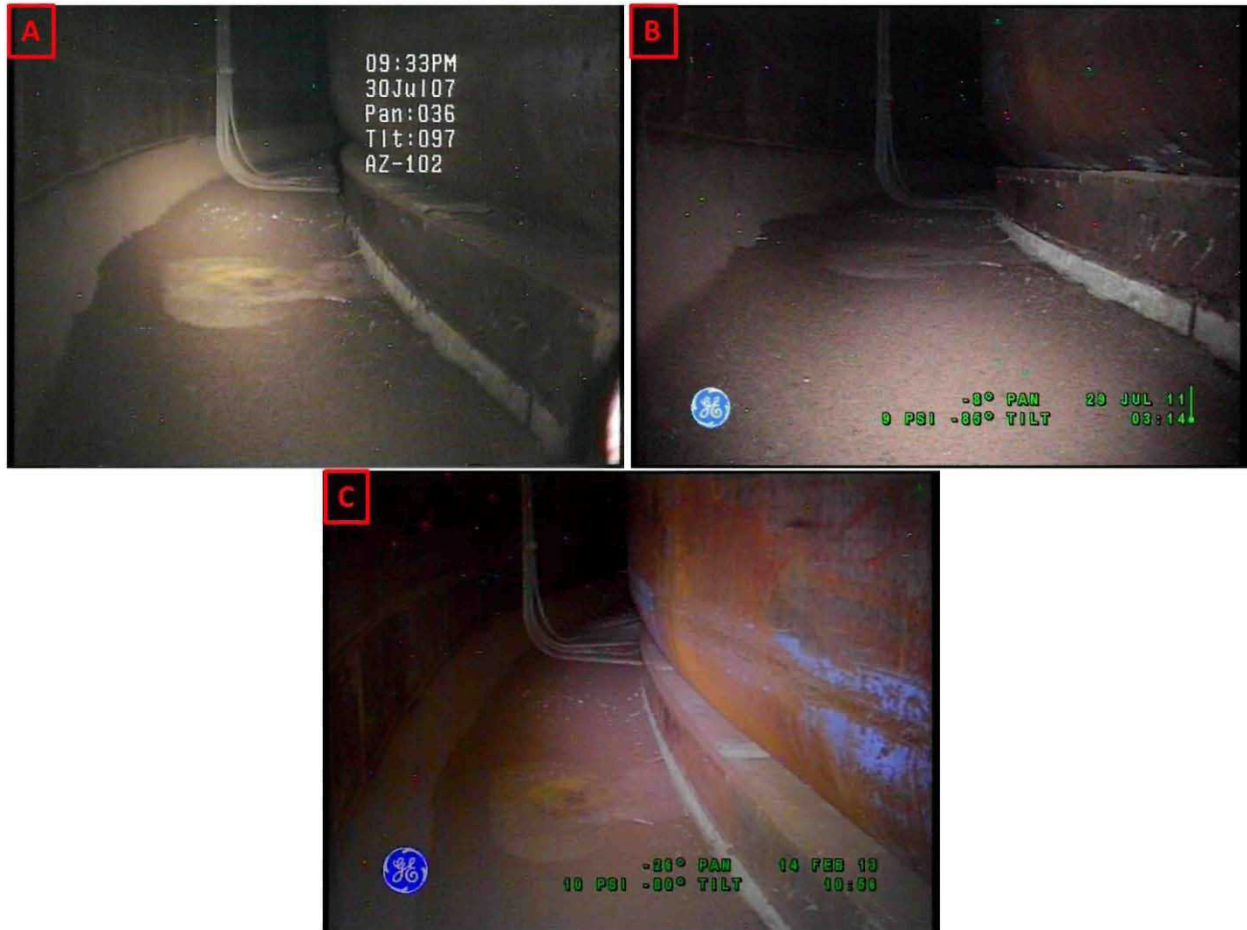
Figure 3-12. Riser 80 Lower Knuckle and Annulus Floor Comparisons Between Inspections on July 30, 2007 (A), July 29, 2011 (B), and February 14, 2013 (C) Looking Towards Riser 91
