PNNL-19731

**American Recovery and  
Reinvestment Act (ARRA)  
FEMP Technical Assistance  
United States Pacific Command (PACOM)  
Guam  
Task 3.3: Building Retuning Training**

September 2010

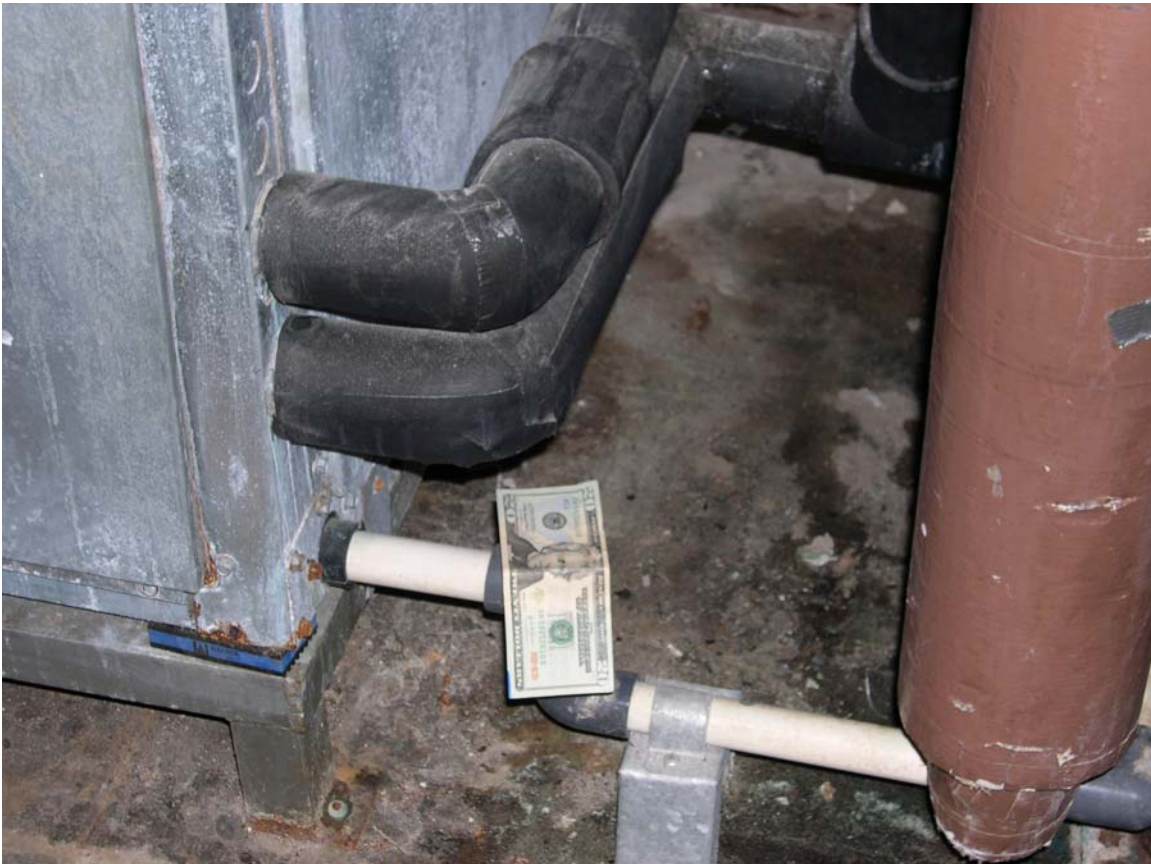
- Controls have been modified in this facility and the air handlers are now basically a standalone system with no feedback from actual zone controllers. This eliminates the ability to reset conditions based on actual zone conditions. A return air sensor is now used for control.
- The coil drain P-traps are open to the room. This is causing air to suck back into the air handler and maintain a layer of water in the unit. P-traps, which allow water to drain from a coil, are critical in this high humidity environment.
- P-traps on other air handlers were missing altogether (see Figure 2).

**Figure 2.** P-Trap line with no trap, which allows water to collect in air handler.

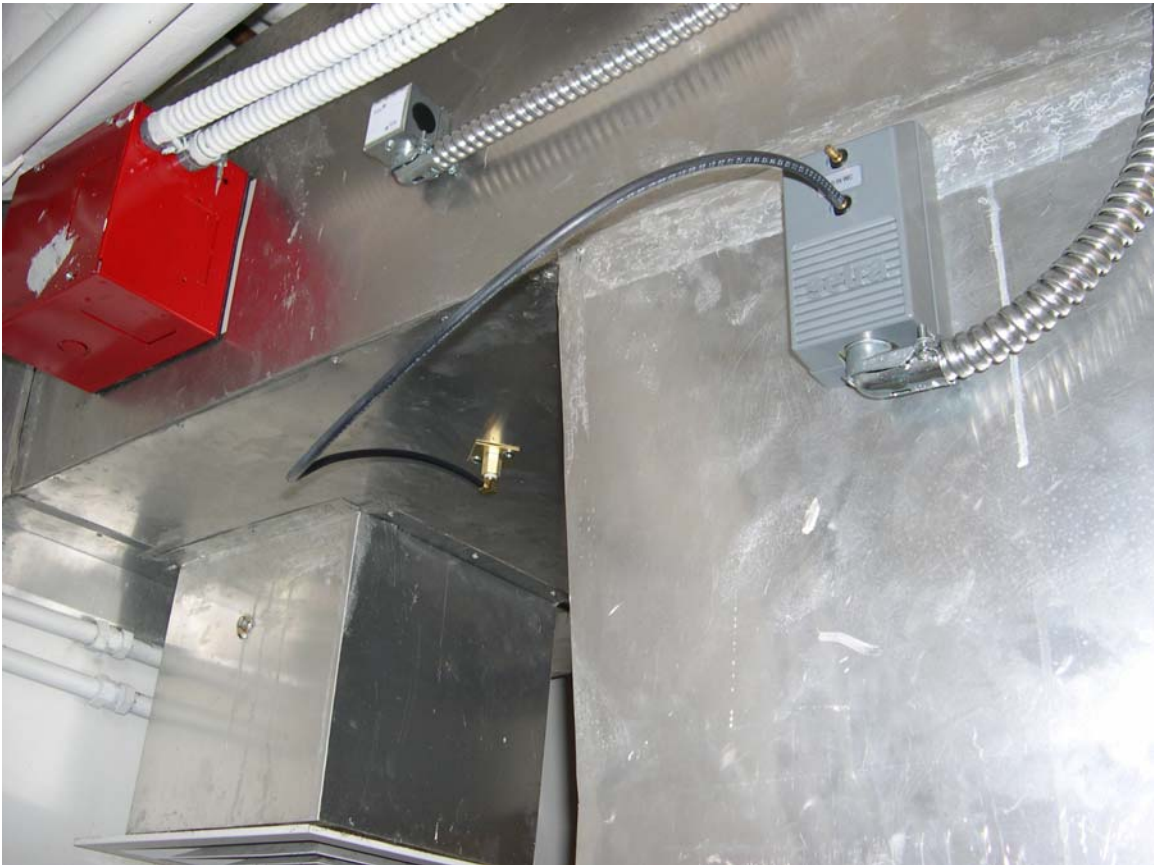
- The static pressure sensors in this and other facilities were mounted next to fan and ductwork where the air flow is very turbulent (see Figure 3). The manufacturer's recommendation is for this sensor to be about two-thirds of the way down the main trunk line for best control.
- This and several other facilities had exterior wall pipe and other penetrations that were not completely sealed. These penetrations allow humidity to infiltrate into the facility.

**Figure 3.** Sensors mounted in improper position.

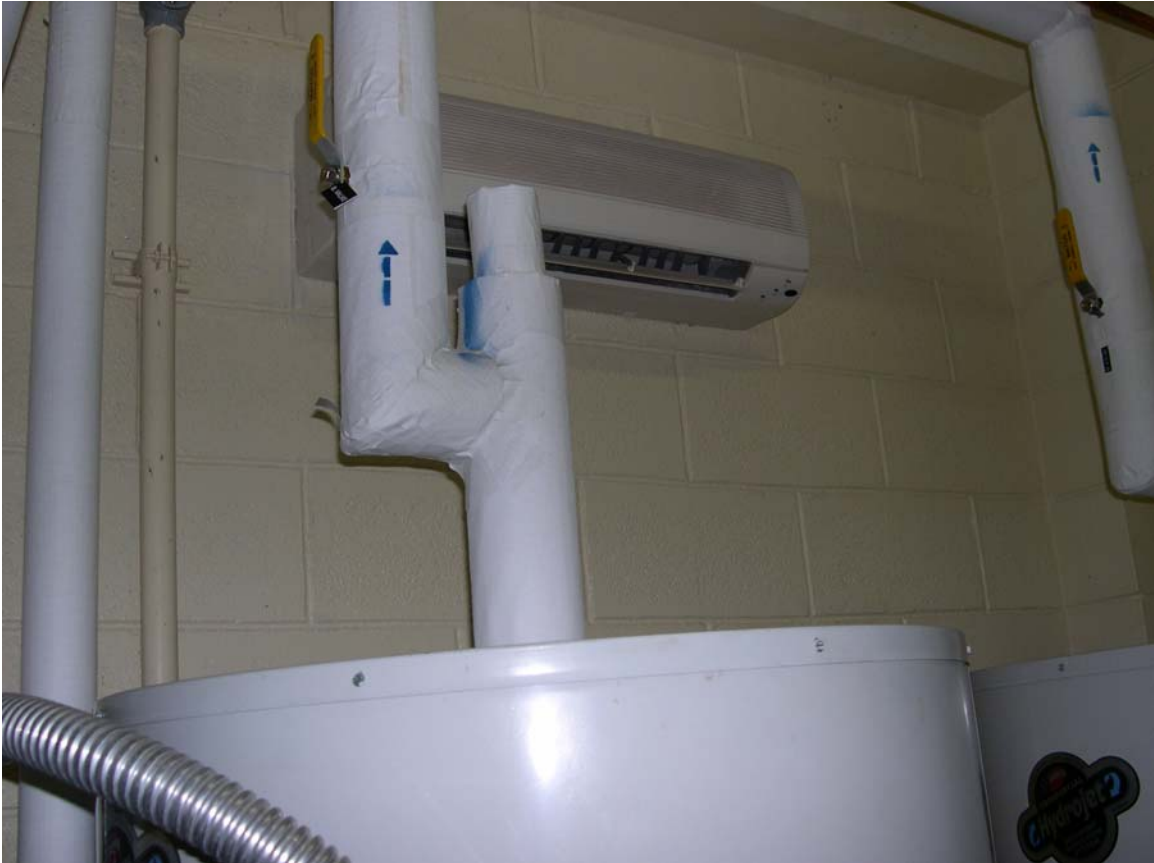
- Figure 4 shows an air conditioner (A/C) that serves a small solar tank room. The room was cooled to below 70°F but only has equipment in it. Because this room is quite cool, it appears to be used for staff breaks.

**Figure 4.** Split A/C unit in mechanical room

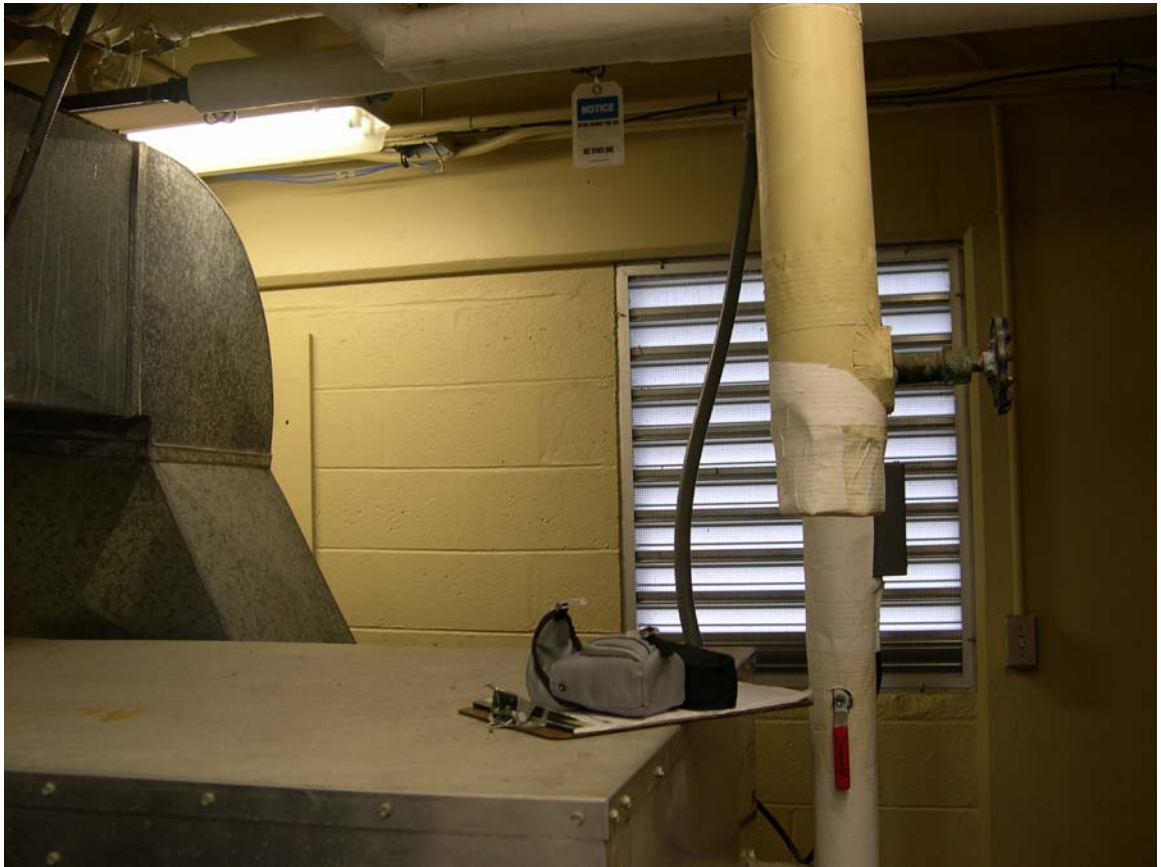
- Figure 5 shows a barracks mechanical space with full open outside air grill.

**Figure 5.** Fully open outside air grill.

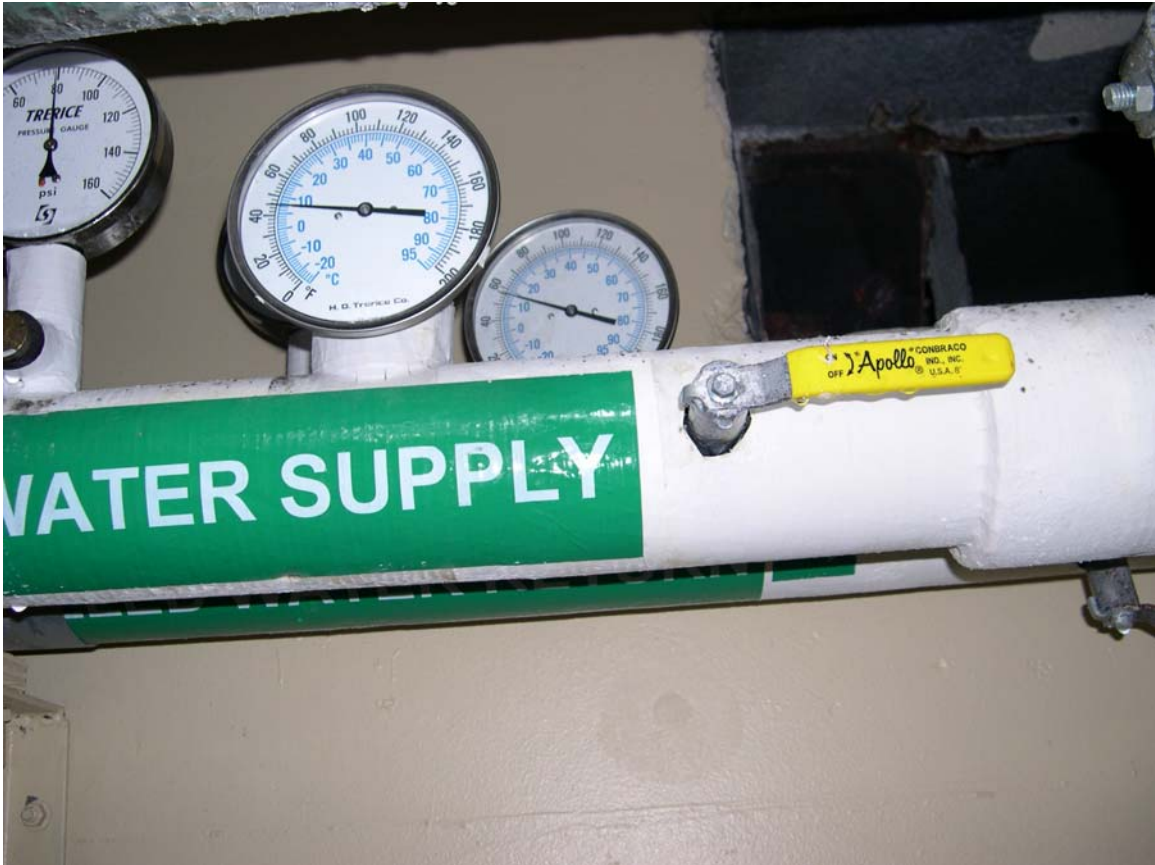
- Figure 6 shows the chilled water supply. The low chilled water temperature and very high pump pressures both waste energy.

**Figure 6.** Chilled water supply gauges
