**Pacific Northwest
National Laboratory**

**Ultrasonic Examination of Double-Shell
Tank 241-AW-103 Examination
Completed September 2006**

AF Pardini
GJ Posakony

November 2006

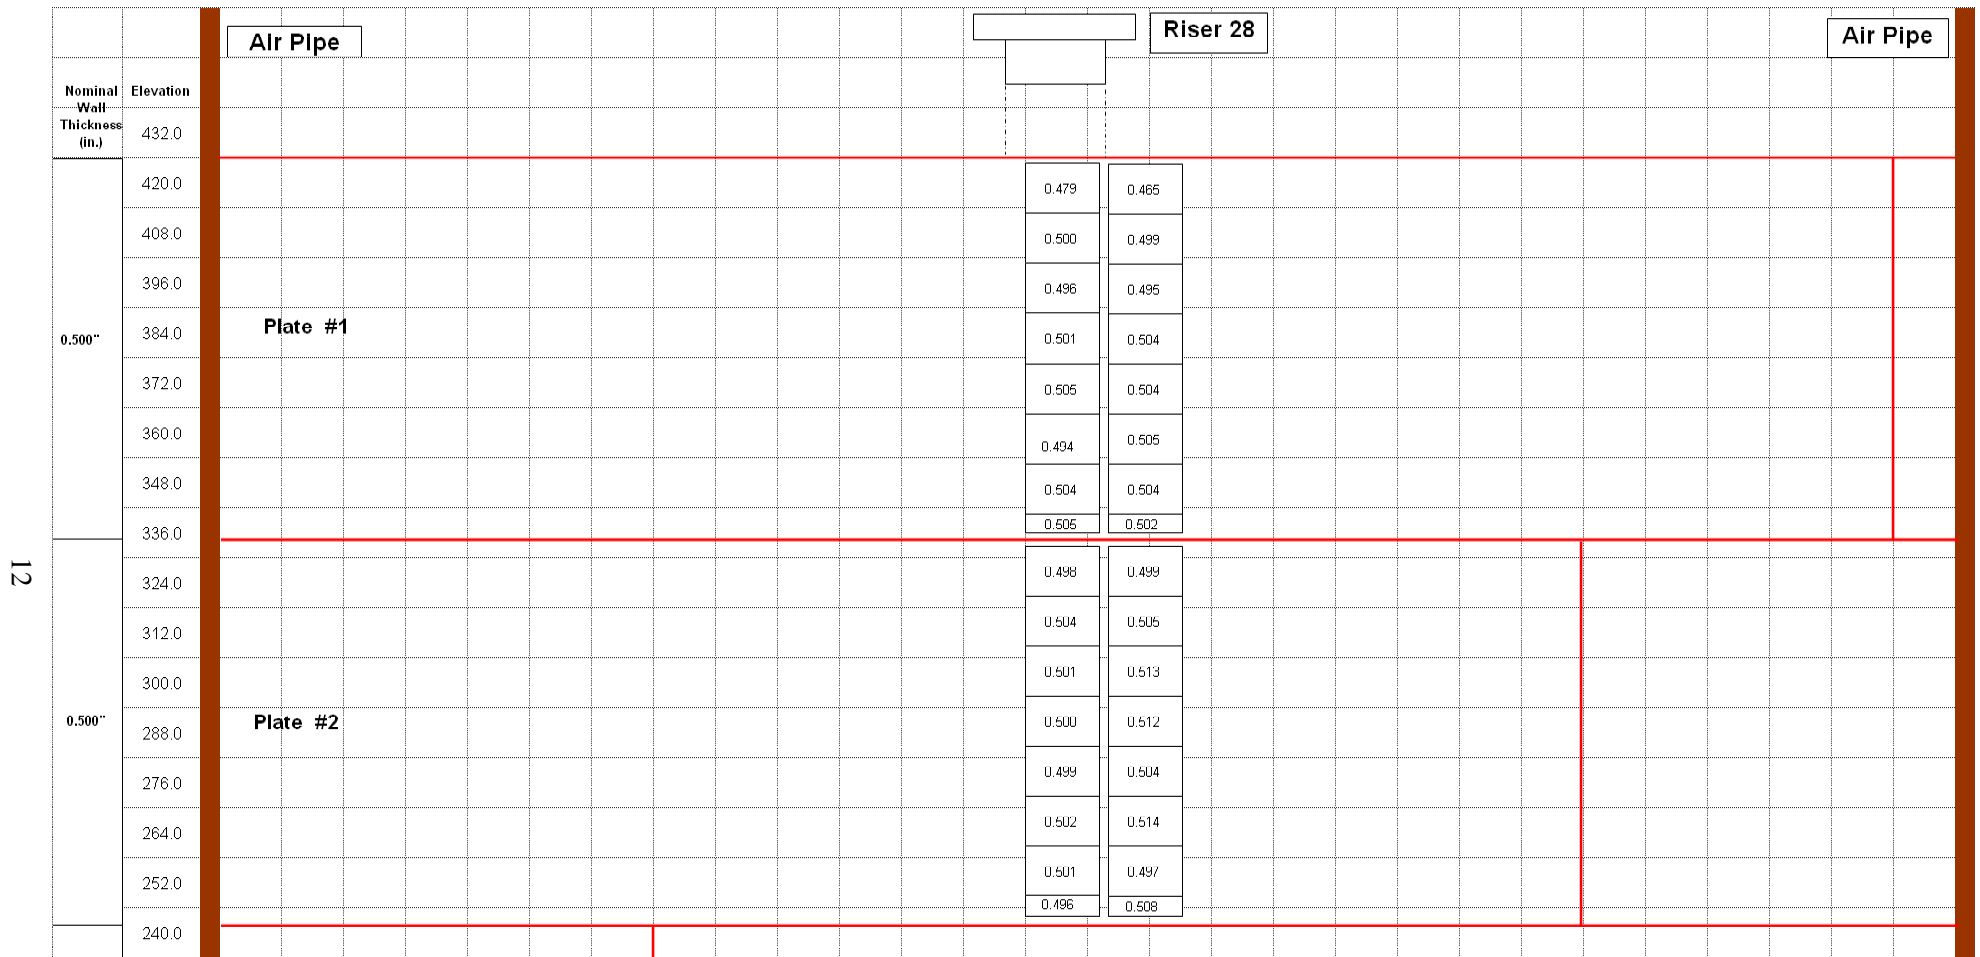
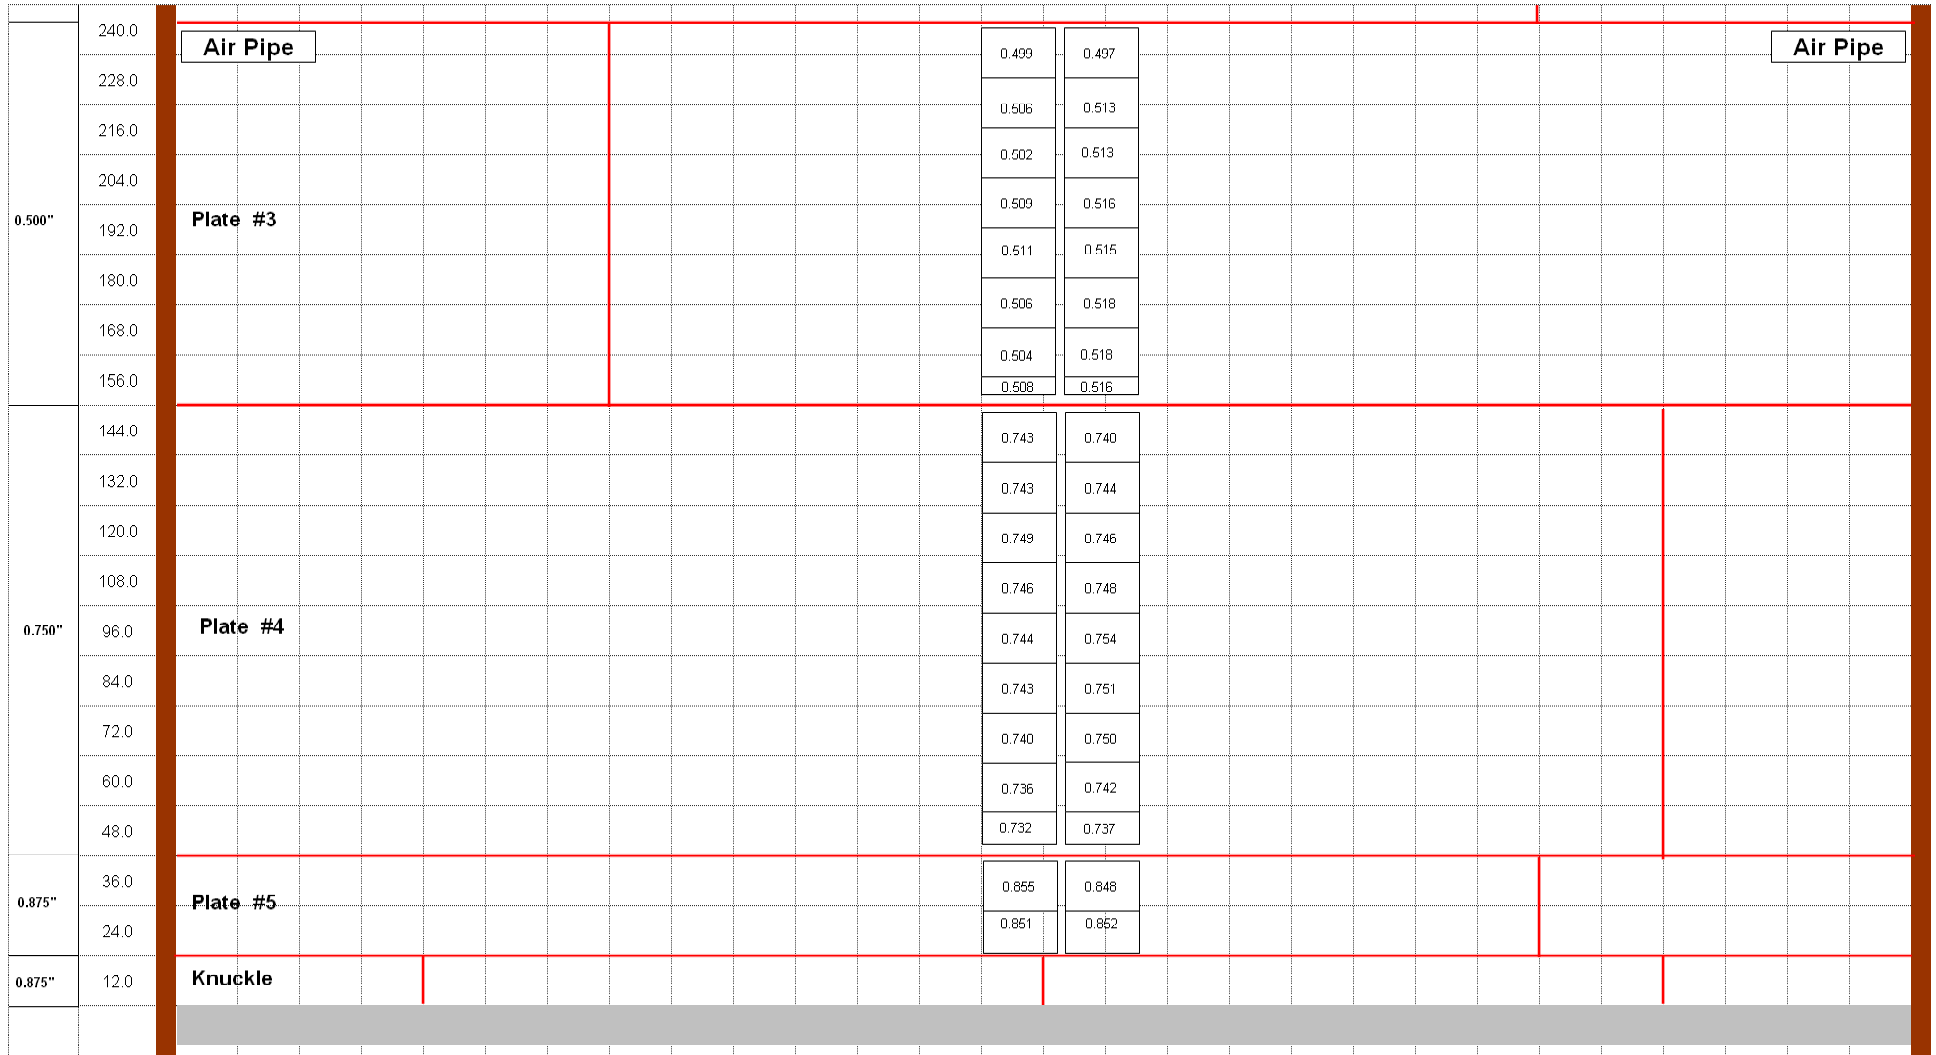
Figure 5.1. UT Data from Tank 241-AW-103 Primary Tank Riser 28

Figures 5.1 and 5.2 show the wall thickness examination results for the primary tank wall from Riser 28. The examination consisted of two vertical paths beneath the 24-in. diameter riser. Vertical scan #1 was 15-in.-wide on Plates #1, #2, #3, #4, and #5 near the centerline of the 24-in. riser. Vertical scan #2 was adjacent to vertical scan #1 and was also 15-in.-wide on Plates #1, #2, #3, #4, and #5. Vertical scans were conducted in the downward direction. Figures 5.1 and 5.2 display the minimum readings taken in each 15-in.-wide by 12-in.-long area of the scan.

Two 15-in.-wide vertical scan paths were performed on Plates #1, #2, #3, #4, and #5 from Riser 28. The plates were examined for wall thinning, pitting, and cracks oriented vertically on the primary tank wall. The results indicated that the minimum thicknesses in the areas that were scanned with nominal thickness of 0.500-in. are as follows; Plate #1 was 0.465-in., Plate #2 was 0.496-in., and Plate #3 was 0.497-in. The nominal thickness in Plate #4 is 0.750-in. and the minimum thickness in this area was 0.732-in. The nominal thickness in Plate #5 is 0.875-in. and the minimum thickness in this area was 0.848-in. There were no areas of wall thinning that exceeded the reportable level of 10% of the nominal thickness. No pitting or vertical crack-like indications were detected in Plates #1, #2, #3, #4, or #5.

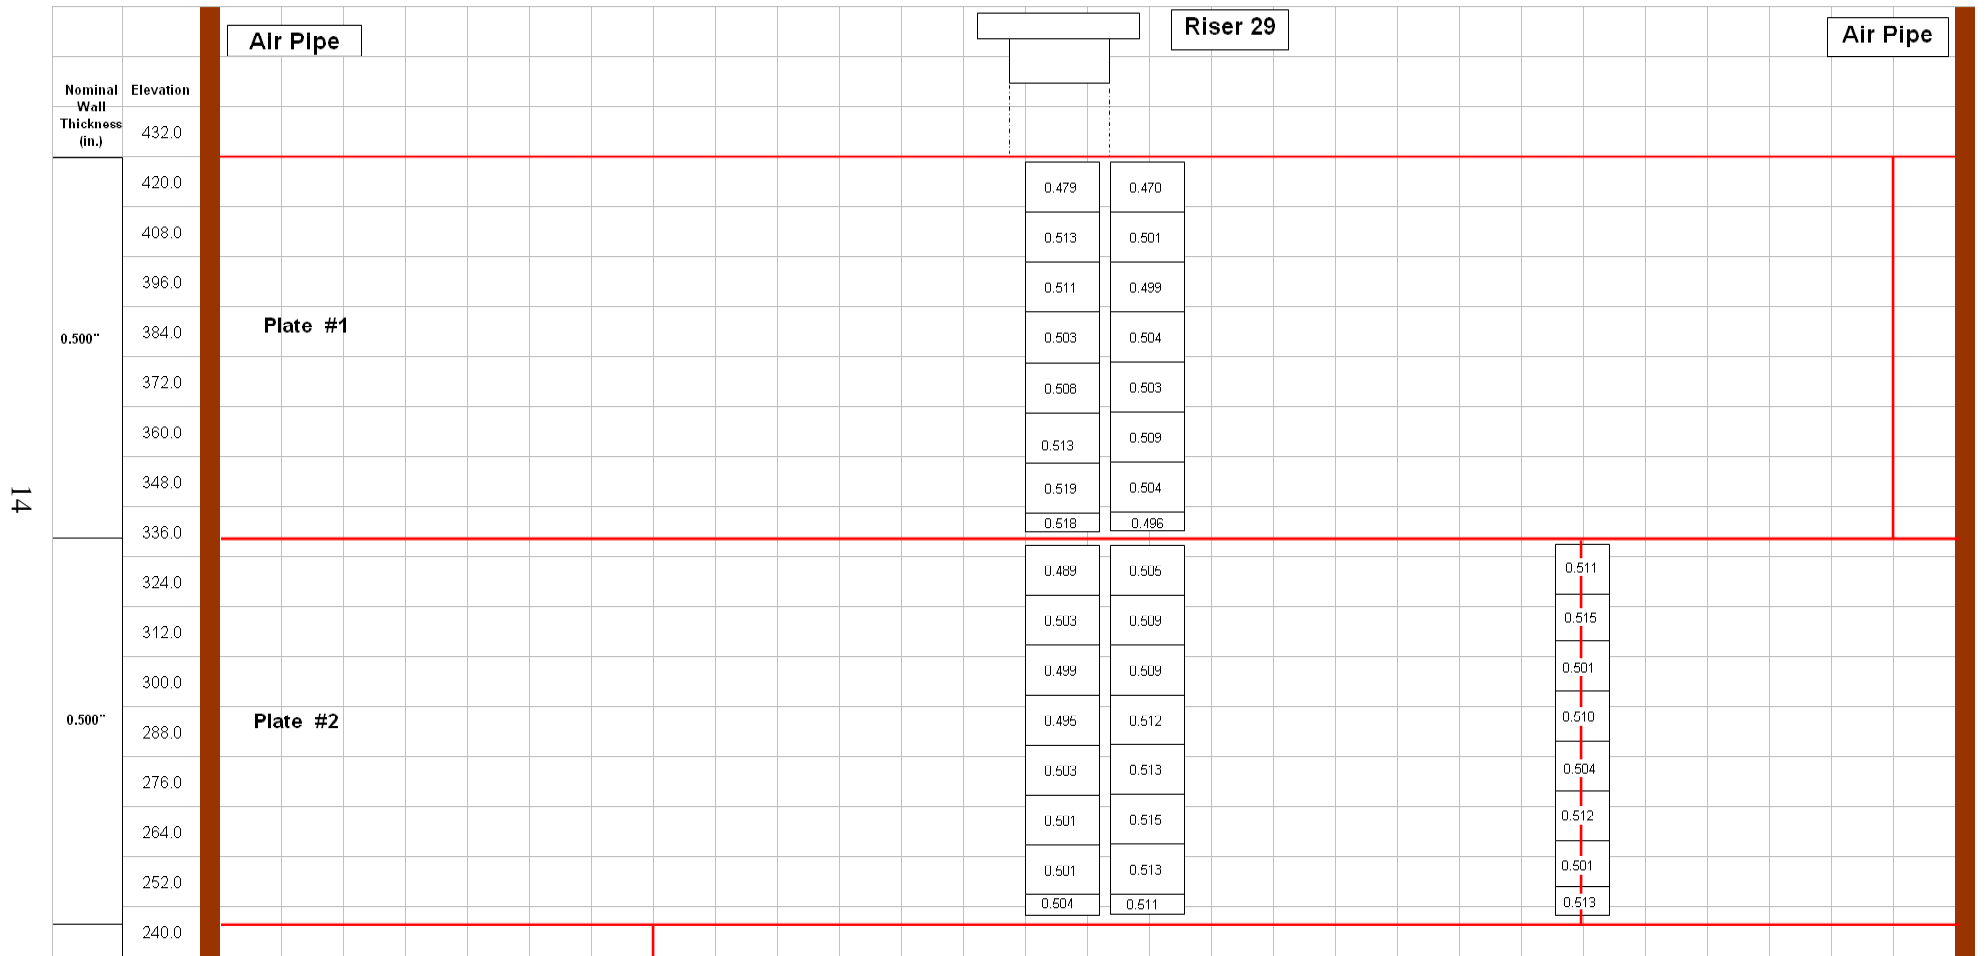
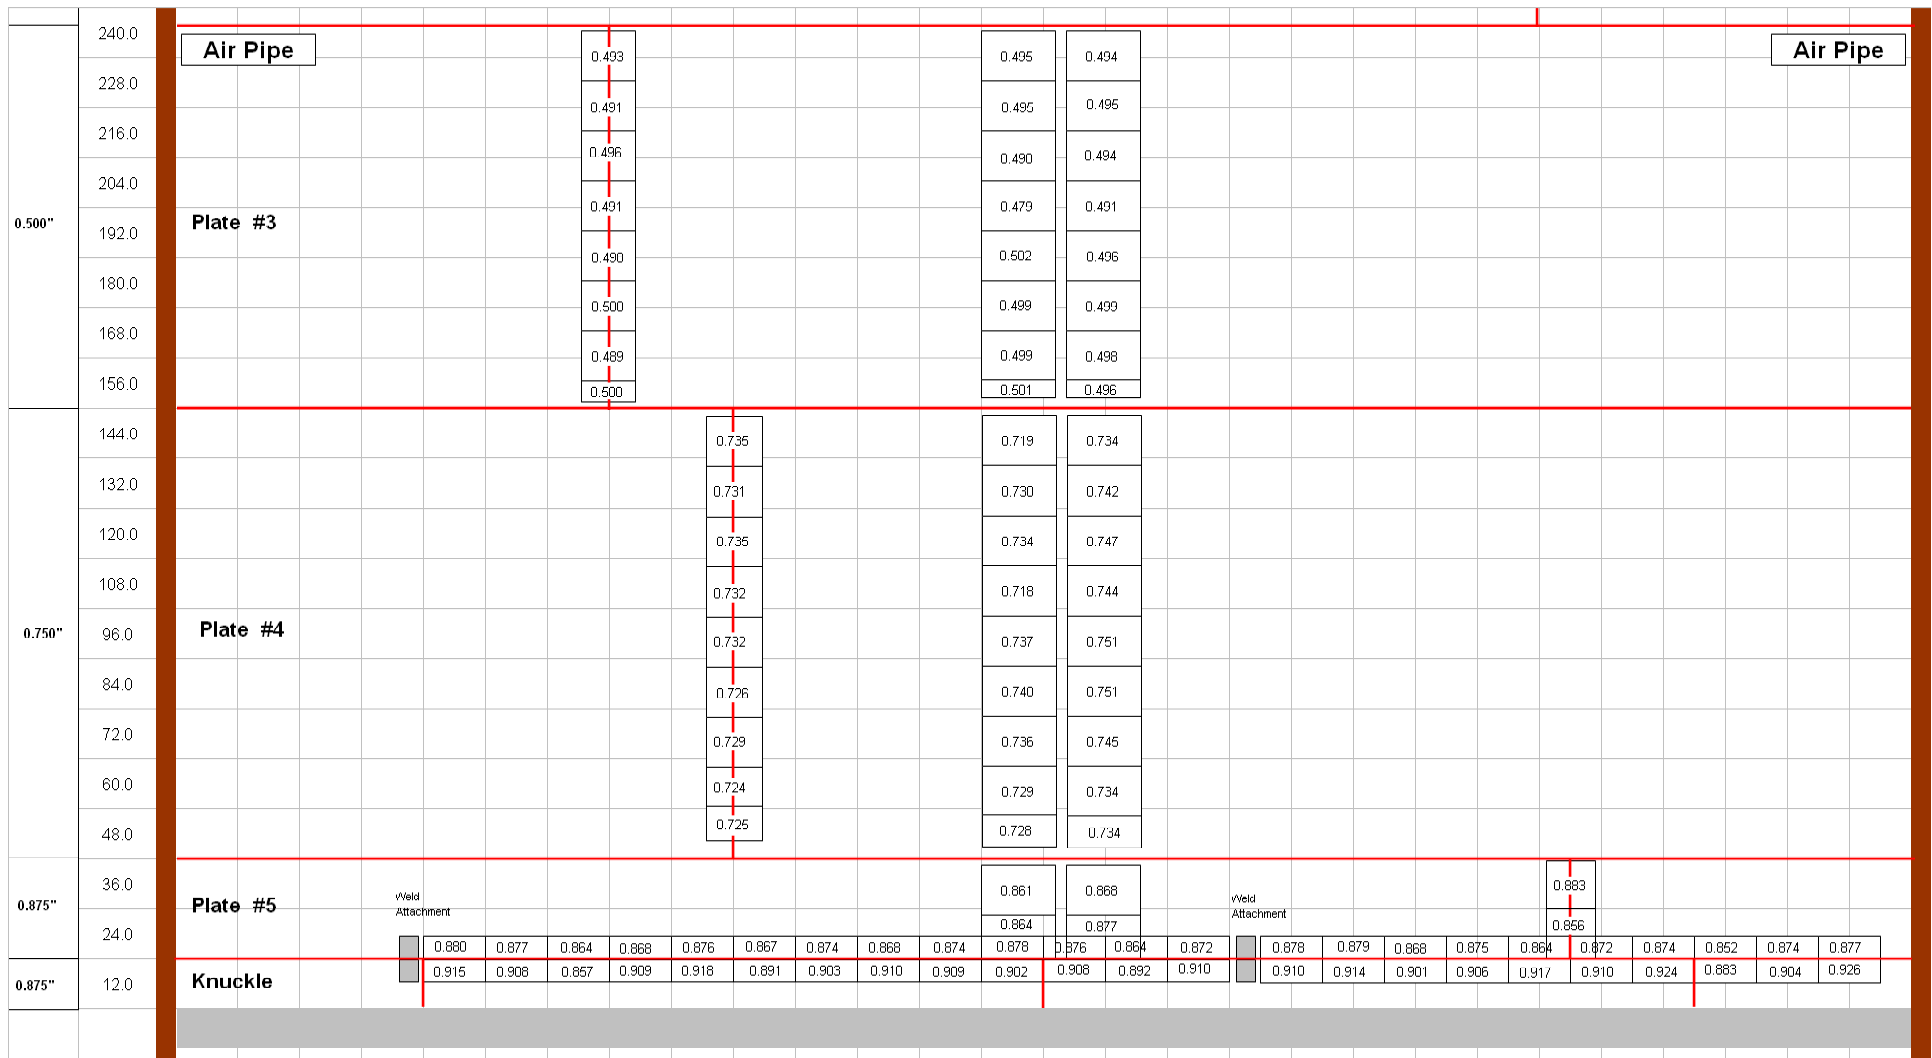
Figure 5.3. UT Data from Tank 241-AW-103 Primary Tank Riser 29

Figures 5.3 and 5.4 show the wall thickness examination results for the primary tank wall and the HAZs of both vertical and horizontal welds from Riser 29. The examination consisted of two vertical paths beneath the 24-in. diameter riser. Vertical scan #1 was 15-in.-wide on Plate #1, #2, #3, #4, and #5 near the centerline of the 24-in. riser. Vertical scan #2 was adjacent to vertical scan #1 and was also 15-in.-wide on Plates #1, #2, #3, #4, and #5. Vertical scans were conducted in the downward direction. The HAZs of vertical welds in Plates #2, #3, #4, and #5 were examined and the HAZ in the horizontal weld between Plate #5 and the knuckle section was also examined. Weld area exams include approximately 5-in. on each side of the weld. Areas in the figures that show two measurements in the same box are the result of the vertical scan paths overlapping the horizontal scan paths. Figures 5.3 and 5.4 display the minimum readings taken in each 15-in.-wide by 12-in.-long area of the scan. In the overlapping areas, both minimum readings from each vertical and horizontal scan paths are given.

Two 15-in.-wide vertical scan paths were performed on Plates #1, #2, #3, #4, and #5 from Riser 29. The plates were examined for wall thinning, pitting, and cracks oriented vertically on the primary tank wall. The results indicated that the minimum thicknesses in the areas that were scanned with nominal thickness of 0.500-in. are as follows; Plate #1 was 0.470-in., Plate #2 was 0.489-in., and Plate #3 was 0.479-in. The nominal thickness in Plate #4 is 0.750-in. and the minimum thickness in this area was 0.718-in. The nominal thickness in Plate #5 is 0.875-in. and the minimum thickness in this area was 0.861-in. There were no areas of wall thinning that exceeded the reportable level of 10% of the nominal thickness. No pitting or vertical crack-like indications were detected in Plates #1, #2, #3, #4, or #5.

The HAZ of vertical welds in Plates #2, #3, #4, and #5 from Riser 29 were examined for wall thinning, pitting and cracks oriented either perpendicular or parallel to the weld. The results indicated that the minimum thicknesses in the weld areas that were scanned are as follows: The nominal thickness of Plate #2 is 0.500-in. and the minimum thickness in this weld area was 0.501-in. The nominal thickness in Plate #3 is 0.500-in. and the minimum thickness in this weld area was 0.491-in. The nominal thickness in Plate #4 is 0.750-in. and the minimum thickness in this weld area was 0.724-in. The nominal thickness in Plate #5 is 0.875-in. and the minimum thickness in this weld area was 0.856-in. There were no areas of wall thinning that exceeded the reportable level of 10% of the nominal thickness. No pitting or crack-like indications were detected in the weld areas in Plates #2, #3, #4, and #5.

The HAZ of the horizontal weld between Plate #5 and the tank knuckle from Riser 29 was examined for wall thinning, pitting and cracks oriented either perpendicular or parallel to the weld. The results indicated that the minimum thickness in the weld area with nominal thickness of 0.875-in. on Plate #5 was 0.852-in. The minimum thickness in the weld area with nominal thickness of 0.875-in. on the knuckle was 0.857-in. There were no areas of wall thinning that exceeded the reportable level of 10% of the nominal thickness. No pitting or crack-like indications were detected in the weld areas on Plate #5 side or on the knuckle side of the horizontal weld.

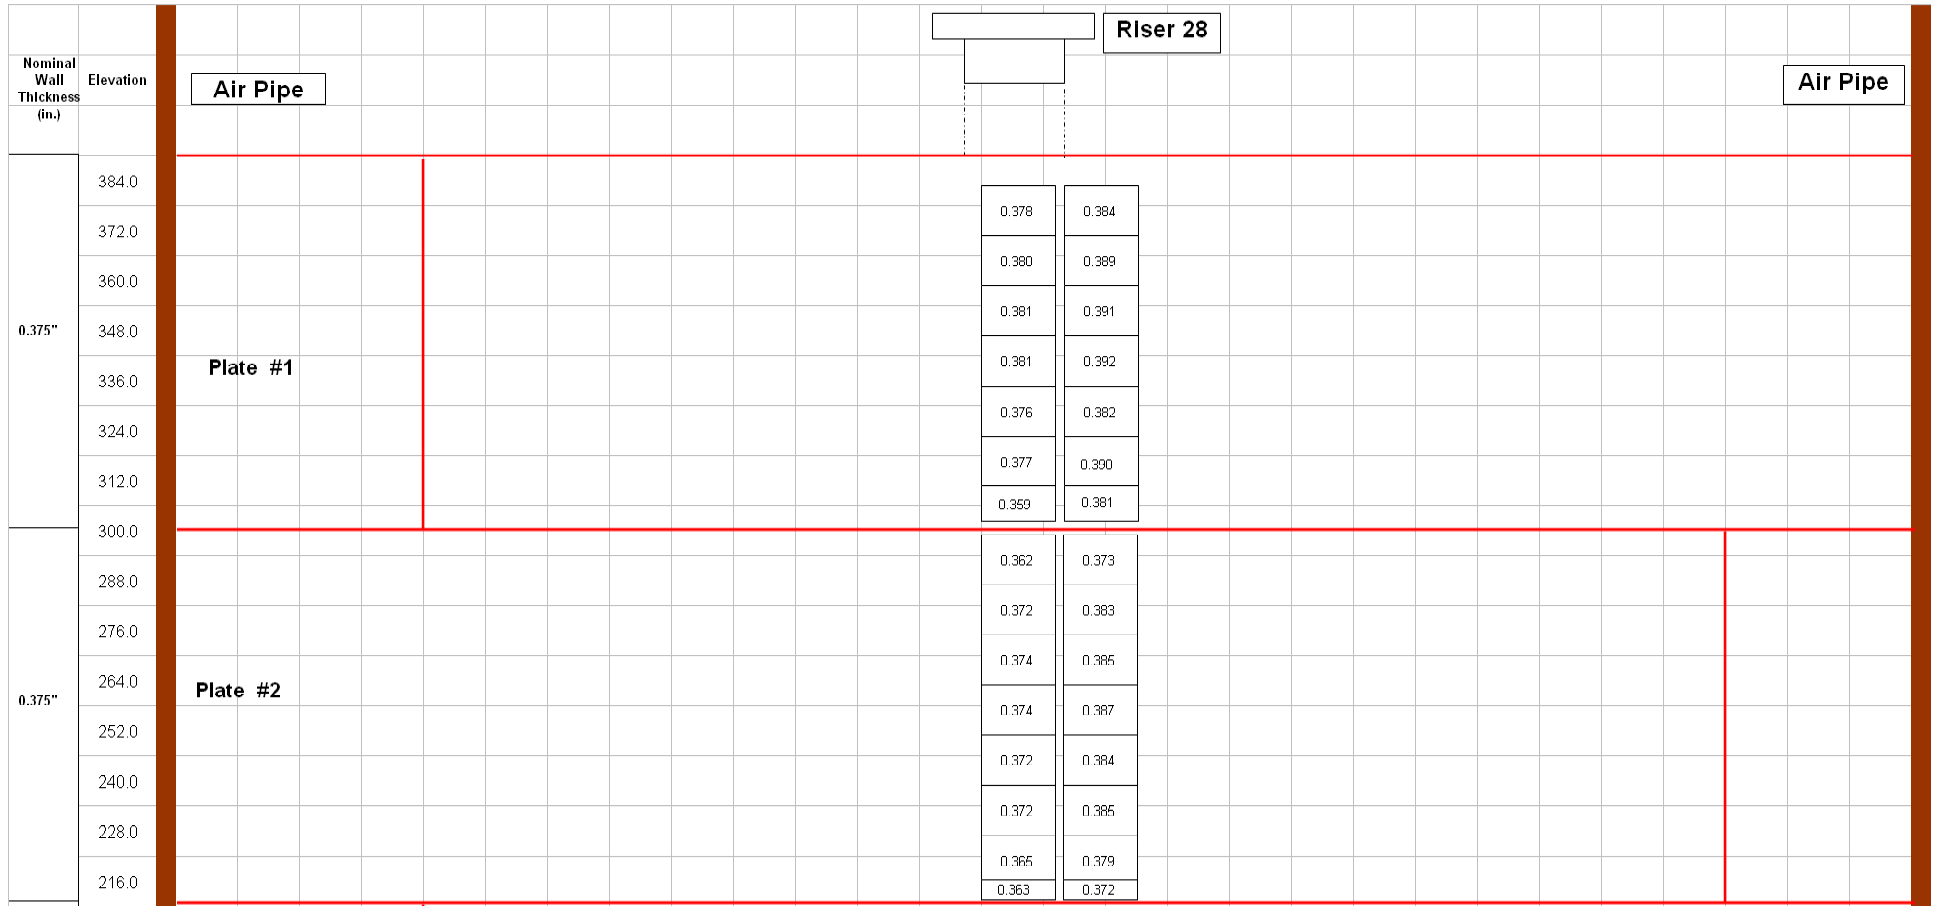
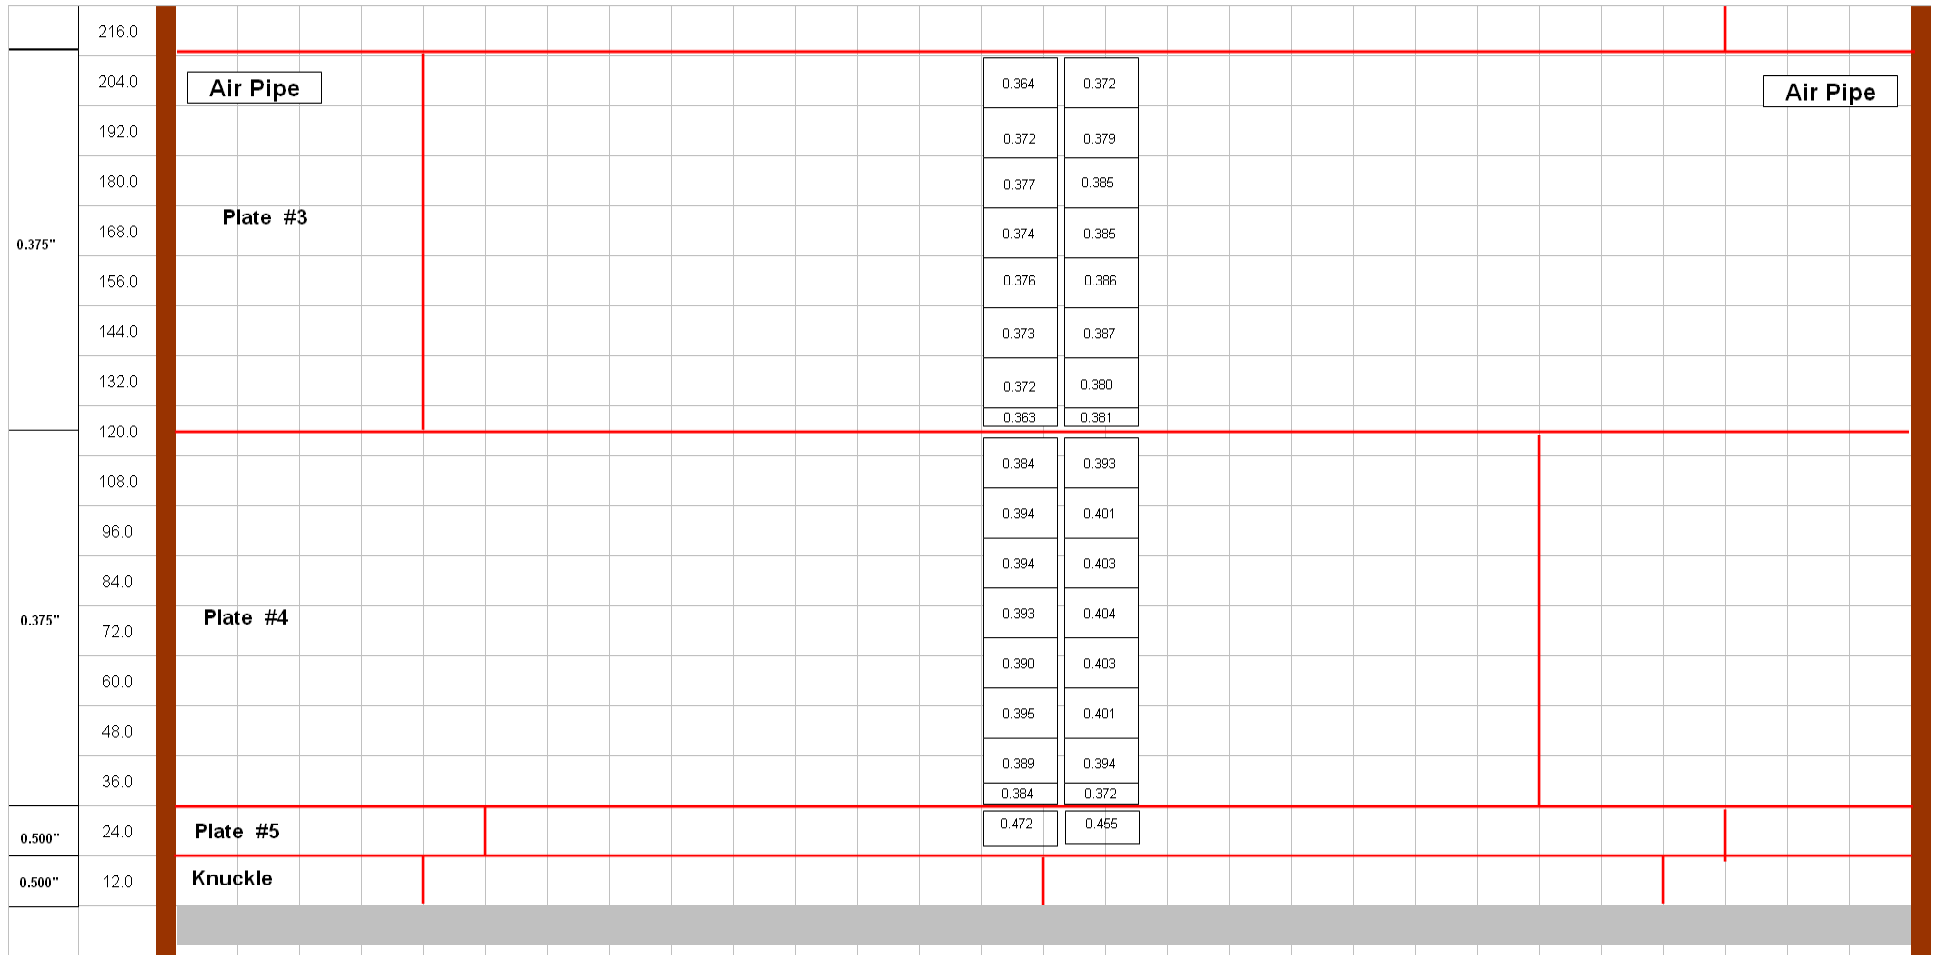
Figure 5.5. UT Data from Tank 241-AW-103 Secondary Tank Riser 28

Figures 5.5 and 5.6 show the wall thickness examination results for the secondary tank wall from Riser 28. The examination consisted of two vertical paths beneath the 24-in. diameter riser. Vertical scan #1 was 15-in.-wide on Plates #1, #2, #3, #4, and #5 near the centerline of the 24-in. riser. Vertical scan #2 was adjacent to vertical scan #1 and was also 15-in.-wide on Plates #1, #2, #3, #4, and #5. Vertical scans were conducted in the downward direction. Figures 5.1 and 5.2 display the minimum readings taken in each 15-in.-wide by 12-in.-long area of the scan.

Two 15-in.-wide vertical scan paths were performed on the secondary tank wall on Plates #1, #2, #3, #4, and #5 from Riser 28. The plates were examined for wall thinning, pitting, and cracks oriented vertically on the secondary tank wall. The results indicated that the minimum thicknesses in the areas that were scanned with nominal thickness of 0.375-in. are as follows; Plate #1 was 0.359-in., Plate #2 was 0.362-in., Plate #3 was 0.363-in., and Plate #4 was 0.372-in. The nominal thickness in Plate #5 is 0.500-in. and the minimum thickness in this area was 0.455-in. There were no areas of wall thinning that exceeded the reportable level of 10% of the nominal thickness. No pitting or vertical crack-like indications were detected in Plates #1, #2, #3, #4, or #5.
