Wind Turbine Gearbox Failure Modes – A Brief

**ASME/STLE 2011 International
Joint Tribology Conference
October 24-26, 2011
Los Angeles, California
NREL/PR-5000-53084**

**Shuangwen (Shawn) Sheng
National Renewable
Energy Laboratory**

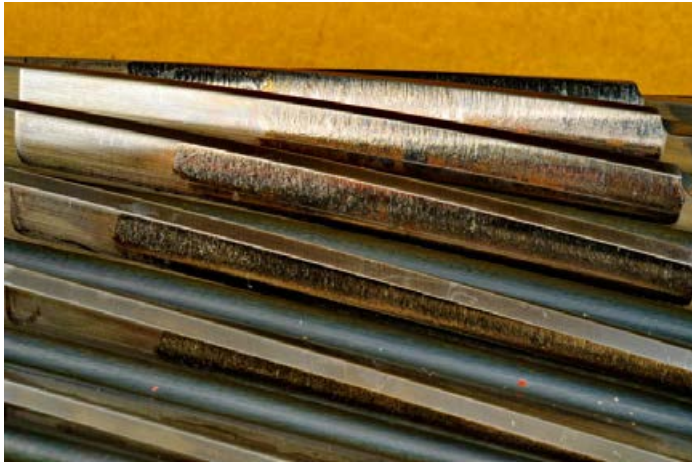
| Failure # | Component / Location | Mode | Severity |
|---|---|---|---|
| 1 | HSS Gear Set | Scuffing | Severe |

High-Speed Stage Pinion (Severe Scuffing)
Photo from GEARTECH, NREL/PIX 19743

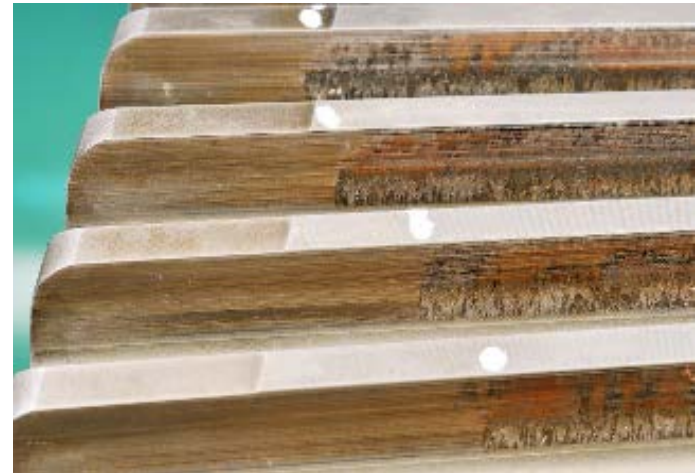
High-Speed Stage Gear (Severe Scuffing)
Photo by Robert Errichello, NREL/PIX 19599

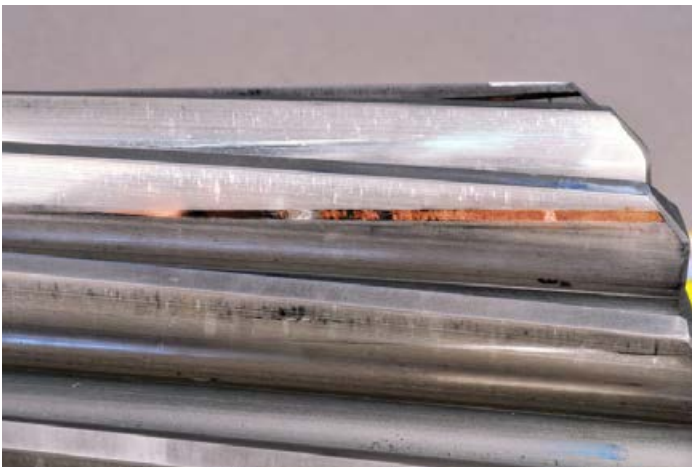
| Failure # | Component / Location | Mode | Severity |
|---|---|---|---|
| 6 | Annulus/Ring Gear, or Sun Pinion | Scuffing and polishing | Moderate |
| | | Fretting Corrosion | Severe |

Sun Pinion (Severe Fretting Corrosion)
Photo from GEARTECH, NREL/PIX 19750

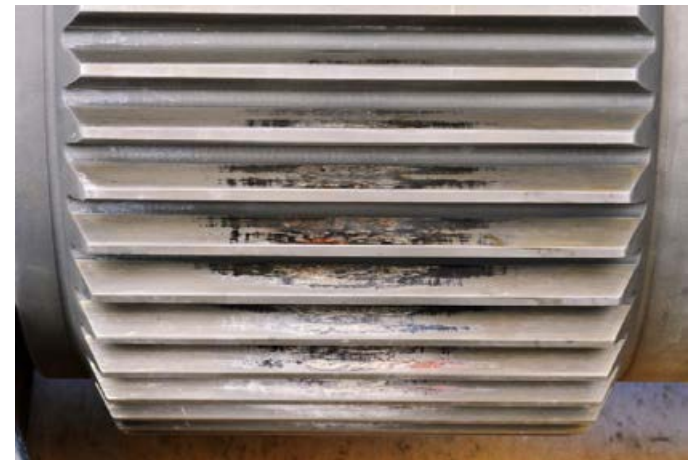
Sun Spline (Severe Fretting Corrosion)
Photo from GEARTECH, NREL/PIX 19751

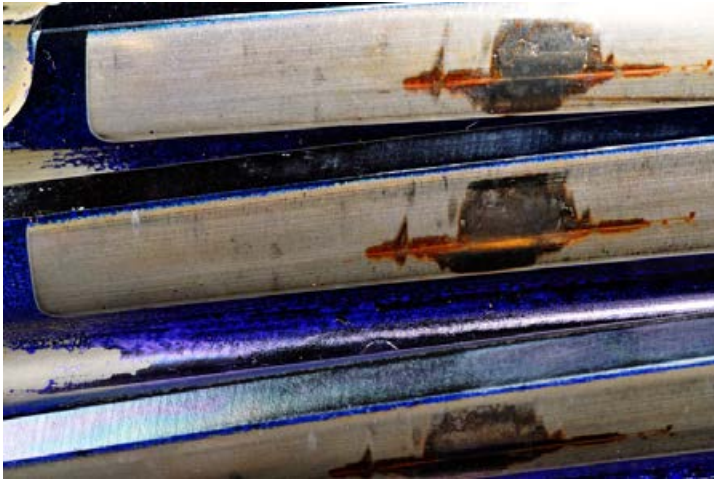
| Failure # | Component / Location | Mode | Severity |
|---|---|---|---|
| 3 | ISS Gear Set | Fretting Corrosion | Severe |

Intermediate-Speed Stage Pinion
Photo from GEARTECH, NREL/PIX 19745

- Failure mode 1: fretting corrosion, severe
- Failure mode 2: polishing wear, severe (local)
- Failure mode 3: scuffing, severe (local)
- Description: Damage was imprinted on all teeth because the gear set had a hunting gear ratio.

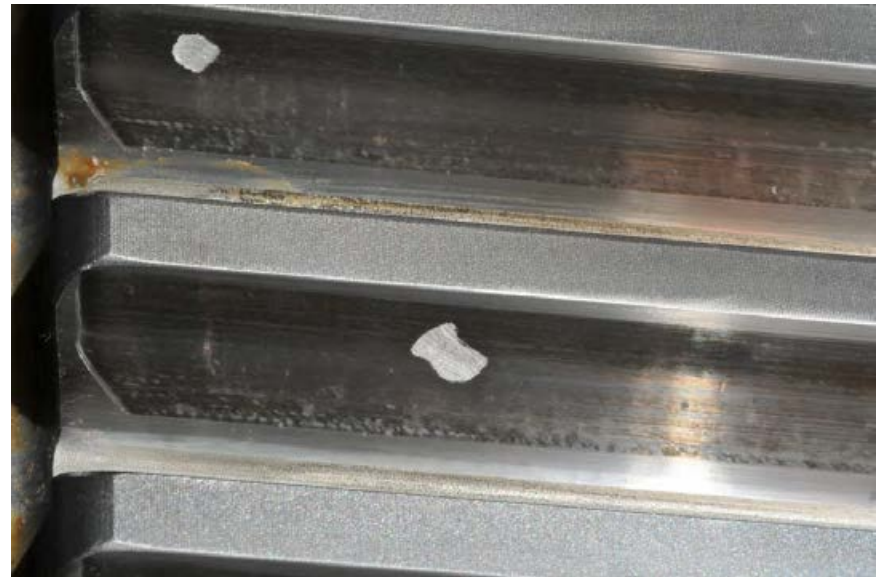
- Failure mode 1: scuffing, moderate (local)
- Failure mode 2: polishing wear, severe
- Description: Two original, hand dressed macropits are shown. Polishing wear removed all traces of the grind marks and created a wear step at the end of contact.

Annulus Gear. *Photo from GEARTECH, NREL/PIX 19749*

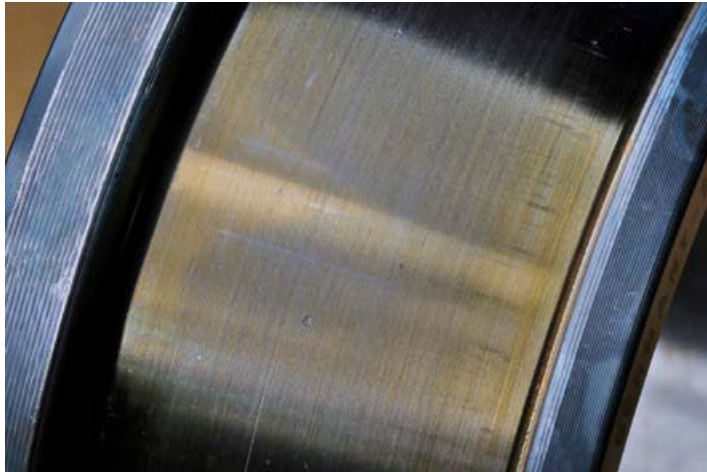
| Failure # | Component / Location | Mode | Severity |
|---|---|---|---|
| 2 | HSS Downwind Bearings | Overheating | Mild |

Bearing HSS-C Inner Raceway (Mild Overheating) *Photo from GEARTECH, NREL/PIX 19744*

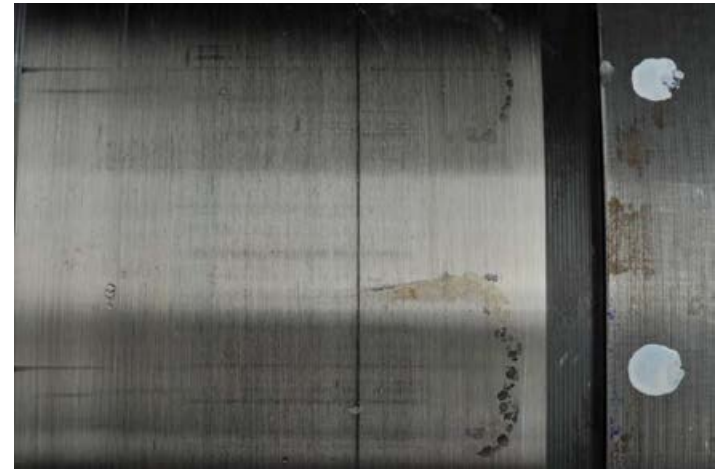
| Failure # | Component / Location | Mode | Severity |
|---|---|---|---|
| 4 | ISS Upwind Bearing | Assembly damage | Moderate |

Bearing ISS-A Inner Raceway (Mild Contact Corrosion) *Photo from GEARTECH, NREL/PIX 19746*

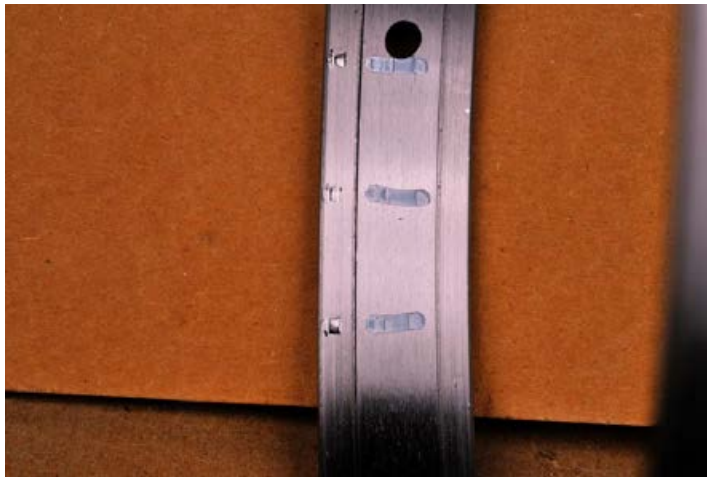
| Failure # | Component / Location | Mode | Severity |
|---|---|---|---|
| 5 | ISS Downwind Bearings | Assembly damage | Severe |

Bearing ISS-B/ISS-C Outer Raceway Spacer (Severe Assembly Damage) *Photo from GEARTECH, NREL/PIX 19747*

- Simple causes may lead to complex damage
- Operation and maintenance improvements are necessary to minimize the possibility of oil loss
- Additional attention to assembly is needed to avoid damage.

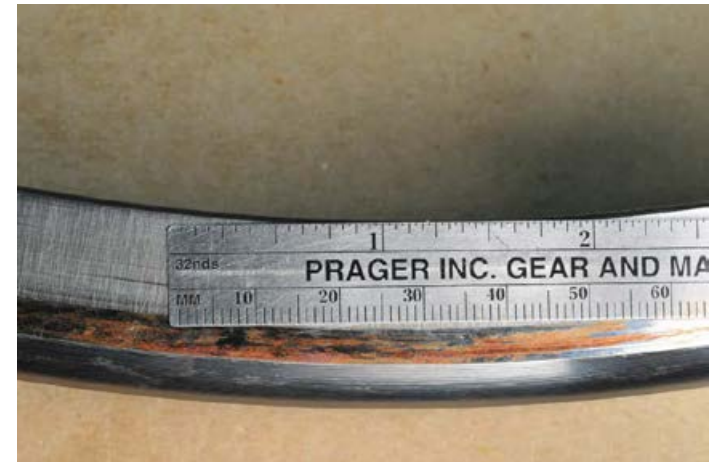
| Failure # | Component / Location | Mode | Severity |
|---|---|---|---|
| 7 | Planet Carrier Upwind Bearing | Fretting Corrosion | Severe |

Bearing PLC-A Outer Raceway (Severe Fretting Corrosion) *Photo from GEARTECH, NREL/PIX 19748*
