LAB-RPT-10-00011
Rev. 0

RESULTS OF THE EXAMINATION OF ELECTROCHEMICAL NOISE PROBE SPECIMENS REMOVED FROM TANK 241-AN-107, JUNE, 2010

G. A. Cooke
R. B. Wyrwas
J. B. Duncan
Washington River Protection Solutions LLC

Date Published
October 2010

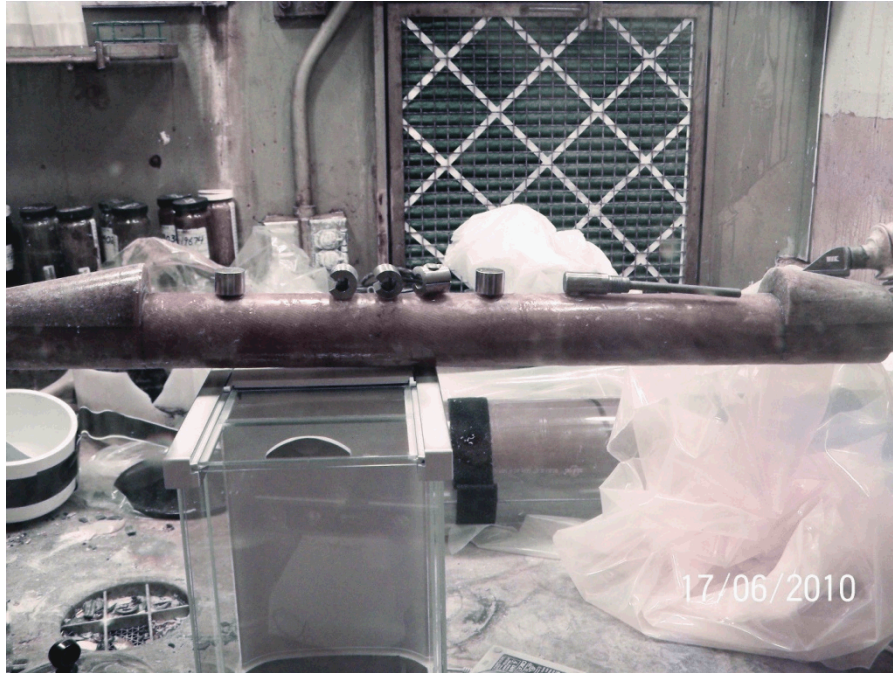
Figure 5. Detector Section 1, Unpackaged in Hot Cell 1E1.

On June 17, we stripped the outer packaging with a little difficulty as the two probe sections were packaged slightly differently and neither was packaged the same way as the mock-up we observed in May 2010. The exposed detector section 1 (Figure 5) and detector section 2 (Figure 6) were rinsed and the manipulators were used to attempt removal of the individual components. However, the bullets were impossible to remove, as the manipulators were unable to deliver enough torque to turn the specimens. We could turn the C-rings with difficulty, but they would bind up after about $\frac{1}{4}$ turn. If worked back and forth many times, it would free up for another $\frac{1}{4}$ or $\frac{1}{2}$ turn before binding again. After much effort, we were able to get one of the end C-rings (S10R000241) off and started on the middle one. We stopped shortly thereafter for fear that we would damage the stressed C-ring.

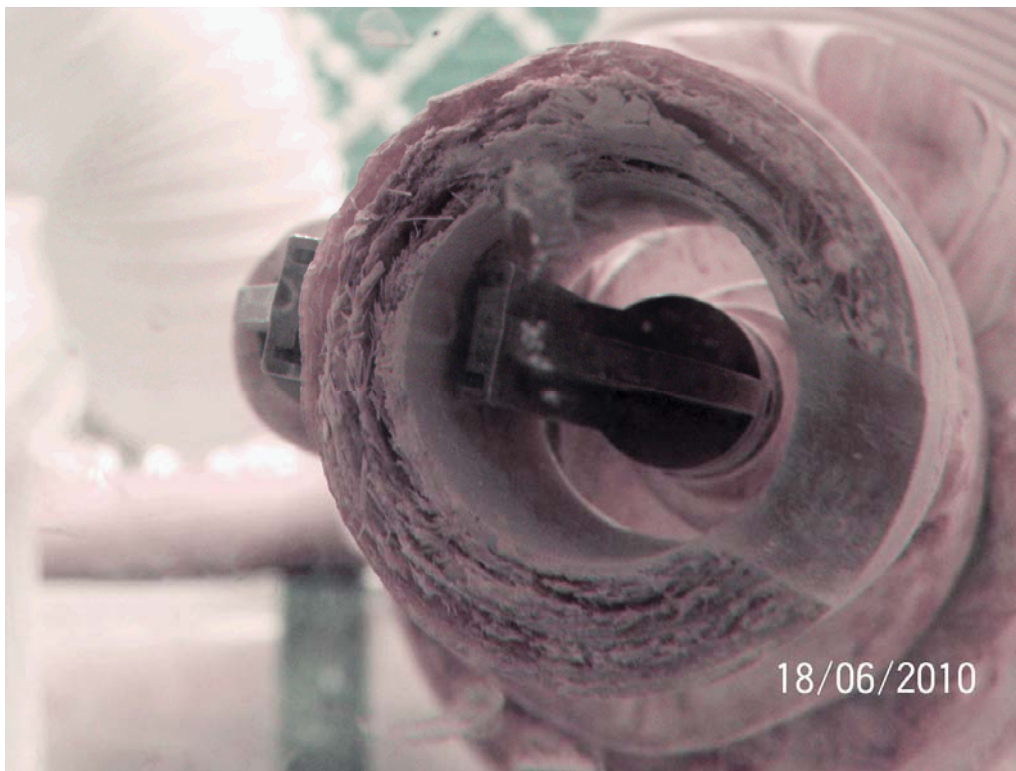
Figure 10. The Inch-Thick Piece of Fiberglass from the Failed End.

Brittle failure of the fiberglass probe in the middle of detector 2 resulted in the recovery of only three vapor space C-rings and six supernatant bullet specimens. The design of the bullets and how they were attached to the probe made the recovery of the components more difficult. The use of glue/epoxy on the bullets and the attachment of the flat bottom of the bullets to the curved surface of the fiberglass probe body meant that weight loss on cleaning and surface area of the specimens could not be determined with acceptable accuracy. Macrophotography of all specimens reveals that corrosion was slight in the vapor space and extremely slight in the supernatant.

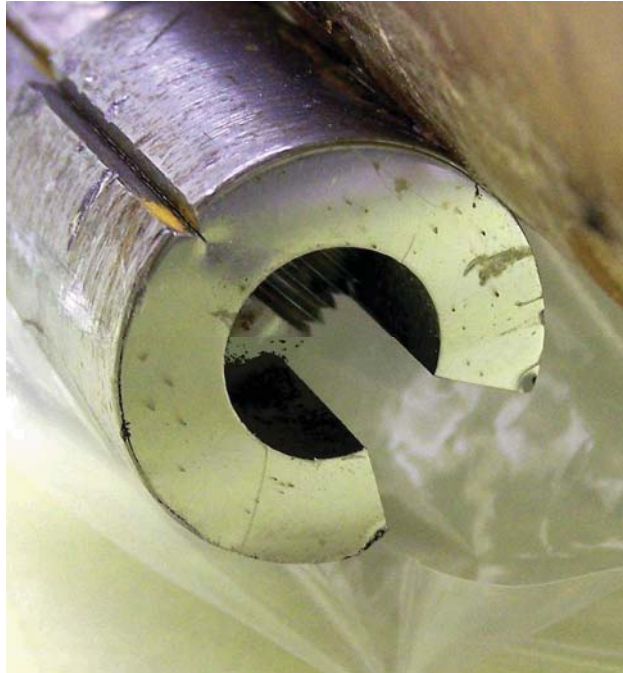
Figure 11. Pre-Stressed C-Ring VS-ENC-W (S10R000240) Showing Stress Bulge is Undisturbed.

The one pre-cracked C-ring recovered from the vapor space still had the stress bulge visible on the polished surface, indicating that crack propagation had not occurred in the tank. No photographs were taken of the C-ring before deployment. No further analysis was conducted on this specimen. A detailed discussion and photographic documentation are provided in this report.

- 4) The C-rings recovered from the vapor space show the slight corrosion (dominantly crevice corrosion) that has been seen in the past (RPP-RPT-32425, *Final Analytical Results from the Examination of Corrosion on Sections of Corrosion Probe Removed from Tank 241-AN-107 on August 10, 2006* and 7S110-GAC-06-087, “Results of the Examination of Electrochemical Noise Probe Specimens Removed from Tank 241-AN-107”). The one stressed C-ring still shows the characteristic bulge in the polished surface indicating that the stress that was imparted during pre-cracking has not been relieved by further cracking (Figure 11). We do not have pictures of the crack before deployment, but every indication is that the crack has not progressed any further.

Metrology of the bullets has been corrupted by the use of glue and by the design of the bullets prohibiting the measurement of an exposed surface area. Macrophotography shows an overall low level of corrosion. Visible evidence for corrosion is slightly more evident on the vapor section C-rings than on the bullets suspended in the supernatant of Tank AN-107. These observations are consistent with previous studies, referenced above. The macrophotographs also demonstrate that the pre-cracked C-ring still retains its stress bulge at the tip of the crack, on the polished end of the C-ring (Figure 11).
