RFP-1557

November 6, 1970

GLOVEBOX FIRE TESTS

THE DOW CHEMICAL COMPANY
ROCKY FLATS DIVISION
P. O. BOX 888
GOLDEN, COLORADO 80401

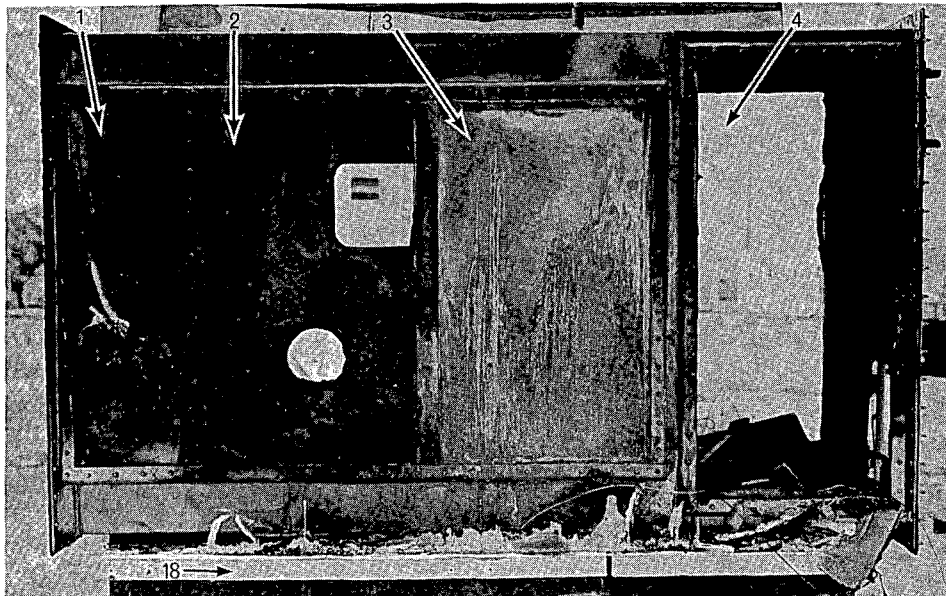
Figure 8. Vertical Side of Glovebox after Experiment No. 1 (See Table I and V for added description of reference numbers.)

3.	Sheet stainless steel (1/8 in.) with a lead overlay (1/8 in.) fastened with 1/4 in. stainless steel studs and nuts.	Figure 6 Panel 3	The lead melted away from the steel panel leaving only a slight amount of lead in the form of beads. Some of this lead had been oxidized to a yellow compound. Most of the lead dripped onto the lead-faced Benelex panel (Ref. No. 18) located under the box. See Figure 8.

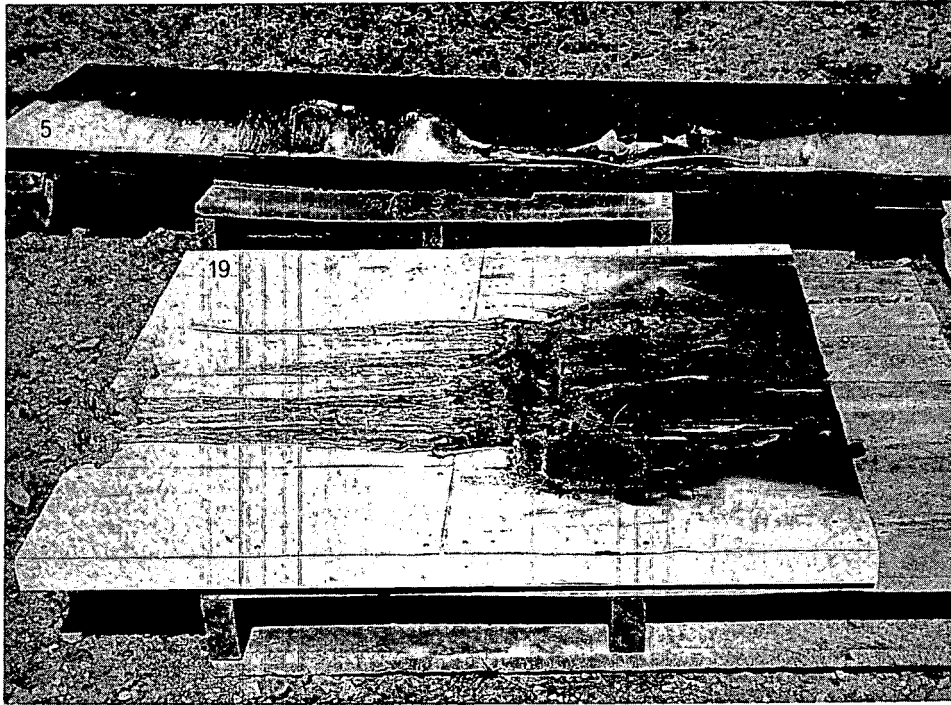
Figure 9. Shielding Panels after Experiment No. 1. (See Tables II and V for added description of reference numbers.)

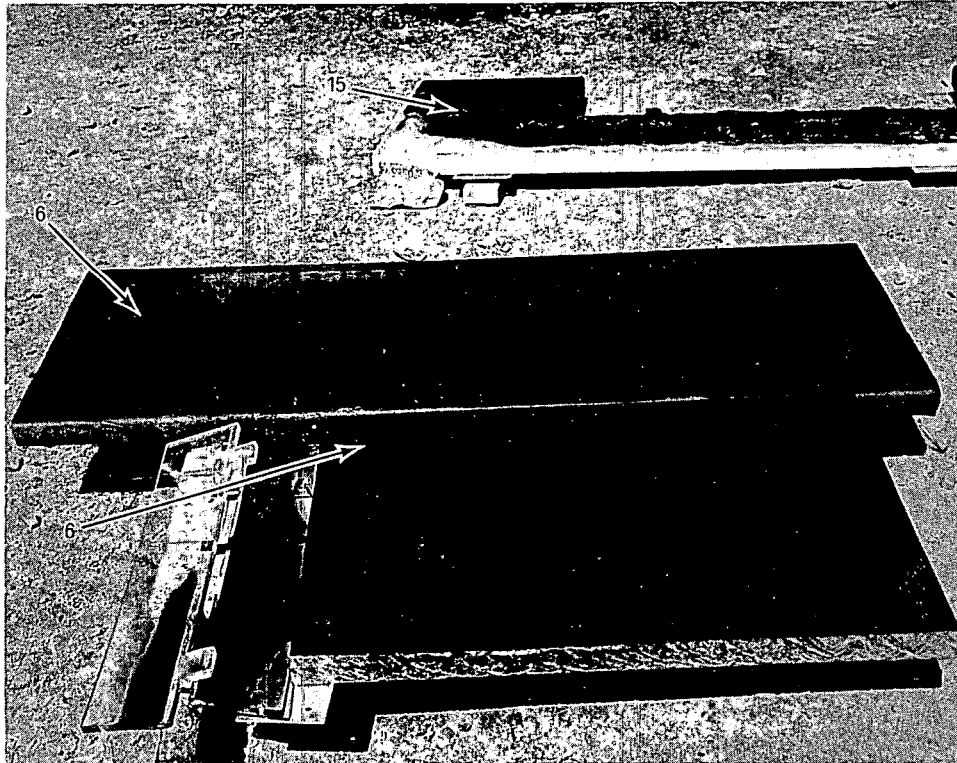
Figure 10. Shielding Panels after Experiment No. 1. (See Tables II and IV for added description of reference numbers.)

6.	Plexiglas G panel, 25 in. by 95 1/2 in. by 2 inches. This panel was made of two pieces spliced together.	Figure 6 Panel 6	The panel showed only a minor alteration of its original dimensions. The inside surface (toward box) was blackened with soot and had a sand-blasted texture. Some rounding of the top edge was noted where the Plexiglas was burned away. Figure 10 shows the Plexiglas after the fire test.

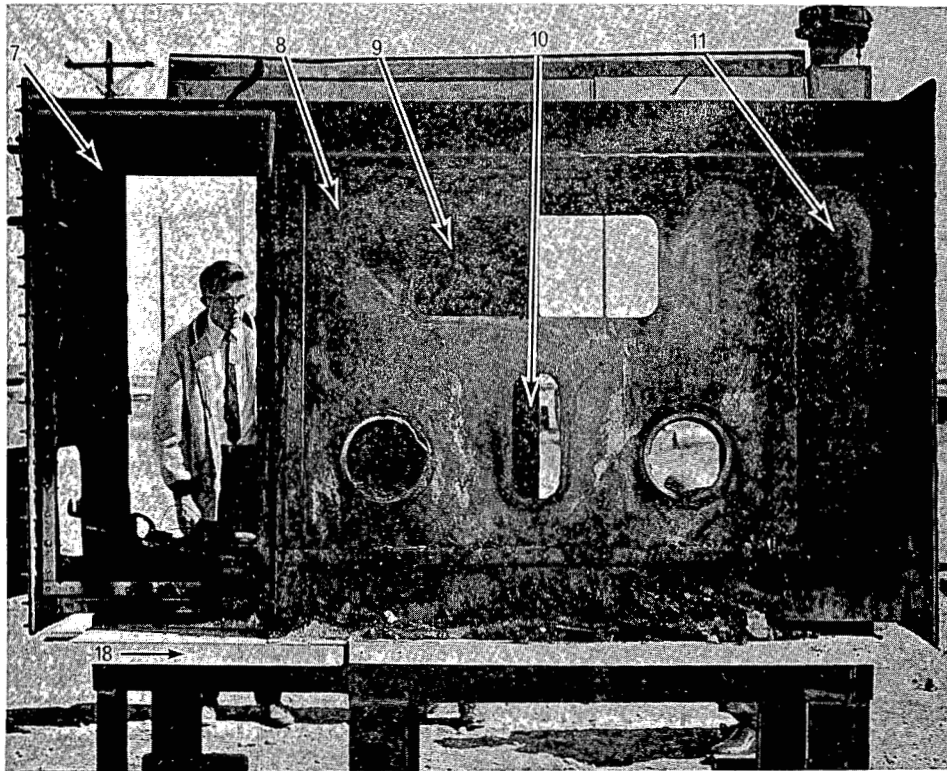
Figure 11. Sloped Side of Glovebox after Experiment No. 1. (See Tables III and V for added description of reference numbers.)

8.	Stainless steel panel, 42 in. by 65 in. by 1/8-in. thick, with outer edge built-up to 1/2 in. with narrow stainless steel strips tack welded to the plate. Four openings were cut in the plate; two for glove rings, and two for Los Alamos-style windows. The panel was covered with 1/8 in. lead attached with studs and nuts.	Figure 7 Panel 8	The stainless steel panel was warped from the heat and lead had melted away from its surface. The molten lead accumulated in a puddle on the shielding below the box. The glove rings had been partially melted. The Los Alamos-style windows had fallen out of the panel. (See Figure 11.)

9.	Los Alamos-style window, 10 1/2 in. by 24 1/2 in. by 1/2 in., with laminated construction of 1/4 in. lead glass sandwiched between two 1/8 in. panes of safety glass by adhesive films. The window was installed in the stainless steel plate using the custom designed Neoprene "zipper" gasket. The window is actually smaller than the opening in the metal plate and in effect "floats" in the opening.	Figure 7 Panel 9	The window and its gasket dropped out of the opening and fell to the floor of the box. This event took place fairly early in the burning sequence. When this happened, the fire from the interior of the box gained direct access to the Plexiglas shielding. Figure 11 shows the opening in the stainless steel panel in which the window had been mounted.

Ref. No.	Description of Test Section <u>Before</u> Fire Test	Location On Glovebox	Observations <u>After</u> Fire Test
10.	Los Alamos-style window, 4 1/2 in. by 12 in. by 1/2 in., with same laminated construction described under Ref. No. 9.	Figure 7 Panel 10	This window and its gasket fell into the box and was found on the box floor. The opening which resulted permitted direct access of the fire in the box to the Benelex shielding panels. Figure 11 shows the panel in which this window was mounted.

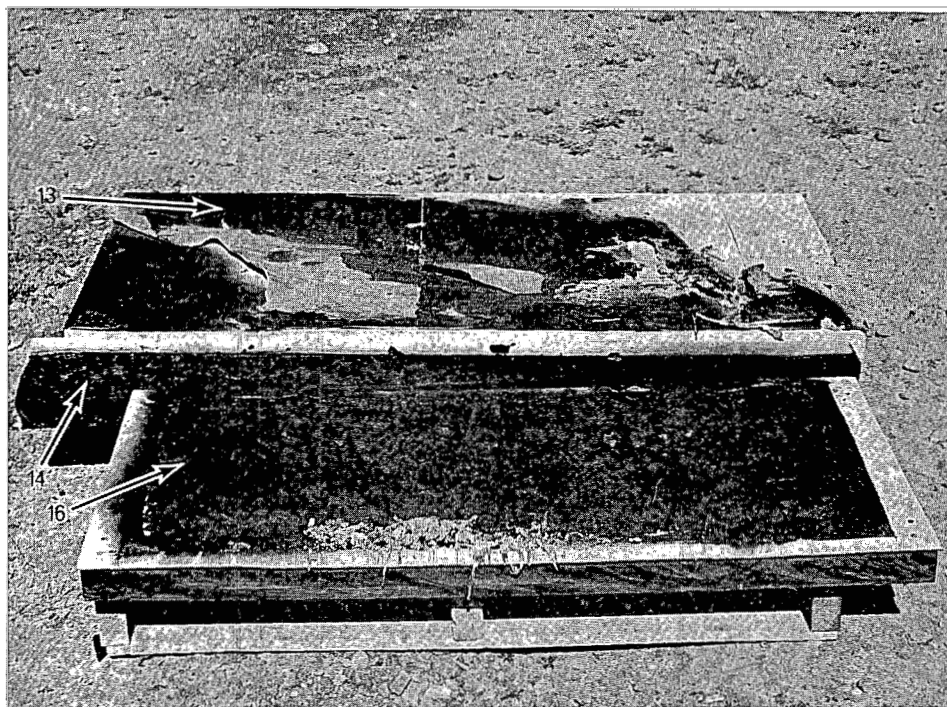
Figure 12. Shielding Panels after Experiment No. 1. (See Table IV for added description of reference numbers.)

Ref. No.	Description of Test Section <u>Before</u> Fire Test	Location On Glovebox	Observations <u>After</u> Fire Test
13.	The dimensions of this panel were 55 in. by 24 in. by 2 inches. The panel was Benelex painted white with epoxy type paint overlaid with 1/8-in. -thick sheet lead, also painted white with epoxy paint. A 1-in. separation existed between this panel and the wall of the glovebox.	Figure 7 Panel 13	The most severe damage to this panel occurred along the front edge of the inner side. The lead had melted away and the exposed Benelex had charred and blistered. One area in the upper corner at the back end of the box was apparently in a cooler region. The panel is shown in Figure 12. (Top panel.)

16.	This Benelex panel was painted with white epoxy paint and covered with 1/8 in. lead sheet painted with white epoxy paint. The dimensions of this panel were 19 in. by 46 in. by 2 inches.	Figure 7 Panel 16	This gloveport cover panel was one of the most seriously damaged by the fire. The lead lining had melted away from all of the area exposed to the fire. There was no paint remaining on the burned area. Bulging and charring of the Benelex was apparent (see Figure 12 - bottom panel).

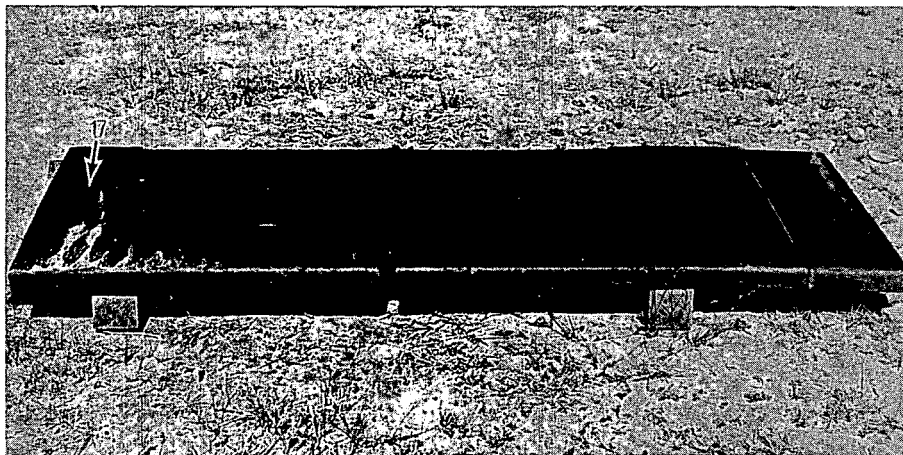
Figure 13. Shielding Panel after Experiment No. 1. (See Table IV for added description of reference number.)

17.	Plexiglas G panel, overall dimensions 25 in. by 69 in. by 2 in. This piece was made of two pieces, 57 in. and 12 in., spliced with metal plate.	Figure 7 Panel 17	The panel was blackened and the side which faced the box had a sand-blasted texture. It was also noted that the area which was positioned over the Los Alamos-style window was eroded most severely. Panel is shown in Figure 13.

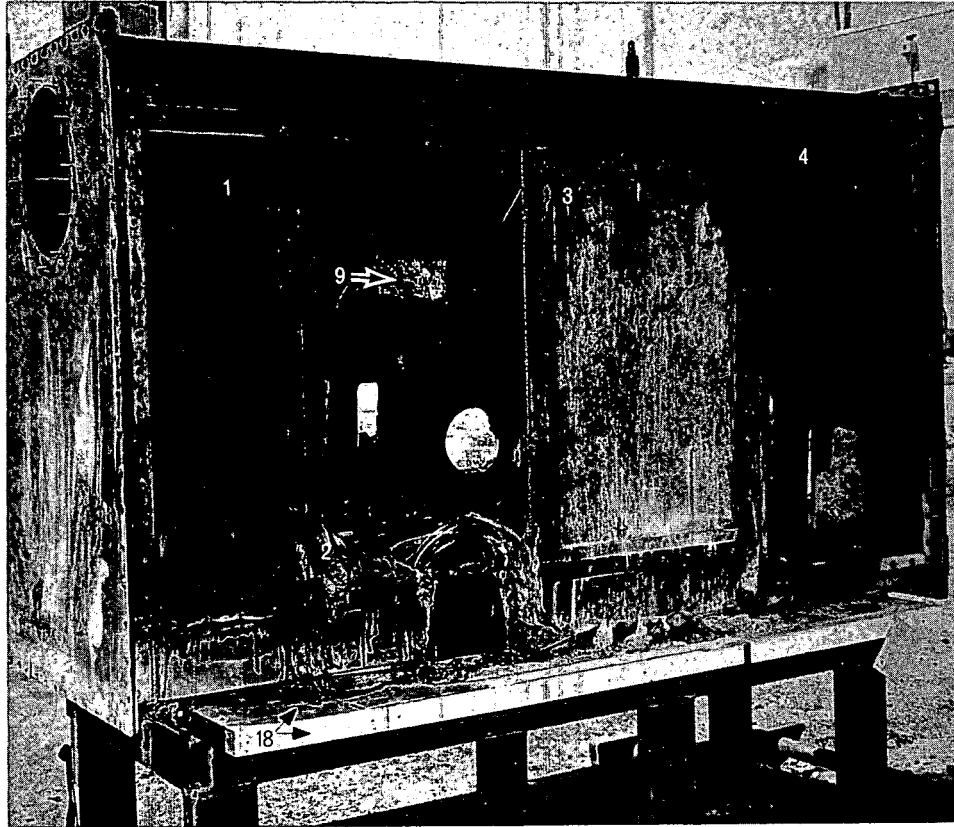
Figure 16. Vertical Side of Glovebox after Experiment No. 2. (See Tables VII, IX and XI for added description of reference numbers.)

2.	Polycarbonate plastic. Two aluminum glove rings and Neoprene gloves.	Figure 6 Panel 2	Gloves burned, window slumped out of frame. Much more tendency of polycarbonate plastic to melt and flow than for Plexiglas. Although somewhat charred, most of the plastic did not burn. See Figure 16.

3.	Stainless steel panel.	Figure 6 Panel 3	Panel blackened on inside surface and lead sheet overlay melted from outside surface. Some warpage from heat. See Figure 16.

4.	Plexiglas SE-3. Two aluminum glove rings and gloves in vertical array.	Figure 6 Panel 4	Panel slumped out of frame onto box floor. Plexiglas burned away from lower ring. See Figures 16 and 17.

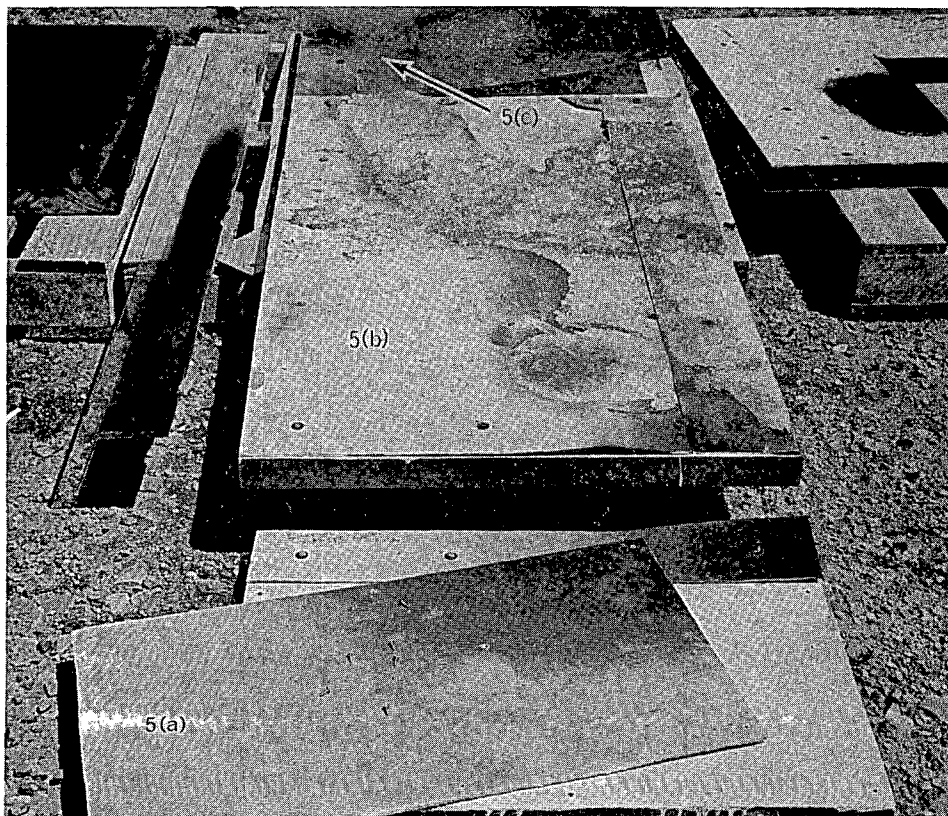
Figure 18. Shielding Panels after Experiment No. 2. (See Table VIII for added description of reference numbers.)

Ref. No.	Description of Test Section <u>Before</u> Fire Test	Location On Glovebox	Observations <u>After</u> Fire Test
5.	Benelex panel painted with Tenaco epoxy paint; (a) the section of Benelex at the shielded end of the box overlaying panel 1 was covered with 1/4-in. cement asbestos board, (b) the central area overlaying panels 2 and 3 was covered with lead sheet painted with fire-retardant (Albi) paint, (c) the last section of the Benelex, overlaying panel 4, was covered with 20 gauge stainless steel sheet.	Figure 6 Panel 5	(a) Benelex under cement-asbestos board in excellent condition. No charring of paint or Benelex was noted. (b) Some of the lead had melted from the central section of the shielding and exposed an epoxy-painted surface which was not damaged. The fire-retardant paint, surrounding the area where the lead fused, had expanded and probably helped in forestalling fusion of the lead. (c) The stainless steel protected the Benelex and its epoxy-paint finish adequately; only slight damage was noted. See Figure 18.

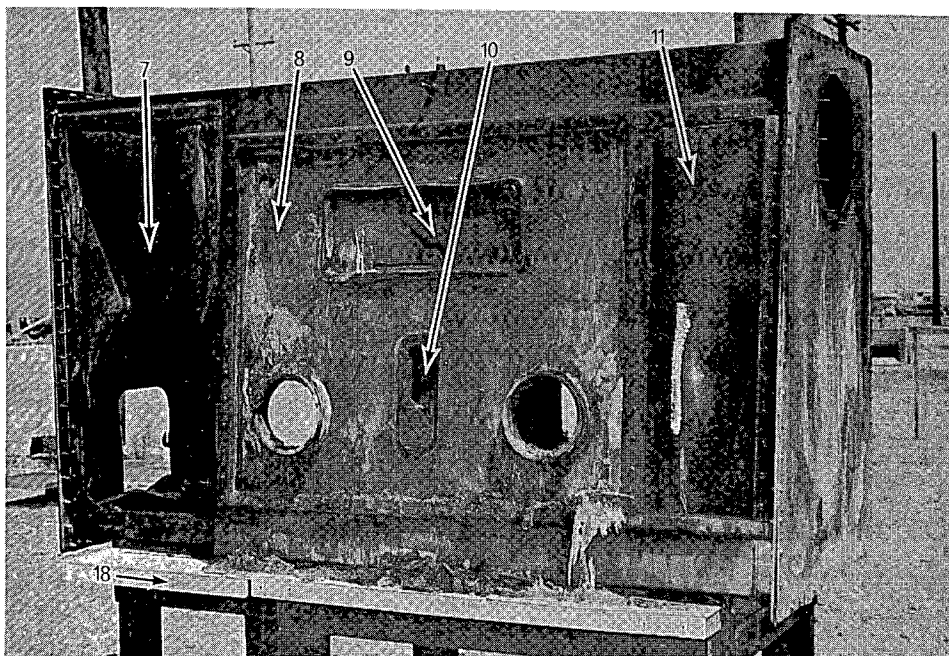
Figure 19. Sloped Side of Glovebox after Experiment No. 2. (See Tables IX and XI for added description of reference numbers.)

Ref. No.	Description of Test Section <u>Before</u> Fire Test	Location On Glovebox	Observations <u>After</u> Fire Test
7.	Plexiglas SE-3 window. No gloveports.	Figure 7 Panel 7	Lower half of window burned away with appreciable thinning of top portion which was still held in frame. See Figure 19.

8.	Stainless steel panel with openings for two gloves and two Los Alamos-style windows. A simple frame was welded around the inside surface of the Los Alamos window opening to help protect the gasket and to prevent the window from falling in. Panel was covered with lead sheet painted with fire-retardant paint.	Figure 7 Panel 8	Gloves were burned off rings. Lead melted away from panel. Los Alamos windows and gaskets remained intact. See Figure 19.

9.	Los Alamos-style window. Because of warped panel it was necessary to seal window in part of the gasket with Duxseal. ^a	Figure 7 Panel 9	Window shattered but most pieces were still in frame. Outside laminate of glass still intact but cracked. See Figures 16 and 19. Note: Duxseal withstood fire test in excellent condition.

11.	Plexiglas SE-3 window without glove rings.	Figure 7 Panel 11	Window was thinned but remained intact in its frame. See Figure 19.
12.	Fire-rated wire-glass windows covered with fluorescent light reflector	Figures 6 and 7 Panel 12	Windows cracked but remained intact. See Figure 20.

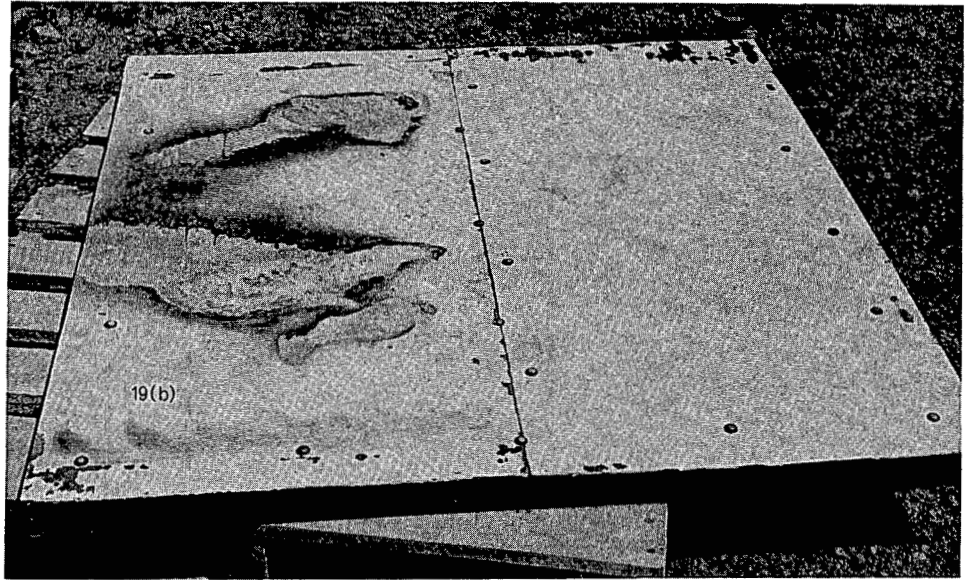
Figure 26. Shielding Panel after Experiment No. 2. (See Table XI for added description of reference number.)

19.	Two-inch Benelex panel in two sections. Both sides of Benelex were painted with fire-retardant paint (Albi). Sheet lead, also painted with fire-retardant paint, was applied to one side. (a) The top section was placed with the Benelex side facing the box; (b) the bottom section was placed with the lead facing the box.	Figures 6 and 7 Panel 19	(a) Paint around exhaust pipe on top section was expanded. Also some blistering of Benelex surface was noted in certain areas. Lead was unaffected. See Figure 25. (b) Paint on surface of lead sheet was expanded although no lead was melted from the surface. See Figure 26.

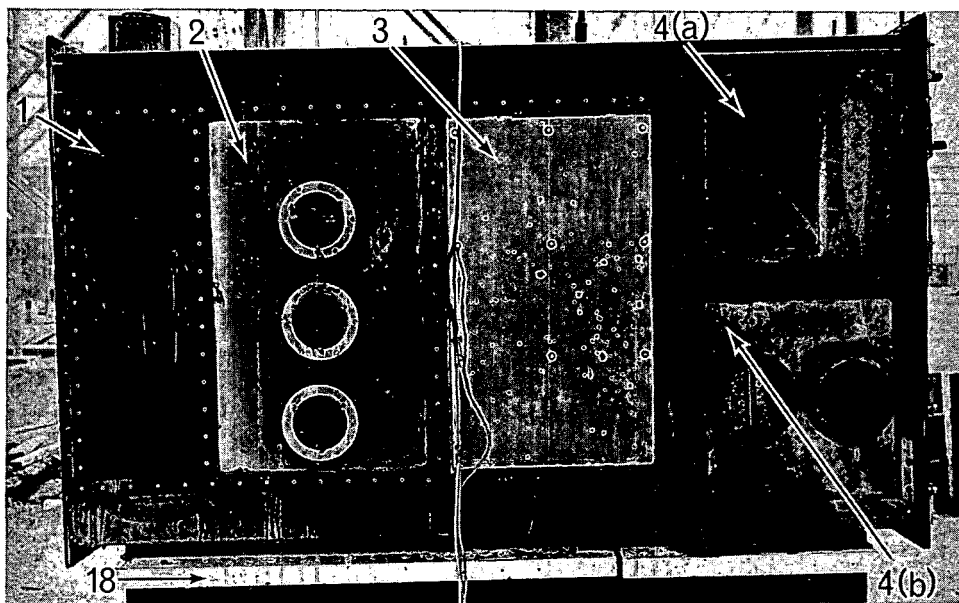
Figure 29. Vertical Side of Glovebox after Experiment No. 3. (See Table XII and XVI for added description of reference numbers.)

2.	Stainless steel panel with three Pyrex (6-in. diameter by 1/2-in. thick) windows in specially designed ports.	Figure 6 Panel 2	Panel and windows remained intact and only slightly affected by the fire. See Figure 29.

3.	Stainless steel panel with a "tank" (38 in. by 22 in. by 2 in.) bolted on the outside surface. The tank was sealed with butyl caulk on its side and bottom edges and was filled with Gelgard ^{® b} . See Figure 30.	Figure 6 Panel 3	Panel was not affected by the fire. A small quantity of water was evaporated from the Gelgard. See Figure 29.

4.	(a) The top half of this window panel was fire-rated wire glass. (b) The bottom section was fabricated from stainless steel sheet (1/8 in.) and provided with two gloveports positioned side by side. One of the ports was covered on the inside with a metal gloveport cover. The other was covered with an asbestos fabric curtain (Silvabestos). See Figure 28.	Figure 6 Panel 4	(a) The wire glass section was cracked in numerous places but remained intact. Some of these cracks developed shortly after installation. (b) The gloveport covers were in place after the test, although the gloves had burned away. The metal cover was functional and only blackened by soot. The asbestos cloth cover was fragile since most of its supporting fiber (not asbestos) had burned away during the test. See Figure 29.

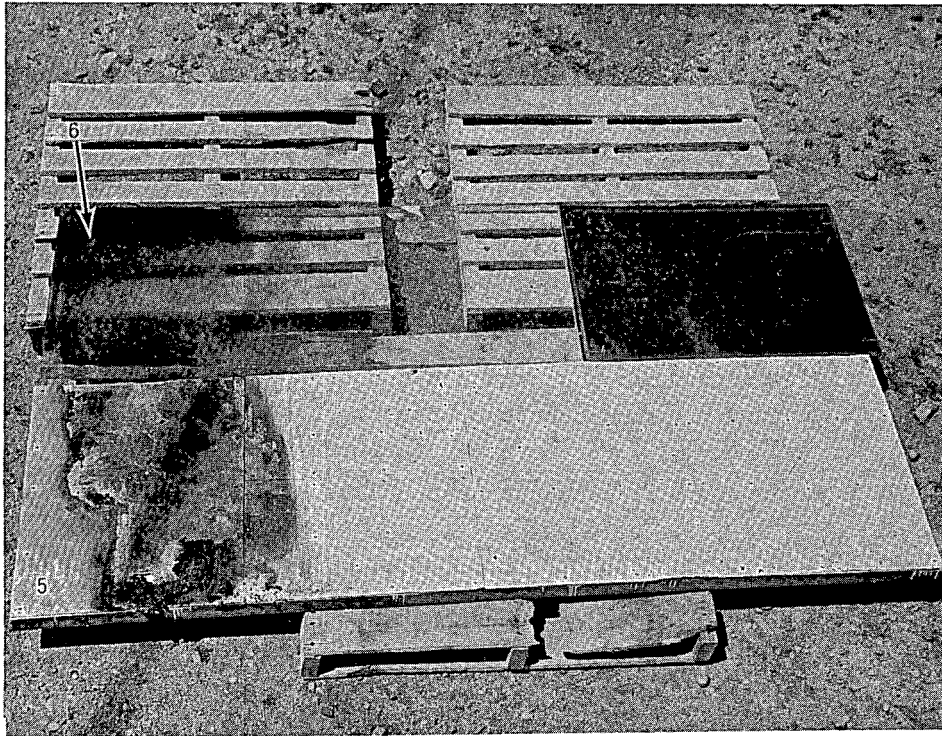
Figure 31. Shielding Panels after Test No. 3. (See Table XIII for added description of reference numbers.)

Ref. No.	Description of Test Section <u>Before</u> Fire Test	Location On Glovebox	Observations <u>After</u> Fire Test
5.	Benelex (2 in.) panel painted with fire-retardant paint and covered with sheet (1/8 in.) lead also painted with fire-retardant (Albi 107-A) paint.	Figure 6 Panel 5	Only one area on this panel showed any effect from fire. This was the area located outside of the gloveports (Panel Reference 4). The damage was limited to melting away of lead sheet in two very small areas. The fire damage occurred when two gloves burned in the space between the glovebox and its shielding. See Figure 31.
6.	Plexiglas G panel (2 in.).	Figure 2 Panel 6	The surface of the Plexiglas was eroded and discolored in the area above where the gloves burned. See Figure 31.

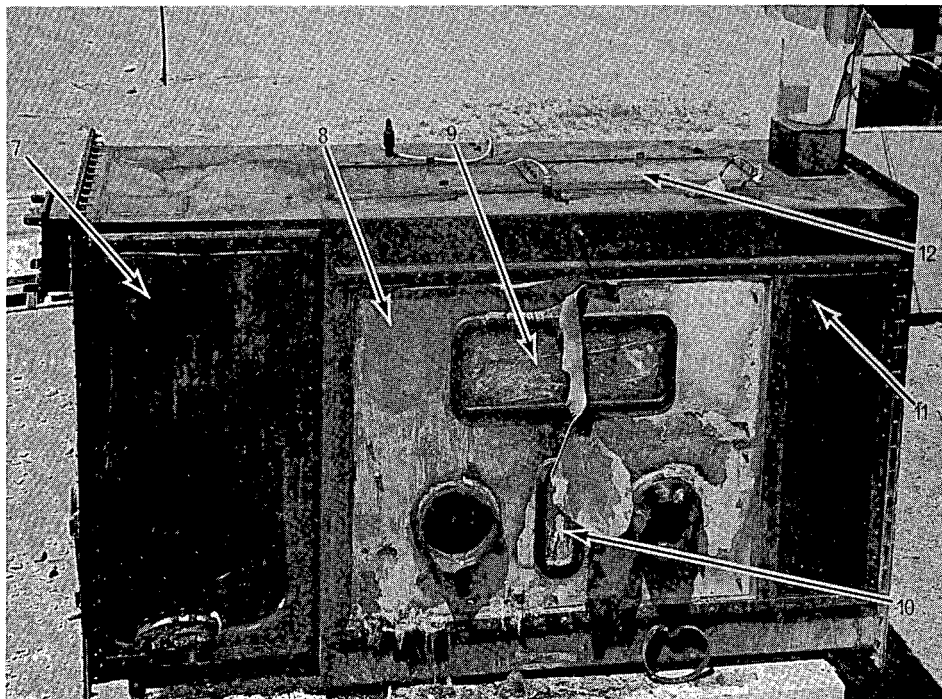
Figure 32. Sloped Side of Glovebox after Experiment No. 3. (See Table XIV for added description of reference numbers.)

10.	Los Alamos-style window (small). See Figure 33.	Figure 7 Panel 10	Fire effect was very similar to that observed for Reference No. 9. See Figure 32.

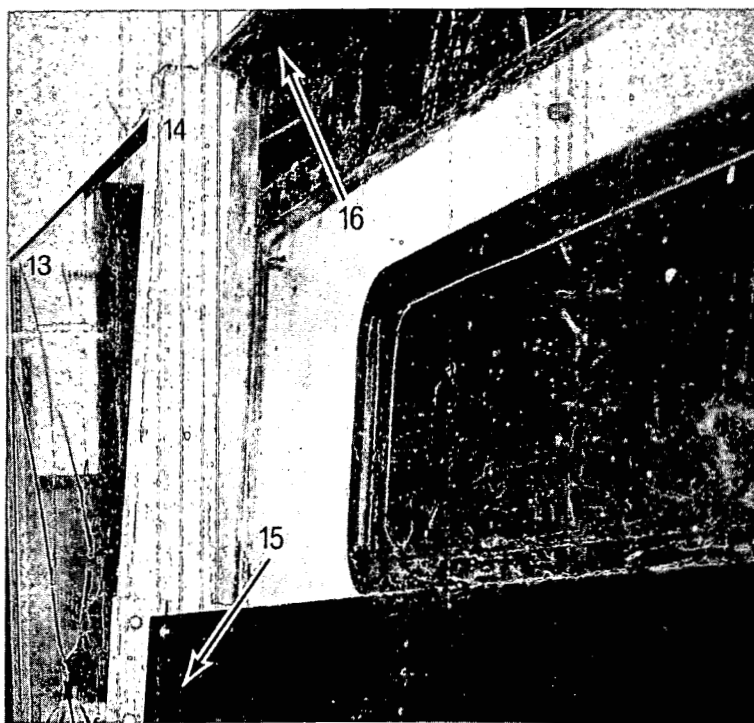
Figure 34. Shielding Installed on Sloped Side of Glovebox before Experiment No. 3. The thermopane panel (Reference No. 13) broke while being filled with water. It was replaced before test. (See Table XV for added descriptions of reference numbers.

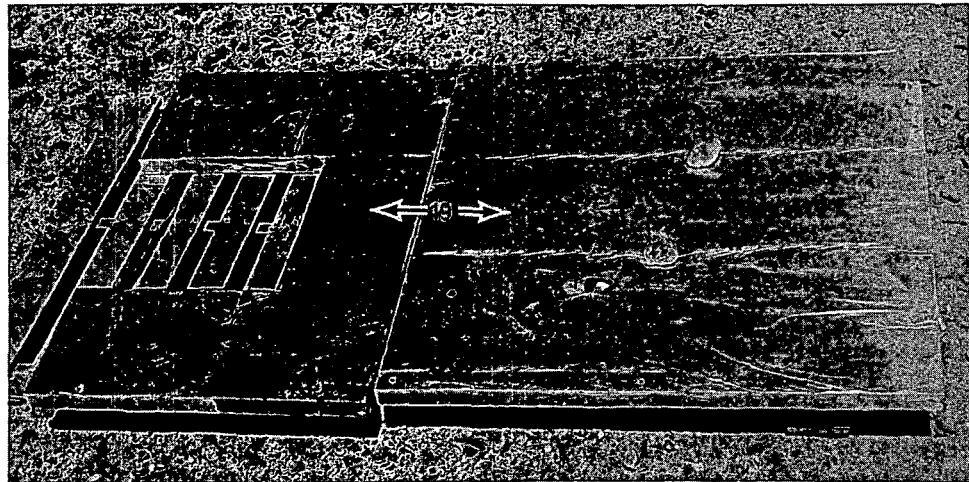
Figure 37. Shielding Panels after Experiment No. 3. (See Table XVI for added description of reference number.)

Ref. No.	Description of Test Section <u>Before</u> Fire Test	Location On Glovebox	Observations <u>After</u> Fire Test
18.	Two-inch Benelex panel painted with epoxy enamel.	Figures 6 and 7 Panel 18	Very little effect on panel. Apparently it did not get hot. Edge views of this panel can be seen in Figure 29.
19.	Two-inch Benelex panel in two pieces. Surface was painted with fire-retardant paint which was then covered with aluminum foil.	Figures 6 and 7 Panel 19	Nominal effect on panel. Slight scorching appeared around the opening for the exhaust duct and a small area where the stainless steel bulged out and contacted the surface of the shielding. See Figure 37.
