EVALUATION OF IRRADIATED
EXPERIMENTAL OMR FUEL ELEMENTS

J. H. WALTER
E. E. GARRETT
J. M. DAVIS

ATOMICS INTERNATIONAL

CONTRACT: AT(11-1)-GEN-8
ISSUED: APRIL 1, 1960

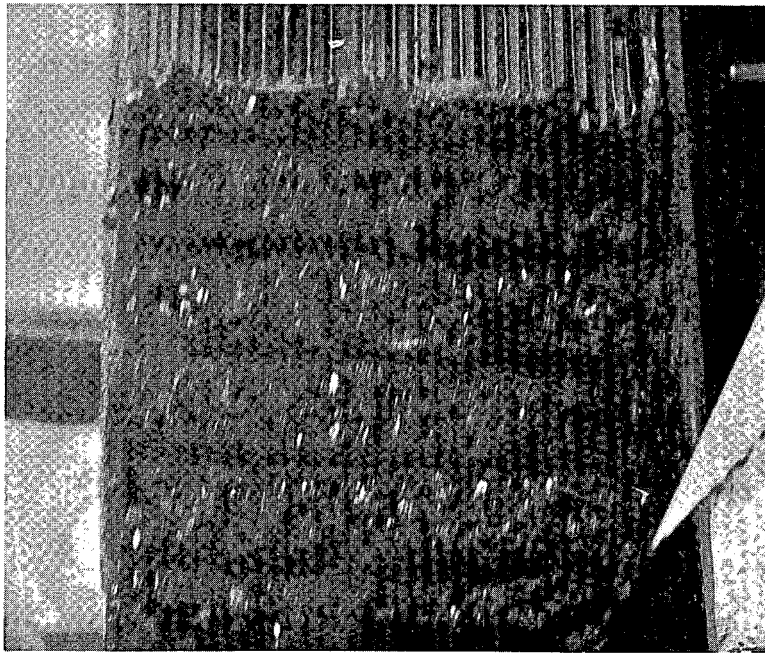
Figure 10. Inlet End of HB-1

Initial viewing of the outside of the fuel element revealed no damage other than the bend near the inlet end, which had occurred during closing of the shipping cask. The entire element was covered with a glossy, dark coating of residue. The residue had a reddish appearance and was somewhat viscous. Over several hours, the coating appeared to dry and harden, particularly over the fueled portion of the element. By use of Tempilsticks (crayon-type materials of known melting points) the temperature of the shroud box over the fueled portion was determined to be between 125 and 150°F.

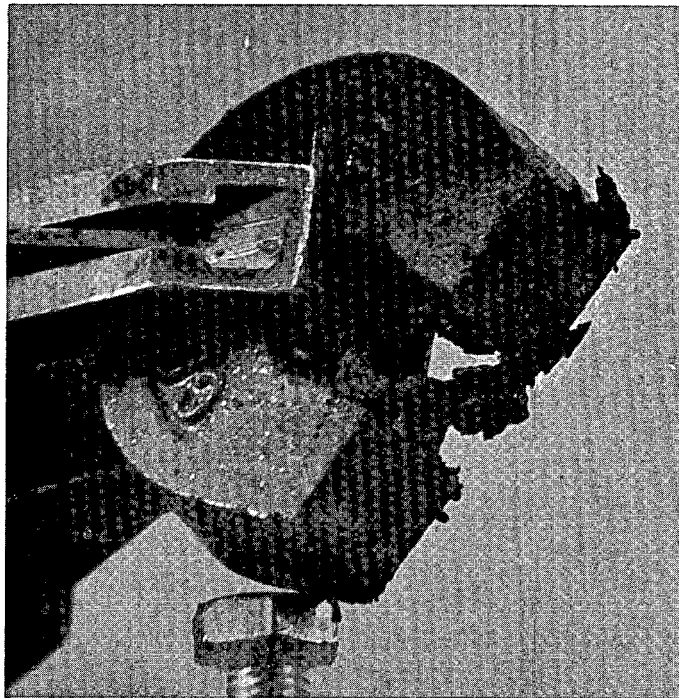
Figure 11. Magnetic Material
Blocking Inlet of HB-1

some extent, had an insoluble composition of approximately 75% carbon, 3% hydrogen, and 23% ash. Since the blocking deposits appeared particulate, rather than as a homogeneous deposit, it is likely that they contained a mixture of a variety of foreign materials in the coolant, such as iron oxide from residual rust and makeup coolant and carbonaceous material from the damaged standard element.

Subsequent to the damage to the HB-1 and HT-1 fuel elements, provisions were made to remove particulate impurities from the OMRE coolant. Filtration and centrifuging of the coolant, and distillation of coolant makeup are presently being performed. Experimental fuel elements presently operating in the OMRE have shown no signs of blockage of coolant flow.

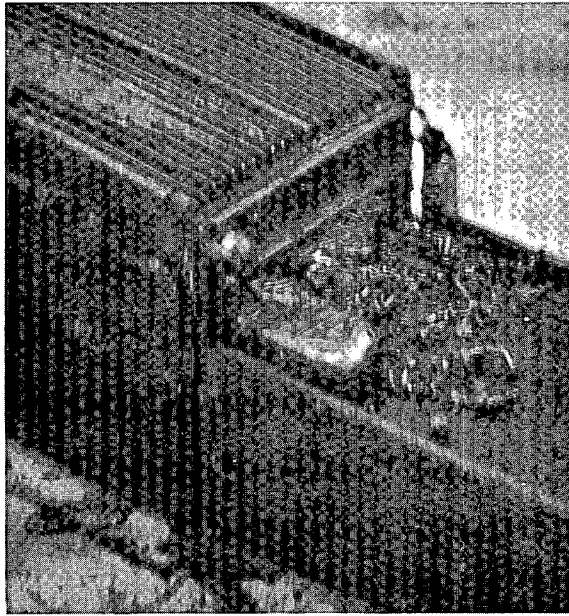
Figure 12. Metallic Deposit at
Outlet End of HB-1

The boron steel plates on the outlet end of the assembly were removed, one at a time. A large metallic deposit was noted between the third and fourth steel plates. The deposit was attached to Fuel Plate 341-6, as shown in Figure 12. The metal was relatively soft when scratched, and had the appearance of a solidified, large, molten drop. Smaller metallic pieces were noted between the fourth and fifth steel plates. The deposits were not attached to the steel plates. Figure 13 shows the outlet end of the fueled section. With the exception of the globs of metal, the coolant channels were relatively free from blockage.

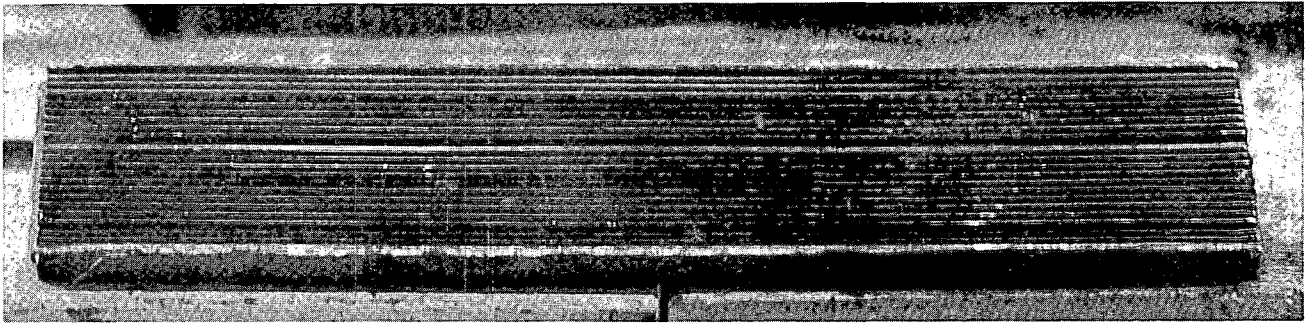
a. Plate 341-1 — Undamaged Plate

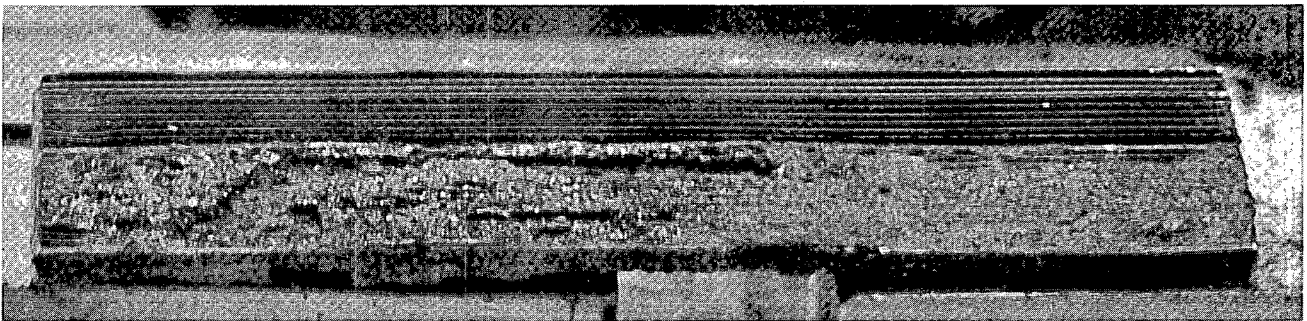
The five fuel plates were separated and examined individually. It was apparent that partial melting of the cladding had occurred on four of the five plates. In addition to, and apparently associated with, the melted areas, some areas of the cladding were coated with a dark deposit. In some areas, the deposit completely filled the space between adjacent fins. Figure 14 shows typical fuel plate surfaces. The side of the plates where most of the melting occurred was facing Core Position 16. The majority of the melting occurred between the 5th and 4th,

b. Plate 341-5 — Plate With Partially Melted Cladding, Typical of 4 of the 5 Plates in HB-1

From visual inspection of the HB-1 experimental fuel element, it is apparent that part of the cladding melted, exposing bare uranium alloy core. The melting occurred on the side of the fuel element facing OMRE Core Position 16, and was most pronounced on the third and fourth plates, counting from the side closest to the center of the core. The plate that was closest to the center of the core, and should therefore be the highest power-output plate, was undamaged. The amount of plugging in individual coolant channels was apparently a greater factor in the distribution of the damage than the relative power output of the plates. None of the cladding thermocouples were located at, or in the immediate vicinity of, the melted areas.

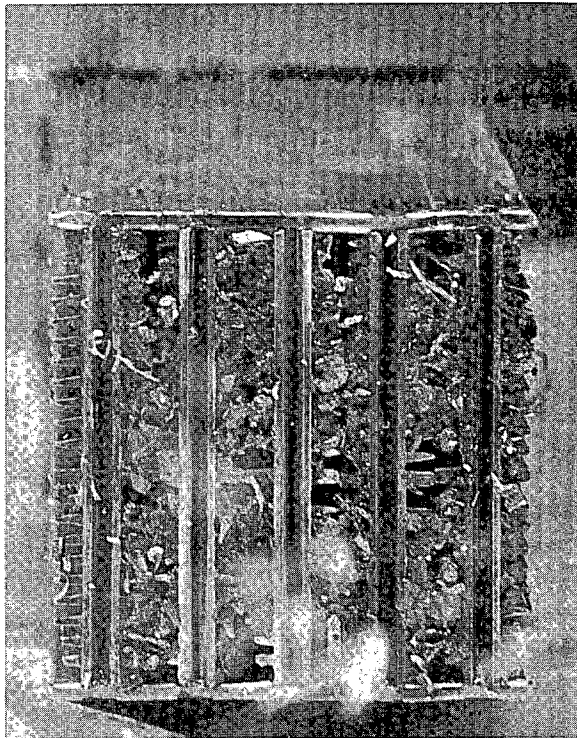
Figure 15. Inlet End of HT-1

The shroud box was milled open, as with the HB-1 element. No gross distortion of the three subassemblies of fuel plates was noted. The flat sides of the fuel plates, perpendicular to the extended surface portion, were coated with a dark, flaky, hard deposit, similar in texture to the deposits in the same location on the HB-1 fuel element. The inlet end of the lower fuel section, shown in Figure 15, was largely blocked by a hard, granular deposit. The outlet end of the fuel element, and the interfaces between the three fueled sections, had only occasional deposits.

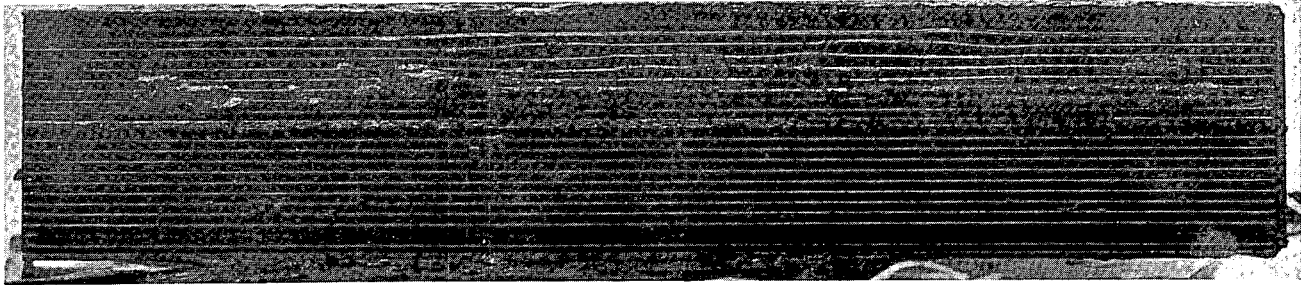
b. Plate 347-1 — Blistered Plate From Center Section of HT-1, Adjacent to Plate 348-3 (The blister is evidenced by the wavy fins in the top half of the photo)

and was the second plate from the edge of the element closest to the center of the reactor core. The center plate from the center section evidenced some distortion of the cladding fins in the same location as the blister on adjacent Plate 347-1, but the area had not raised, as on Plate 347-1. The only other deformed areas noted were small blisters on the center plate from the lower fueled section. These blisters had been noted during fabrication, and appeared to be the same size as before irradiation. The deposits on the finned cladding surfaces were most pronounced on fuel plates from the lower and center sections. The five plates from the upper section were noticeably more free from deposits. The deposits on the finned surfaces were relatively soft and could be readily removed. Part of some of the deposits had a matted, fibrous appearance.

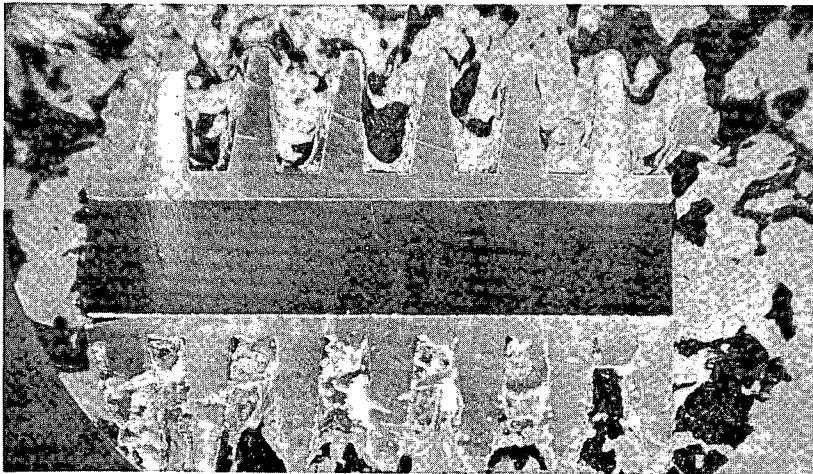
Figure 21. Cross Section of Unblistered Area of Plate 347-1

Figure 21 is a photomicrograph of the unblistered region. The bond between the core and cladding was intact, except for a small split at one edge, which probably occurred during sectioning. The microstructure of the bond area showed almost complete consumption of the nickel bond by the aluminum, to form brittle Al-Ni intermetallic compounds. Some diffusion of aluminum into the uranium core was evident. Figure 22 is a typical photomicrograph of an unirradiated "as-fabricated" bond. Figure 23 is a photomicrograph of a typical bond area from the unblistered specimen, with the probable components identified. Identification of the compounds was based on previous experience with Al-Ni-U diffusion bonds.⁸ The dark band due to relief polishing contained no cracks or voids. The microstructure of the core alloy in the unblistered section was very similar to the unirradiated structure, and is shown in Figure 24.

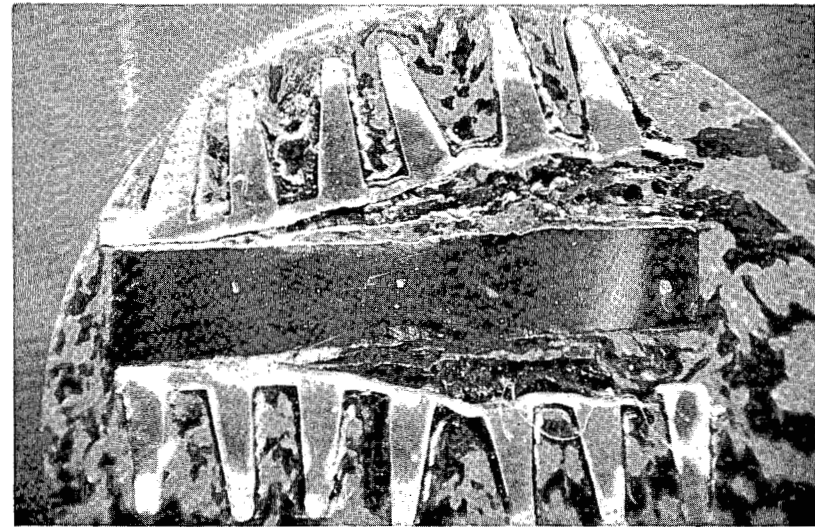
As Polished 4X
 Figure 25. Cross Section of Blistered Area of Plate 347-1

Figure 25 is a photomicrograph of the blistered section. Both sides of the fuel plate were blistered. The space between the cladding and the core is apparently filled with coolant decomposition products and U-Al and Al-Ni intermetallic compounds. One small hole was observed in the cladding. The cladding varied in thickness from 0.020 in. to zero at the break. The Al-Ni compounds contained many cracks. The core material showed no evidence of gross attack by the organic coolant. Figure 26 is a photomicrograph of the blistered area, with the probable components identified. The microstructure of the core alloy was not homogeneous in the region of the blister. Figure 27 shows the affected region.

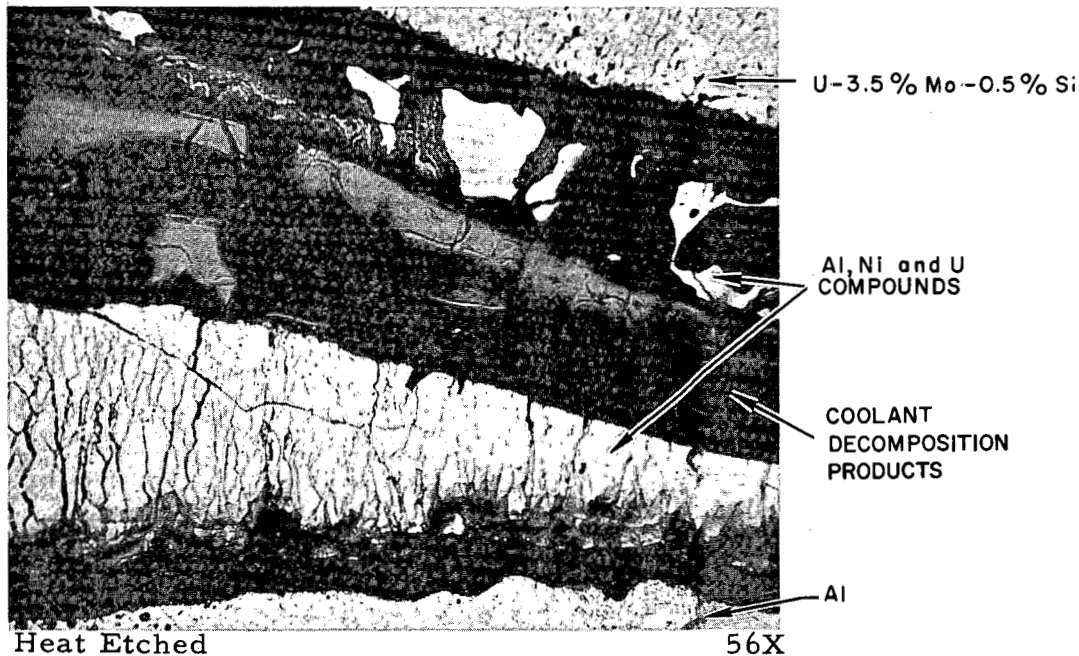
Heat Etched 56X
 Figure 26. Microstructure of Blistered Area of Plate 347-1

The postirradiation microstructure of the cladding-to-core bond and of the fuel core showed signs of higher-than-anticipated temperatures in the HT-1 fuel element. In the blistered area, high temperatures were evidenced by the formation of massive intermetallic compounds and the uneven core microstructure, indicative of partial alpha-to-gamma transformation. In this area, a substantial portion of the aluminum cladding had been converted to brittle intermetallic compounds. Fracture of these compounds apparently allowed coolant to enter the bond layer, decompose, and enlarge the blistered area. From the appearance of the core microstructure, it was estimated that the maximum center fuel temperature in the blistered area was between 1200 and 1300°F. The insulating effect of the blister would account for these temperatures.
