## OAK RIDGE NATIONAL LABORATORY Coorated by UNION CARBIDE NUCLEAR COMPANY

SUBJECT: A Galvanic Corrosion Problem Associated with

the Preparation of Multimetallic Beryllium Samples

# A GALVANIC CORROSION PROBLEM ASSOCIATED WITH THE PREPARATION OF MULTIMETALLIC BERYLLIUM SAMPLES

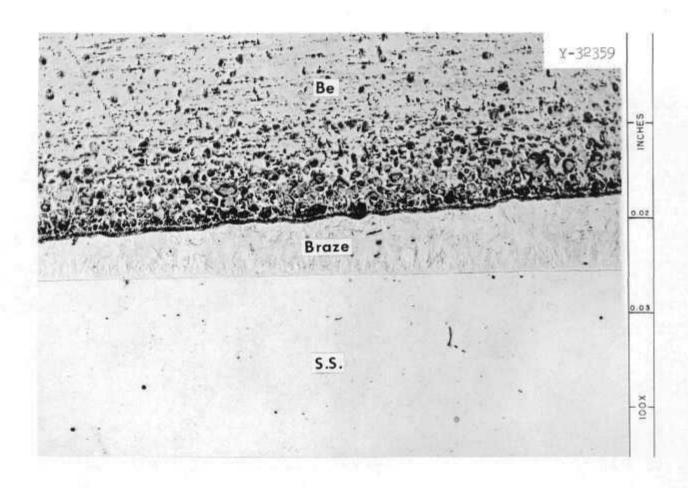
The attack at the interface of a beryllium-type 430 stainless steel braze is shown in Fig. 1. The same type of effect was noted on a nickel-clad beryllium tube. This attack was eventually judged to be a galvanic corrosion effect. However, at first the effect was blamed on the diffusion of beryllium into the adjacent braze metal or nickel, since both samples had been heated at elevated temperatures.

Fig. 1 Beryllium-Type 430 Stainless Steel Braze - Brazed with 49% Ti-49% Cu-2% Be. Note the peculiar appearance of the beryllium at the beryllium-braze metal interface. This appearance has been proven to be due to galvanic corrosion taking place during polishing with the beryllium being anodic to the braze metal and stainless steel. As-polished, bright field, 100%.

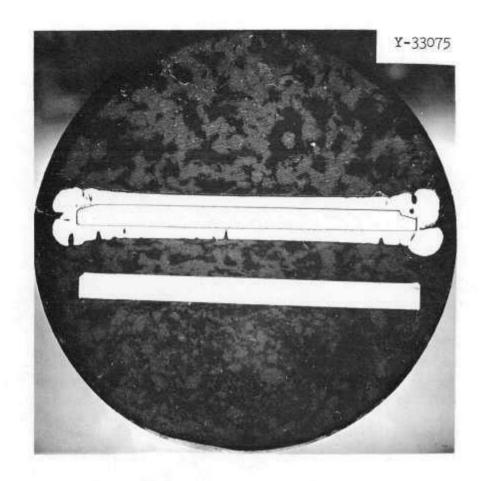
Fig. 2 Cross Section of a Mounted Nickel-Plated and Unplated Beryllium Sheet.

The clue that suggested a corrosion effect was the appearance of the microstructure of a nickel-plated beryllium sheet. A simple experiment had been made to determine how effective nickel plating was in the preservation of the edge of a beryllium sample. A beryllium sheet was cut in two, and one-half was nickel plated while the other half was not. The plated sheet and unplated sheet were mounted in bakelite as shown in Fig. 2. This specimen was polished in the same manner as the brazed and clad specimens.

As-polished without NaNO<sub>3</sub> inhibitor. This sample was prepared to examine how effective nickel plating is in the preservation of the edge of a beryllium sample. Approximately 3-1/2X.

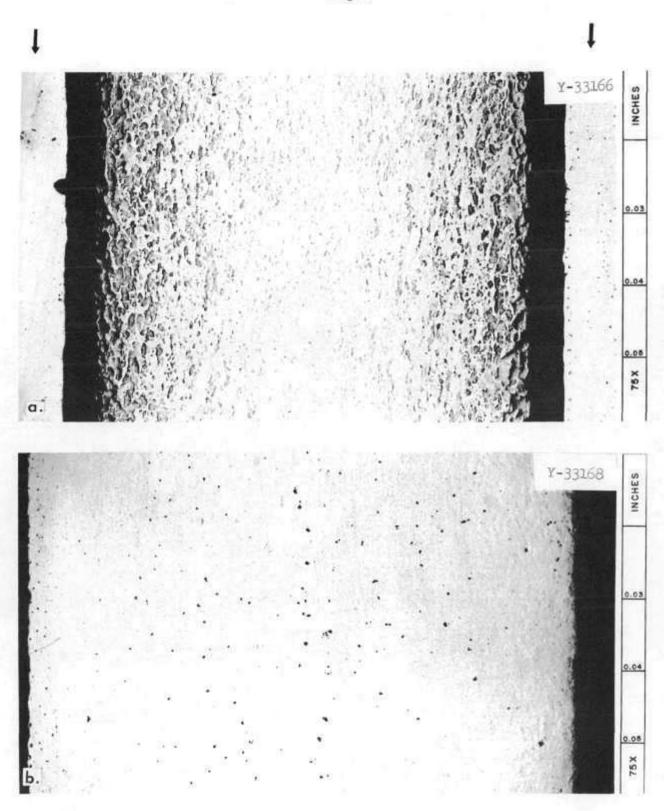
The appearance of the nickel-beryllium interface of the nickel-plated sheet was similar to the appearances of the beryllium-dissimilar metal interface of the clad and brazed samples as shown in Figs. 3a and 4a. The unplated sheet exhibited a homogeneous microstructure as shown in Figs. 3b and 4b. The effect at the beryllium-dissimilar metal interface in this case could not be due to diffusion of beryllium into the nickel because the sample was never heated above the specimen mounting temperature of approximately 160°C.

The attack at the beryllium-dissimilar metal interface was therefore thought to be due to the setting up of a galvanic cell within the sample during polishing with the beryllium being anodic to the stainless steel or nickel. In corrosion studies on beryllium in contact with other metals, J. L. English found that extruded beryllium metal was attacked preferentially when in contact with type 347 stainless steel and exposed at 85°C in quiescent demineralized water containing small amounts of hydrogen peroxide. English found that additions of 5 ppm sodium nitrate completely eliminated pitting-type corrosion in extruded beryllium exposed to the same conditions as given above.

Fig. 3 (a) Nickel-Plated Beryllium Sheet, (b) Unplated Beryllium Sheet. Arrows point out the nickel plate. Note the attack at the beryllium sheet adjacent to the nickel plate. As-polished, 75X.

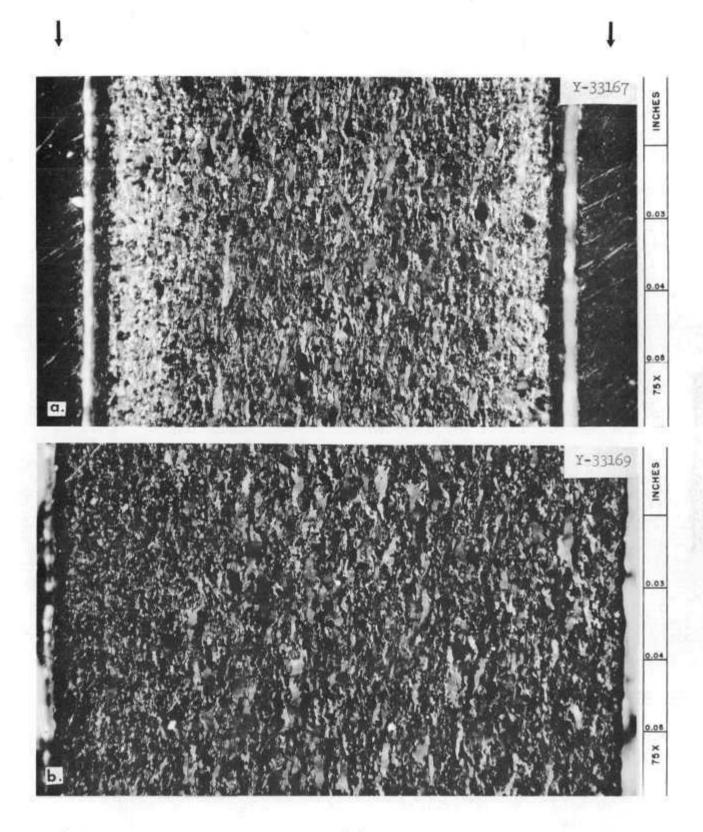
Fig. 4 (a) Nickel-Plated Beryllium Sheet, (b) Unplated Beryllium Sheet. Arrows show the nickel plate. Note the specular appearance of the plated beryllium. As-polished, polarized light, 75%.

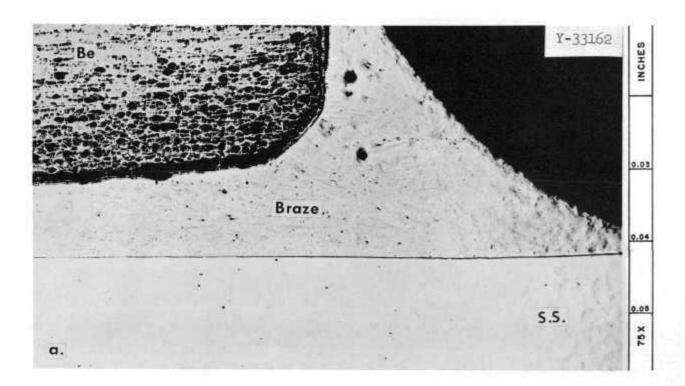
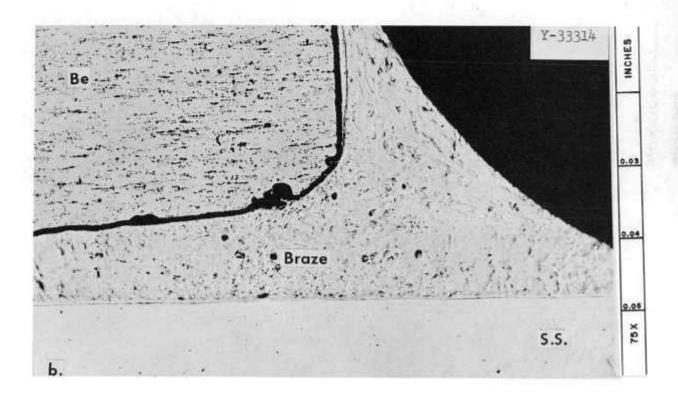
Unfortunately the sodium nitrate reacted with some components of the samples as seen in Fig. 5, the beryllium-stainless steel braze, where a diffusion layer has been stained black. In addition, the nickel-plated beryllium sheet was pitted considerably. The pitting took place generally throughout the plated sheet and not preferentially at the nickel-beryllium interface.

Fig. 5 Contrast Between Microstructures of Type 430 Stainless Steel-Beryllium Braze, (a) As-Polished Without Inhibitor, (b) As-Polished With Inhibitor. The sodium nitrate has reacted with a diffusion layer, located between the beryllium and the braze, staining it black. 75X.

Based on these findings, it was expected that the addition of sodium nitrate to the abrasive slurry might possibly eliminate the attack at the interface. The brazed, nickel-clad, and nickel-plated beryllium samples were re-prepared in the same manner as before except that 1 g of sodium nitrate per 300 ml of solution was used in the abrasive slurry of the last polishing operation. The attack at the beryllium-dissimilar metal interface was eliminated. The contrast of the appearance of the microstructure of the stainless steel-beryllium braze polished with and without the inhibitor is shown in Fig. 5.

The attack on the beryllium was eliminated by the addition of small amounts of sodium nitrate to the abrasive slurry. This is not the ultimate solution to the problem, for the sodium nitrate reacts unfavorably with some components of the samples.
