SUBJECT: Inspection and Maintenance Experience with HRE-2 (Presented at the Nuclear Engineering and Science Conference in Cleveland, Ohio, in April 1959) TO: Distribution

J. S. Culver, D. M. Shepherd and C. W. Collins

ABSTRACT

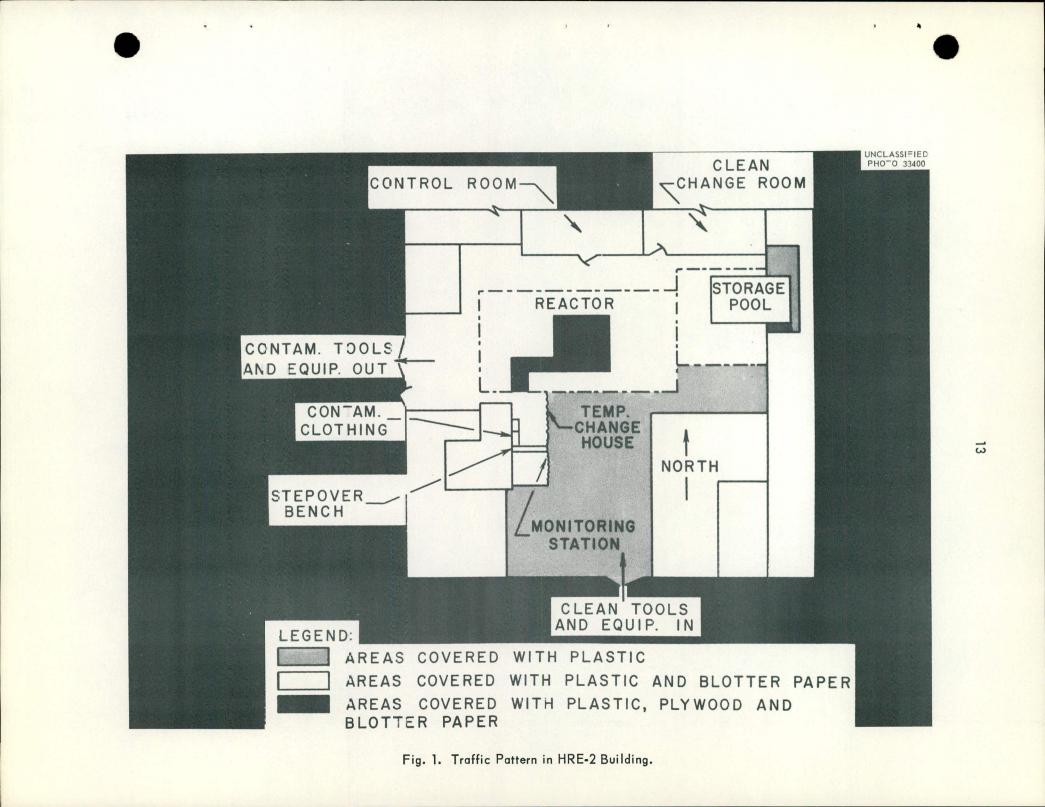
A traffic pattern was established (see Fig. 1) to prevent the inadvertent spread of contamination. All personnel entered and left the area over the reactor cell via the temporary change room. All imcoming clean tools and equipment were passed over the barrier from the south. All contaminated equipment or waste left the building in hot trucks loaded directly at the west end or from the hot storage pool at the east end.

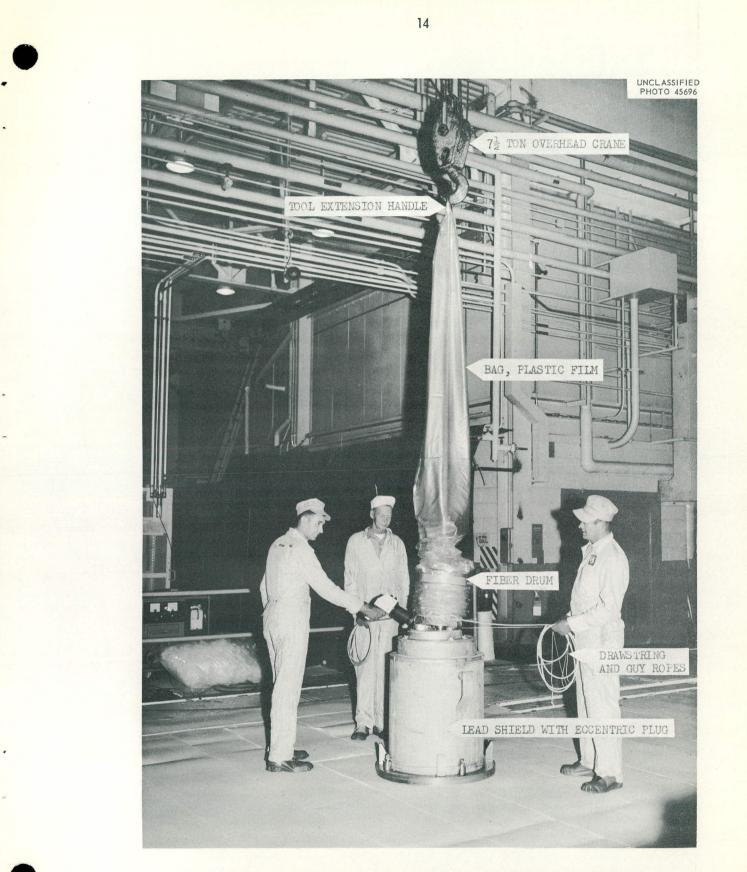
Fig. 2. Method of Containing Contamination on Tools Withdrawn from HRE-2 Core.

Tools, lights, periscopes, and other devices used on or in the pressure vessel were enclosed in plastic-film bags as they were withdrawn (see Fig. 2). The top of the bag was taped to the tool handle. A fiber drum, with heads removed, held the bag open while the tool was withdrawn by the overhead crane. A drawstring closed the bottom of the bag when the tool was fully withdrawn; hand lines provided a means of guiding when required.

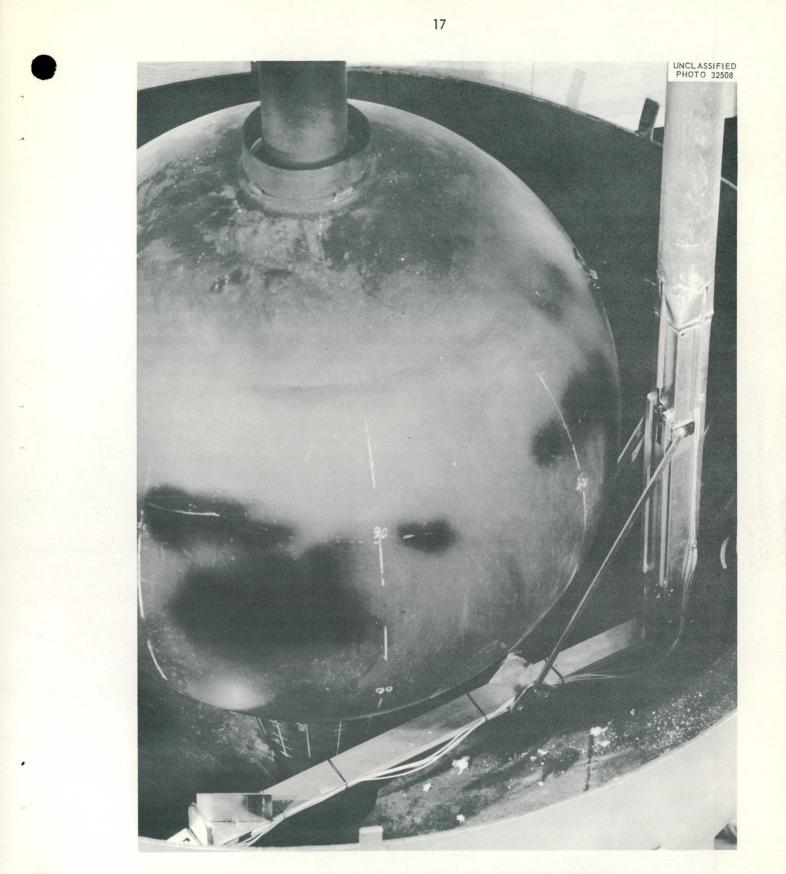
Fig. 5. Folding Arm Viewing Device Inserted in Core Mockup.

With the azimuth thus fixed, the folding-arm device was inserted through the blanket access flange and erected on the west side of the core. A minor adjustment of the mirror brought the hole into view.

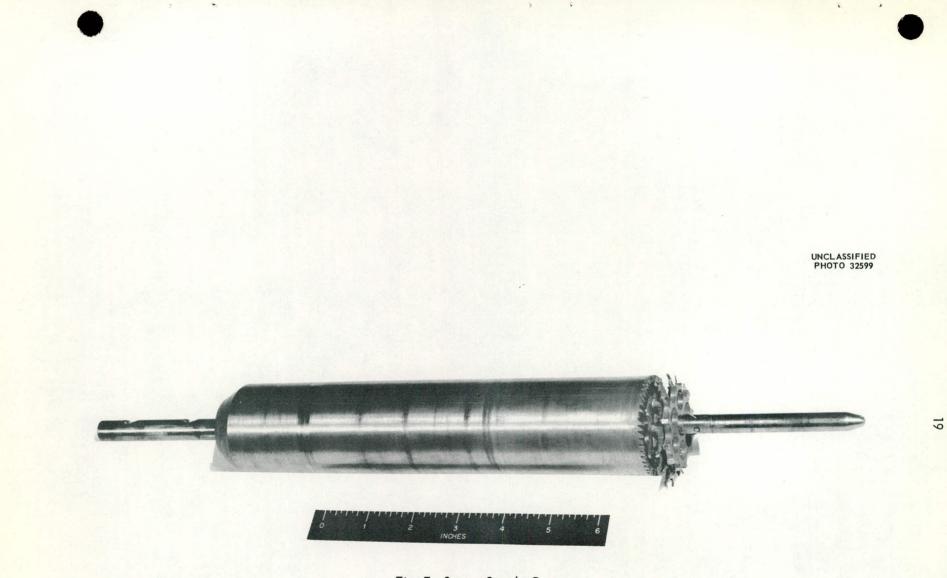
Fig. 7. Screen Sample Cutter.

Original plans called for 1-in.-diameter samples to be cut from the top diffuser screen adjacent to the core wall for metallurgical study. A tool to accomplish this was designed, built, and successfully tested; however, following viewing of the core defect from the outside it was decided to construct another tool to cut 2-in.-diameter discs out of the center of the top six screens. This would accomplish the following objectives: (1) give an access port for the tilt-mirror periscope so that the hole in the core wall could be viewed and photographed from the inside, (2) provide a series of Zircaloy-2 samples which had experienced a range of neutron fluxes, (3) provide a well in which a receptacle could be placed to aid in retrieving the corrosion specimens which had fallen onto the top screen. Tests run in the shop showed that Zircaloy-2 could be successfully cut with water being used as a lubricant and coolant if the cutter speed did not exceed 60 ft/min. A specially made toolsteel cutter, shown in Figure 7 with cut specimens retained, was successfully tested on samples of core-tank screen material. The long pilot of the cutter was intended to be inserted in the aligned center holes of all six screens. The small wire springs serve to retain the specimens after cutting. A 20-ft-long drive shaft and housing, incorporating a rack and pinion for feeding the cutter, completed the tool. Power was supplied by a low-speed (130-rpm) air drill.

Subsequent examination showed that the pilot had started 1/2 in. west of center and passed through a broken screen. In the drilling process the tool-steel pilot was broken off at the retainer springs. During withdrawal two of the specimens were stripped off the pilot, but the other four came out in the cutter. One of the dropped discs was subsequently retrieved. These five specimens were submitted to the metallurgical examination facility for study. The 2-in. hole through the diffuser screens allowed a specially constructed tilt-mirror periscope with its own light source to be inserted for viewing between the screens. The hole was readily observed and photographed. Because of the restricted space no one position of the periscope gave a good view of the entire hole. Figure 8 is a composite photograph made from pictures taken through the periscope.

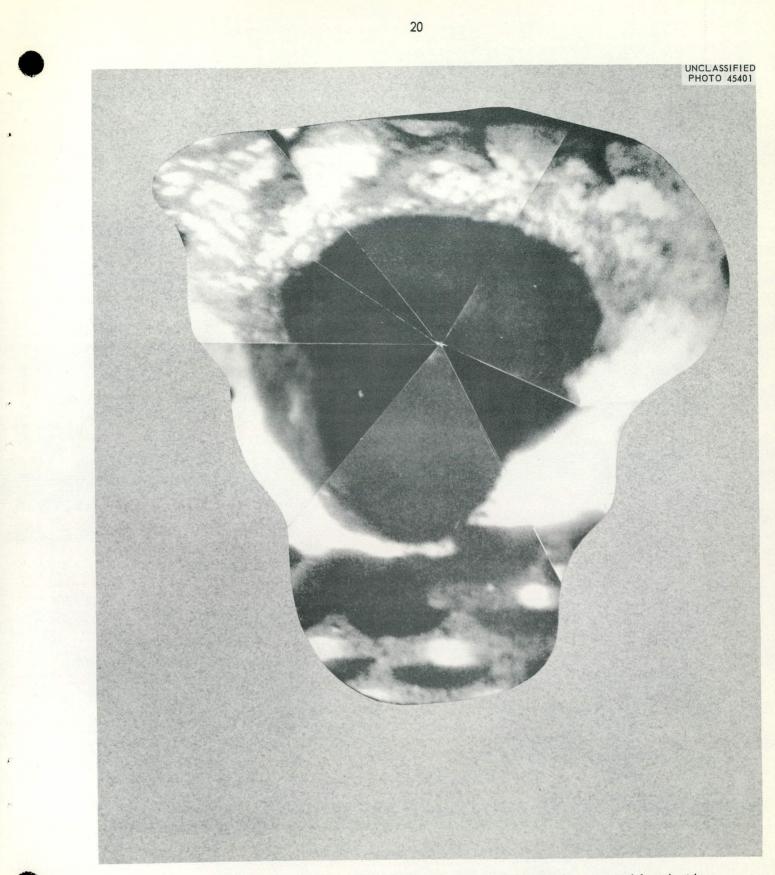
Fig. 8. Composite Photograph of the Hole in the HRE No. 2 Core Tank as Viewed from Inside.

Browning of the periscope lenses reduced the brilliance of the image rapidly, but sufficient viewing time was available to photograph the hole and allow several people to observe it. A second similar periscope was rapidly browned up by further viewing. These were then replaced by a tilting-mirror periscope of the type used previously in the core which supplied an image nearly as clear as that of the new glass scope. This equipment served satisfactorily for three days, allowing study of the nature of the hole, and providing the photographs shown in Figure 6. Owing to the limited field of view in the 2×4 -in. mirror, it was necessary to take three pictures to bring out the detail of the hole and the tail that extends below it. The silhouette of the core vessel can be seen at the left side of the image in the mirror.

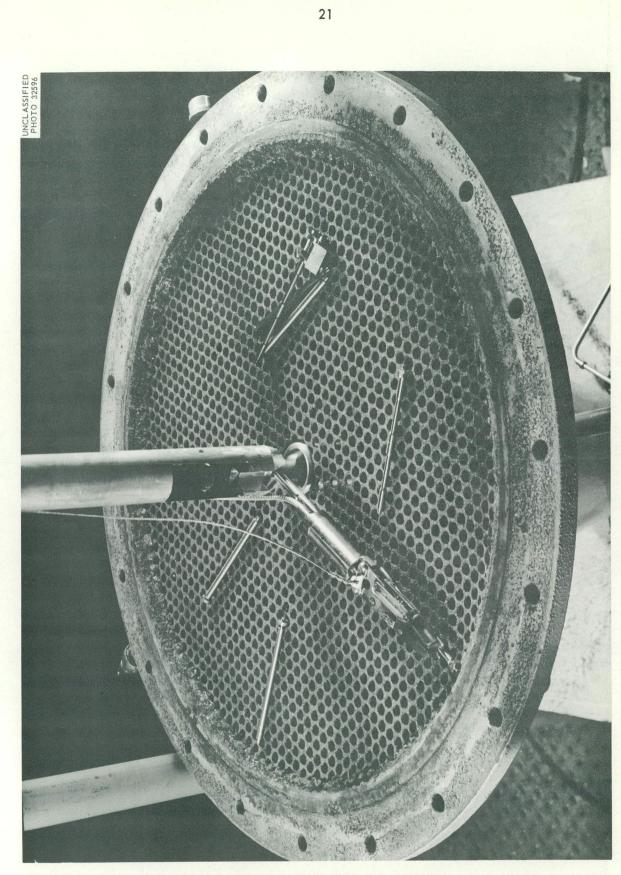
Fig. 9. Corrosion Specimen Recovery Tool.

One approach combined an essentially standard tilt-mirror periscope and a pair of remotely controlled fingers to pick up the corrosion specimens. The original model is illustrated in Figure 9 in operating position over a screen mockup prepared for the purpose.

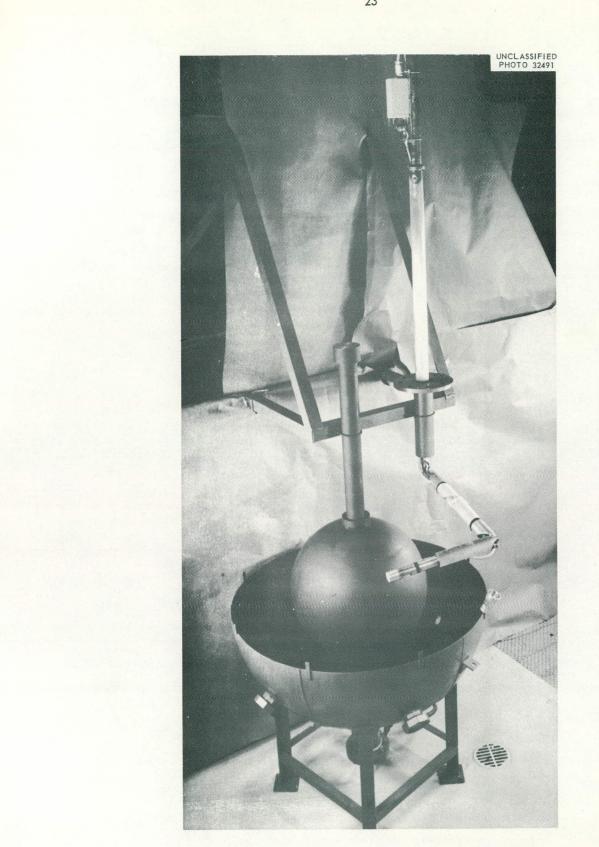
Fig. 11. Television Viewing Device Inserted in Core Mockup.

The television viewing device, although thoroughly tested in the mockup and found to operate quite satisfactorily, was never inserted in the reactor since the hole was observed with simpler and less expensive equipment. However, the device (Fig. 11) has many features of general interest.
