Phil  
10/5

RECEIVED BY DTIE OCT 5 1967

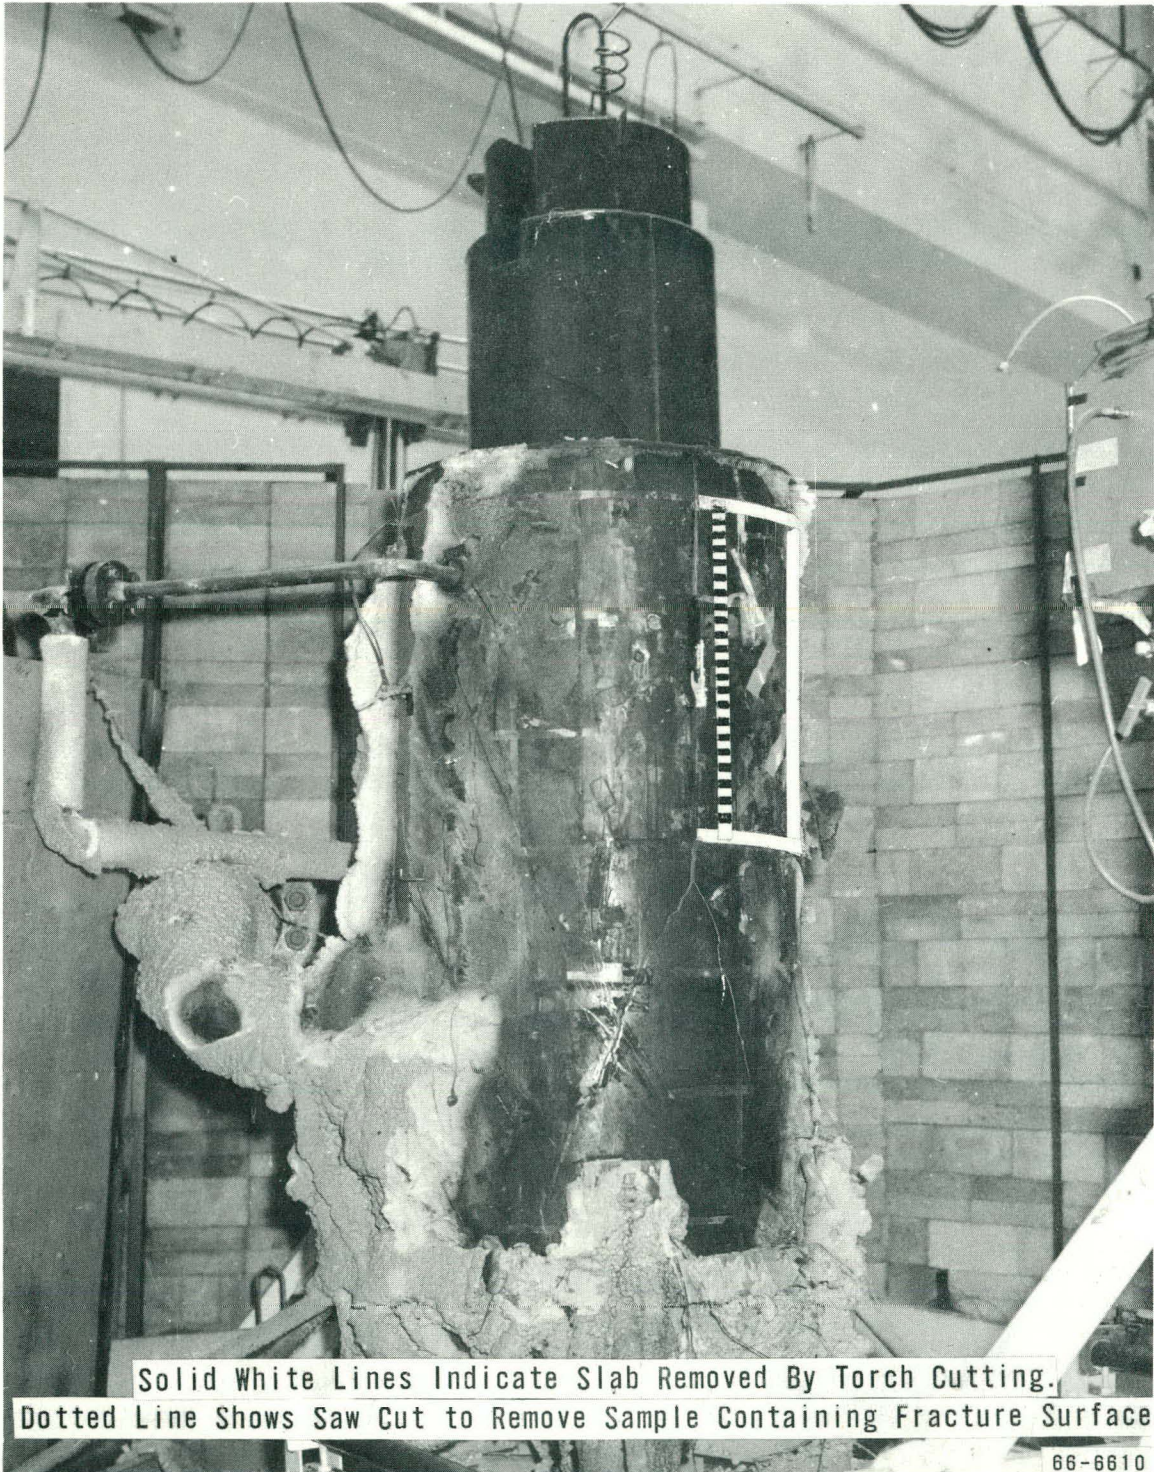
Pressurization to 5250 psi at -20°F with the large defect present, including several hundred cyclic pressurizations in an attempt to introduce fatigue damage, did not produce failure. Accordingly, resort was made to stress corrosion cracking to sharpen and deepen the root of the defect.

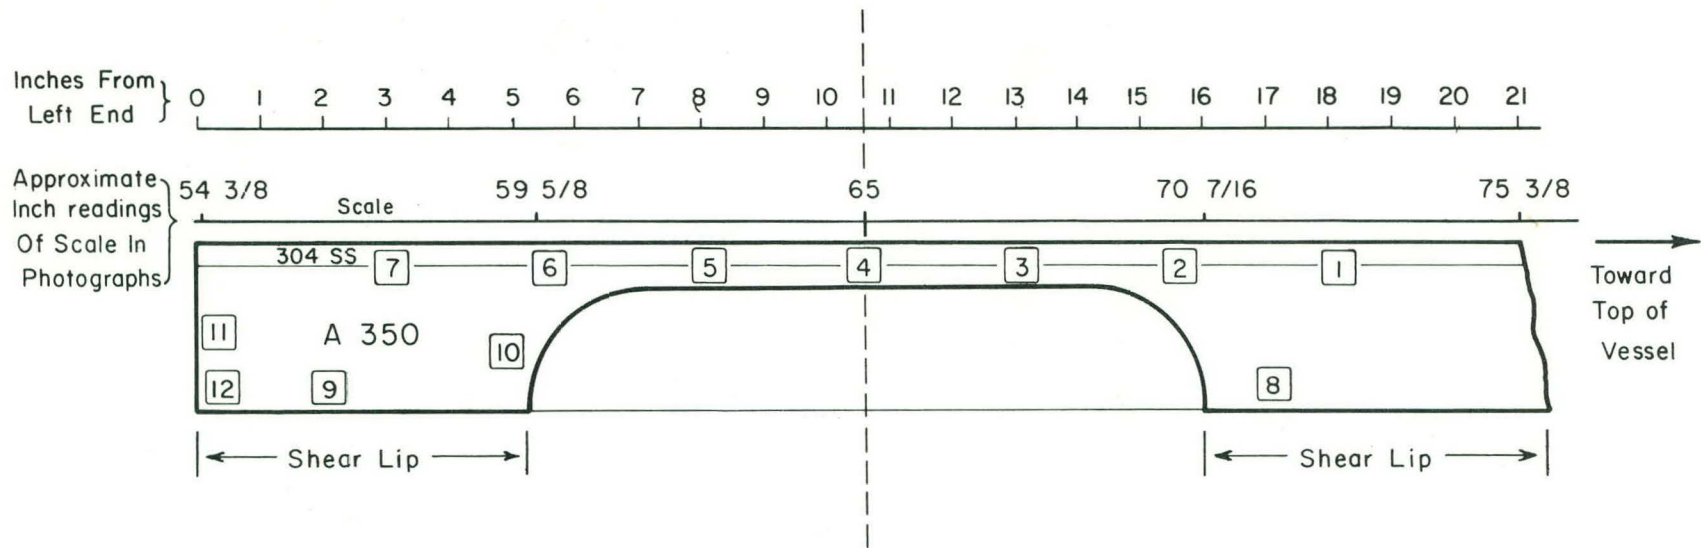
Sketch of Sampling Positions on Fracture Surface of PM-2A.

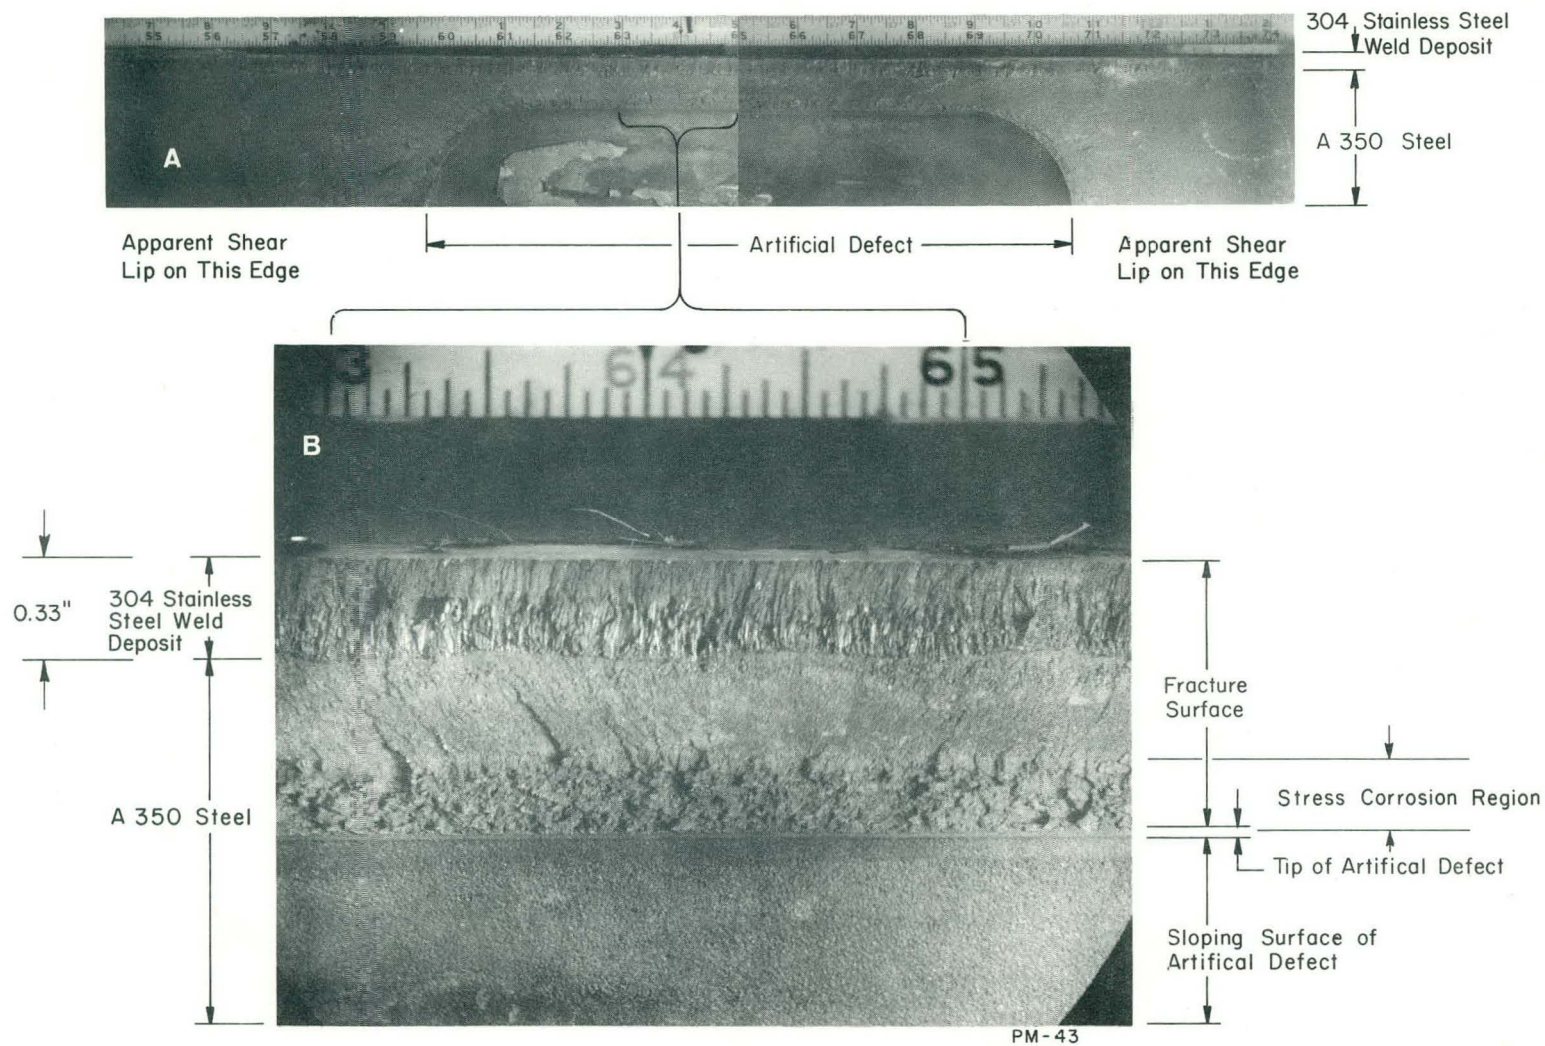
Figure 3 (A) Overall View of Fracture Surface Including Artificial Defect. (B) Magnified View (3x) of Region Containing Origin of Fracture. Note the "chevron" Lines Sloping Toward the Origin of the Fracture and the Jagged Tear Reg on Next to the Artificial Defects, and that the Chevron Lines do not Penetrate the Stress Corrosion Region.

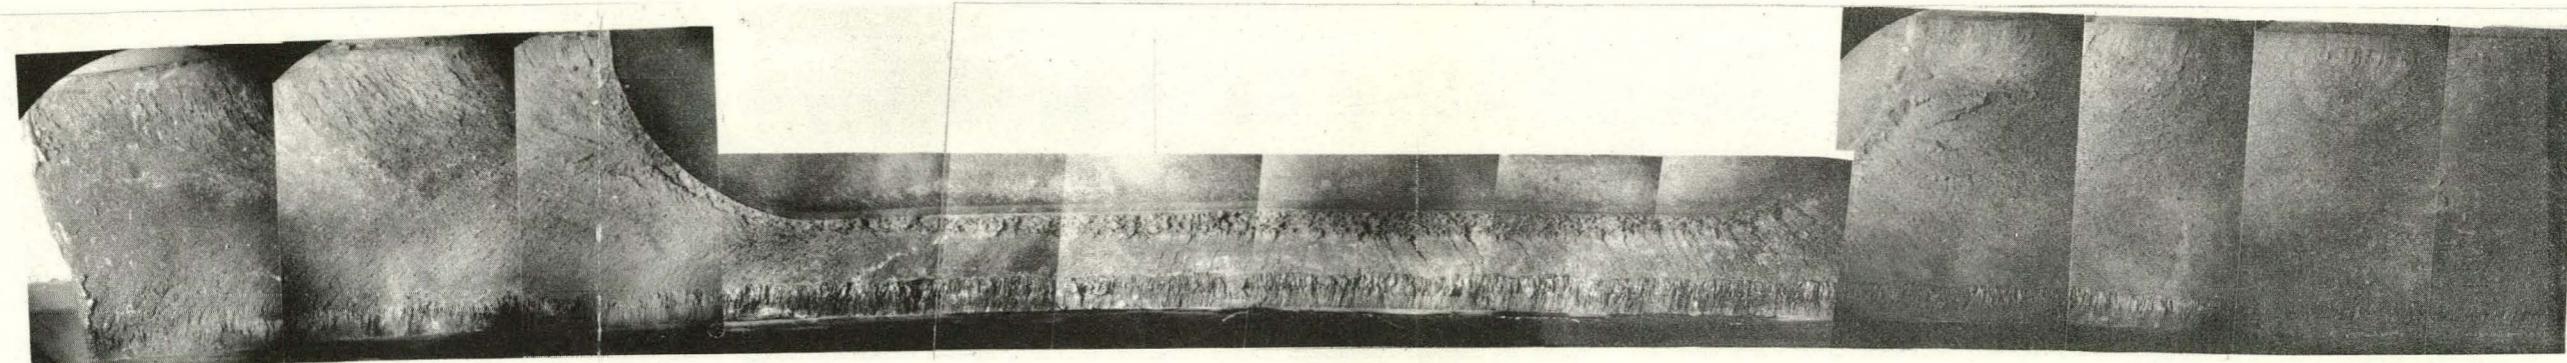
Several pieces of evidence were used in finally assigning a boundary to the extent of the stress corrosion cracking which preceded the final destructive test. Visual observation and color photographs revealed a region characterized by the reddish-brown color of oxidized iron, roughly outlined by the dotted line in the tracing, Figure 5. It will be noted in Figure 4 as indicated in Figure 5 that the oxidized surface is most extensive in the lower end of the artificial defect and tapers to almost nothing at the upper end. Almost all of the "rusty" area also showed a distinct roughness ("mountains and valleys") most clearly observable and impressive if Figure 8 is viewed in stereo. Still another experimental observation is the fact that the chevron marks (one is shown in Figure 8) do not enter the rough region.

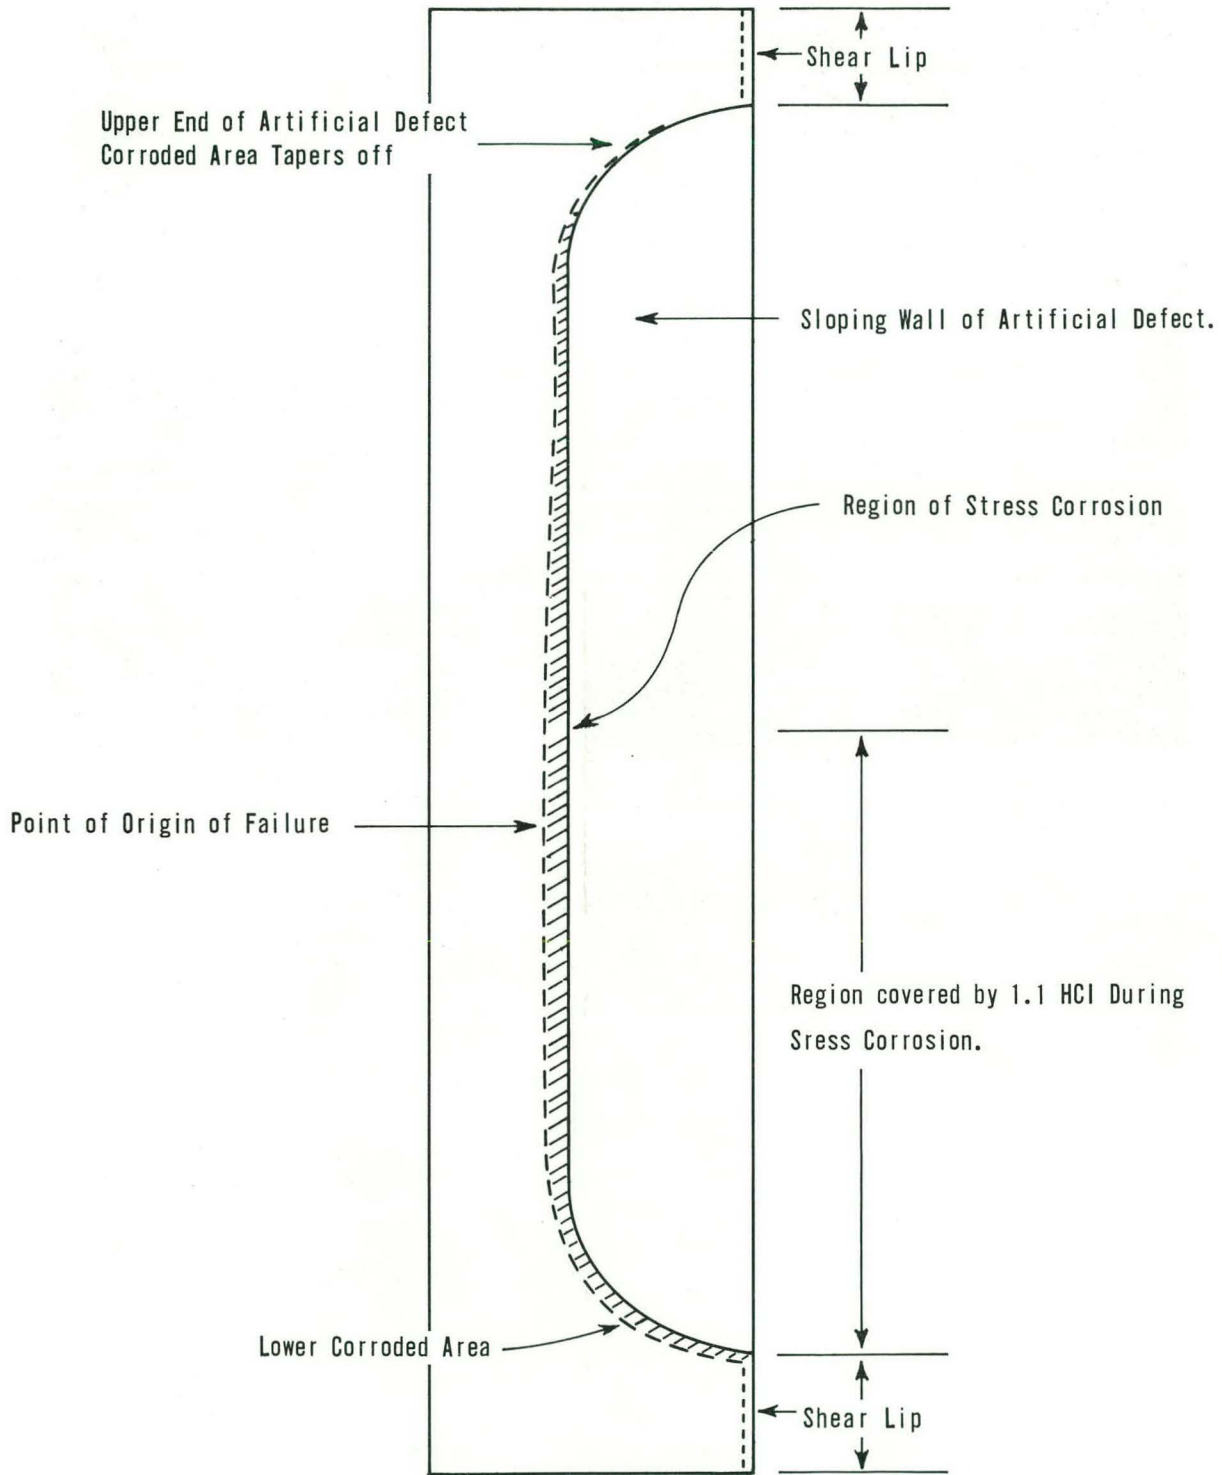
Tracing of Artificial Defect and Crack Origin Region

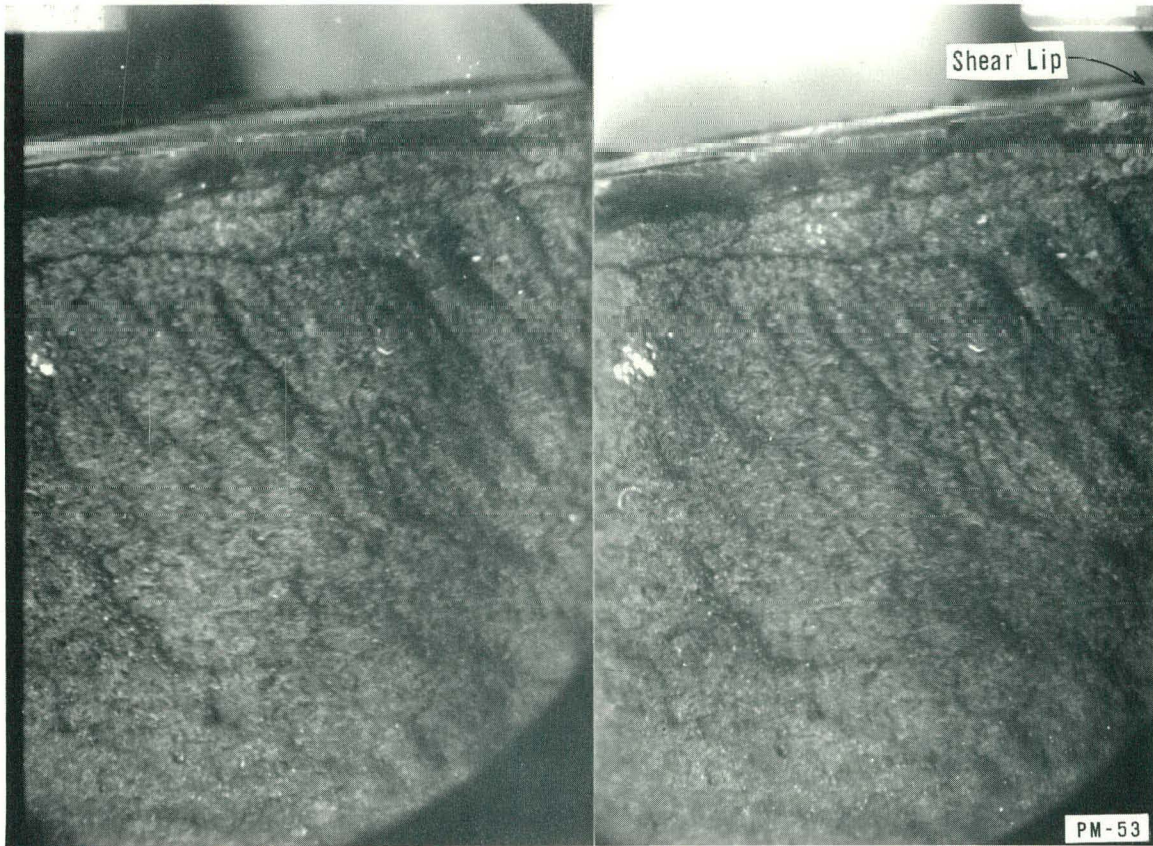
FIG 6. Stereophotograph of Shear Lip. 3 x

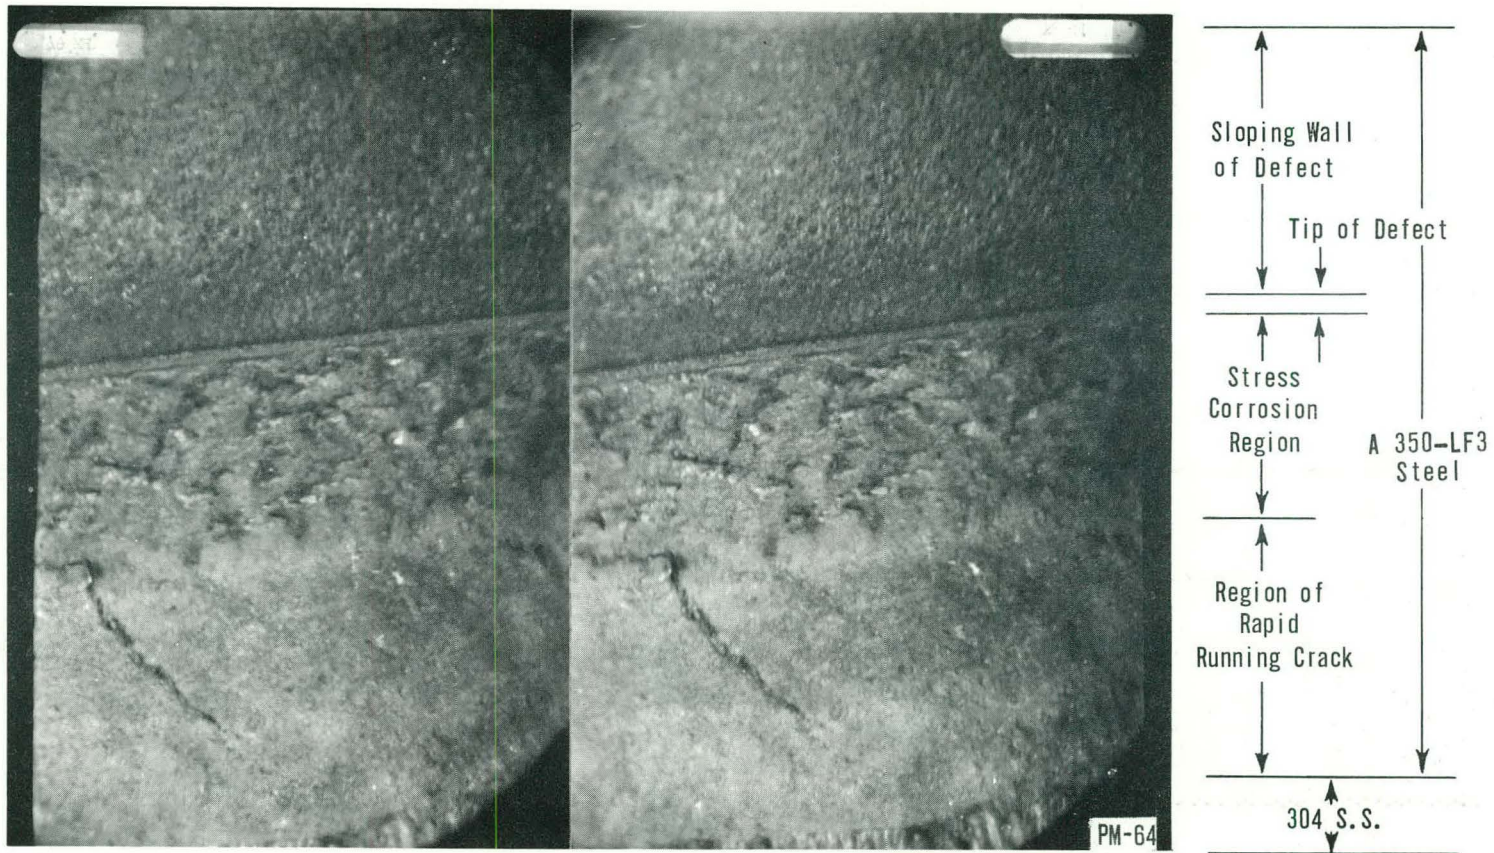
Stereophotograph of Fracture Surface, Showing Defect, Stress Corrosion Region ,  
Rapid Running Crack and Edge of Stainless Steel Liner. Note That Chevron  
( Lower Left Hand Quadrant of Photo ) Does Not Enter Stress Corrosion Region. 3 x

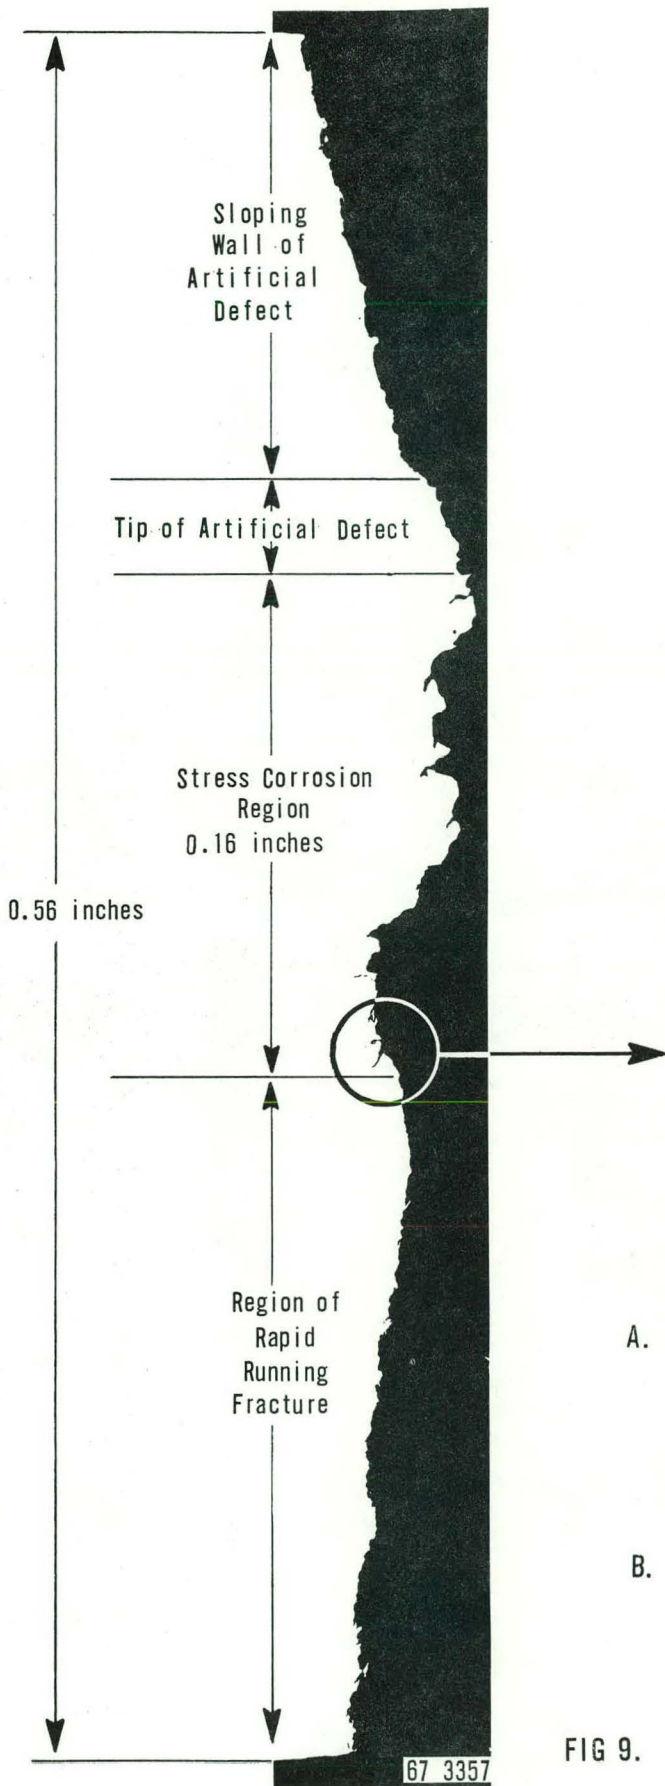
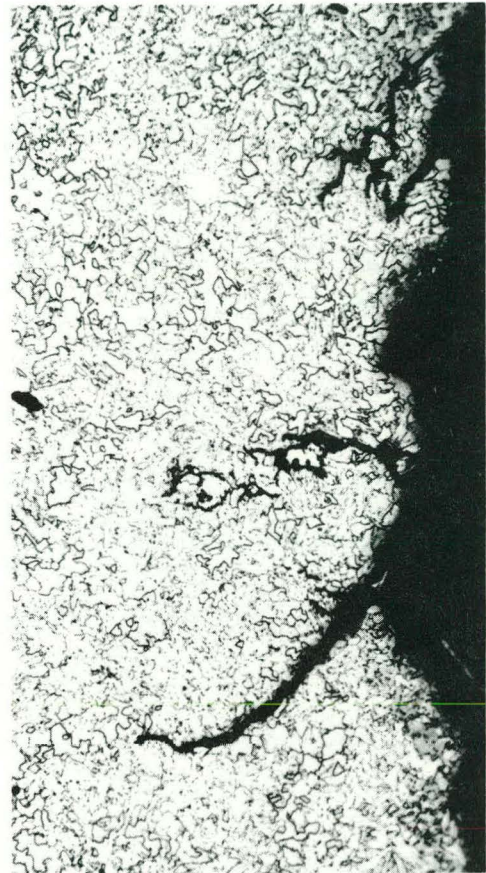
- A. Profile of Part of Artificial Defect and Fracture Surface, Including Sloping Wall and Tip of Artificial Defect, Stress Corrosion Region and part of Rapid Running Fracture.
- B. Photomicrograph of a few of the Branching Stress Corrosion Cracks.

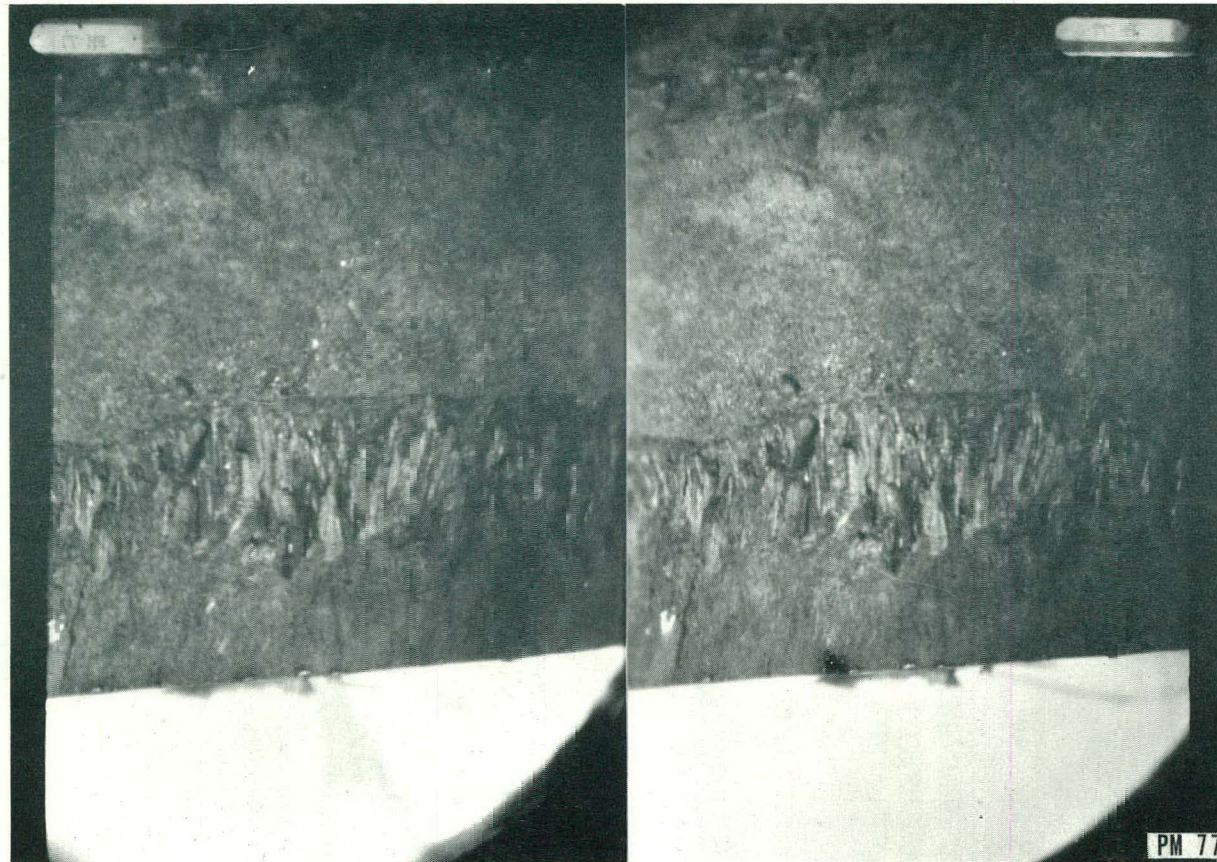
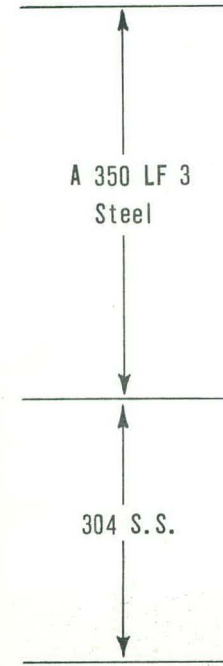
Stereophotograph of Fracture Surface Across Stainless Steel Weld Deposit.  
Note Faint Traces of Shear Lip.

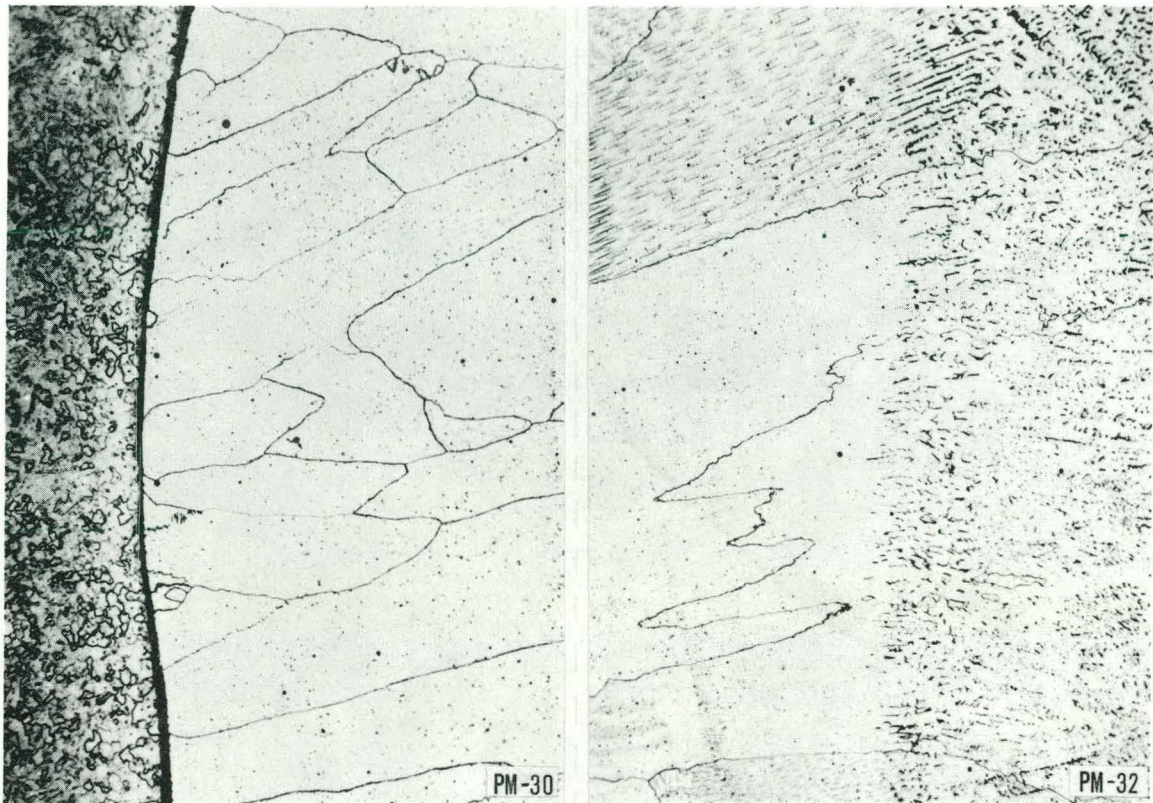
A. Boundary Between A 350 LF 3 Steel and B. Boundary Between Two Regions of 304 S.S.  
 304 Stainless Steel, With Large  
 Columnar Grains in the 304 S.S.

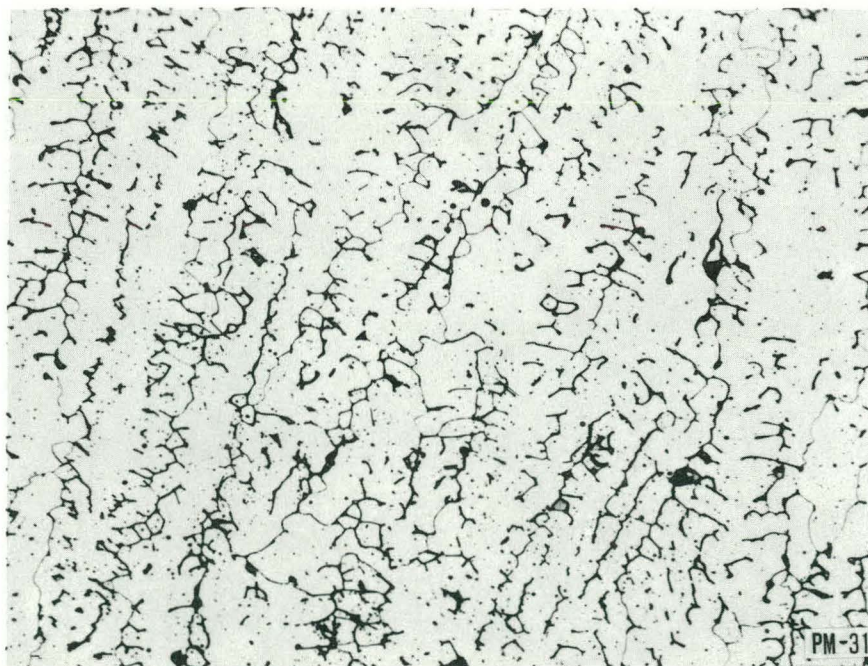
C. Finer Grained Dendritic Structure of Outer Layer of 304 S.S.

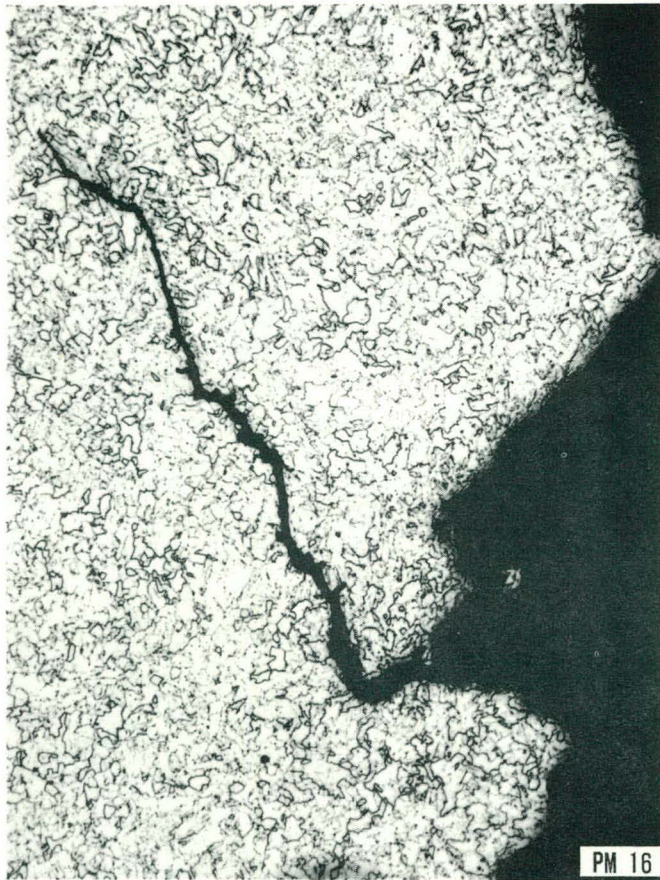
A. A Region Free of Inclusions. A Stress Corrosion Crack is Present. Nital Etch. 200 x.

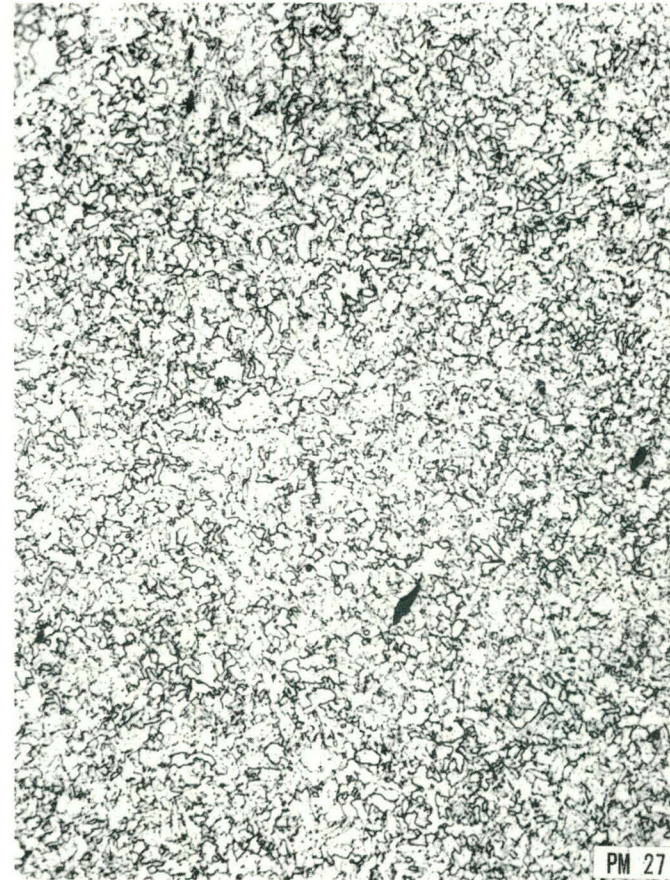
B. A Region Containing Typical Inclusions, Nital Etch. 200 x.

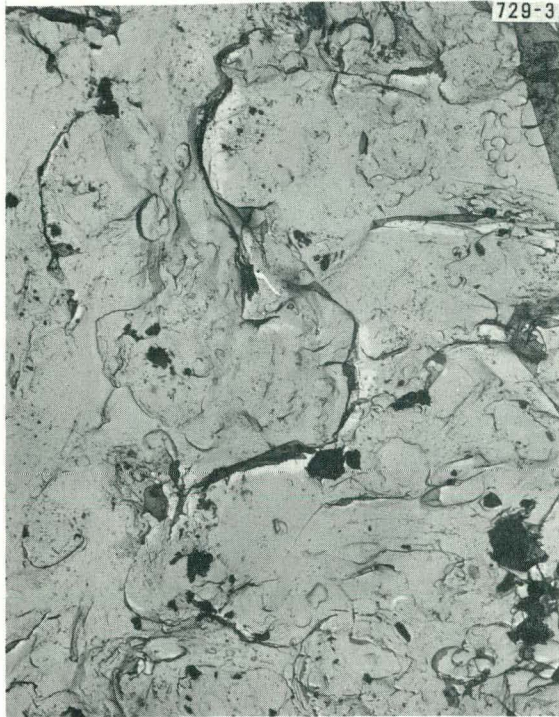
A. Region 4 of Figure 3. 3340 x.

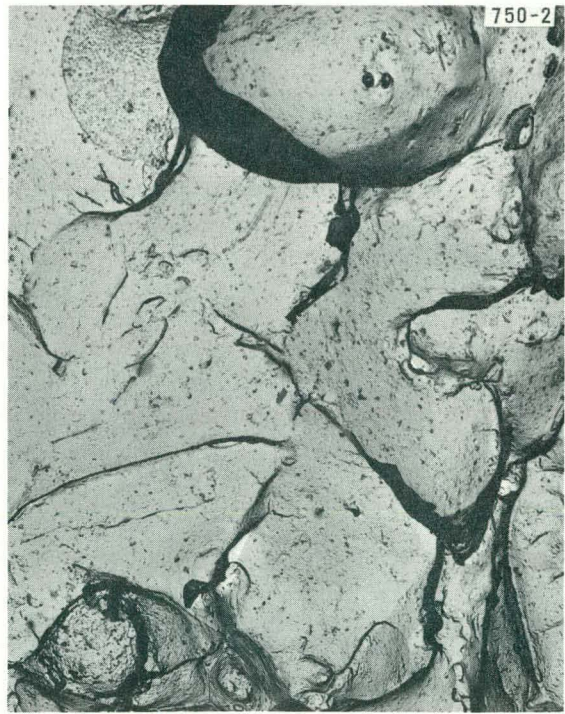
D. Region 9 of Figure 3. 7980 x.

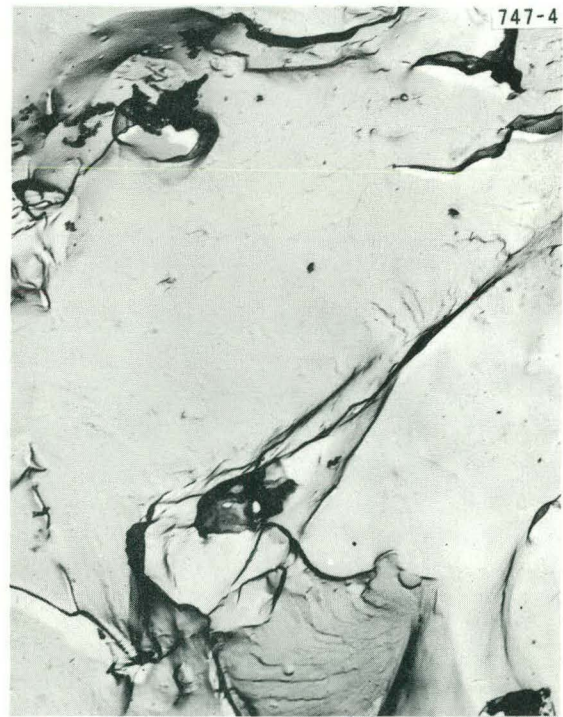
H. Region 2 of Figure 3. 7980 x.

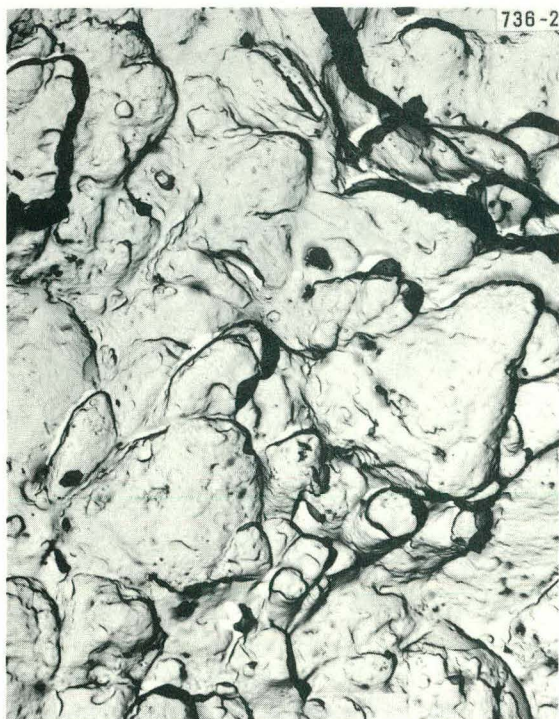
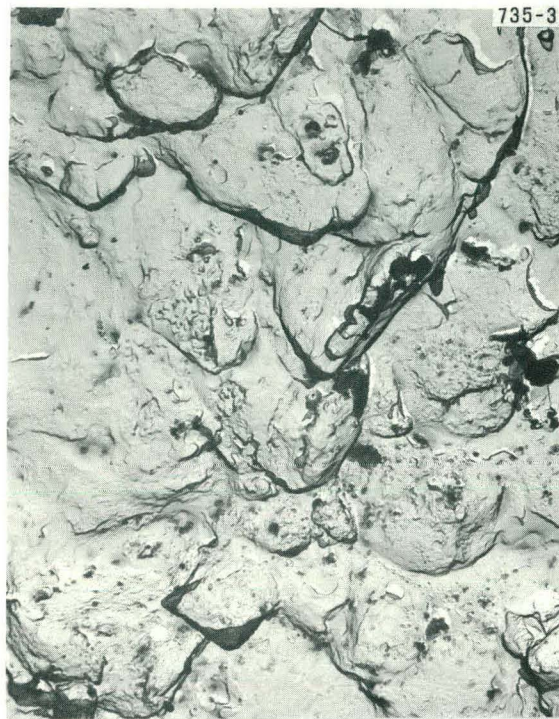
Electron Fractographs From Shear Lip From Region 8 of Figure 3. 7980 x.

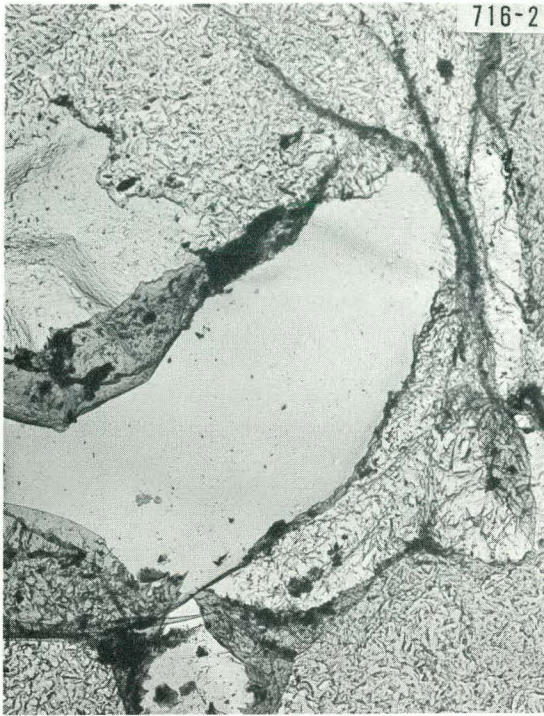
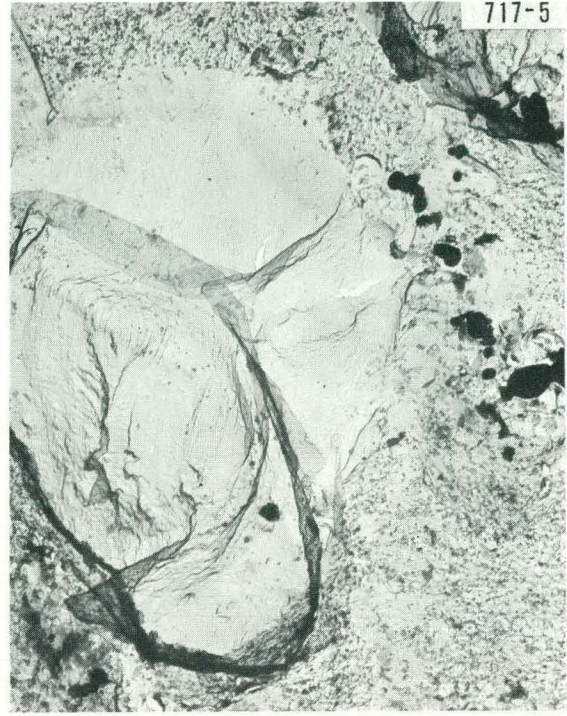
A. 7980 x Both Cleavage Planes and Corrosion Products. B. 7980 x

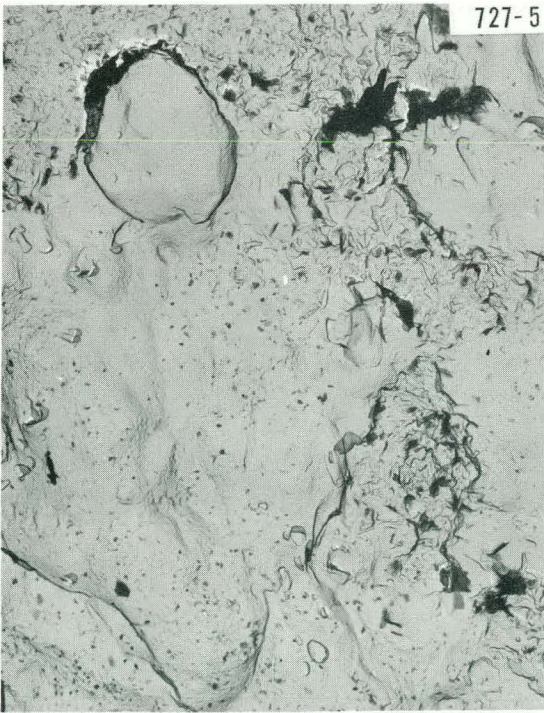
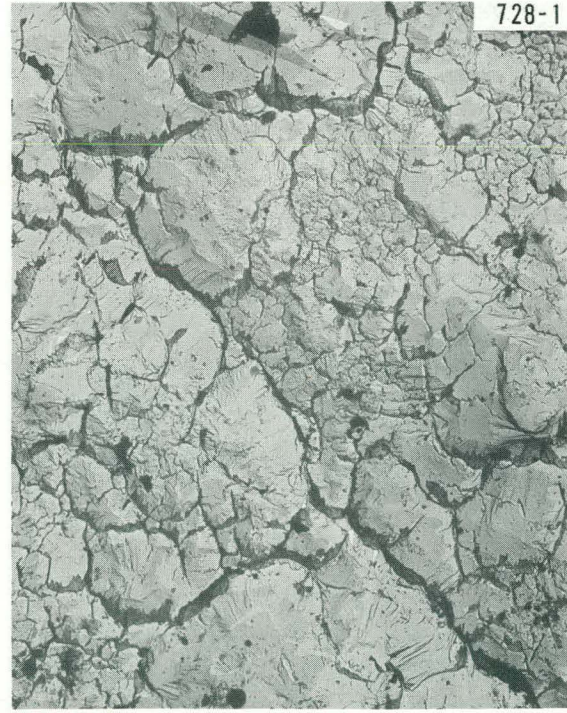
C. 7980 x. Principally Corrosion Products. D. 3340 x.
