Hanford Double-Shell Tank Extent-of-Condition Construction Review - 14174

Hanford Double-Shell Tank Extent-of-Condition Construction Review – 14174

ABSTRACT

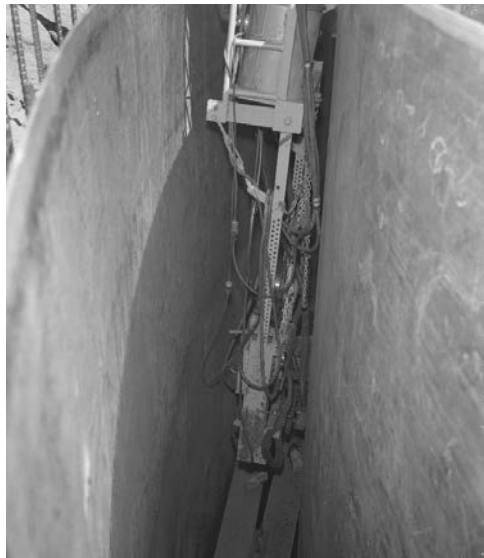
Fig. 3. Challenges in access when welding 241-AY tank farm primary liners.

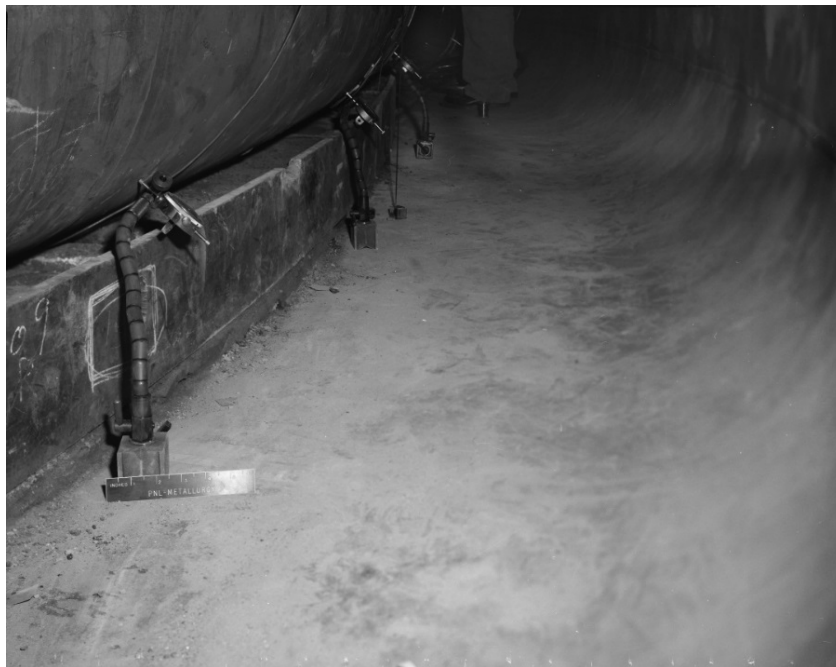
farm, the new contractor used a different plate layout for the bottoms and bulging problems were seen in all of the tanks. In tank SY-101, out-of-tolerance areas were noted and plate repair was attempted, which caused new out-of-tolerance areas to appear. A maximum bump height of 79 mm (3 inches) was measured in the primary tank bottom and the decision was made to support the bottom by filling the bulges with grout. After gaining access through the annulus, two 0.6 meter by 2.4 meter (2 foot by 8 foot) deep sections of the refractory were cut out and refilled with grout. In tank SY-103, out-of-tolerance bulging in several areas was found, up to 6 mm per meter (13/16 inch per foot). Computer modeling of the bulge indicated that excessive stresses might be seen in the lower knuckle. Eventually an empirical solution was used which included strain gage monitoring and acoustic testing during the hydrostatic test. These tests determined that stresses from flattening the bulges were acceptable. A picture of the strain gage monitoring is shown in Figure 4. Additional non-destructive testing was conducted on the primary tank during and after hydrostatic testing such as liquid penetrant examination, magnetic particle testing, and visual examinations.

Fig. 4. Strain gage monitoring in tank SY-103 to assess impacts from primary bottom bulges.

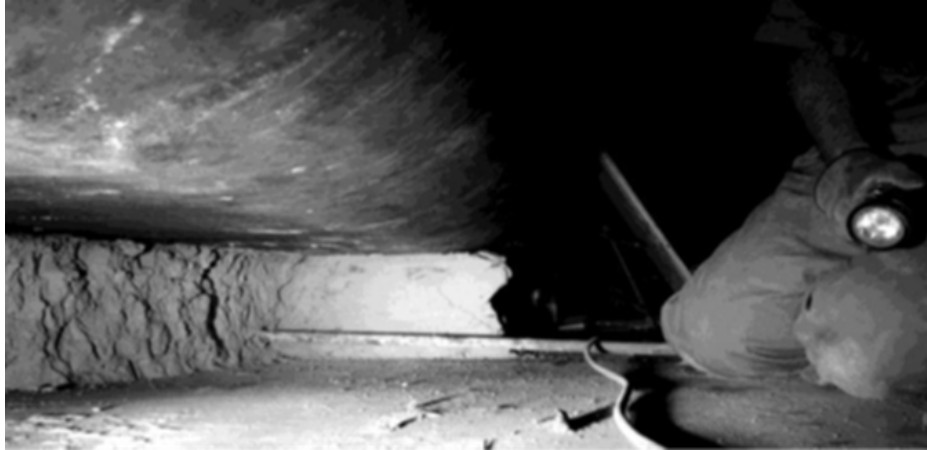
Castable refractories are typically poured or “gunned” into place. After air drying or “curing,” the refractory is then “fired” or heated to high temperatures to convert hydrated compounds into a more durable, de-hydrated, ceramic structure. During the initial air-drying and until the firing is completed, protection from freezing and water saturation is important. During construction of the 241-AY tank farm, there were problems with both of these protections. After heat treatment and hydrostatic testing, the refractory material in both tanks was found to be badly cracked and degraded, caused in some part by poor weather protection. Concerns about lack of support in the high-stress knuckle region led to the decision to remove ~533 mm (21 inches) of the refractory and replace it with structural concrete in both tanks. Given the location and access constraints, the effectiveness of this repair and proper concrete placement was identified as a concern during the leak assessment of tank AY-102. As previously mentioned, voids from primary bottom bulging that were beyond the ~533-mm (21-inches) perimeter were filled with foam prior to placement of the structural concrete repair. See Figure 5 for pictures of the refractory repair in progress on tank AY-101.

Figure 5. Refractory repair under bottom knuckle of tank AY-102.

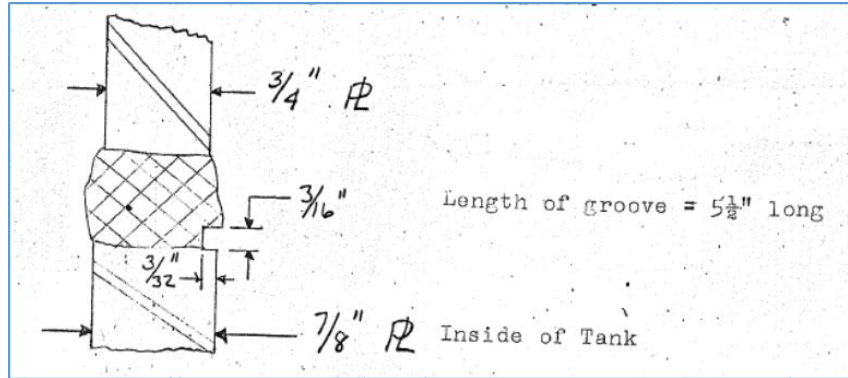
Both tanks AZ-101 and AZ-102 had leaks found during hydrostatic leak testing in the upper knuckle section above the maximum waste level. As the tank had already been subject to stress relieving, these weld repairs were performed without additional stress relief. An unrepaired weld grind-out was found in the lower knuckle weld seam in tank AZ-101 during final inspection. The groove, sized at approximately 140 mm long by 5 mm wide by 2 mm deep (5-1/2 in. long by 3/16 in. wide by 3/32 in. deep), (see Figure 6) was accepted based on expert opinion. The logs also mentioned that two fires occurred during construction in the annulus of tank AZ-102 and in the bottom of the primary tank in tank AZ-102, but the job logs did not indicate that any significant damage was caused by these two fires. The fire issues are not expected to significantly affect the tank integrity.

Figure 6. Unrepaired weld grind-out at lower knuckle of tank AZ-101 (construction deficiency report).
