# Final Report on PCRV Thermal Cylinder Axial Tendon Failures

FINAL REPORT ON PCRV THERMAL CYLINDER  
AXIAL TENDON FAILURES

D. A. Canonico, J. C. Griess, and G. C. Robinson

JANUARY 1976

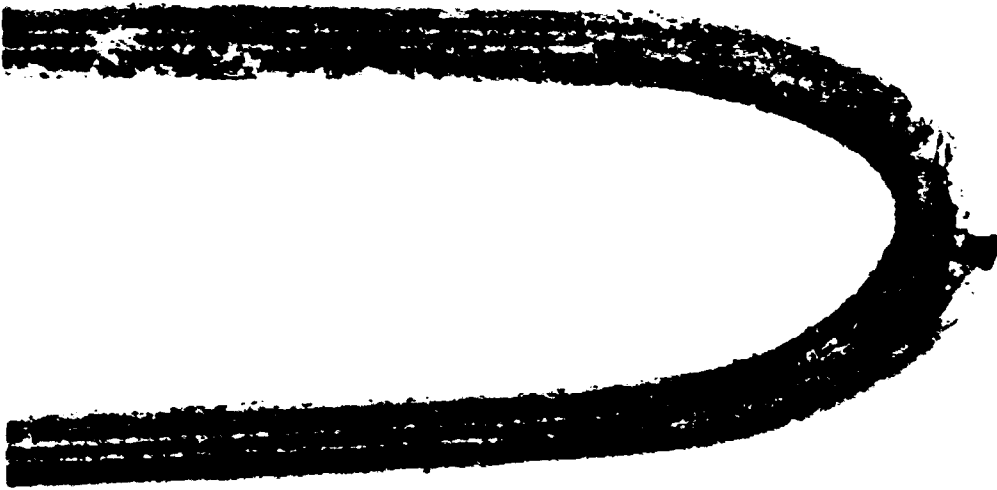
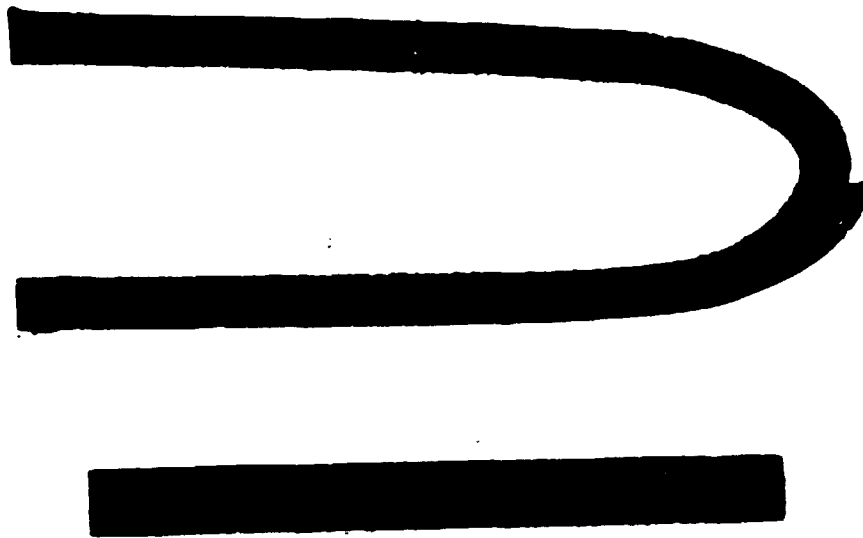
Cracking was noted only in the 0.2 and 2.0 M ammonium nitrate solutions. In the 0.2 M solution at  $70^\circ\text{C}$  duplicate specimens cracked in three days. Under the same conditions the one specimen exposed to the 2.0 M solution cracked in the time interval between 7 and 10 days. A failed specimen is shown in Fig. 4. Failures in the other two U-bend specimens looked almost identical to the one shown. The one specimen exposed to the saturated solution of ammonium nitrate at  $70^\circ\text{C}$  did not crack during the 94-day test.

Fig. 4. Failed U-bend Stress-Corrosion Specimen. This specimen failed in a 0.2 M ammonium nitrate solution in 72 h. at 70°C.

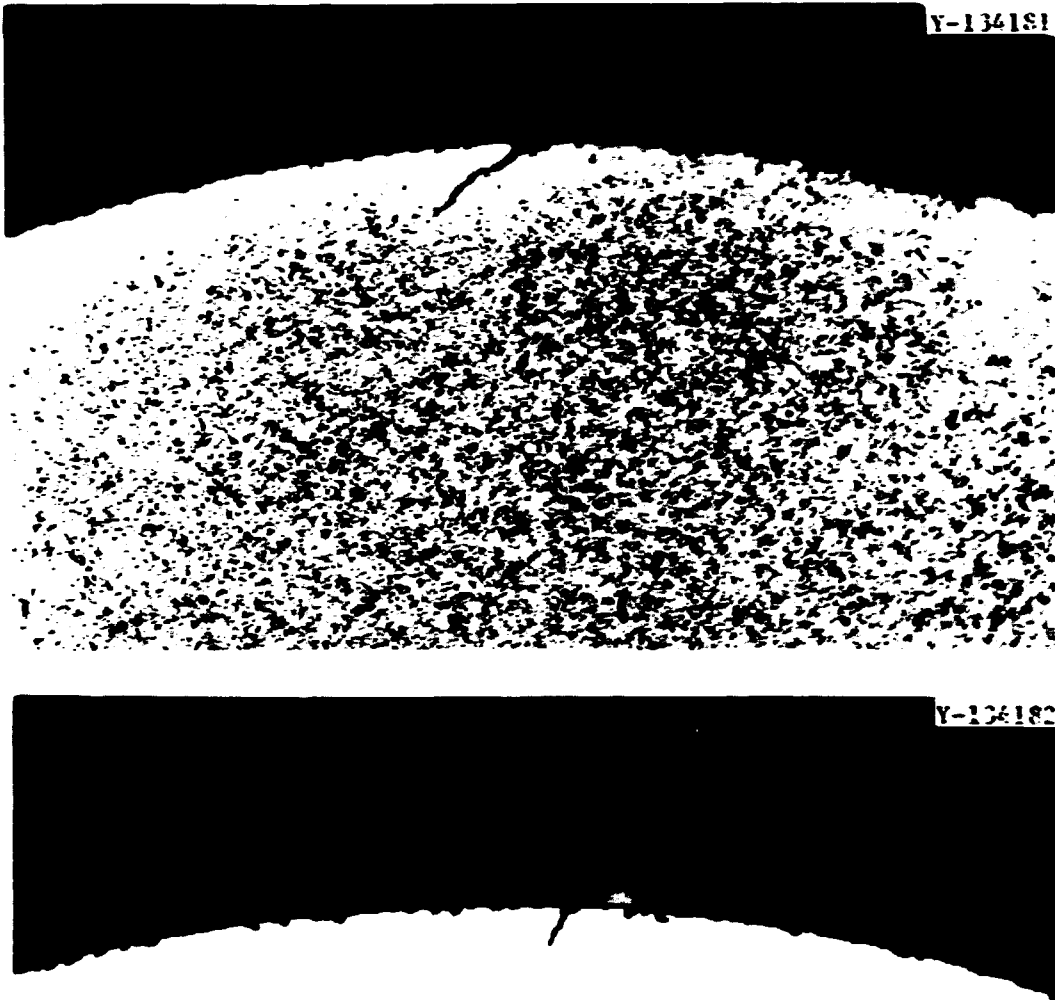
During the course of this investigation, numerous incidences of poor wire quality were noted. Some of these observations were previously<sup>5</sup> reported. Since the release of the interim report additional studies of randomly selected wires have revealed that the wires in the tendons used in the thermal cylinder test were of questionable quality. Locating defective areas in the wires is fortuitous. Radiographic examinations of randomly selected wires removed from archive (unused) tendons did not reveal any evidence of defects in the wires. However, metallographic examination of these "acceptable" wires revealed fine hairline cracks. Figures 7 and 8 contain typical photomicrographs of the types of defects observed. These cracks are not detectable by the usual examination standards. The most damning evidence was obtained during the centerless grinding of the wires before the preparation of the U-bend stress corrosion test specimens. During grinding one wire sample separated into two pieces; a metallographic examination of the wire revealed the quality shown in Fig. 9. These fissurelike cracks could serve as both locations for concentrating any contaminants present and stress concentrating sites. Thus, these cracks could have contributed to the failures observed in the thermal cylinder test.

**Fig. 7. Surface Defects in a Wire Used in the Manufacture of Tendons. 100 $\times$ . These surface laps could serve as concentrating sites for contaminants that cause stress-corrosion cracking.**

2. A critical assessment should be made of the wire(s) that are used in prestressing tendons. There is evidence that suggests that the wires used in the manufacture of the ASTM A 416 tendons employed in the Thermal Cylinder Experiment were of questionable quality. A study should be undertaken to determine whether or not the wires used in this study represent current metallurgical quality.
